**FINAL INVESTIGATION REPORT
ON ACCIDENT TO AIRBUS AS350 B3 HELICOPTER
VT-HDX
AT MOLDI VILLAGE ON 21st AUGUST 2019.**

**GOVERNMENT OF INDIA
MINISTRY OF CIVIL AVIATION
AIRCRAFT ACCIDENT INVESTIGATION BUREAU**

**FINAL INVESTIGATION REPORT ON ACCIDENT TO
M/s HERITAGE AVIATION PVT. LTD. AS350 B3 HELICOPTER VT-HDX
AT MOLDI ON 21st AUGUST 2019**

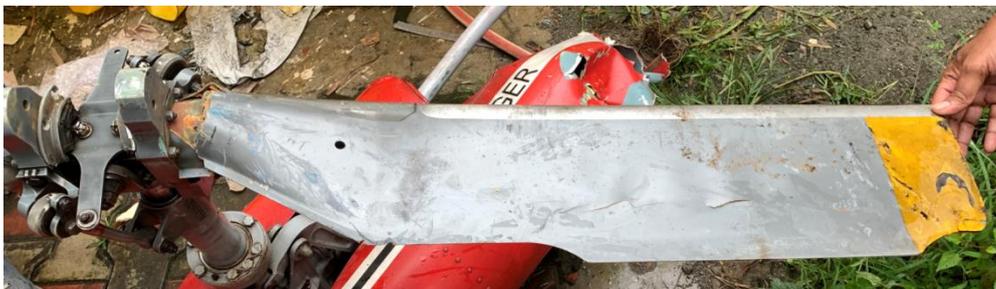
A tail rotor blade in full with consequential impact damages

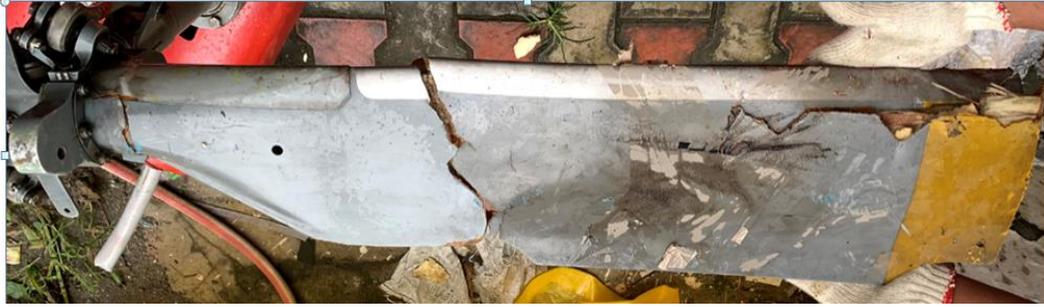
Sheared off tail rotor blade

The tail portion otherwise suffered minimal damages (only during rolling down hill)

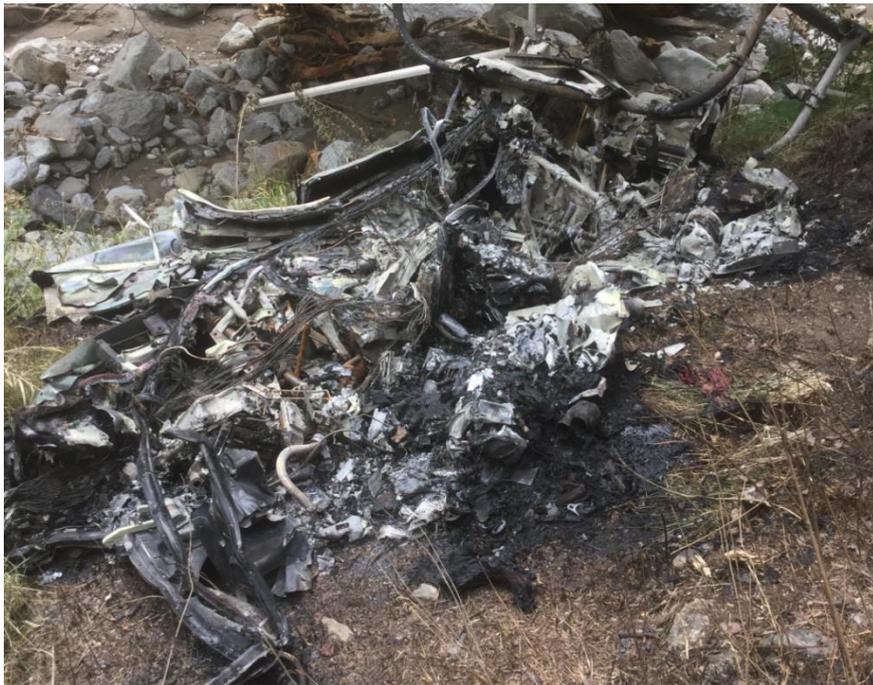
Cockpit portion

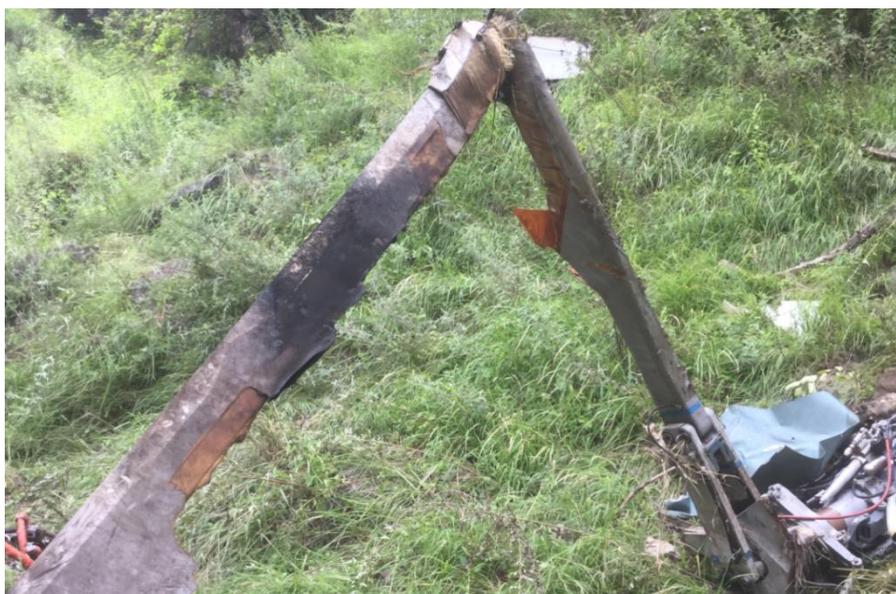
Main Rotor Blade (Blue) (location disturbed during rescue operation)

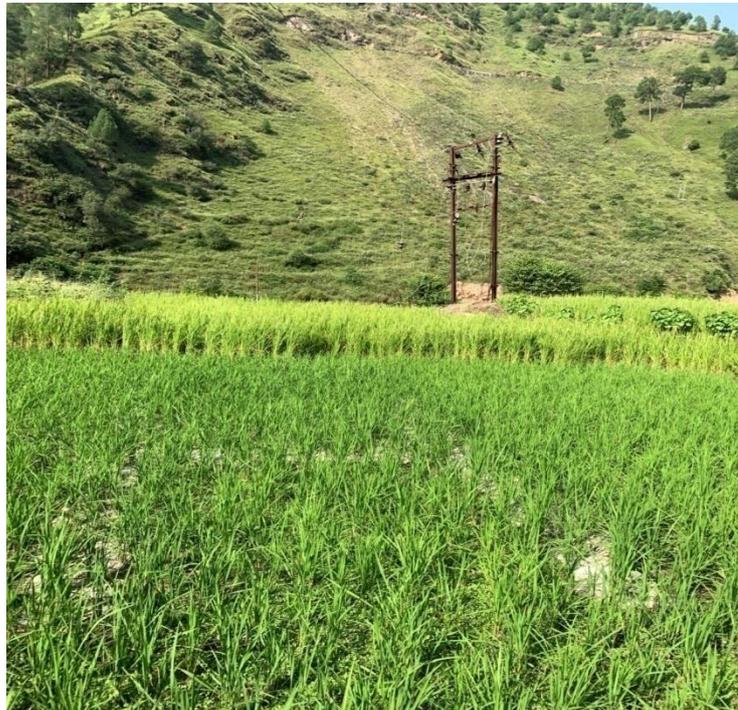
The helicopter took off from a helipad where there was no possibility of taking off in the forward direction because of a pole in front and power cable running on one side with houses on other side.

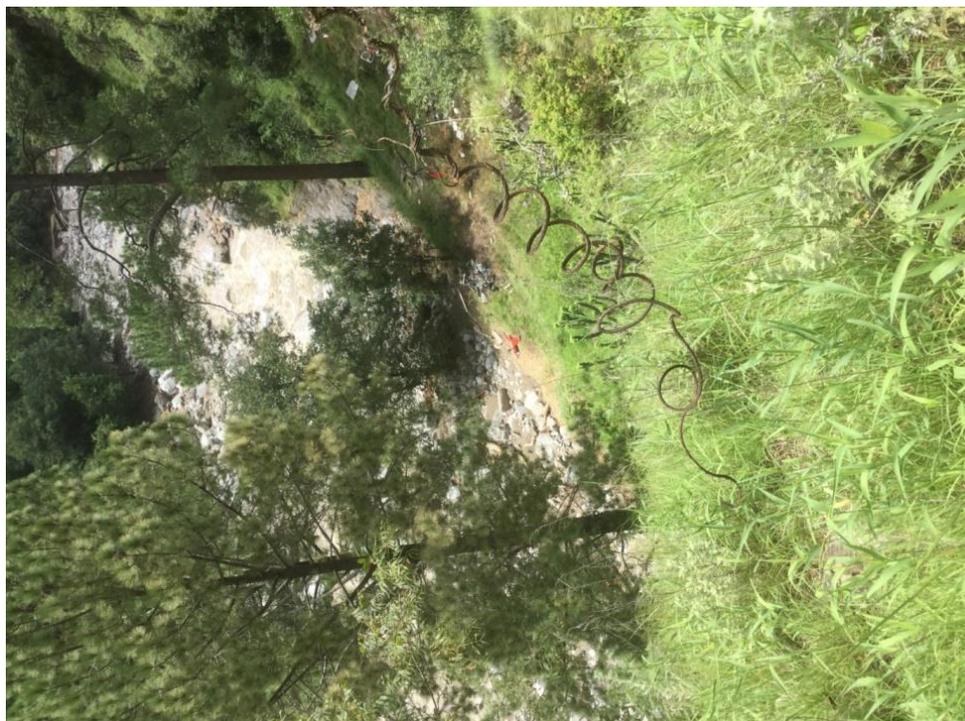
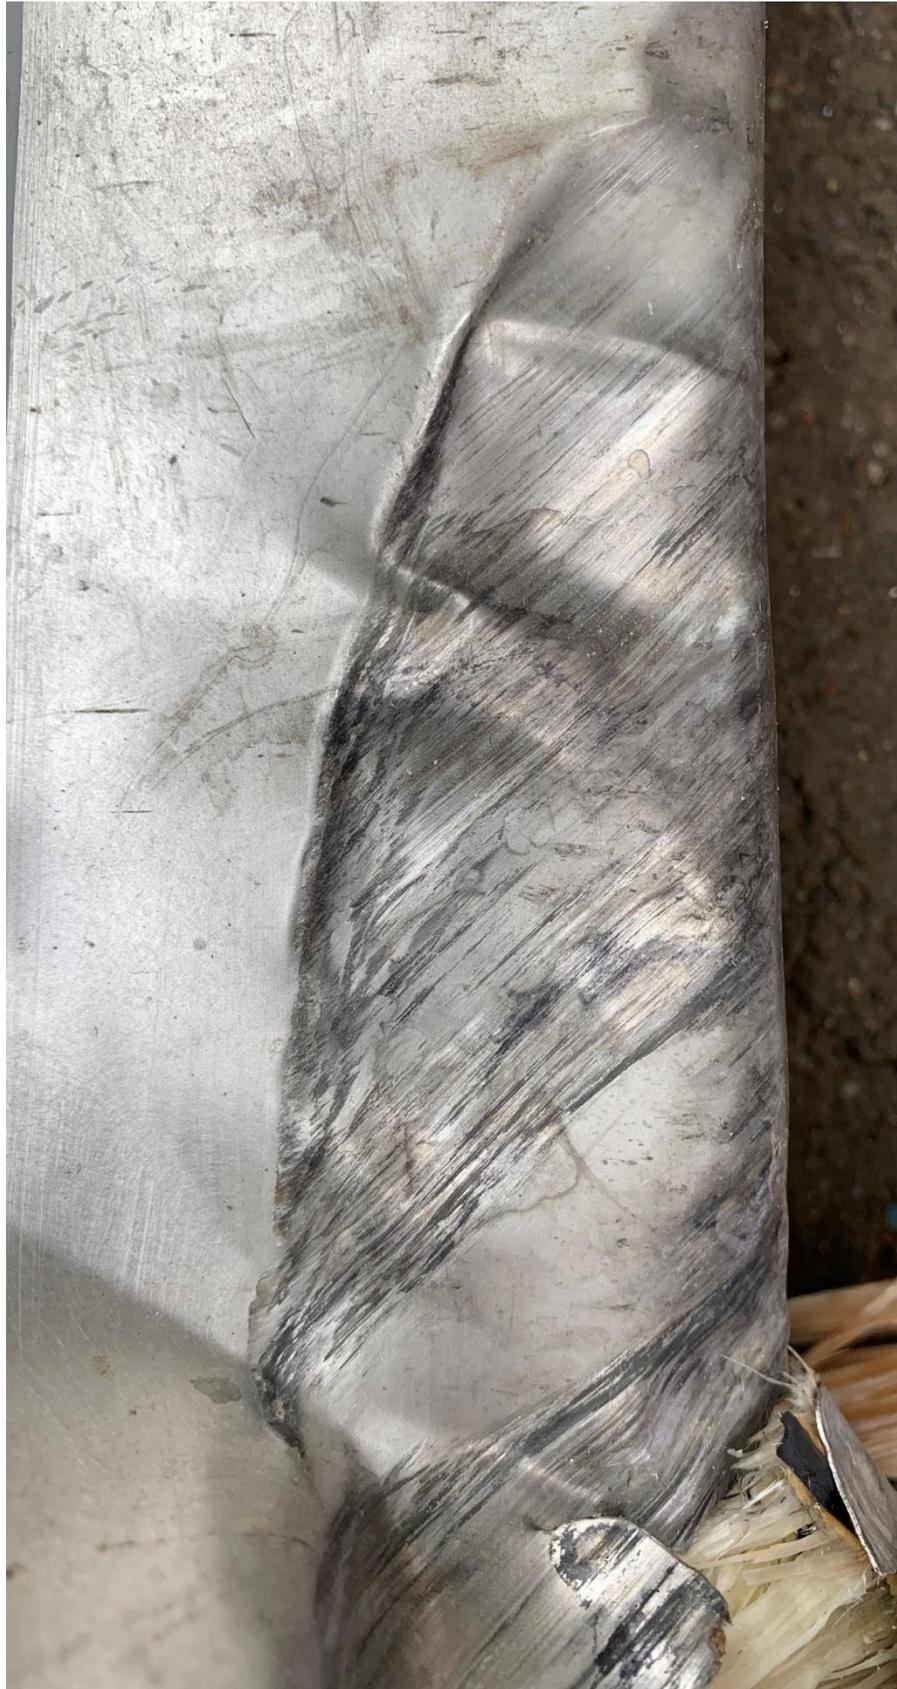
Rubbing marks of trolley cable on LE of main rotor blades

The helicopter on completion of 180° turn after take off (OGE), impacted the trolley cable while it was in climb mode. The main blades were rotating at full rpm. From the damage to the main rotor blades, it is evident that blue blade was the last to hit the cable as it got and remained entangled with the cable till the breakage of cable. The yellow blade which is ahead of blue blade had got

sheared off from almost the same distance at which the blue blade had impacted the cable. The red blade which was the first to impact took the maximum impact load and got detached from the attachment points at star flex. The patterns of cable rub marks on blue and yellow blades indicated that the cables had rubbed with these blades from tip to root side.

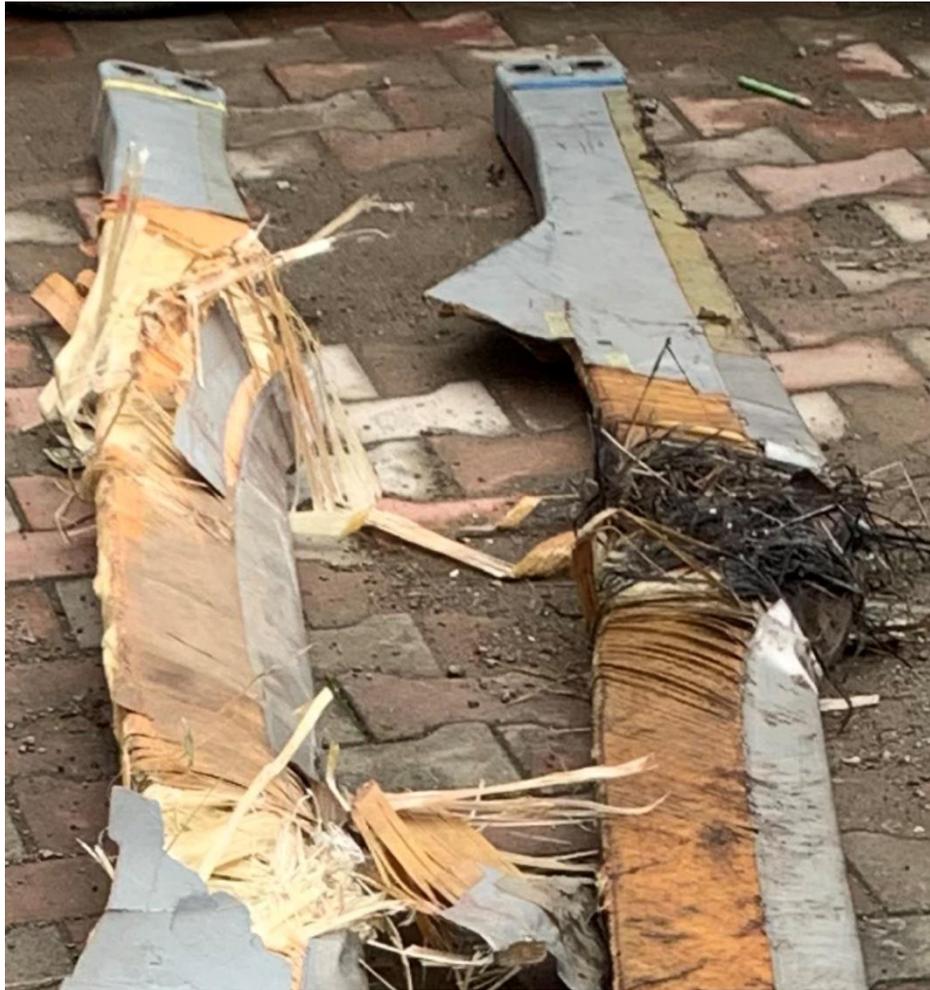
Damages suffered by Yellow and Blue main rotor blades (above)

Close up of the portion of leading edge of main rotor blade blue entangled with trolley cable (below)

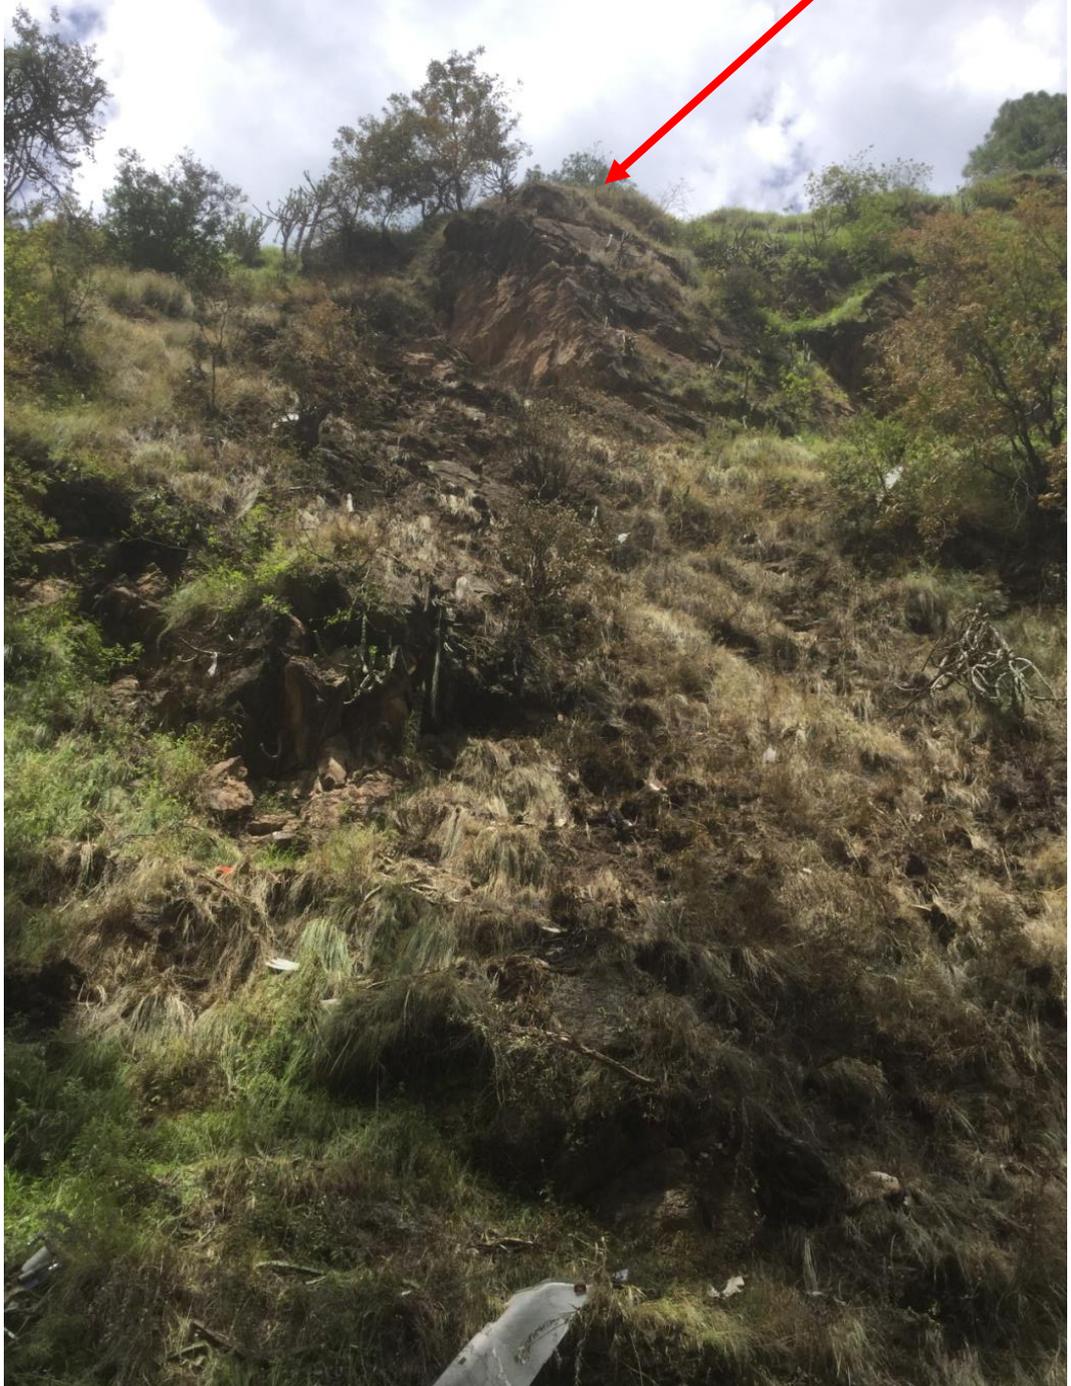
The helicopter hit a hill in the right side of valley.

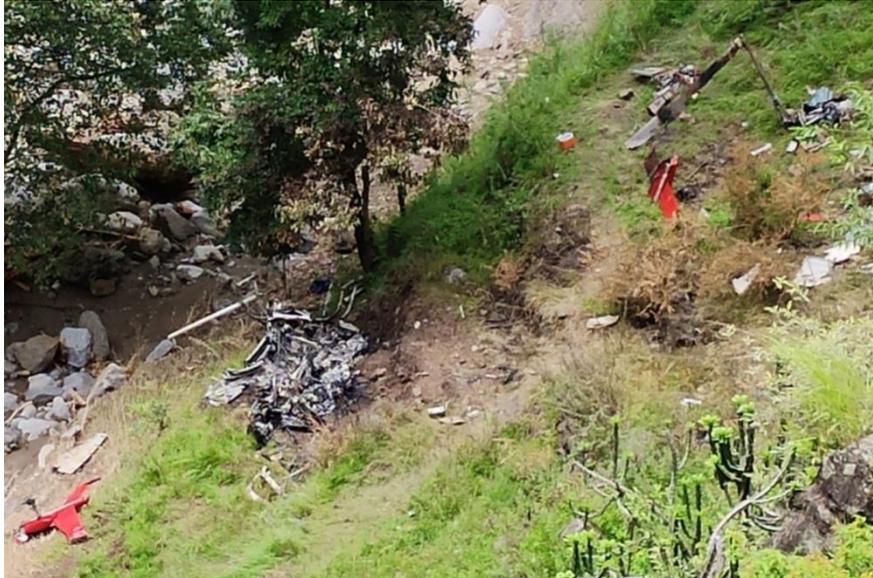
The debris rolled down from the hill and finally stopped at base of foothill. The main fuselage was totally crushed and suffered fire damages. The tail rotor and aft portion suffered minimum damage. One of the tail rotor blades was broken at 35% of its length (from root) and the other blade was of full length. Both pitch change mechanism and TGB mechanism were working satisfactorily. The red main rotor blade had sheared off close to the root section. The blue main rotor blade though attached with the MGB star flux, however, was broken at approximately 470 centimeters from the root and was having soot formation near the broken portion. The yellow main rotor blade also had broken away at a distance of 465 centimeter from the root section.
