**FINAL INVESTIGATION REPORT
OF
ACCIDENT TO AS350 B3e
HELICOPTER VT-UTC
AT SHRI KEDARNATH JI
ON 23/09/2019**

**AIRCRAFT ACCIDENT INVESTIGATION BUREAU
MINISTRY OF CIVIL AVIATION
GOVERNMENT OF INDIA**

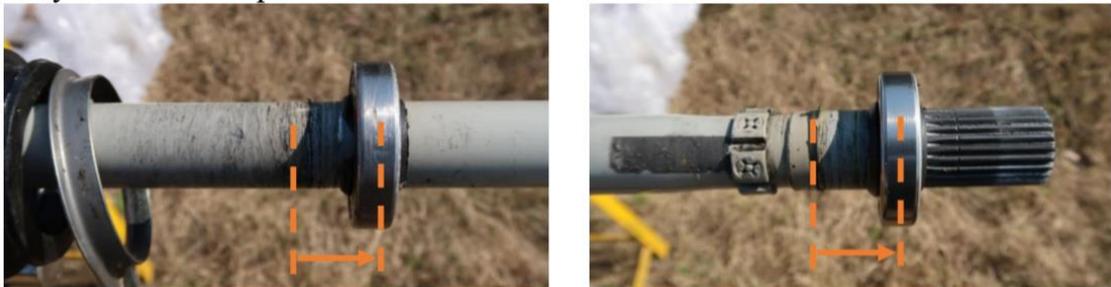
The helicopter wreckage was self contained barring the tail rotor assembly which had completely separated from the helicopter during the accident.

There was no damage to “engine to MGB assembly” except buckling was observed on the flexible coupling located on engine side. The tail gearbox and tail rotor assembly have got separated from the tail boom after the impact. The tail rotor blades were rotating even after the landing. It got separated most probably due to an unbalance effect and a weakening of the tail gear box attachments after the impact. Resultantly, tail rotor blade got damaged.

Rubbing marks were observed under the right hand side skid, consistent with a lateral displacement at the time of the impact with the ground. The skid also suffered deformation of its section in the vicinity of the rubbing marks consistent with the impact.

The tail boom exhibited wrinkles/ buckling, at attachment with the central fuselage. The lower vertical fin was bent as a result of a contact with the ground. This was due to the impact of the tail skid causing lateral displacement leading to a load application to the left hand side. The lower fin skin got torn as a result of impact of a rotating tail rotor blade.

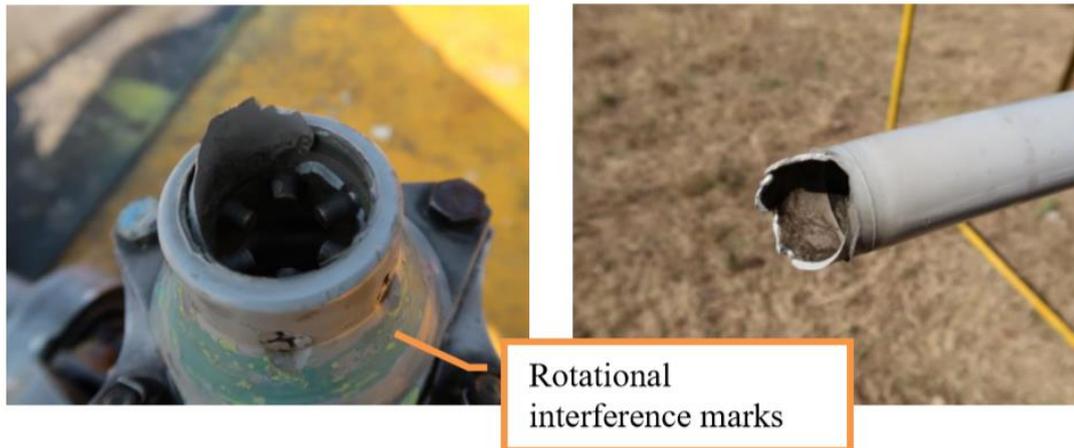
The tail transmission cowling exhibited external damages because of an interference between the flexible coupling installed between the forward steel drive shaft and the light alloy drive shaft while the tail transmission was rotating. The forward steel drive shaft exhibited rotational interference marks in the area where it crosses the bulkhead. The light alloy drive shaft exhibited an overload rupture at its extremity (riveted coupling between the end flange and the tube). This flange also exhibits some rotational interference marks.

The damage observed on the tail rotor drive shaft assembly confirms that the tail drive shaft was rotating at the time of the accident. The displacement of the roller bearings due to the backward displacement of the light alloy drive shaft and the overload failure of the shaft extremity (riveted coupling between the end flange and the tube) was as a result of the tail gear box and tail rotor assembly separation from the tail boom.

The tail rotor assembly was completely separated from the helicopter during the accident sequence. Its attachments were all broken by overload (tail gear box torn off from the tail boom).

The extremity of the tail gear box input pitch control rod exhibited some severe interference marks resulting in the failure of the rod. One was still attached to the control bell crank. These interference marks and the associated rupture was as a result of the contact between the tail gear box input rod and the tail gear box flexible coupling which was rotating when the tail gear box got torn off.
