FINAL INVESTIGATION REPORT ON ACCIDENT TO

M/s WINGS AVIATION PVT. LTD.,

CESSNA 172S AIRCRAFT, VT-RGF ON 06-10-2019

AT SULTANPUR VILLAGE, TELANGANA.

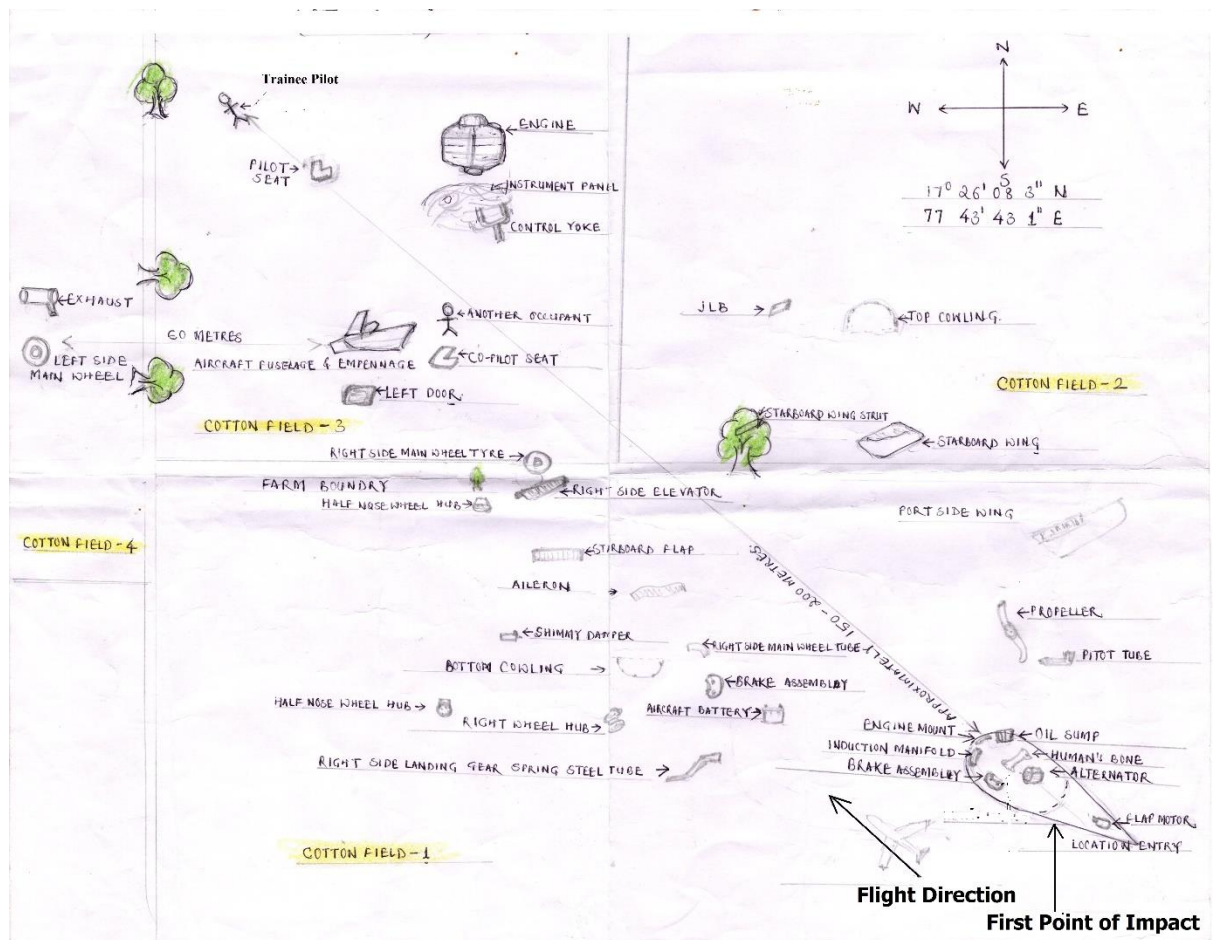
WRECKAGE DISTRIBUTION

The aircraft was destroyed during the accident. The aircraft wreckage was scattered in an area of about a radius of 100 meters ahead of first point of impact. The wreckage distribution is shown in following figure:

The damage to aircraft and scatter of the wreckage also fully conform to the aircraft entering very bad weather. There was no indication of aircraft disintegrating in air. Because of getting engulfed into a heavy downdraft, it had impacted the ground with heavy force, while in forward motion and little nose down attitude.

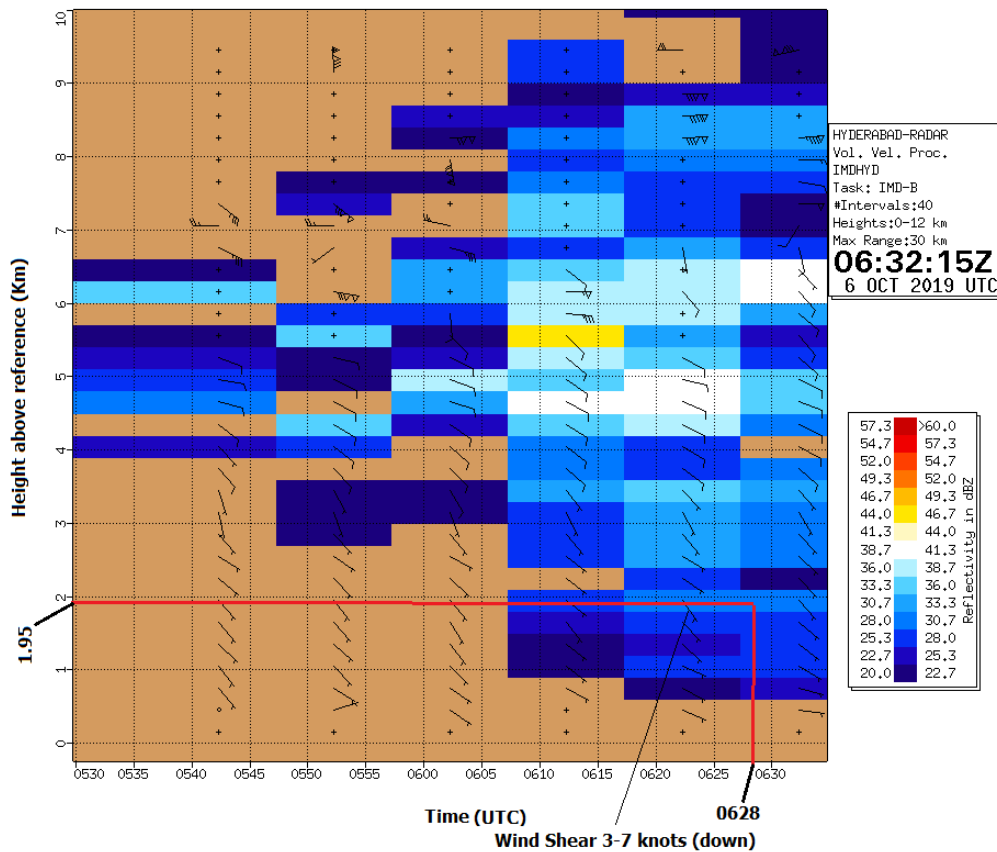
REFLECTIVITY INDEX WITH HEIGHT FROM 0530 UTC TO 0630 UTC

The above graph shows reflectivity index (in dBZ) viz-a-viz height (altitude in Kms) from 0530 to 0630 UTC. Areas of heavy precipitation (with big raindrops or snowflakes) return a lot of power to the radar and appear as brighter colors in reflectivity images. In this reflectivity image, the heaviest precipitation is in red, while lighter precipitation is in blue and green. The colours - yellow, orange and white shows moderate precipitation.

The aircraft after obtaining clearance from ATC for return was maintaining altitude of approximately 6400 feet (1950 meters) when it disappeared from the radar. At that time as per the above graph the precipitation was moderate with reflectivity value between 30.7 to 33.3 dBZ (decibel relative to equivalent reflectivity factor). The wind shear symbol indicates downwind shear of 3-7 knots just prior to accident.

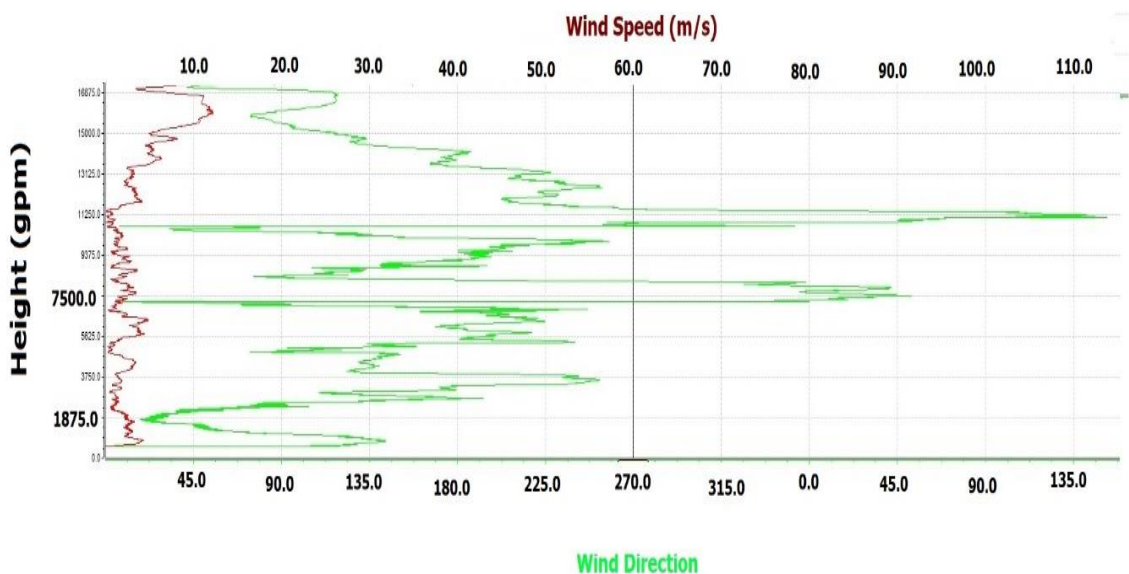
VARIATION OF WIND (SPEED & DIRECTION) WITH HEIGHT (ALTITUDE)

The above graph shows variation of wind speed (shown in red) and wind direction (shown in green) with height (in gpm) around the time of accident. As per the graph, the wind direction variation with height is sudden & very erratic, thereby indicating wind shear phenomenon. The wind speed variation with height was moderate and at an altitude of 1950 meters the wind speed was app. 4 knots.

During investigation, weather trend (variation) with altitude was obtained from IMD, Shamshabad, which revealed that just prior to the accident at an altitude of 6400 feet (1950 meters) there was a downward wind shear of 3 to 7 knots with moderate precipitation. The same was corroborated from the graph of variation of wind (Speed & Direction) v/s height. The graph showed that the wind direction variation with height (including altitude of 1950 meters) was sudden & very erratic, thereby indicating wind shear phenomenon. The shear phenomenon continued for some time around the accident location.
