**FINAL INVESTIGATION REPORT ON SERIOUS INCIDENT INVOLVING M/S**  
**INDIGO AIRBUS A320 (NEO) AIRCRAFT VT-ITG ON 02/04/2019**

| 13. | <b>Type of Occurrence</b> | : | Air Turn Back due to Engine Stall. |

On 02<sup>nd</sup> April 2019, M/s Indigo Airbus A320-271 (NEO) aircraft VT-ITG, while operating a scheduled flight from Pune to Nagpur was involved in an Air Turn Back due to Engine Stall during climb. The aircraft was under the command of an ATPL holder with a CPL holder co-pilot. There were 93 passengers on board the aircraft including 04 cabin crew members.

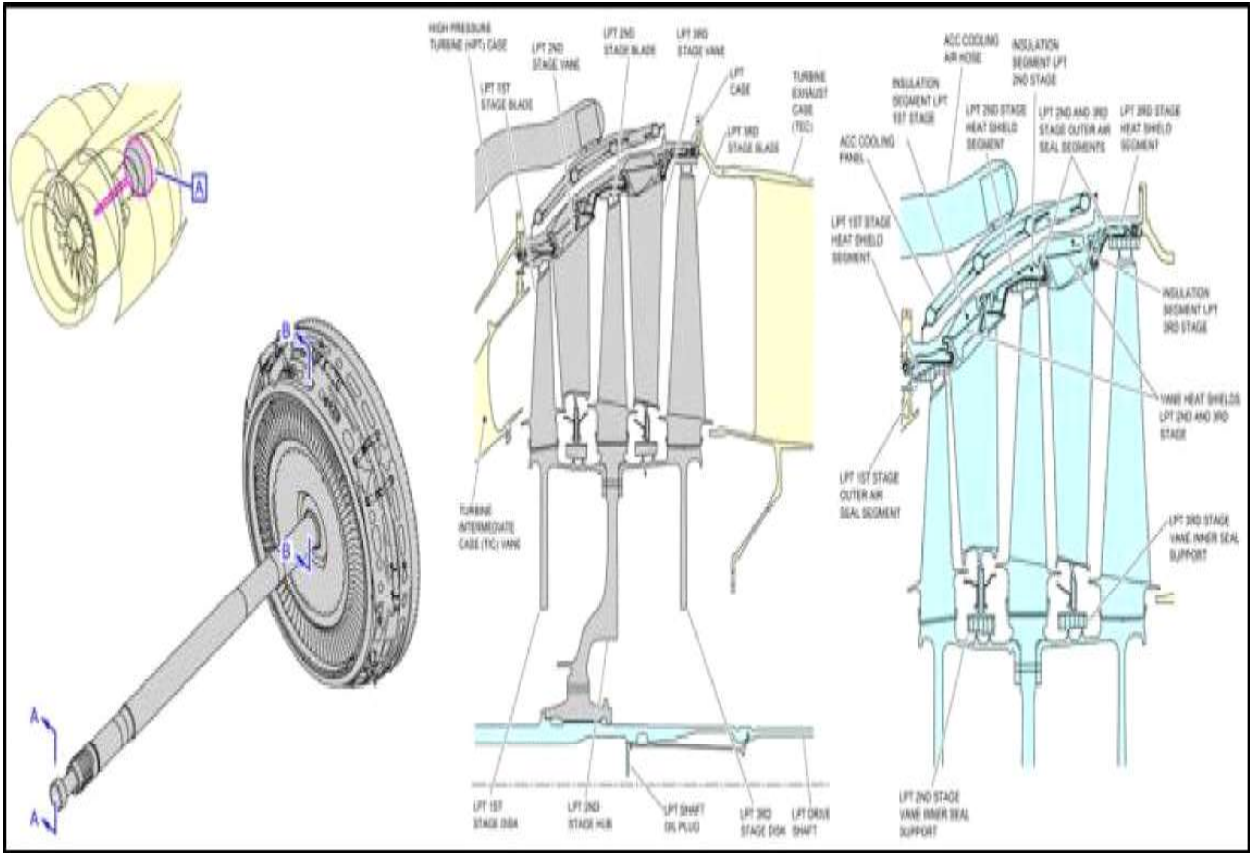
**Figure 4 : LTM – LOW TURBINE MODULE**

- Examination revealed that all 78 LPT 3<sup>rd</sup> stage blades had fractured in the airfoil at varying heights from the blade root platform.
- Impact damages were found present predominantly along trailing edge (TE) of the available part of the airfoil.

- Fracture surfaces of the blades showed a flat appearance with vaguely delineated chevron marks emanating from the crack origins in many occasions.
- Fractography study confirmed that LPT 3<sup>rd</sup> stage blades had fractured instantaneously in a brittle manner. None of the blades showed presence of any signatures of progressive failure such as fatigue.

The fatigue test further confirmed that the material does not have enough crack growth resistance and after initiation, the crack propagated instantaneously leading to fracture. It is, therefore, evident that the LPT stage 3 blades failed in flight as these blades could not withstand possible impact from material liberated upstream and got fractured instantaneously. This led to engine high vibration and EGT overlimit.

The incident was caused by failure of LPT 3<sup>rd</sup> stage blades in flight as the blade material lacked crack growth resistance and damage tolerance to withstand any impact from material that may have liberated upstream.

The SB required that the LPT 3rd stage disk, blades, locking plates, and shroud segments be replaced by the new set made of different material.

7. Pratt & Whitney has issued SB 72-00-0111 to Introduce of a new LPT 3rd stage blade made of a different material which is more resistant to impact damage. The airline has incorporated the said SB in all its affected aircraft.
