**FINAL INVESTIGATION REPORT OF  
SERIOUS INCIDENT TO M/s ALLIANCE AIR  
ATR 72-600 AIRCRAFT  
VT-AIX AT DIU ON 26.01.2019**

**AIRCRAFT ACCIDENT INVESTIGATION BUREAU  
MINISTRY OF CIVIL AVIATION  
GOVERNMENT OF INDIA**

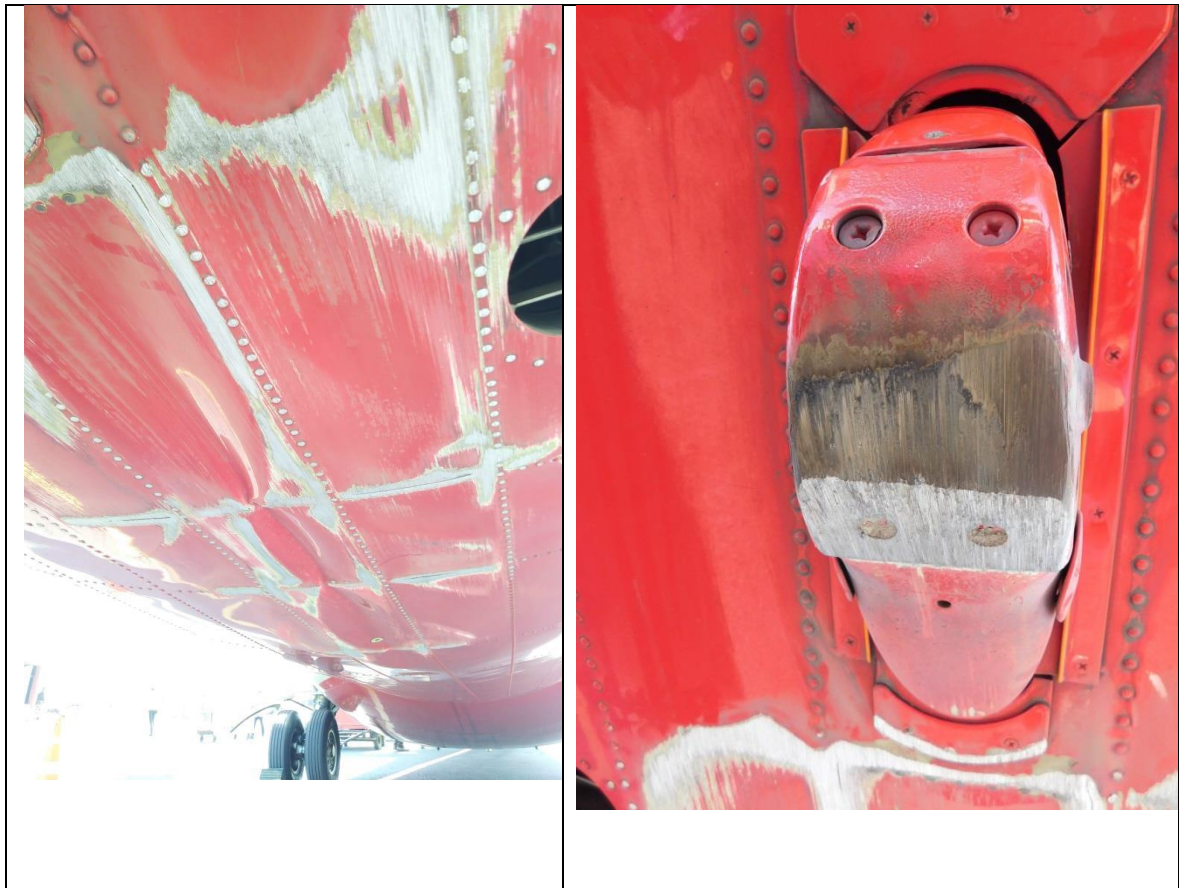
The bottom surface of fuselage rear section (Frame-33 to Frame-40) between stringer 19LH to 19 RH suffered damages.

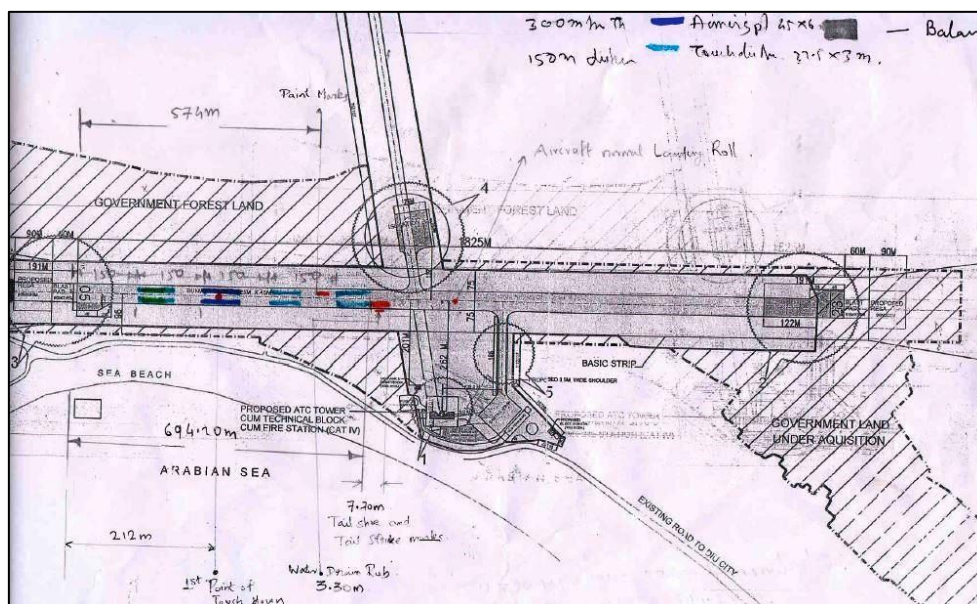
**Sketch indicating impact / rubbing marks on the runway**

The touchdown was 212 m from the threshold. Thereafter, aircraft ballooned and touched (after 362 m from 1st touch) at 574 m from threshold. It bounced and touched at a distance of 694 m from threshold. The impact with ground during first touchdown was heavy. The airplane bounced yet again and after covering a distance of 874m (from threshold), it continued to roll normally. The second bounce was shallow and the aircraft after stopping on the runway taxied to apron under its own power. During touchdown, tail of the aircraft got rubbed against the runway surface.

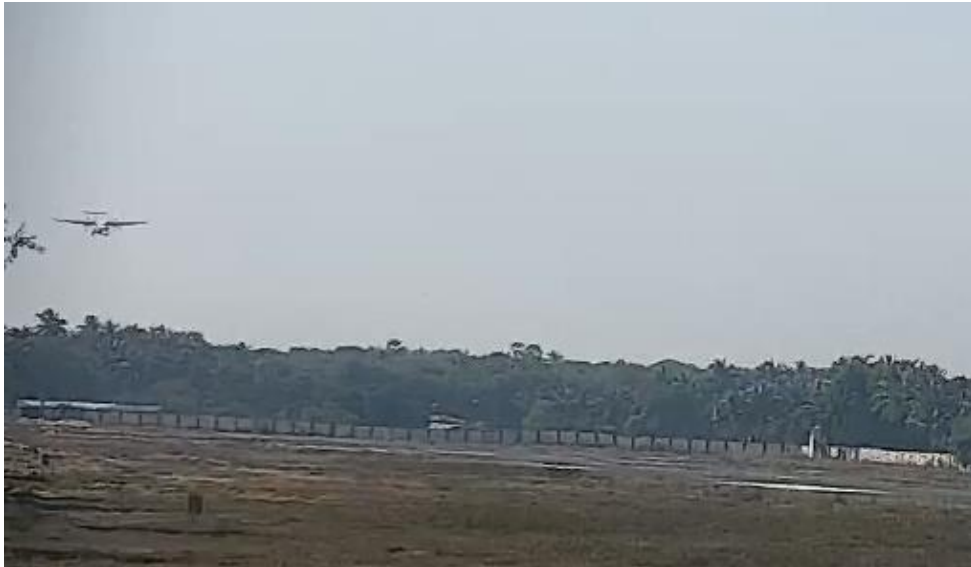
Aircraft at 79 feet (approx.) above the ground

During approach into Diu, when aircraft was at 79 feet above ground, the flight data indicates that the aircraft was in landing configuration with flaps 30, Gross Weight 21320 Kgs, winds of 13 kts. from 043 degrees and IAS of 122 Kts. Calculated Vapp was 113 Kts. with a pitch of 0 degrees. Power Lever Angle (PLA) for both engines 1 & 2 was 45/45.

From the CCTV footage, it could also be seen that the aircraft was experiencing light turbulence due to winds because of adjacent topography and the seasonal thermal effect.

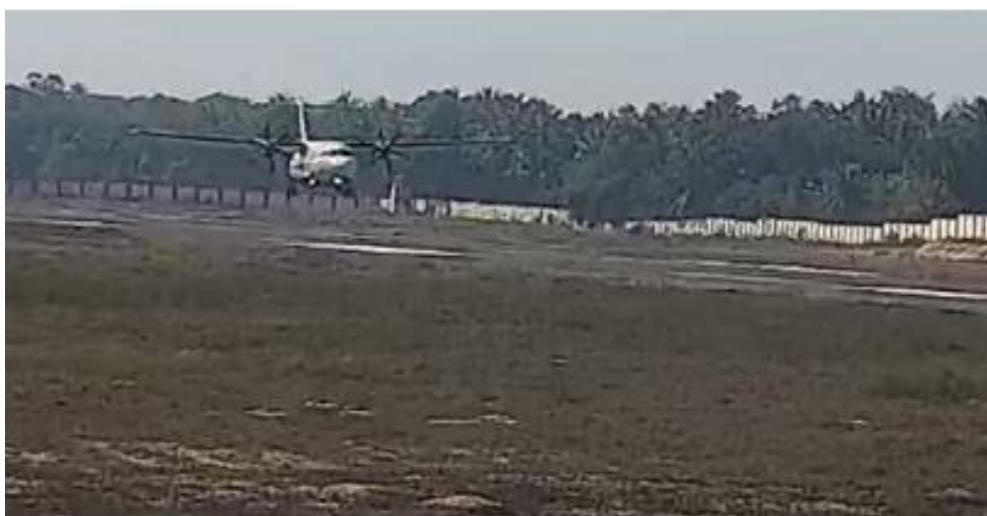
Flare initiation

Between approximately 50 feet RA and the flare initiation, the aircraft was observed on CCTV footage to be “sinking” at a very fast rate, this could be attributed to either down draft causing loss of speed as there was no change in power setting during that period.

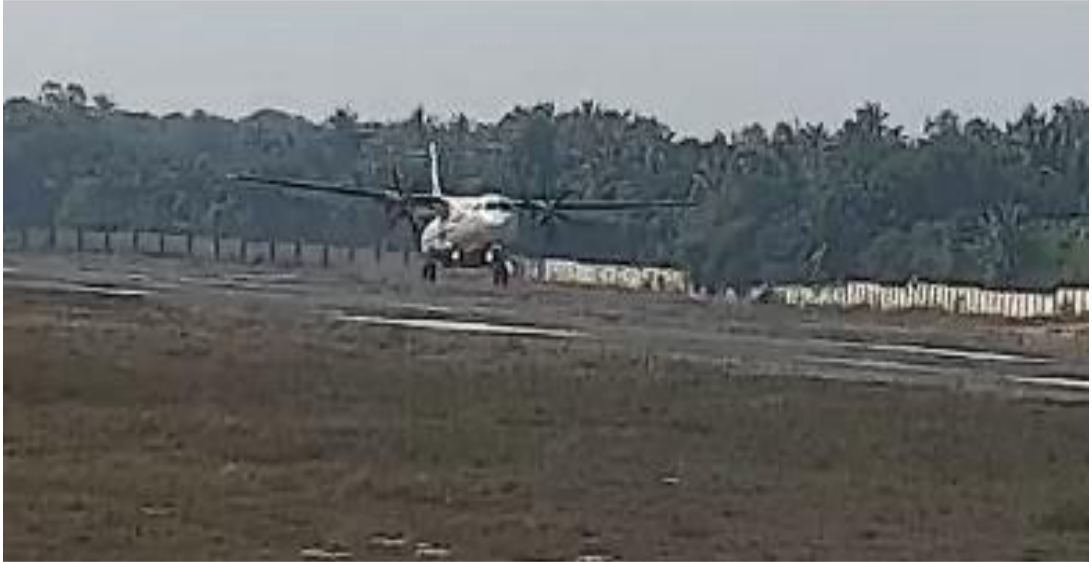
Ballooning

To arrest this aircraft 'sink', PF gave a 'pitch up' input which lead to the aircraft ballooning with a momentary touch of the runway (also observed from the CCTV footage). PF controlled the sink rate from -11 fps (descent) at 07:44:32 to -1 fps at 07:44:40.

Pitch increased from -1 degrees to 4 degrees over 2 seconds & then reduced to 1 degree and then increased to 7 degrees over 3 seconds. (DFDR time frame from 07:44:35 to 07:44:40).

At the time of momentary ground contact, aircraft 'Pitch' was 7 degrees and the IAS had dropped to 103 Kts. Aircraft speed dropped by 19 Kts from 79 feet RA (07:44:26) to touchdown (07:44:40).

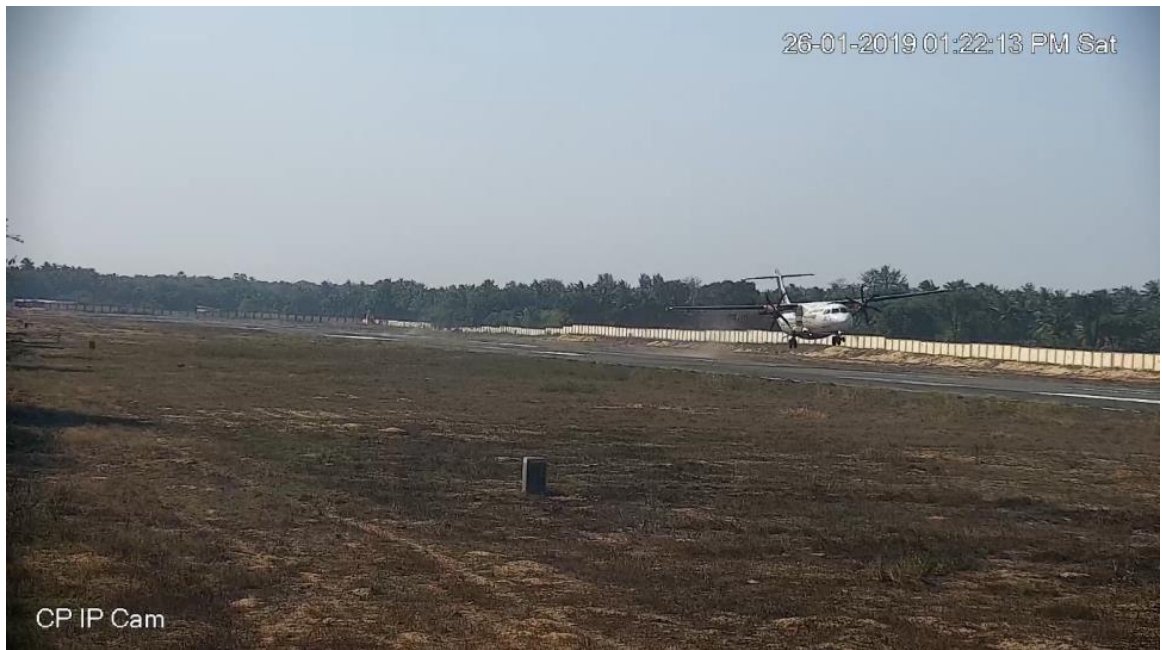
Maximum Bounce height (more than 5 feet)

During ballooning it is observed that the PIC gave forward nose input which can be seen in the CCTV footage & flight data with the pitch reducing from 7 degrees to 5 and then to 2 degrees over 2 seconds. (DFDR time frame from

07:44:40 to 07:44:42). Between 07:44:40 to 07:44:42, aircraft bounce had reached a “Radio Altitude of more than 5 feet”.

- 4.1 The operator may incorporate proper Go Around procedures in case of unstabilised approach and bounce recovery technique in line with ATR procedures.
- 4.2 The operator may emphasize the bounce recovery techniques in every ground refresher and simulator training.

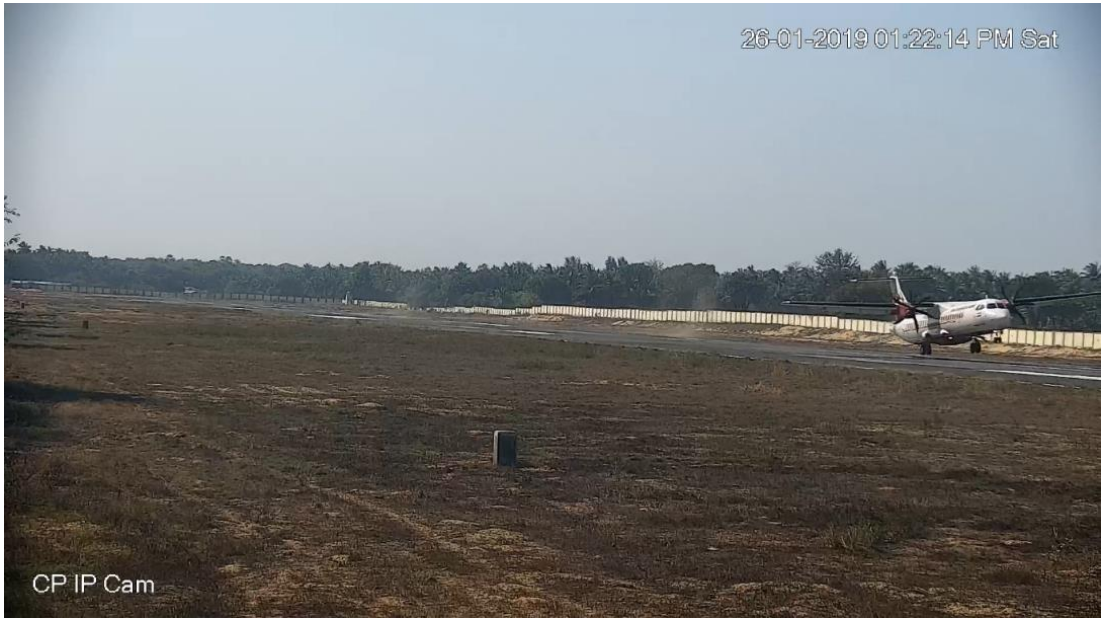
Pitch before 2<sup>nd</sup> touch down

After first touchdown, the pitch increased to 8 degrees (07:44:44) and aircraft then bounced to 6 feet RA.

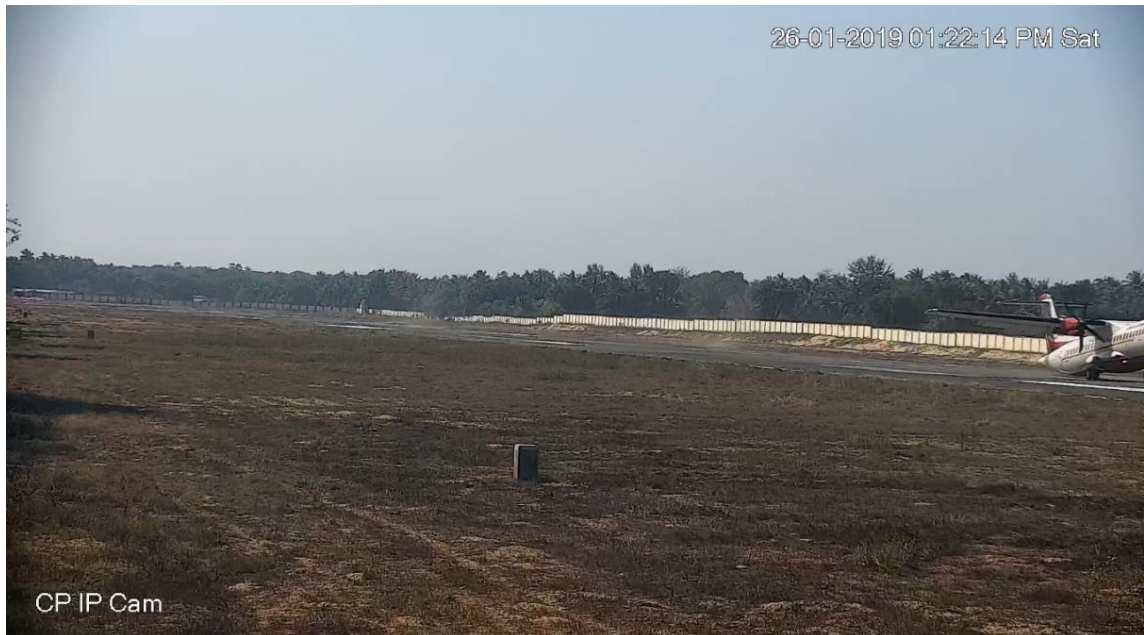
2<sup>nd</sup> touchdown (tail touching)

CCTV footage & DFDR data shows a pitch attitude of -1 degrees and IAS of 83 Kts. Power Lever Angle (PLA) Engine 1 & 2 were moved from 36/36 to 19/18 between 07:44:44 to 07:44:47.

- Unstabilised Approach due to sudden downdraft just after flaring and pilot not going around resulted in ballooning followed by bouncing (twice) of the aircraft which was aggravated due to wrong bounce recovery technique.
- Pilot Monitoring not calling out for Go-Around
