**FINAL INVESTIGATION REPORT ON SERIOUS INCIDENT
TO AIRBUS H 130 HELICOPTER VT-GVO
OPERATED BY M/S GLOBAL VECTRA HELICORP LTD,
ON 21 MARCH '2019 AT KATRA HELIPAD**

**FINAL INVESTIGATION REPORT ON SERIOUS INCIDENT TO M/S
GLOBAL VECTRA HELICORP LTD H130 HELICOPTER VT- GVO ON
21-03-2019 AT KATRA, JAMMU.**

| 13. | Type of incident | | Window Ceiling Glazed Panel sheared off and flew In-flight. |

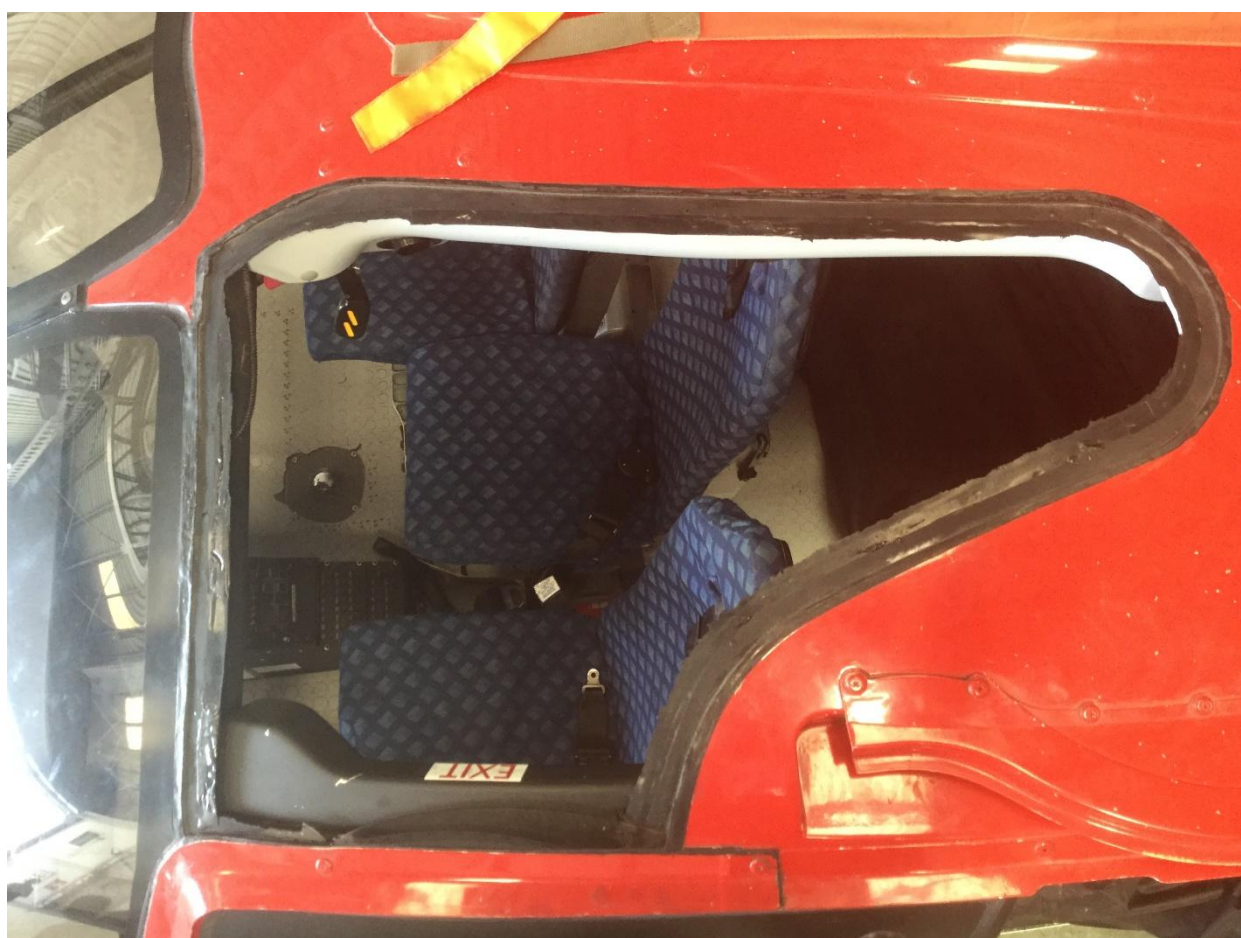
The LH Window glazed panel flew – off in air during flight and hit one of the main rotor blades which was evident from the minor dents observed on the lower surface of the rotor blade. A small portion of the window glazed panel remained intact with the structure. Apart from the LH window glazed panel, there was no evidence of any other part of the helicopter disintegrating during the flight. The separated portion of the window glazed panel could not be located / traced.

Photograph # 4: Missing LH Window Glazed Panel.

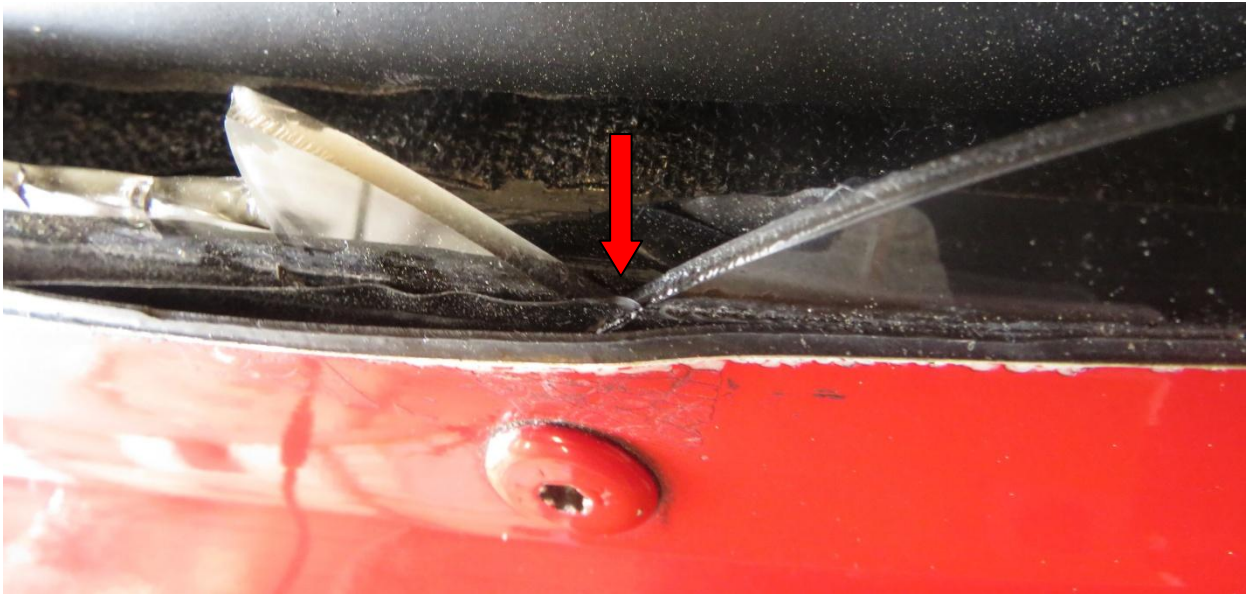
Photograph # 5: Probable point of initiation of crack.

It was further interpreted that a crack must have started developing from glass alignment spacer due to non-adherence of correct maintenance procedure as per AMM which kept on propagating in general direction till the time it gave away.

14. A crack had developed from glass alignment spacer and kept on propagating in the general direction over a period of time which resulted in glazed panel flying off during flight.

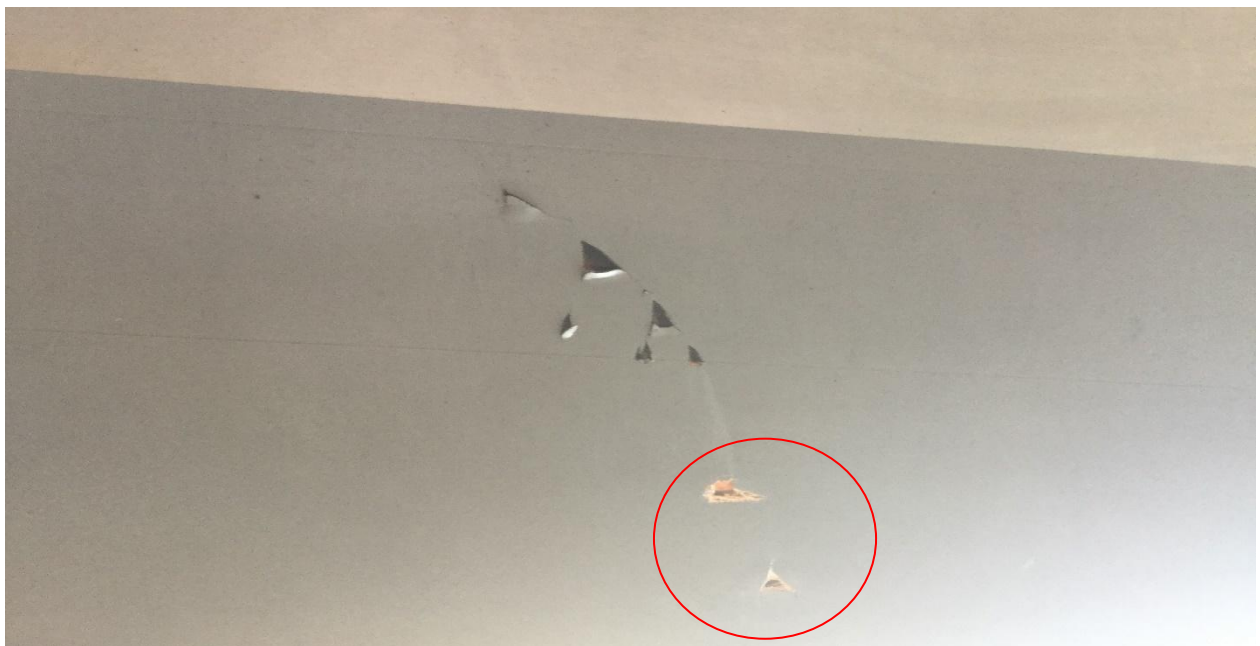
The helicopter received minor damage during the incident. One of the main Rotor Blade received a dent on the lower portion.

Photograph # 6: Dents on one of the Main Rotor Blades

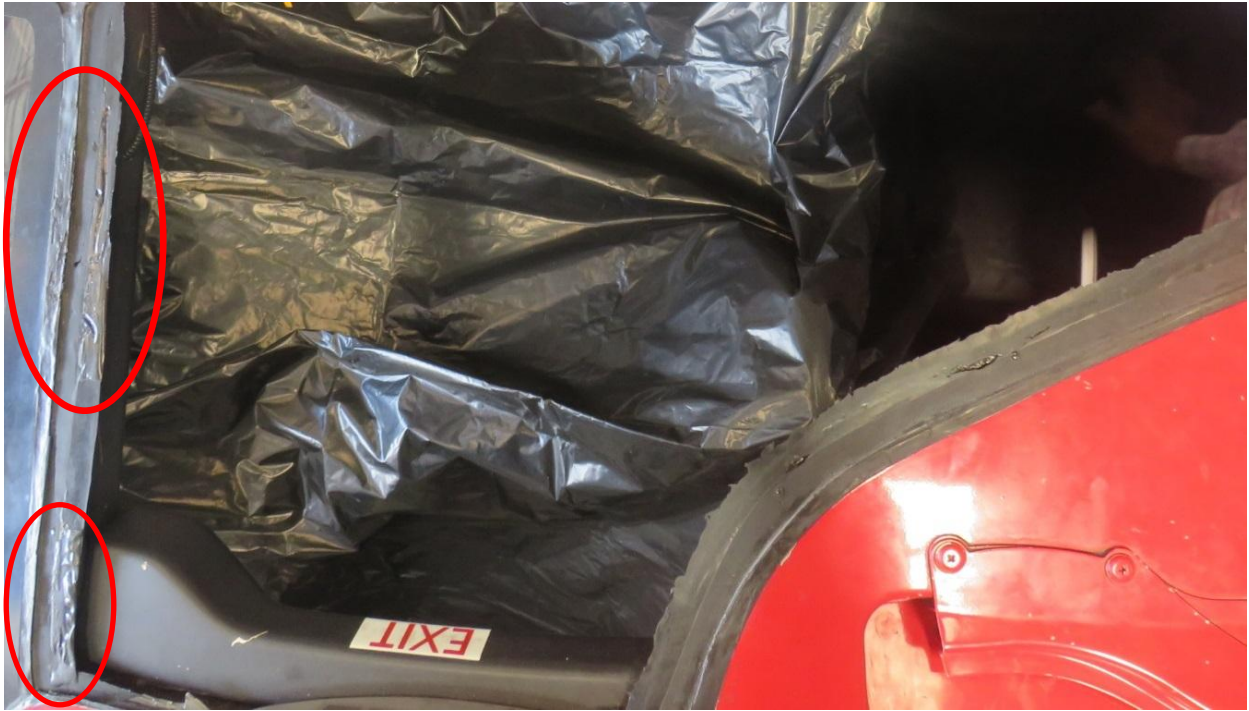
During the inspection of the window ceiling attachment area, a lot of lump formation and uneven surface was observed around the periphery of adhesive application area over which the glazed panel is fixed (Refer Photograph # 7).

Photograph # 7: Uneven surface & Lumps found on periphery of adhesive area

04 days. A lot of lump formation and uneven surface was also observed around the periphery of adhesive application area over which the glazed panel is fixed. This implies that the surface preparation, adhesive application or adequate curing time was not given to fix the glazed panel to its position at the time of replacement of window ceiling glazed panel. This resulted in the glazed panel not bonding properly with the surface. It is to be noted that the single layer glazed panel which is simply pasted to its position with adhesive and there is no other bonding material used, started de-bonding over a period of time.

11. A lot of lump formation along with uneven surface was observed around the periphery of adhesive application area over which the glazed panel is fixed. Thereby, confirming that the adhesives were not applied properly/evenly or adequate curing time was not given while fixing the glazed panel to its position.

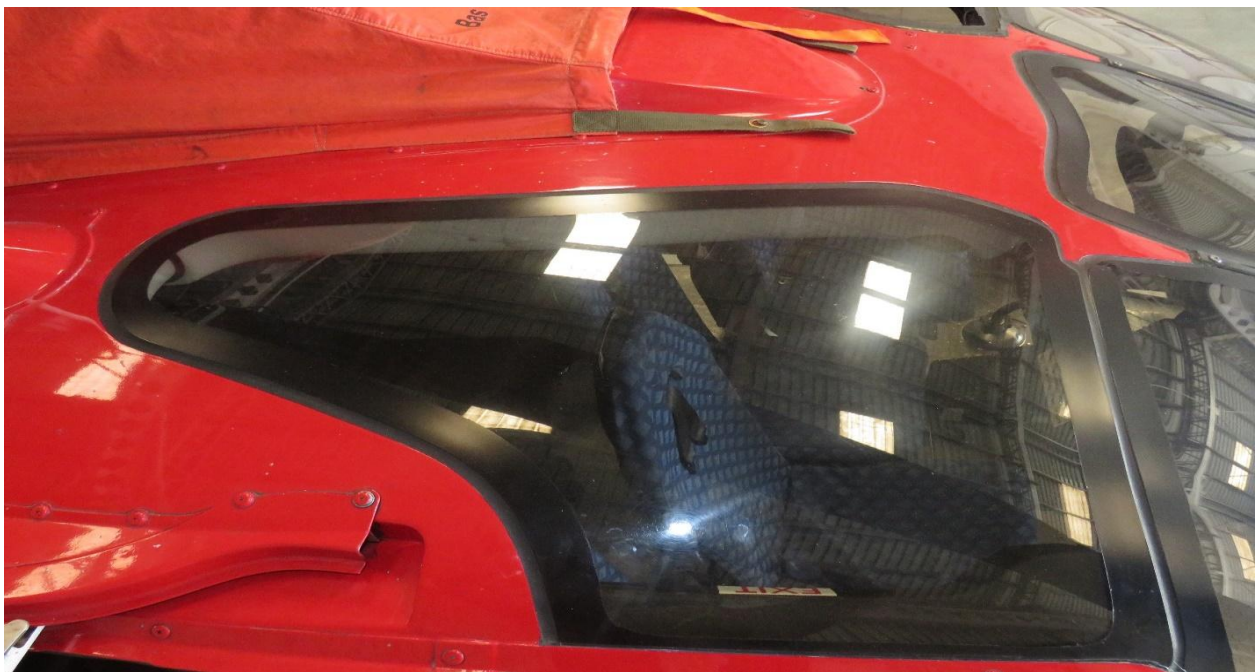
LH & RH window ceiling of the H130 T2 helicopter are fitted with single-layer glazed panel made of plexiglass (as in case of incident helicopter VT-GVO) having part numbers 350A25-9040-21 for LH side (Pilot side) & 350A25-9039-21 for RH side. Both single layer glazed panel are simply pasted to its position and a rubber seal pasted around on the top to protect from radiation (Refer Photograph # 8).

Photograph # 8: Single layer glazed window
