FINAL INVESTIGATION REPORT ON SERIOUS
INCIDENT TO M/s GO-AIR AIRBUS A320
AIRCRAFT VT-WGR AT BENGALURU
AIRPORT ON 11/11/2019

FINAL INVESTIGATION REPORT ON SERIOUS INCIDENT OF M/s GO-AIR
A320 AIRCRAFT VT-WGR AT BENGALURU AIRPORT ON 11/11/2019

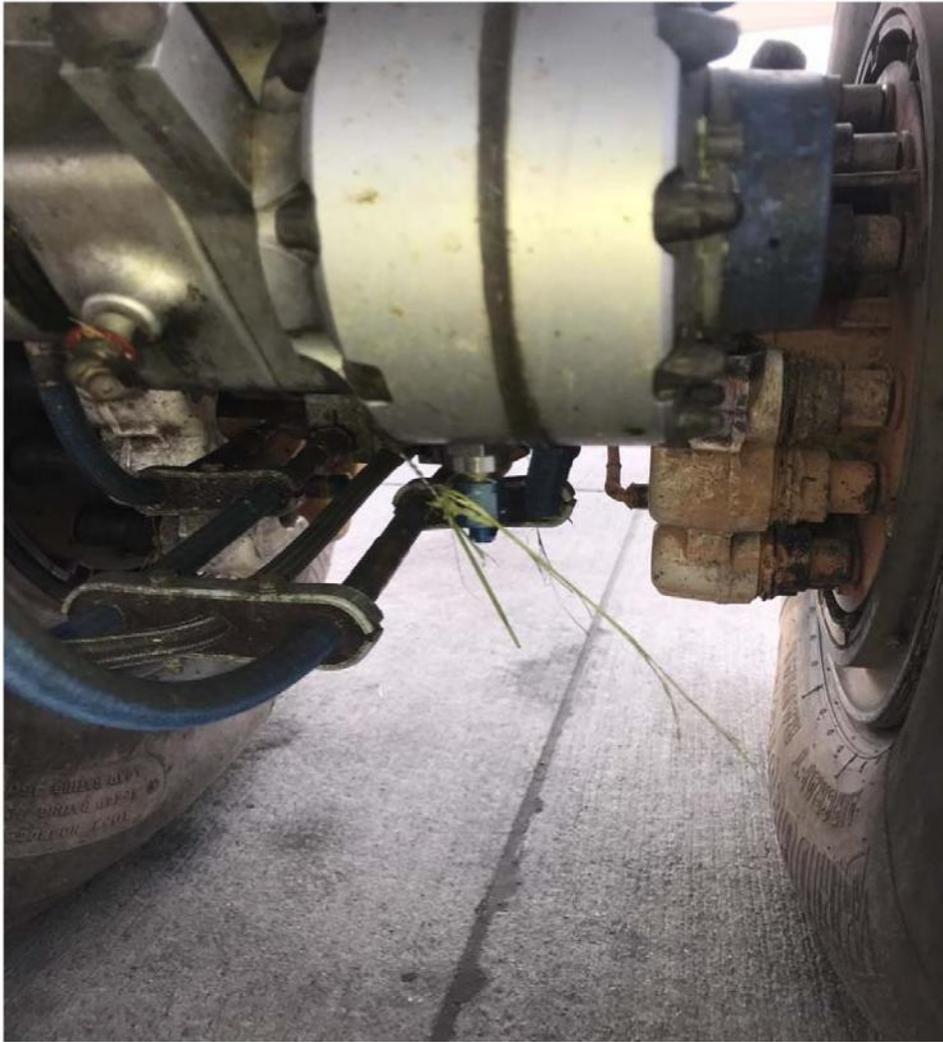
During walk around inspection at Hyderabad, mud and grass was observed on both LH & RH MLG wheels and brakes, No other external damage or abnormality was noticed. Externally, there were no signs of any FOD on engines. There was no damage on landing gear. Extension/ Retraction and free fall checks were satisfactory.

A full Bore Scope Inspection (BSI) of both engines was carried out. On ENG#1 heavy rub marks were observed on HPC Rotor 7 and 8 Outer Air seal. There was spallation of HPC Stator 7 Inner Air seal.

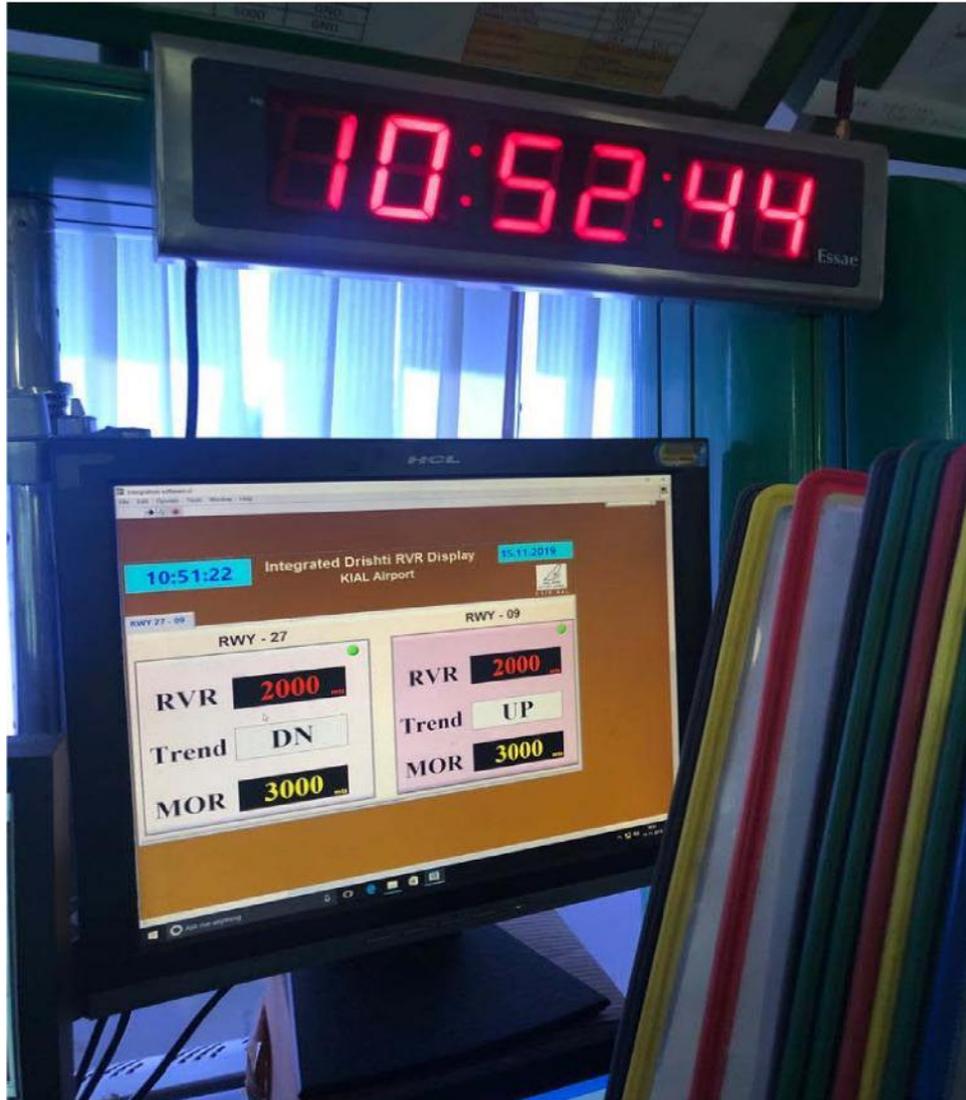
A separate screen is kept at the approach controller station, where current weather is displayed. A time lag of 82 seconds in the Drishti display and actual UTC time display was observed.

Time lag between actual UTC window and Drishti display (Approach position)

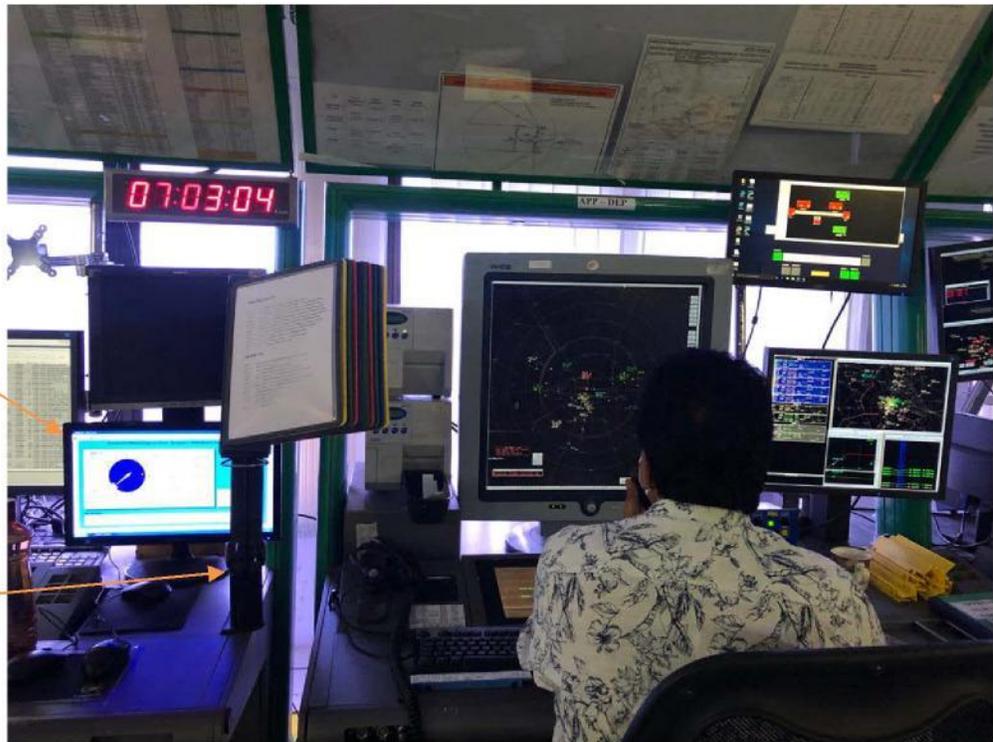
The Drishti Weather Display is not in clear line of sight for the approach controller. The display is obstructed with shift folders placed between the approach controller and the display. The controller would need to turn in order to view the display for any weather change/ update.

Hindrance in Viewing Weather Screen

- 4.5 AAI and IMD must ensure that the software display providing real time visibility / RVR are located in clear sight of the Air Traffic Controller for all stations.
- 4.6 IMD may carry out an evaluation for inclusion of Audio / Visual Alerts from the software being used for updating of RVR/ Visibility, whenever Visibility / RVR reduces below threshold values.
- 4.7 DGCA should extend, the Adverse weather watch system/ procedure for other seasonal variations wherein operating conditions deteriorates significantly like monsoon operations.
- 4.8 DGCA should positively provide closure report as per the time limits on the audit findings after receiving the Action Taken Reports from the Operator.

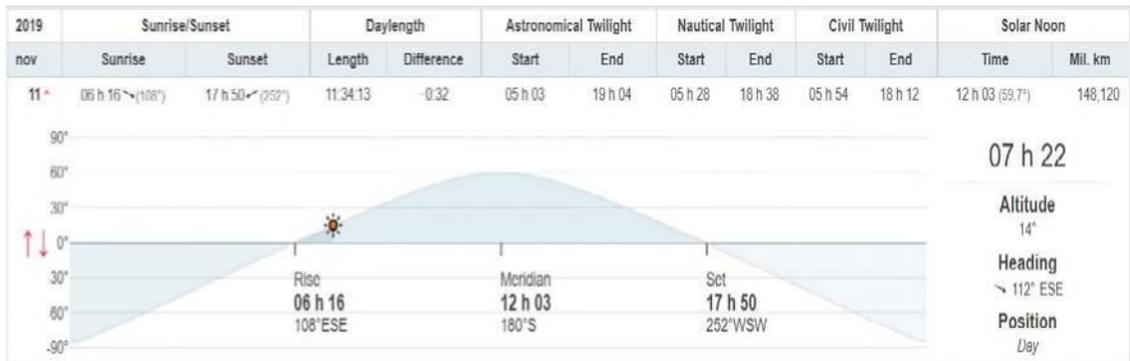
The actual RVR at the time of the approach reduced very rapidly to 125 meters. The time of the incident was just after Sunrise and the Sun was positioned at 14 degrees above the horizon and at a bearing of 112 degrees (20 degrees to the right of the runway alignment). This would have further impacted the already reduced visibility.

The image below illustrates the position of the sun relative to the horizon.

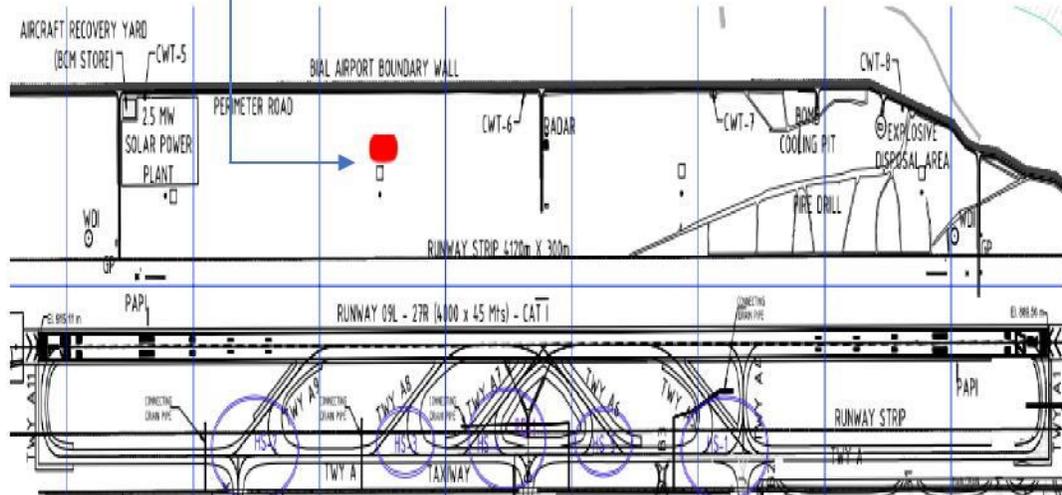
Location of the Bird Chaser

A Bird Chaser who was positioned near A-8 northern shoulder reported that the visibility was low with dense fog. The Bird Chaser heard the engines for the subject aircraft to be louder than usual. The Bird chaser immediately reported to the shift in-charge about the aircraft flying above him.

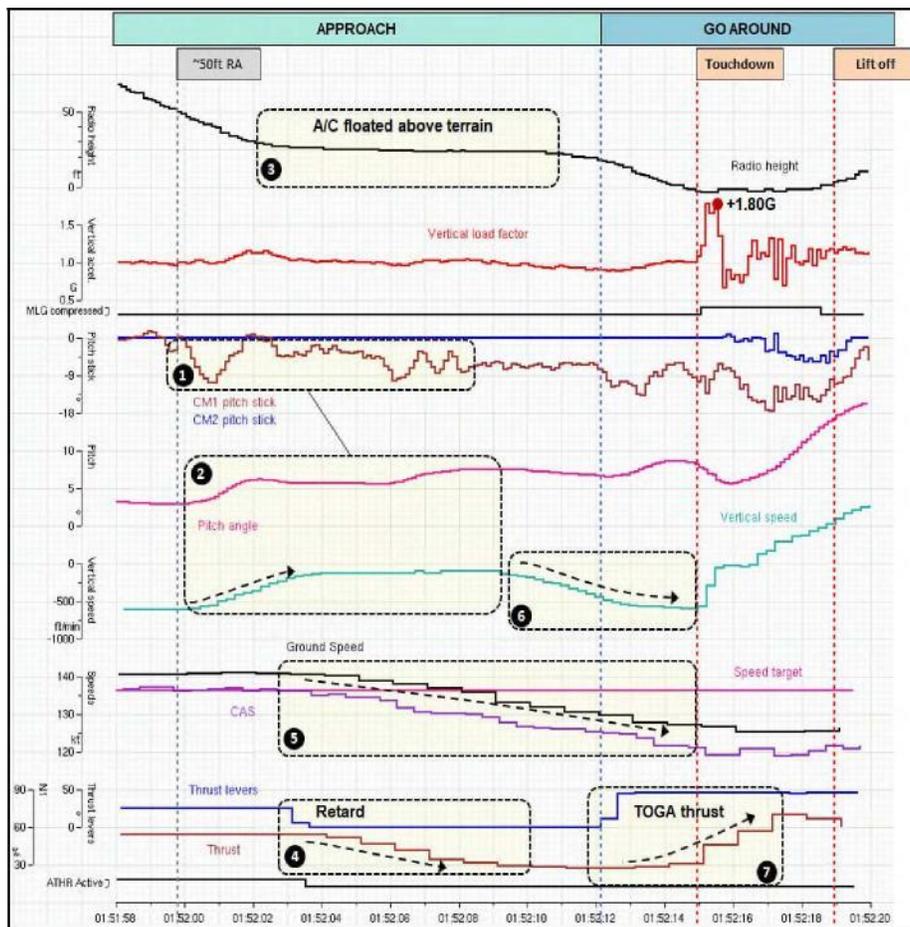
Flare and go-around / longitudinal axis

The First Officer announced Go Around 2 seconds prior to the aircraft contacting the unpaved surface. The Go Around thrust was initiated by the PIC immediately and a pitch up command was recorded by the left side stick. However, the aircraft was below final approach speed and the response to the pitch command did not result in a climb and the aircraft contacted the unpaved surface. After touch down on the main wheels, there is several pitch and roll commands registered on both side-sticks up to the point the aircraft lifted off the surface.

The plot above shows the crew side stick and rudder pedal inputs along the longitudinal axis.

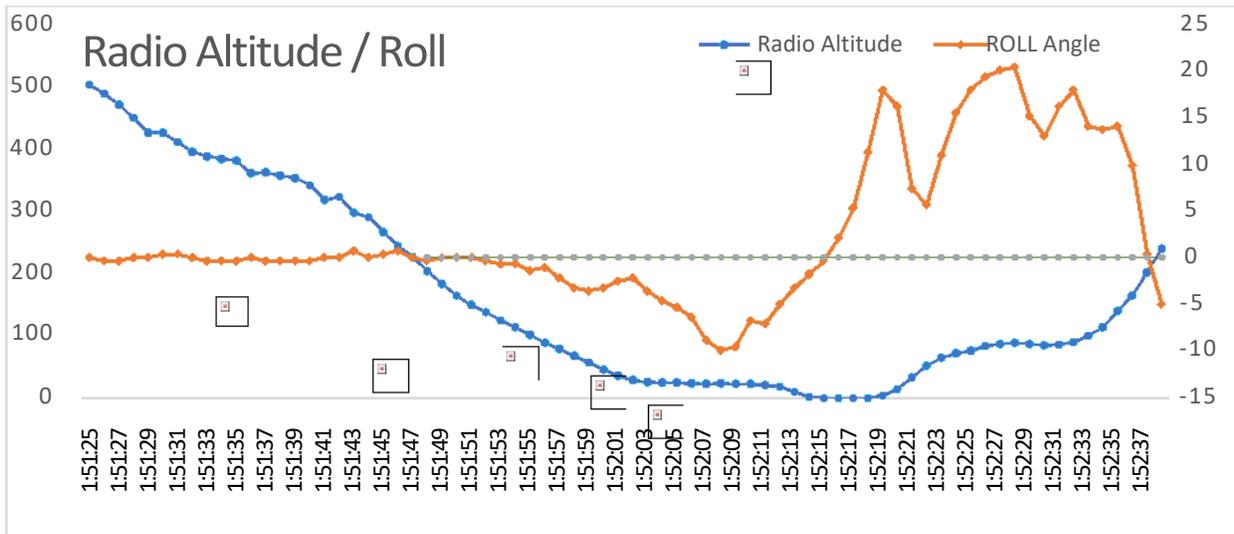
Bank Angle variations prior to and after touchdown

No.	Time	Roll	RA	Comment
1	01:51:55	L 1.5	102	A gradual bank of 1.5 degrees left is developed
2	01:52:02	L 2.1	29	Flare Law is active
3	01:52:08	L 9.8	24	Maximum Bank of 9.8 degrees prior to Touch down
4	01:52:12	L 5.0	18	Extended flare from 29' – 18' for 10 seconds. Bank angle reducing
5	01:52:15	L 0.3	0	Touchdown on main landing gear
6	01:52:19	R 17.0	4	Aircraft banks aggressively to the right and gets airborne again

The aircraft begins a gradual bank toward the left after autopilot is disconnected. The PIC then reduces the descent rate (flying almost level) while increasing left bank to align with the left runway edge lights (which he believes are the center line lights). At the point of touchdown, the wings are near level. During the 5 seconds the aircraft has touched down, the PIC initiates an aggressive right bank which reaches 12 degrees. It reaches 17 degrees just after lift-off. The key points of FDR analysis are shown on the figure below (from OEM report)

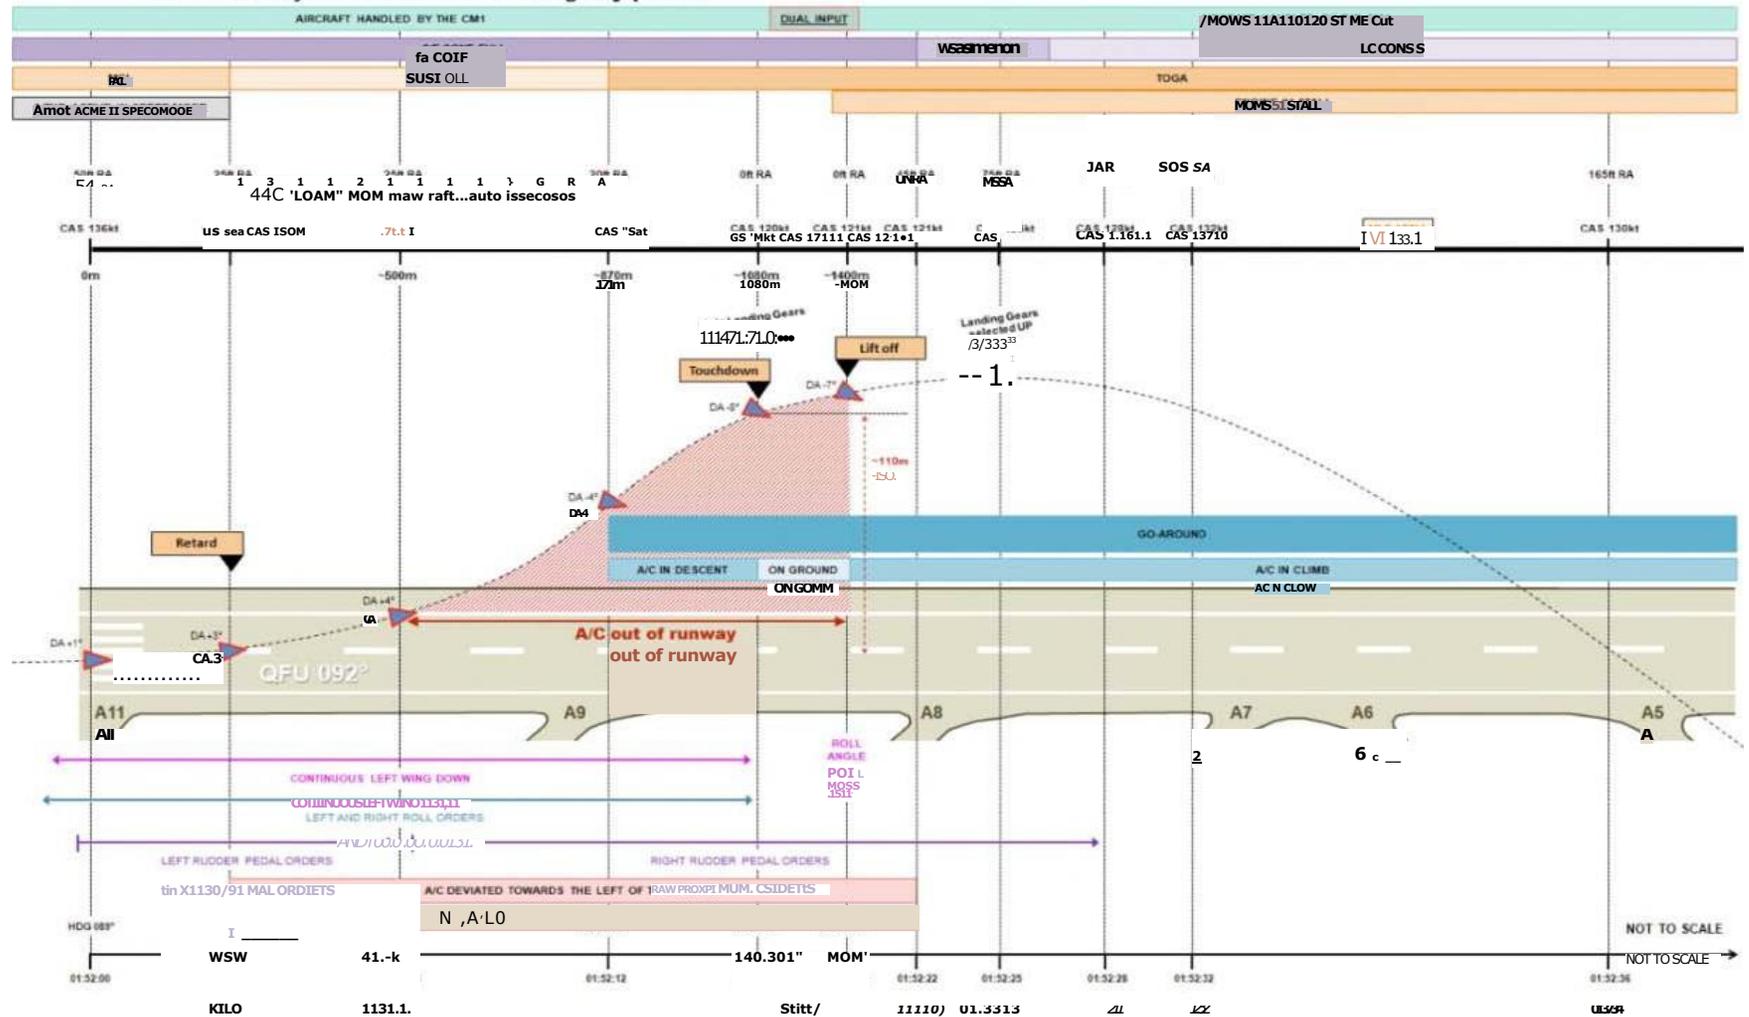
The above plot shows the aircraft flight path over the runway (Airbus handling report).

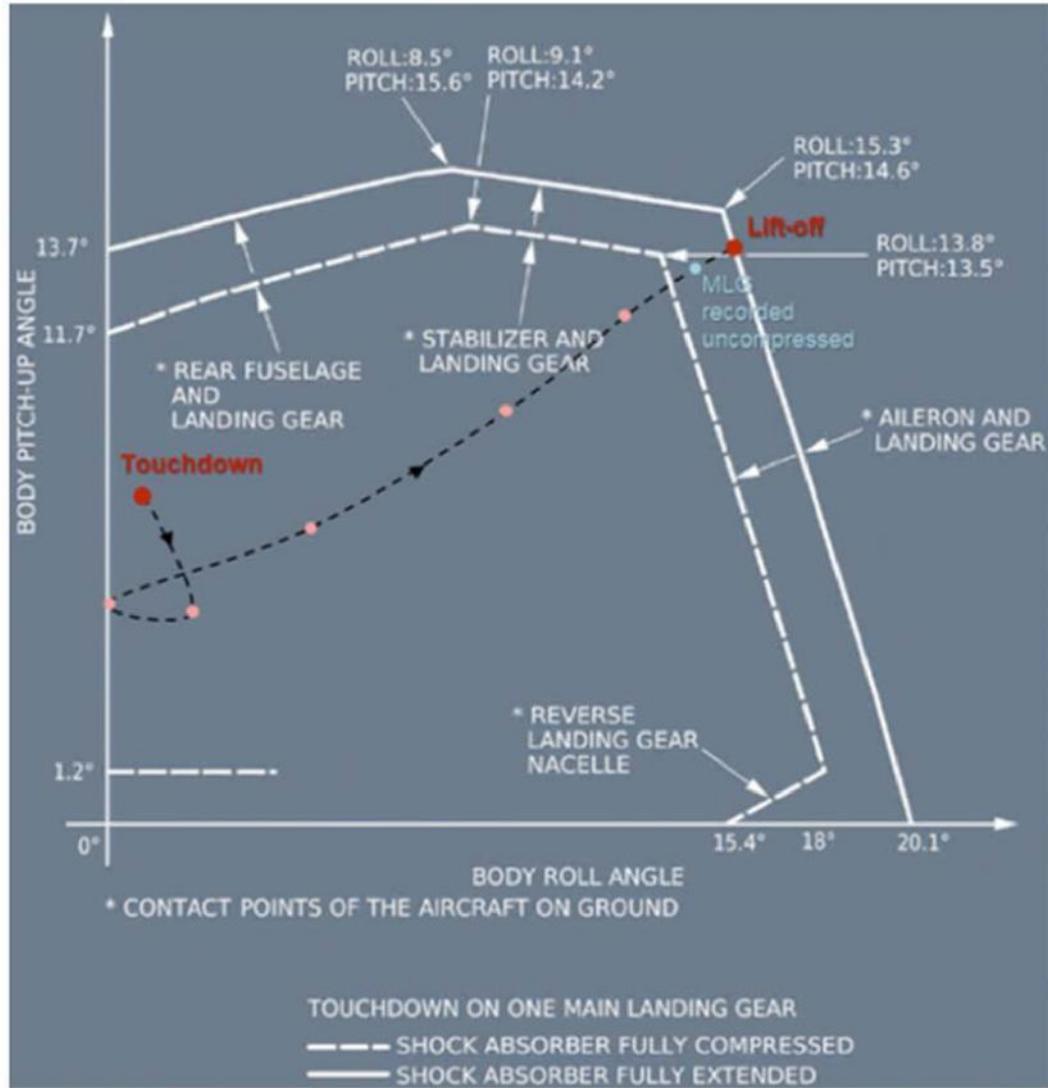
The figure above highlights the clearance margin from body contact

Airbus has given the clearance margins to avoid aircraft body contacting the ground (Body pitch up v/s body roll angle). As per this, with main landing gear fully extended and a pitch angle of +13.5°, the right aircraft aileron will contact the ground when the roll angle reaches +15.7°. In the present case, due to nose-up and right roll orders applied by the flight crew when the aircraft was on ground, pitch and right roll angles increased and reached high values close to the ground clearance diagram limits. The right aileron was close to the ground at lift off.
