**AIRCRAFT ACCIDENT INVESTIGATION BUREAU  
MINISTRY OF CIVIL AVIATION  
GOVERNMENT OF INDIA**

**FINAL INVESTIGATION REPORT ON SERIOUS INCIDENT INVOLVING**  
**M/S AIR INDIA AIRBUS A321 AIRCRAFT VT-PPT**  
**AT RAIPUR ON 08.11.2019**

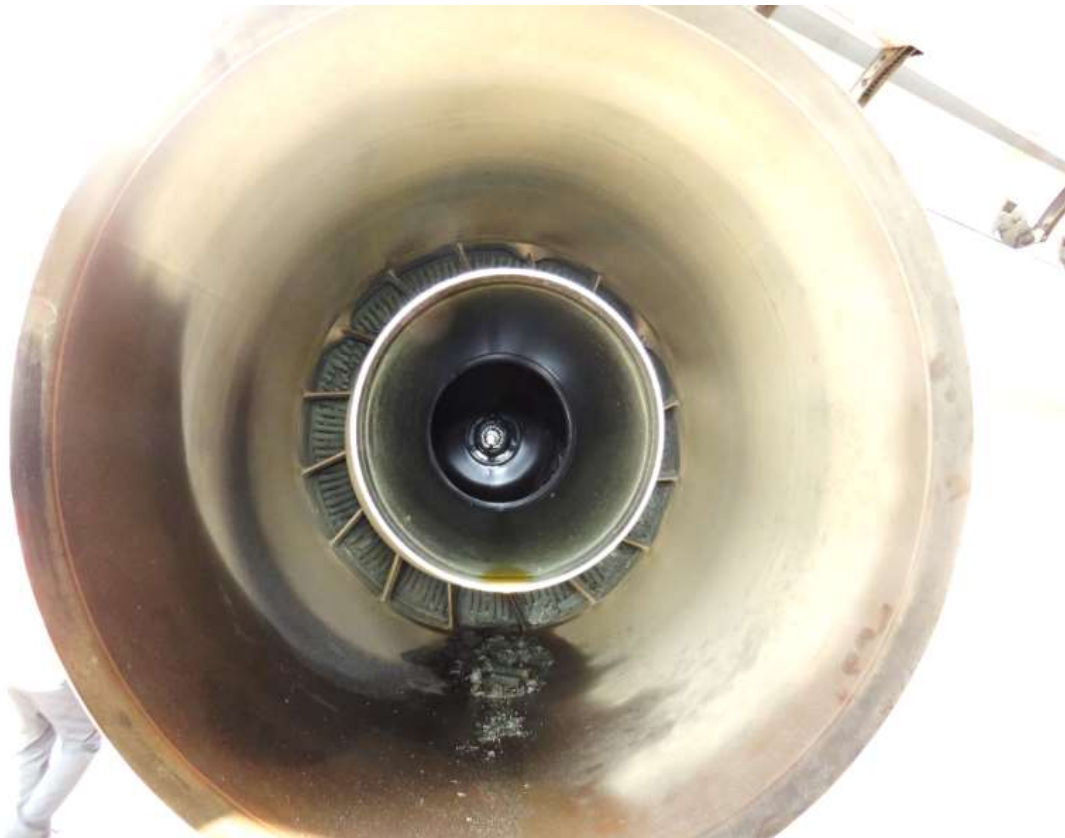
**Fig-1: Aft mount and Centerbody of Engine**

The aircraft had not suffered any damage apart from the damage to its LH Engine. During the post Flight inspection, no damage was observed on the inlet area. Thrust Reverser lower LH Side was found displaced.

Subsequently, the engine was replaced with a serviceable unit and aircraft was released for service. The damages to the Engine observed during post flight inspection are shown in the figure 1 and 2.

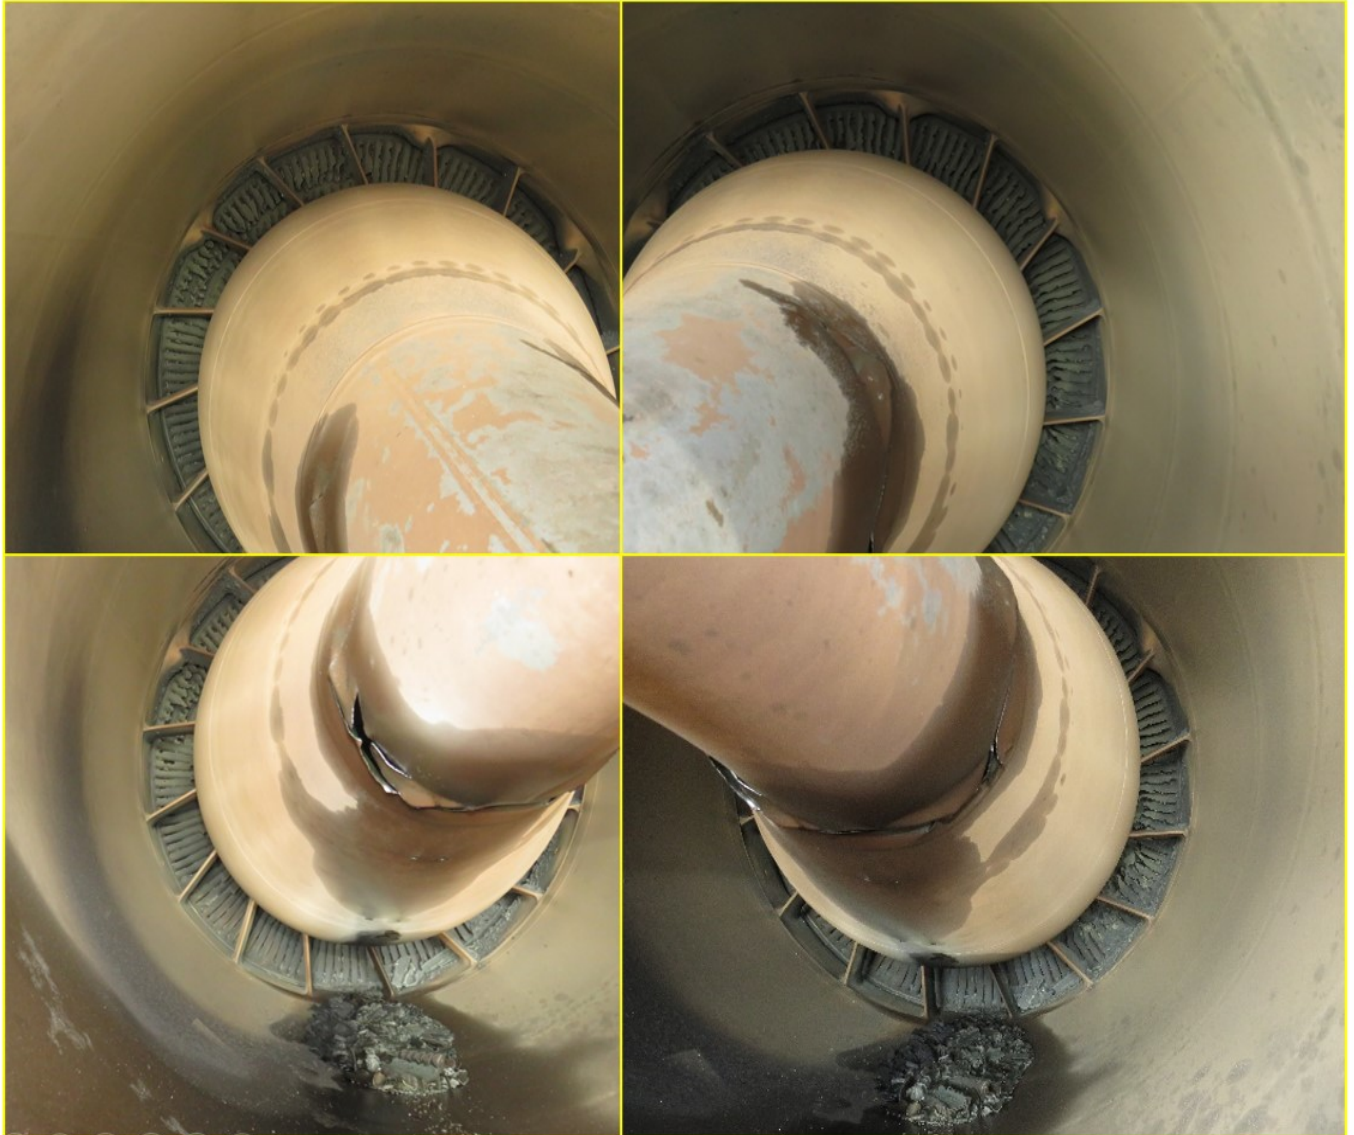
**Fig-2: Damaged Centerbody - Close View (viewed from rear)**

Heavy metal particles were found in the exhaust area with various turbine blades damaged and missing. Metal particles were also found on the EMCD. Only 3.6 quarts of Engine oil was found in the Engine Oil Tank.

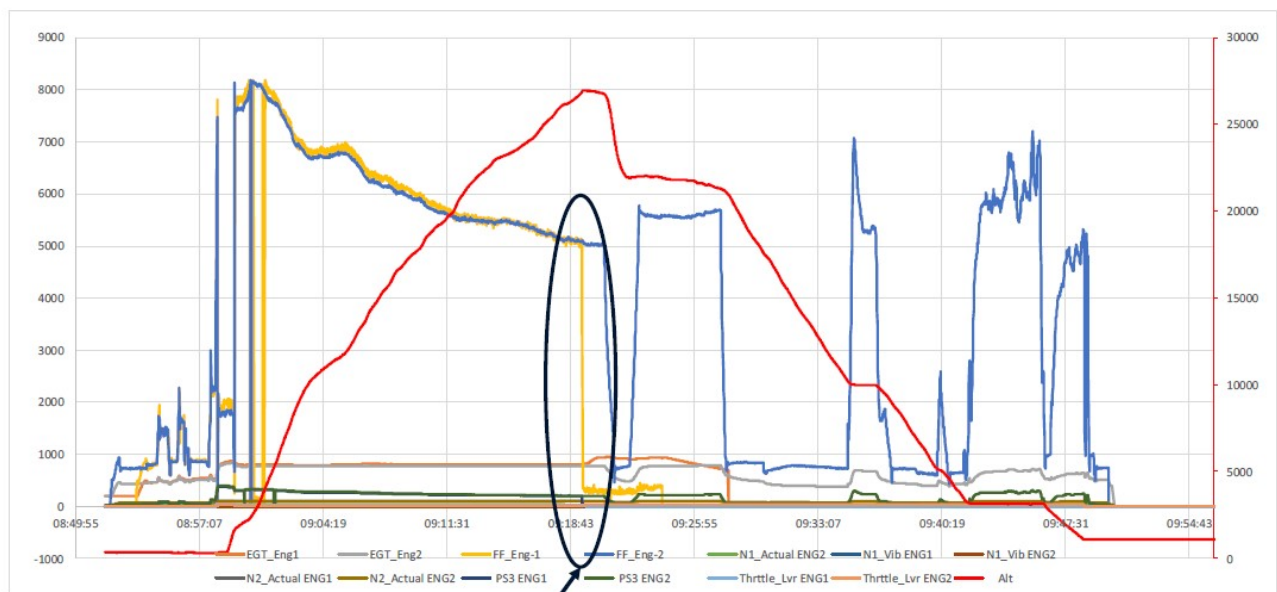
**Fig-9: DFDR Plot**

The DFDR data for the last 10 hours of flight was downloaded. At elapsed time 09:19 Hrs, the LH Engine parameters showed some disturbances. The graphs created using DFDR data with assistance of Technical Adviser appointed by NTSB are shown in Fig-9 and 10: -

Event at +/- 9h19

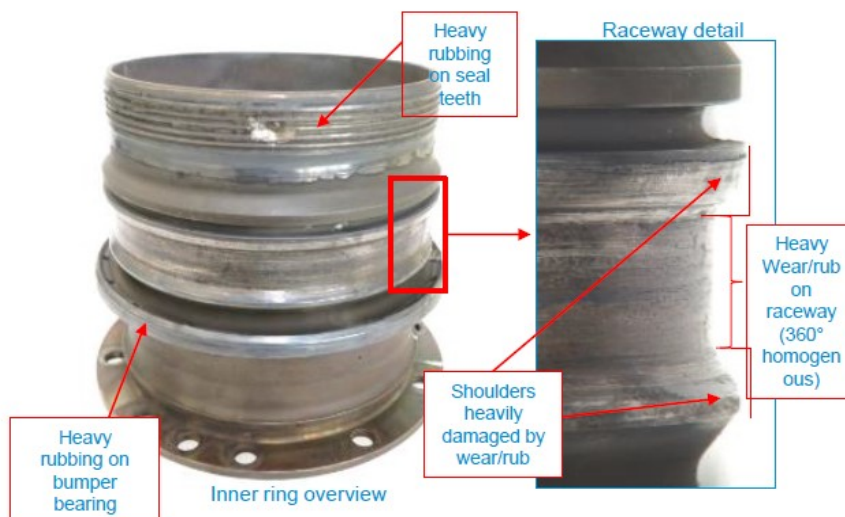
**Fig-11: Disassembly – Bearing no. 4**

- (a) Sectorial wear (160°) of the outer ring raceway machined-grooved by rollers rubbing. No spalling evidence detected on this race.
- (b) Inner ring raceway and shoulder wear due to rubbing.

Owing to the above observations, the No. 4 bearing condition could be attributed to a sudden radial overload (probably brutal HPT unbalance) and was not established as the root cause of the engine event.

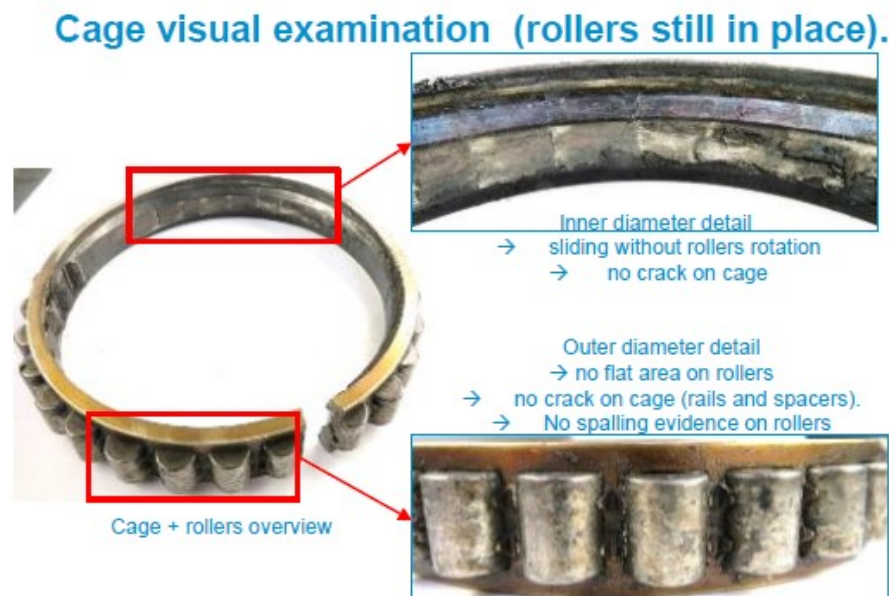
**Fig-12: Disassembly – Bearing no. 4**

- (c) Cage with no crack. All rollers still in place on pockets.
- (d) No spalling evidence on rollers.
- (e) Sectorial rubbing of the cage driving diameter and presence of a flat area on the rollers associated on this area.

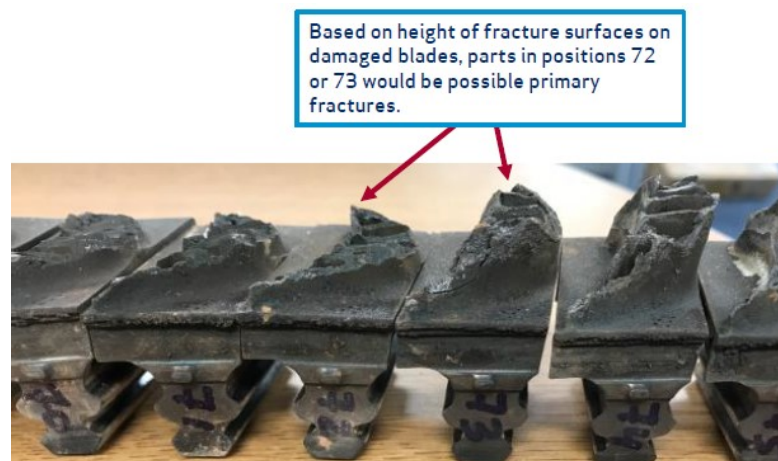
**Fig-13: HPT Blades position 72 and 73**

Based on height of fracture surfaces on damaged blades, parts in positions 72 or 73 would be primary fractures. However, these blades show purely tensile fracture features, alongside indications of elevated temperature exposure, and therefore appear to be secondary mechanisms.

The HPT blade events generally do not cause IGB failure, but it is other way that leads to rotor shift and hence HPT blade failure could be ruled out as cause of failure of the engine.

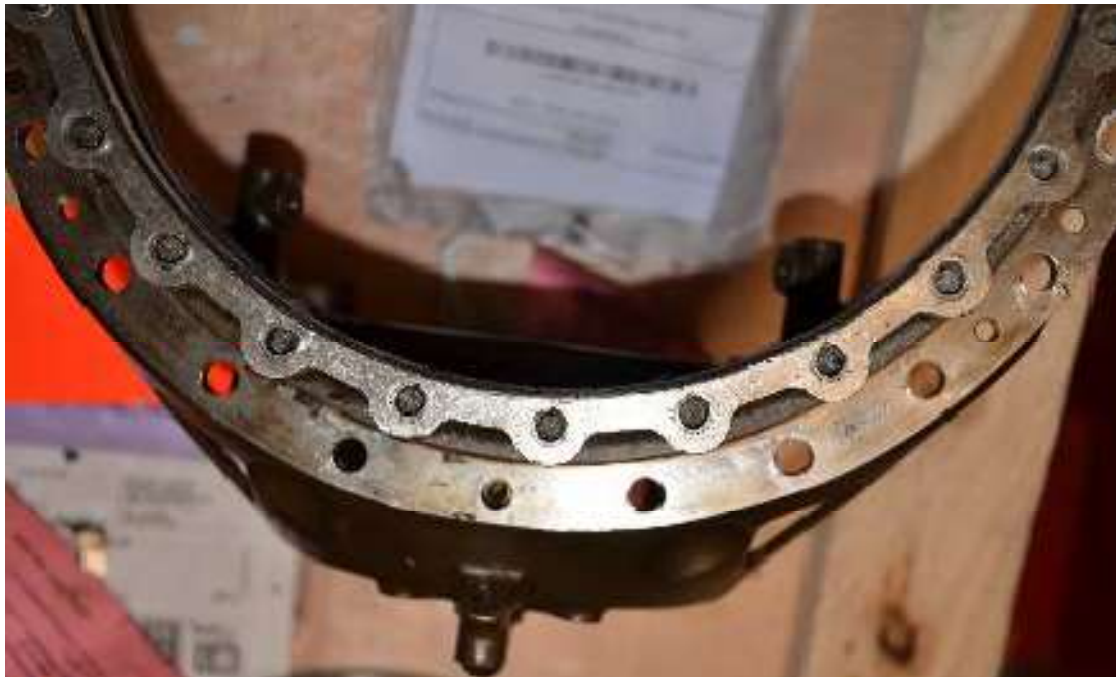
***Fig-14: IGB Broken Studs***

(a) All IGB studs were found broken, majority of the stud fracture surface morphology consistent with tensile overload –based on comparative analysis to historical cases.

As per the report received from the Technical Adviser appointed by NTSB, based on Visual Inspection and Lab Examinations, IGB and No. 3 Bearings Module failure could be established as the most probable cause of Engine Failure.

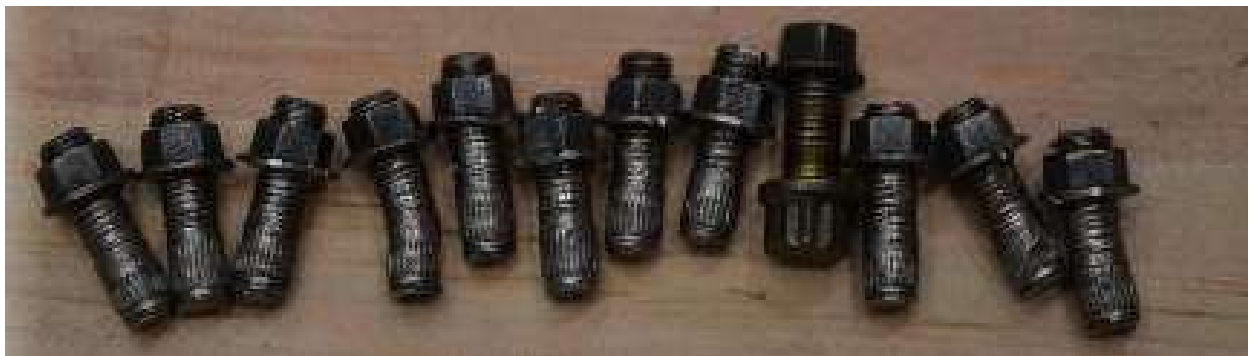
***Fig-15: Damaged IGB studs***

(b) Liberated remnants of IGB studs and nuts showed IGB nuts still in place, but at different height and loose.

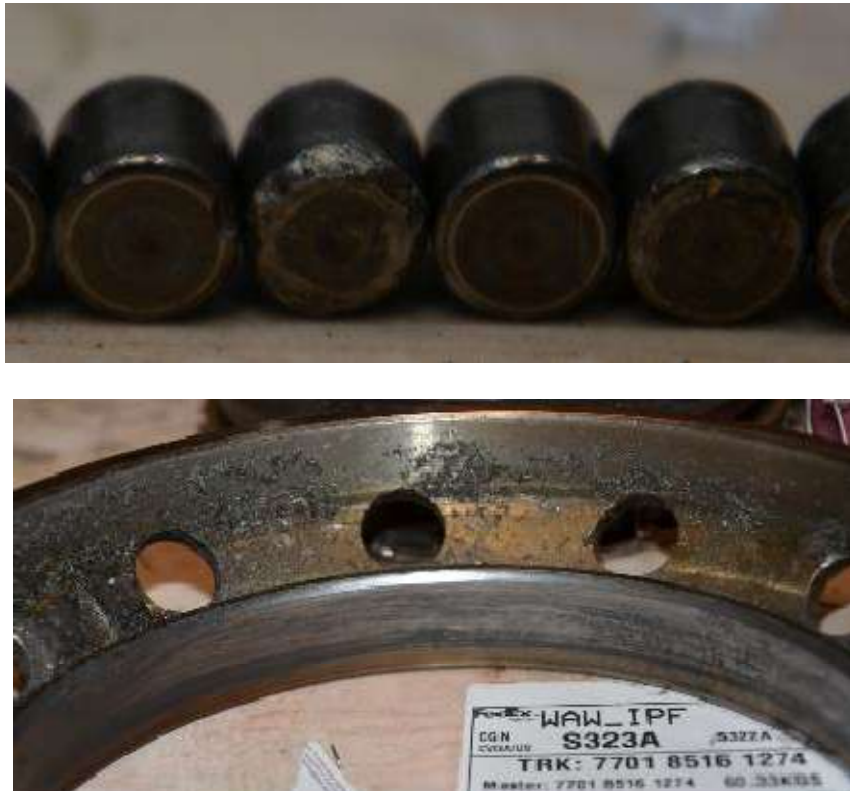
***Fig-16: Damaged Bearings***

- (c) Wear and secondary impact marks observed on #3R Bearing Outer Ring and Rollers but no spalling.

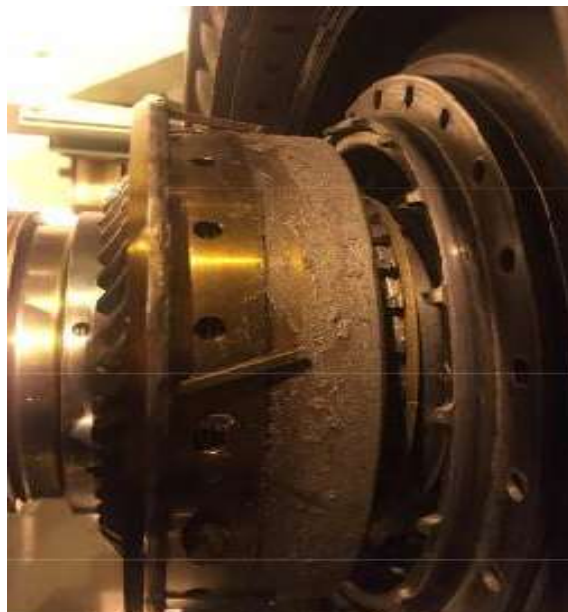
***Fig-17: Damaged No 3B Bearing Finger Housing***

- (d) No. 3B Bearing showed evidence of secondary damage.
- (e) No. 3B Spring finger Housing beams were broken.
