**FINAL INVESTIGATION REPORT**

**SERIOUS INCIDENT TO M/S AIR INDIA EXPRESS LTD.**

**BOEING 737-800 AIRCRAFT VT-AYA**

**AT MANGALORE ON 30<sup>TH</sup> JUNE 2019.**

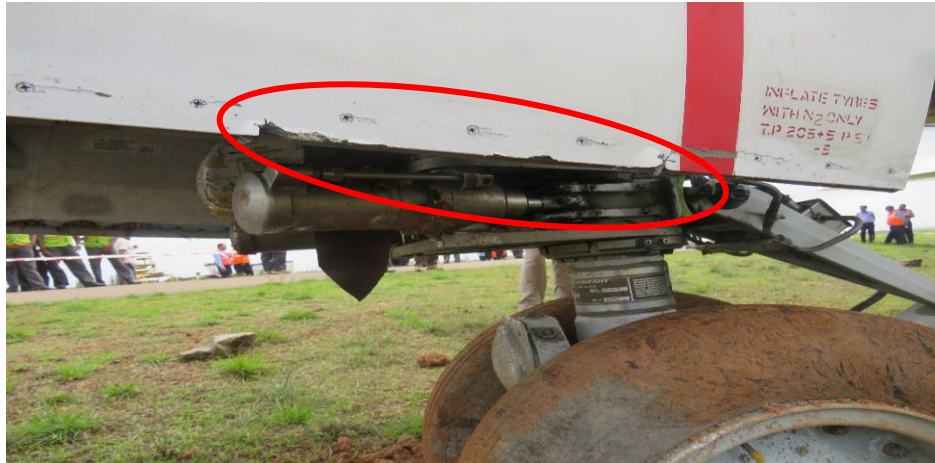
1. Minor damages were found at aft end of NLG (Nose Landing Gear) left side door bottom edge.

***Pic 1: Damage on NLG left door***

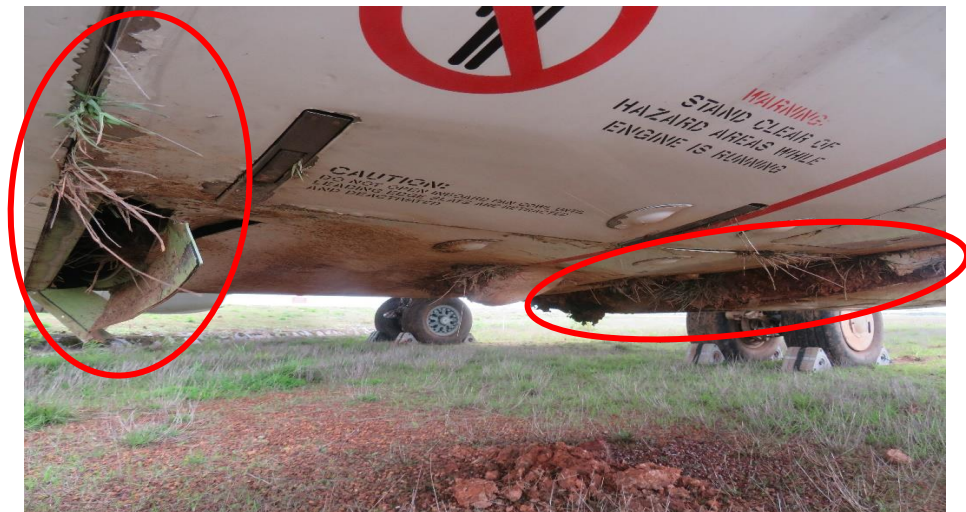
2. Both left and right fan cowls of LH engine were found damaged.

***Pic 2: Damaged LH Engine Cowl.***

Lower surface of Left engine cowling was found damaged with lots of mud.

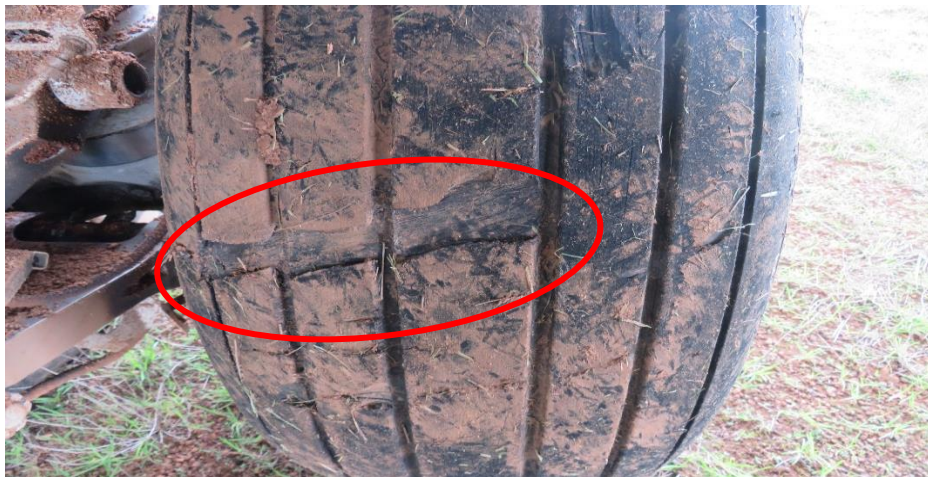
4. Cut marks were observed on the MLG (Main Landing Gear) tyres.

***Pic 3: Cut marks on MLG tyre.***

**2.1.2** The brake assemblies were examined for their serviceability at a DGCA approved MRO in the presence of investigating team and no anomalies were observed on the brake assemblies. Damages on the wheels were during the incident.

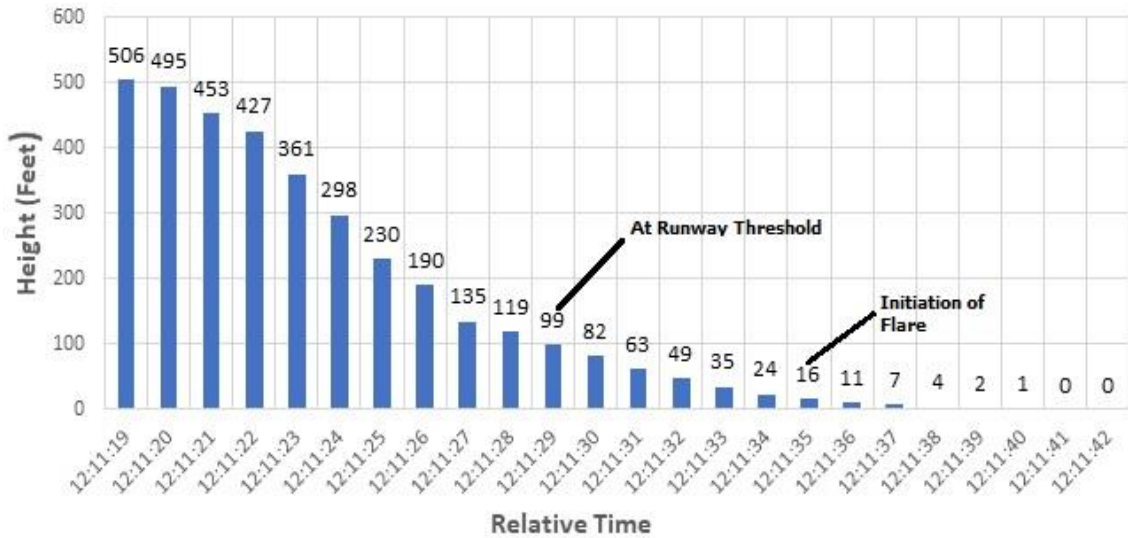
- The autopilot was disengaged at radio height of 506 feet at relative time 121119 and the aircraft made touch down at relative time 121142, i.e. the aircraft took 23 seconds to descend from 506 feet to ground.
- The aircraft was at 99 feet AGL with Vapp of 156 knots and Pitch of - 2.11° (Nose Down) while overflying runway 24 threshold.
- The aircraft rolled for a distance of about 1571 meters and for a duration of 37 seconds after touchdown before coming to its final halt.

**Pic 6:** Graph showing Change in height with Time (500 feet to Touchdown).

- Auto call out of “20” was heard at 121135 UTC and touchdown (Thud) sound was heard at 121142 UTC i.e. it took 07 seconds for aircraft to touchdown from a height of 20 feet. This is in line with the DFDR where it was observed that the aircraft floated for about 07 seconds (from 16 feet to touchdown) before touchdown.

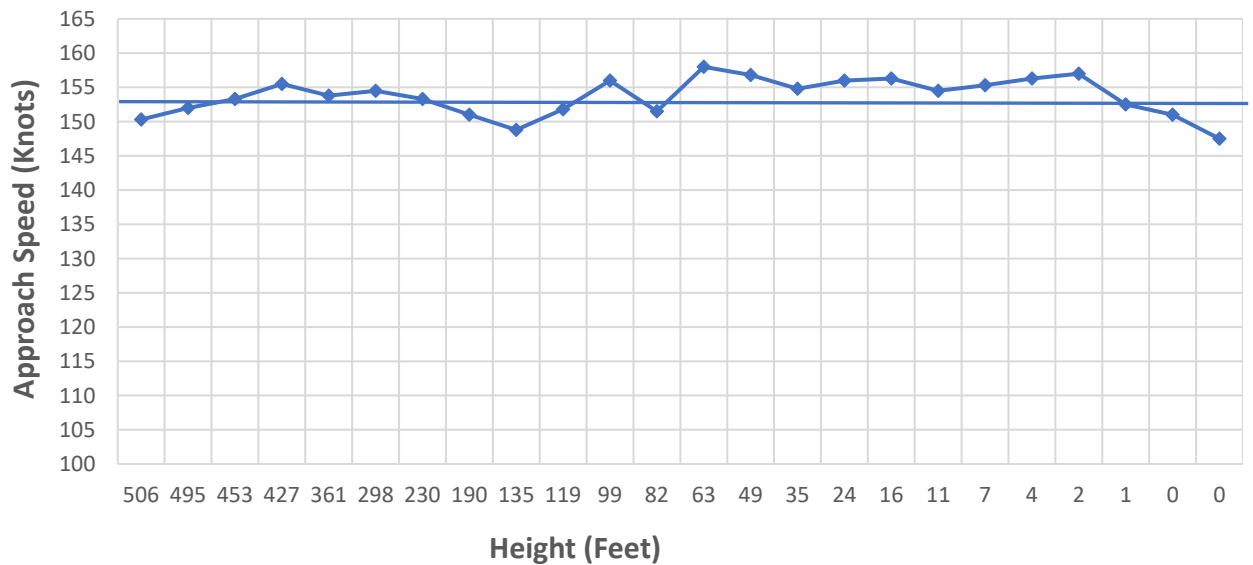
- The Reference speed  $V_{ref}$  was calculated as 138 knots. The Approach speed ( $V_{app}$ ) will be  $V_{ref} + 5$  knots i.e.  $V_{app}$  of 143 knots.
- The approach speed was observed to be 151 knots at 1013 feet AGL and 147.5 knots at touchdown with maximum value of 158 knots at 63 feet AGL.

**Pic 7:** Graph showing Change in Approach Speed with height (500 feet to Touchdown).

- Below 500 feet, co-pilot again calls out for “Speed”, however this time there was no response by the PIC. This is in line with the DFDR data where it was observed that below minimums, the Approach speed was above the limit of Vapp + 10 i.e. 153 knots.

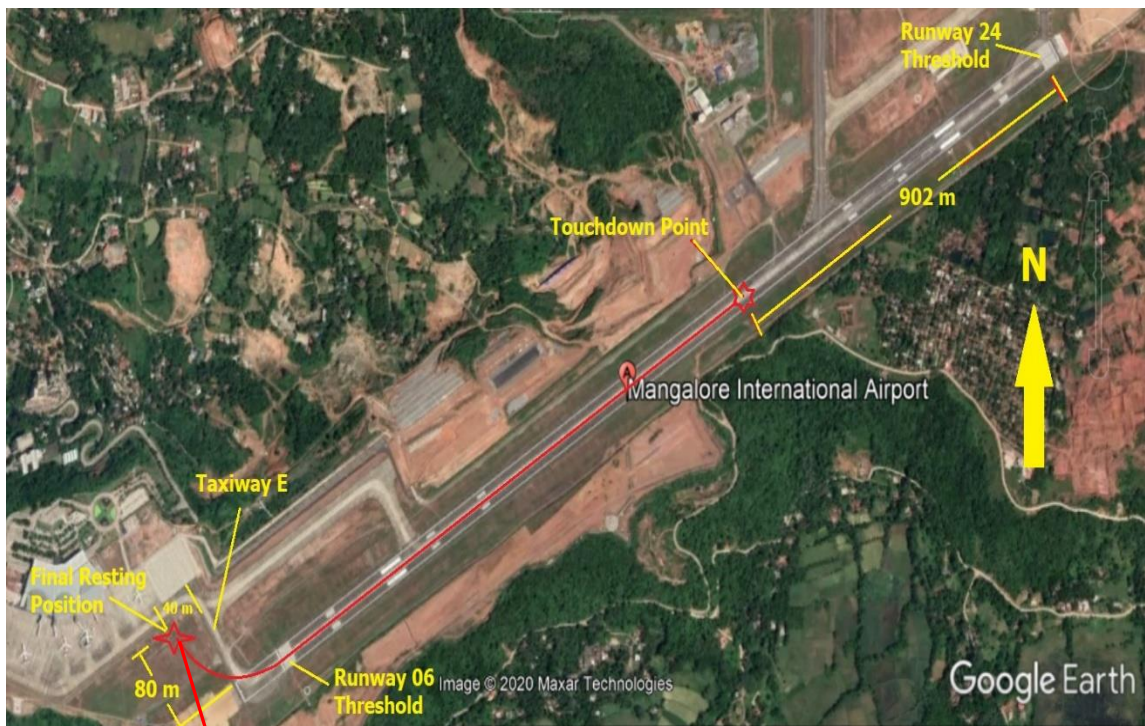
The aircraft was high on approach and made a delayed touchdown on runway at a distance of about 900 meters ahead of runway 24 threshold. The aircraft rolled for about 1488 meters on the runway. The aircraft started deviating towards right just before "Taxiway E" and entered unpaved surface from "Taxiway E" intersection. Tyre marks of the aircraft were observed on the runway before taxiway E intersection which is evident due to heavy application of brakes by the crew. The left main wheel ran over one of the runway edge lights (at taxiway E intersection) which was broken.

*Pic 8: Touchdown and Final Resting Position of Aircraft.*

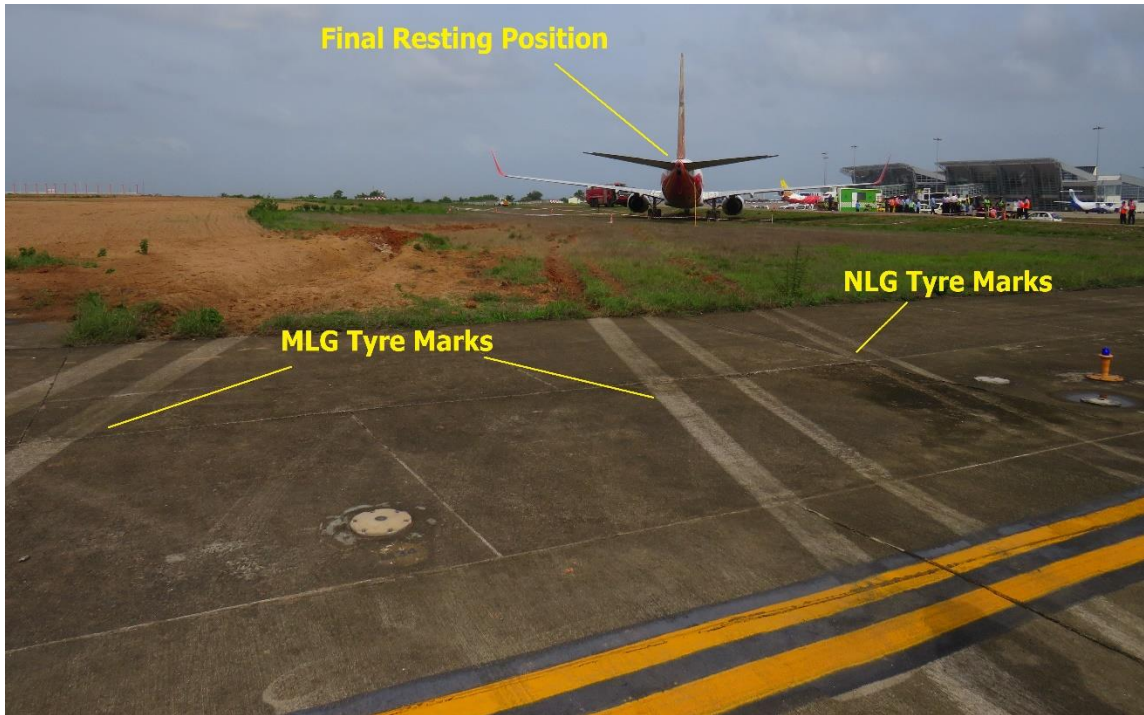
***Pic 9: Final Resting position of the aircraft with tyre marks.***

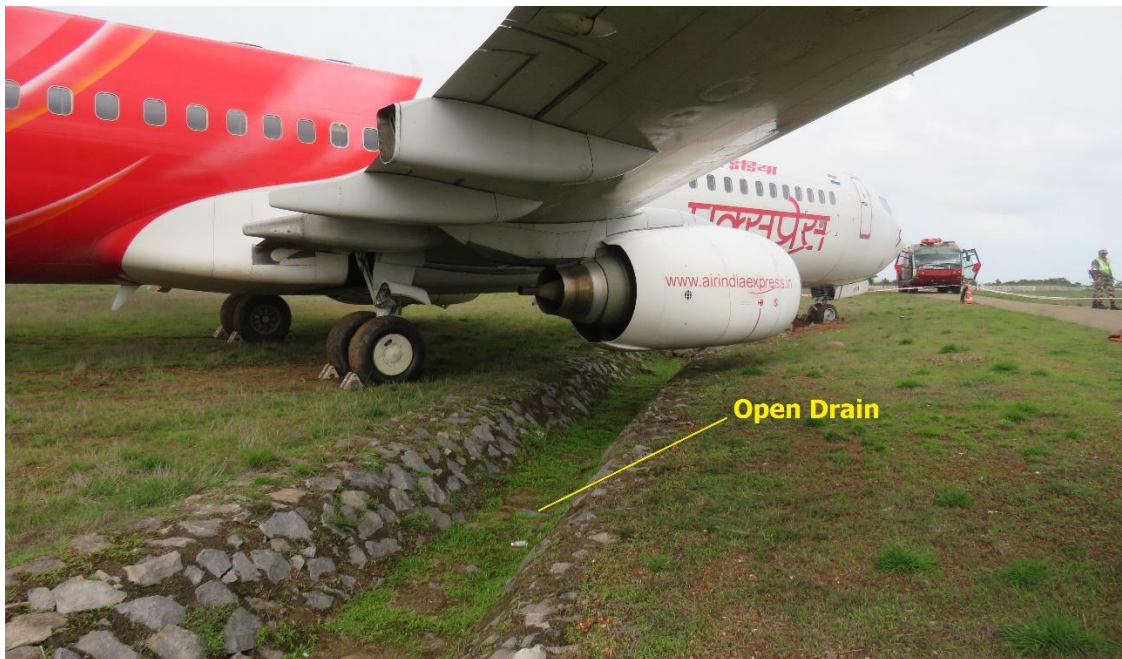
The aircraft travelled for about 80 meters on the unpaved surface (soft ground with mud) before coming to its final halt. The nose wheel of the aircraft ran over the open drain in the unpaved surface which probably arrested the speed of the aircraft. The aircraft was resting on the unpaved surface heading 276° and about 45 meters to the left of Taxiway 'E'.

***Pic 10: Aircraft stopped after Nose wheel ran over open drain.***
