**FINAL REPORT ON SERIOUS INCIDENT INVOLVING  
CESSNA CITATION 525A-CJ2+ AIRCRAFT VT-BRT OF  
M/s TAAL ON 11.09.2019 AT NANDED AIRPORT,  
MAHARASTRA, INDIA.**

**DRAFT FINAL REPORT ON SERIOUS INCIDENT TO M/s TAAL CESSNA**

**CITATION 525A-CJ2+ AIRCRAFT VT-BRT AT NANDED ON 11/09/2019**

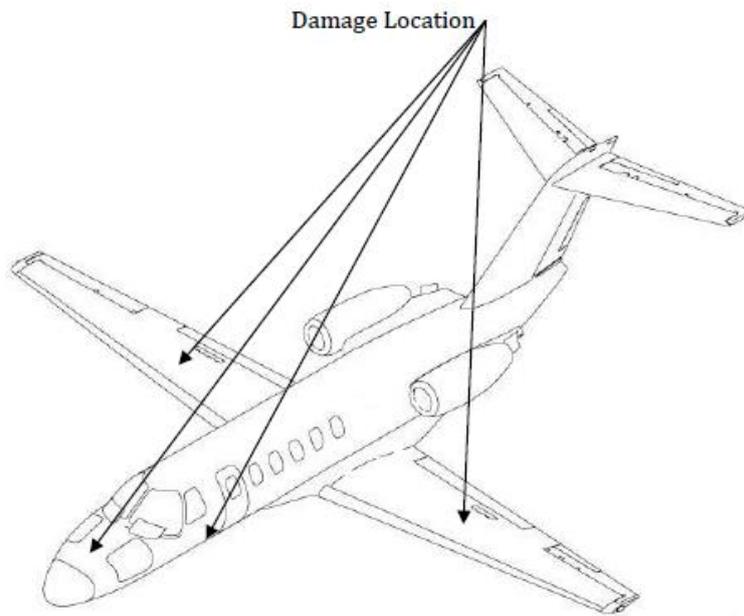
Fig1: Major Damage Locations on 525A-0373

The aircraft sustained substantial damage in the incident. Following damages were observed on the aircraft during damage assessment.

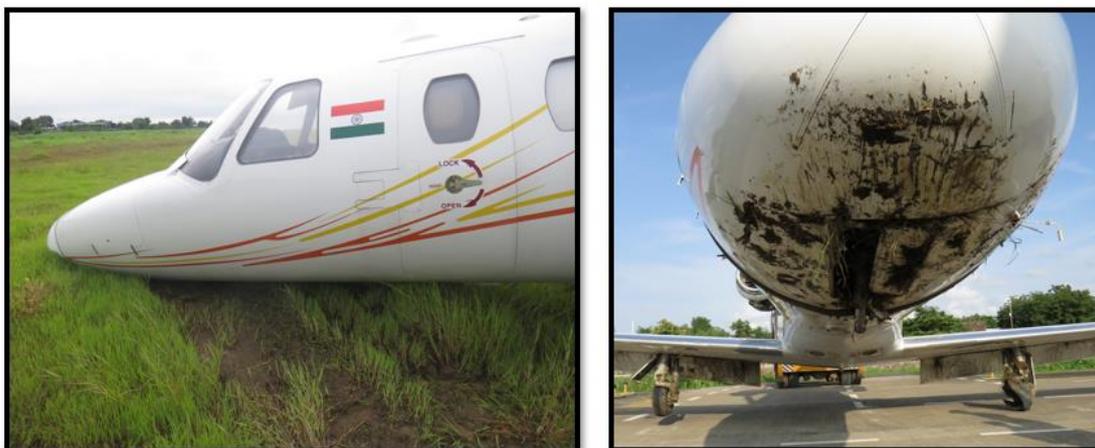
Fig 3: Nose Section

- 1) Drain pipes under fuselage (AC evaporator) broken.
- 2) Composite skin around landing lights cracked and damaged.
- 3) LH landing light broken.
- 4) Dent noticed on skin aft of LH landing light.

- 5) Nose radome damaged.
- 6) Weather Radar Antenna attachment bulkhead dented at bottom and found cracked at radome lock pins (Bottom LH)
- 7) LH & RH Pitot tube detached from its support tube assembly.

- 8) Multiple dents & cracks noticed on bottom skin both sides of Nose Landing Gear Wheel area.
- 9) Dent & Crack noticed on fuselage skin close to RH Pitot support tube assembly.

- 10) ATC transponder antenna damaged. Skin around antenna dented.
- 11) Heavy damage on the bottom skin and structure immediately after of pressure bulkhead. Dent noticed on bottom fuselage at F S 137 approx. Dent and Crack noticed on bottom fuselage at F S 145 approx. Crack length 140mm and width 50mm at the widest. Multiple scratches noticed on RH side bottom fuselage fairing from F S 203 to F S 286 approx. outer. Multiple scratches noticed on LH side bottom fuselage fairing from F S 203 to 286.

- 1) Nose wheel and landing gear fork has sheared from Oleo strut NLG wheel well area multiple dents, cracks and severe damage observed. NLG complete door assembly has damaged. NLG door link rods and hinges damage. NLG fork cracked and detached from Oleo Piston.
- 2) Shimmy Damper detached from its mount.
- 3) Bungee assembly – Nose Steering found damaged Upper torque link cracked at lower hinge end detached.
- 4) NLG actuator eye end sheared. Actuator attaching fork end on NLG damaged.
- 5) Lower steering joint support assembly detached from its all three attachment.
- 6) Nose Wheel tire deep cuts observed.

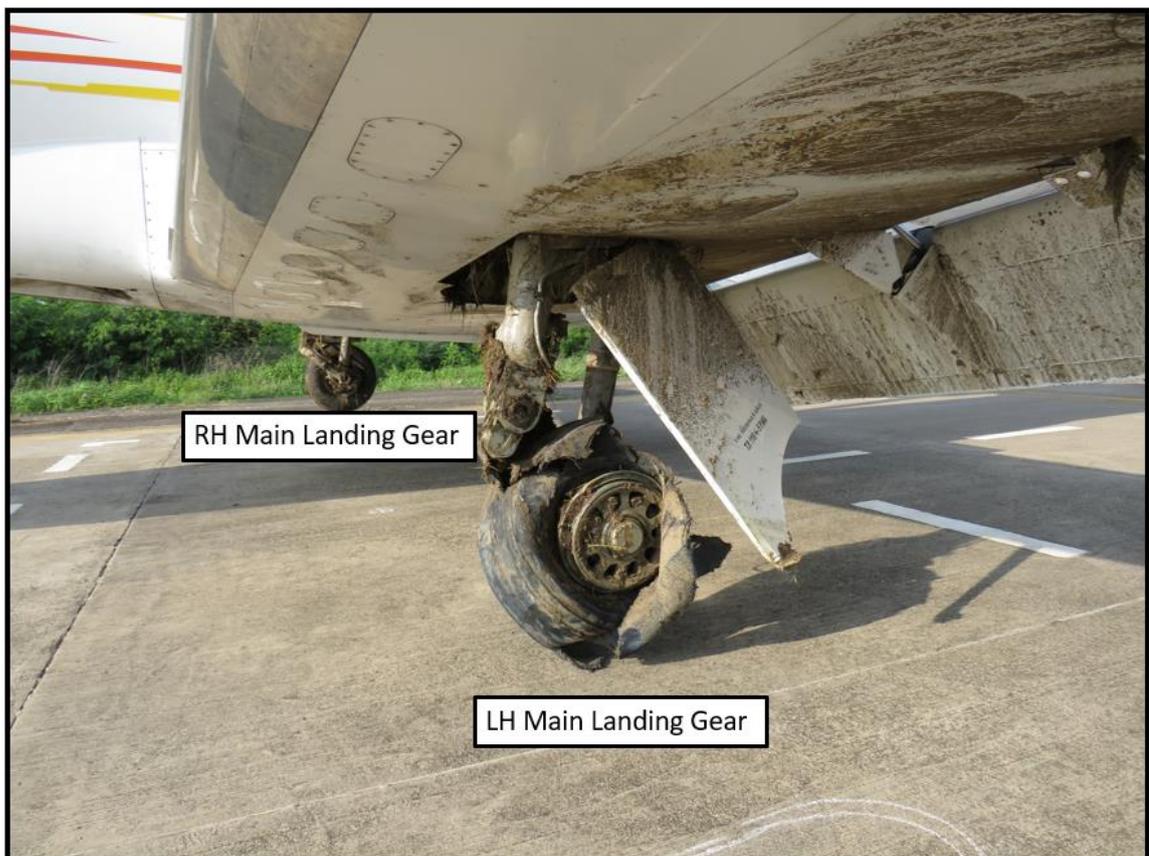
Fig 4: Side View of both MLG

- 1) Main wheel tire deflated and disintegrated to many parts.
- 2) LH & RH landing gear doors damaged.
- 3) Door and MLG connecting rod end found broken.
- 4) Brackets on LH MLG supporting brake hydraulic and pneumatic lines found damaged.
- 5) Clamps supporting antiskid wire on LH MLG found damaged.
- 6) Small dent noticed in wheel well area.

- 1) RH L/G door damaged by hitting ground.
- 2) Multiple deep cuts noticed on RH tire.

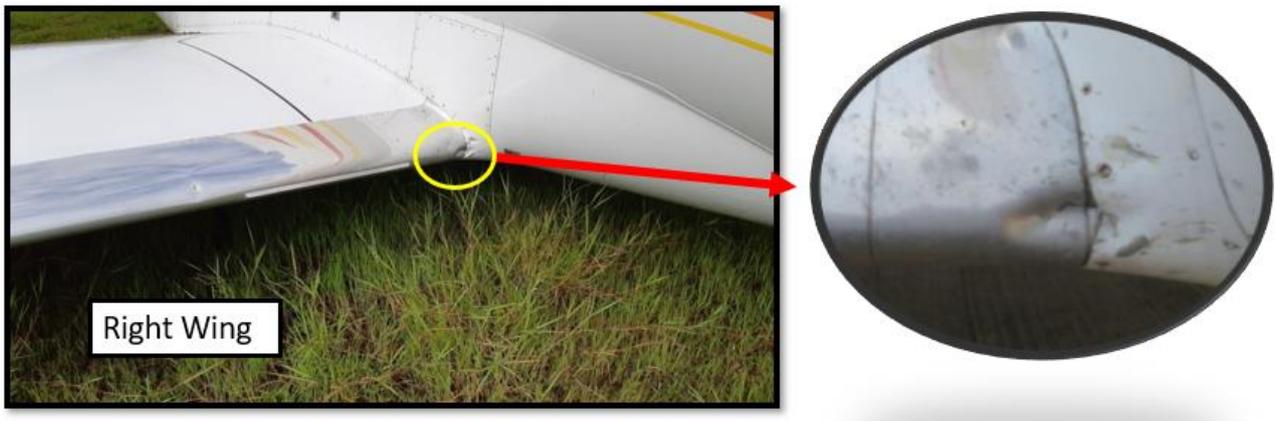
Fig 6: Right Side Wing

- 1) RH wing leading edge cracked at wing root.
- 2) RH flap trailing edge damaged by hitting the ground.
- 3) Multiple scratches observed on leading edge b/w WS 30 and WS 112.
- 4) Multiple scratches observed on stall strip.
- 5) Multiple dents and holes noticed on bottom side of flap.
- 6) Dent noticed on inbound flap hinge bracket on flap assembly.
- 7) Dent noticed on RH wing fairing access panel no. 192 AL adjacent to RH Wing Leading Edge.

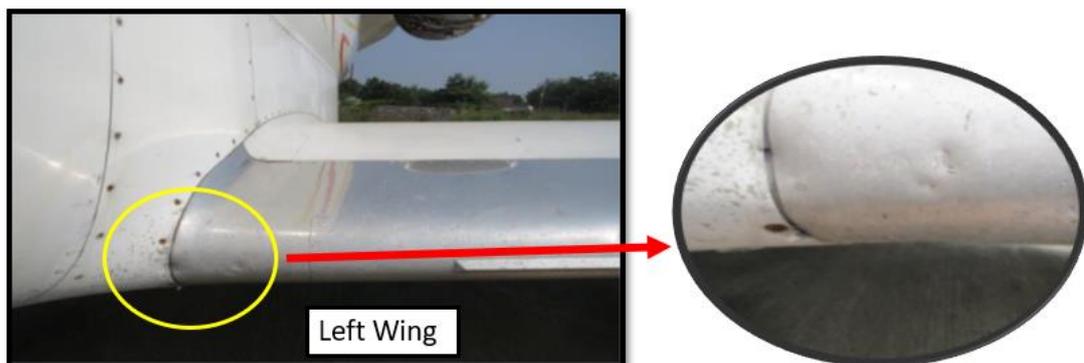
Fig 7: Left Side Wing

- 1) Wing skin riveted joint opened on top of wing at WS 102 approx where flap actuator is attached to wing.
- 2) Dents noticed on Wing Leading Edge (Top & Bottom) between WS 32 to 48 Approx.
- 3) Severe scratches observed on stall strip.
- 4) Fuel leak noticed from the fuel tank access panel no. 621AB, 621BB, 621CB due to deformation.
- 5) Scratch noticed on fuel tank access panel no. 611BB 611AB and 612BB.
- 6) Multiple holes and dents noticed on bottom side of flap. Flap top side trailing edge damaged.
- 7) Inboard hinge bracket on the flap found bent and dented and cracked.

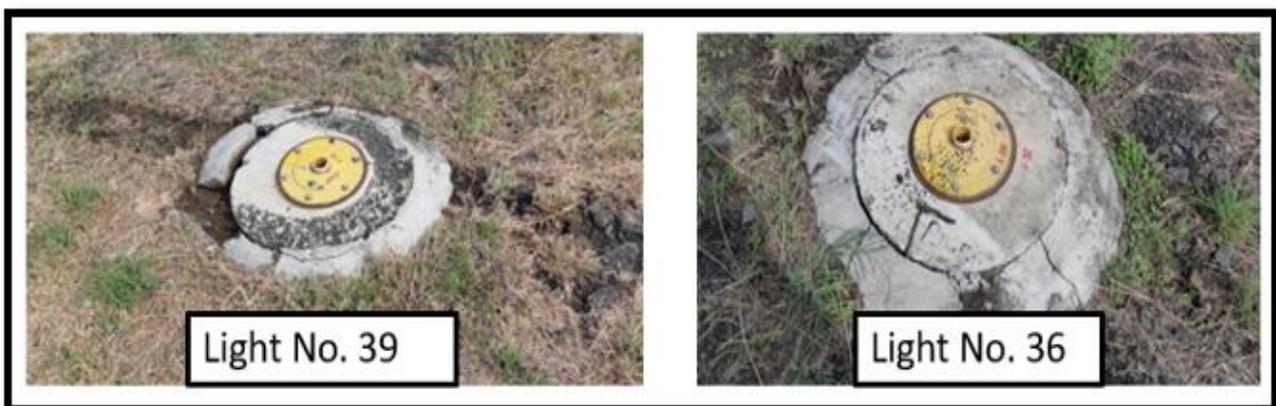
After the incident, two LH side runway edge lights L-39 & L-36 on runway 10 were found broken.

It was evident from the tyre marks that RWY edge light L-39 was broken by LH Main Landing Gear wheel and RWY edge light L-36 was broken by RH Main Landing Gear wheel.

**Fig 8: Broken runway edge lights**

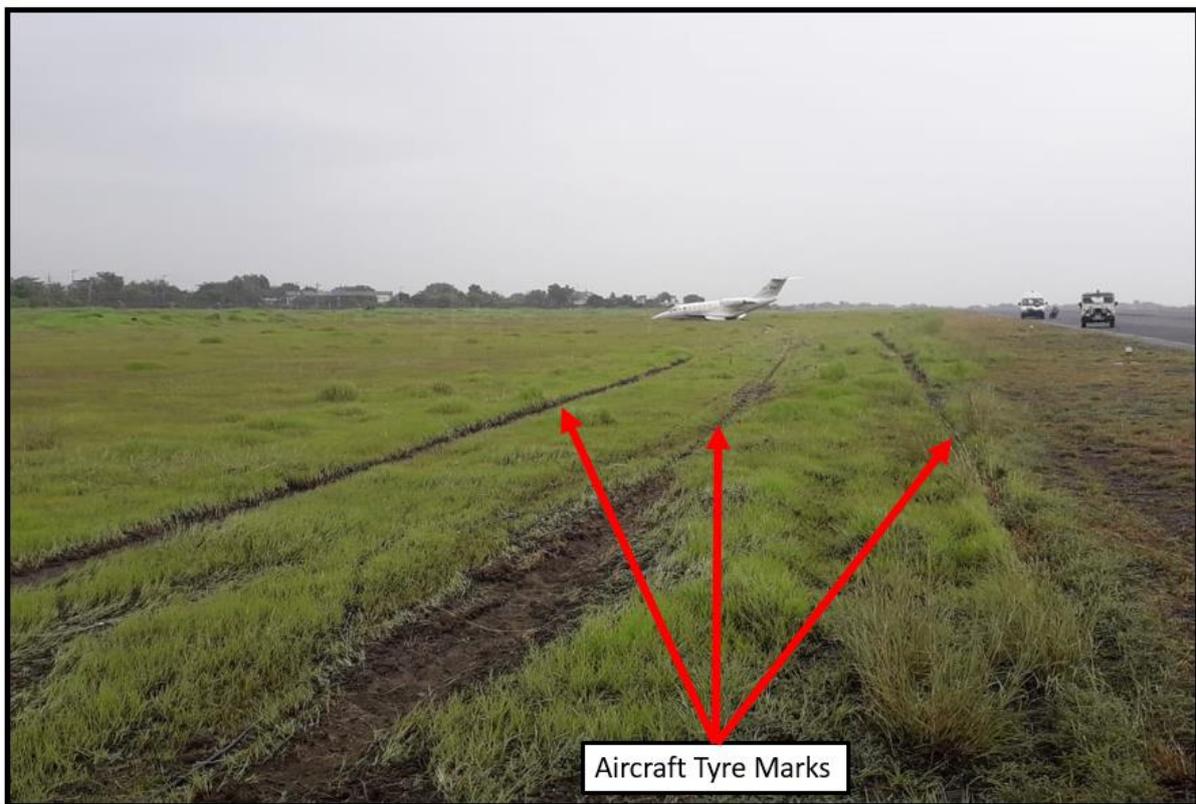
Fig 13: Aircraft Tyres marks on soft ground

The aircraft touched down on left side of runway centreline at approximately 300 m from threshold of runway 10. The aircraft started veering off to the left immediately after it touched down. PM observed that the aircraft was drifting towards left and as a corrective measure gave the call “Right Right”. However, aircraft continued to veer off to the left and after travelling for approximately 400 m, the left main wheel tyre left the paved surface and went into soft ground. After travelling 90 m further, aircraft veered further to left. The left wheel tyre mark was measured at a maximum distance of 3 feet 5 inches from the runway edge. Thereafter, PIC had tried

to bring the aircraft back on the paved surface which was evident from the left main tyre marking wherein it moved towards the right and tyre marks were found at 1 foot 5 inches from the runway edge. In-between due to impact between runway edge light and the left wheel, the left tyre had burst. Consequently, crew failed to bring back the aircraft left wheel on the runway. The aircraft became almost uncontrollable and continued veering further towards left. Aircraft exited the runway at about 1134 m from the threshold of runway 10, and came to rest at approx 1300 m from the threshold of runway 10, facing towards north. The track followed by the aircraft is shown in the figure 13 below:-

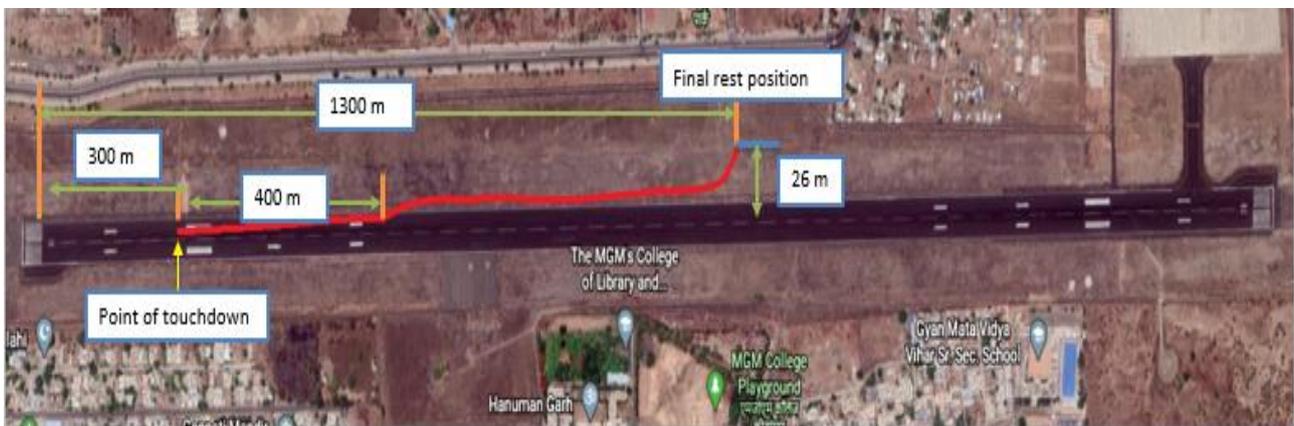
Fig 14: Aircraft Final Resting Position

Aircraft came to a halt after travelling a distance of 1300 m from runway 10 threshold and 26 m from runway edge. Immediately after runway excursion, PIC instructed FO to evacuate all passengers. Before CFT reached on site, all passengers had deplaned from the main door. The aircraft sustained damages beyond economical repair during the incident. However, none of the occupants received any injury. The incident was survivable.

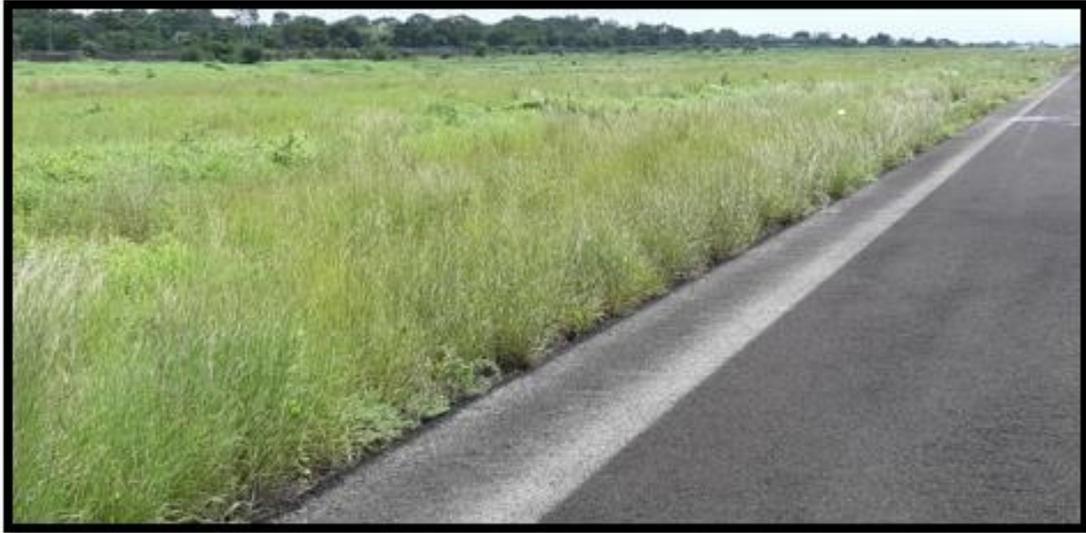
On 12.09.2019, grass of noteworthy height mainly covering few LH side of runway edge lights on RWY 10 was observed.

Fig 16: Grass covering runway edge lights
