FINAL INVESTIGATION REPORT
ON
SERIOUS INCIDENT TO M/S SPICEJET PVT. LTD.
BOEING 737-800 AIRCRAFT VT-SGJ
AT SHIRDI ON 29TH APRIL 2019.

K. Ramachandran
Investigator -In- charge

Amit Kumar
Investigator

**FINAL INVESTIGATION REPORT ON SERIOUS ACCIDENT OF M/S SPICEJET
LIMITED B737-800 AIRCRAFT VT-SGJ AT SHIRDI ON 29th APRIL 2019.**

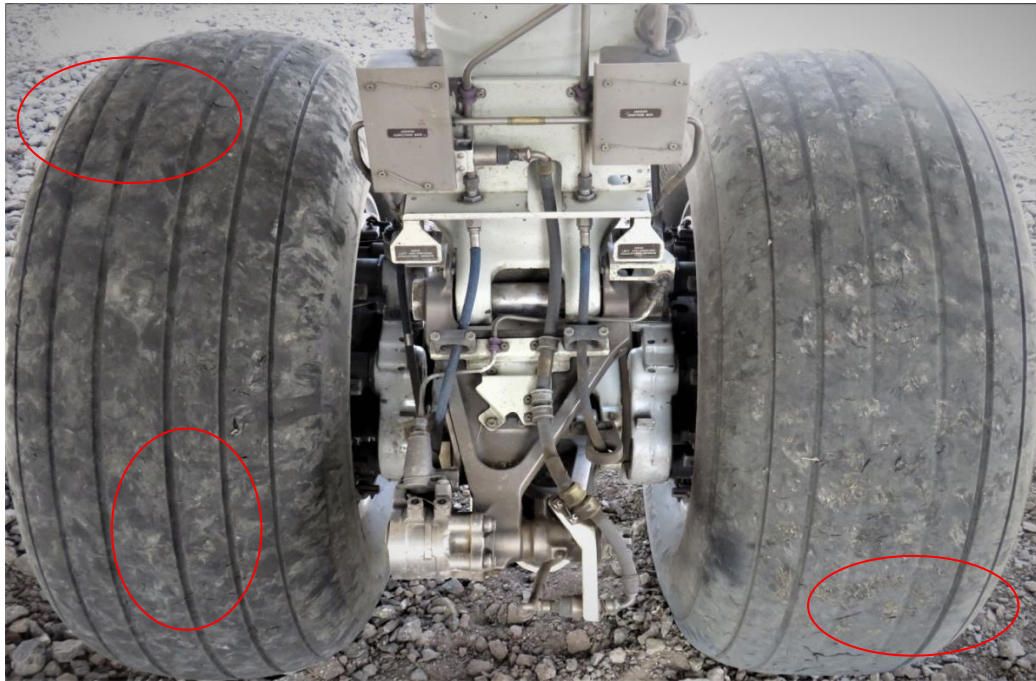
1. Multiple small cuts in all tyres of NLG and MLG were found and ingress of dust into all brake units was also found.

Pic 1: Cut marks on MLG tyres.

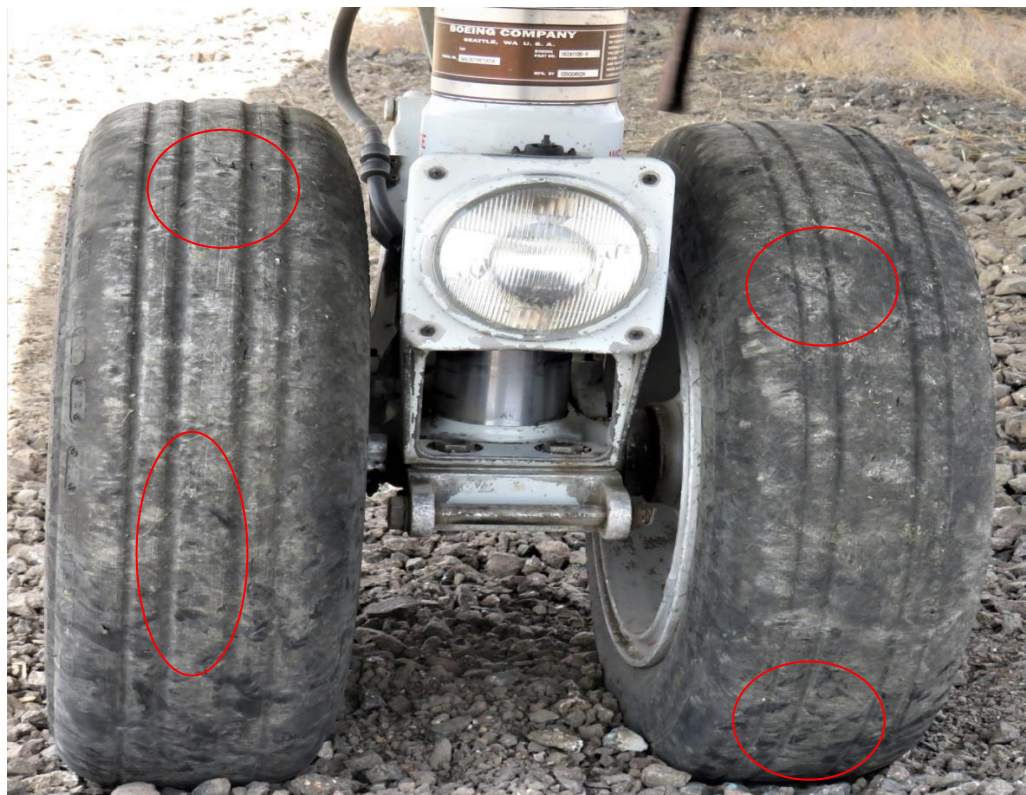
Pic 2: Cut marks on NLG Tyres.

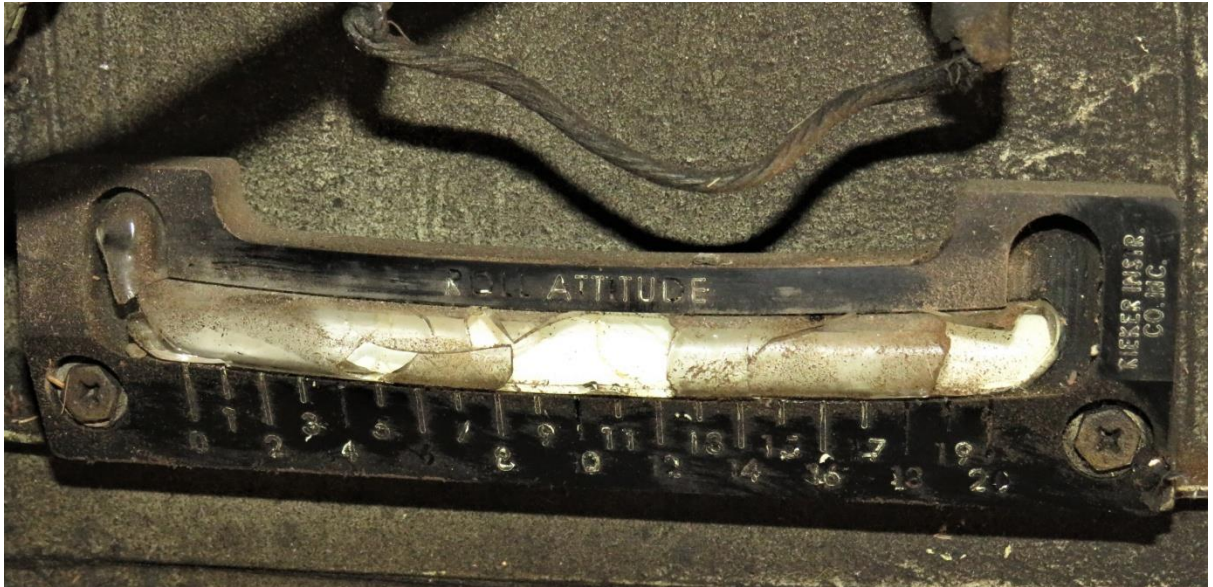
2. Roll Attitude Indicator glass was found broken.

Pic 3: Damaged Roll Attitude Indicator

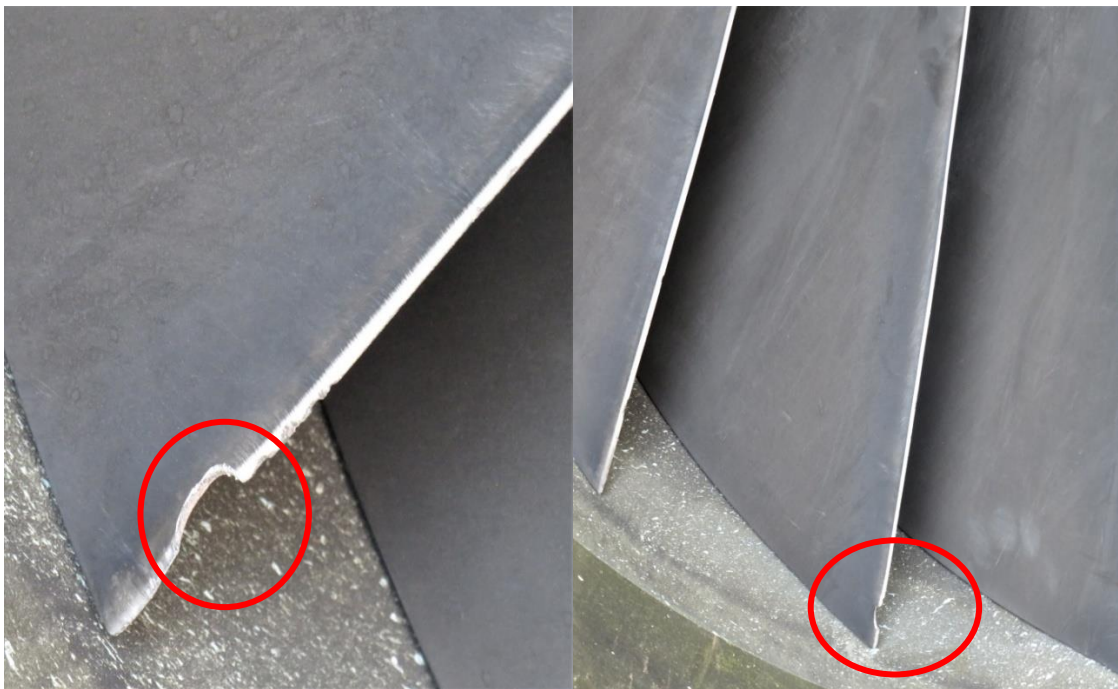
3. Minor distortion was observed on leading edge of blade No. 19 of LH engine.
4. On RH engine, missing material found on blades No. 12 & 14. On blade No.14 missing material of dimension $L=1.5\text{ cm}$ & $W=0.5\text{ cm}$ located 1.2 cm below the tip. Blade No.12 missing material of dimension $L=1.8\text{ cm}$ & $W = 0.6\text{ cm}$ located 2.5 cm below the tip. Both were found out of AMM limits.

Pic 4: Engine Fan Blade Damages.

Dents/nicks were observed on the leading edge of fan blades of engine # 2 probably due to gravels impacting the blades while the engine was running.

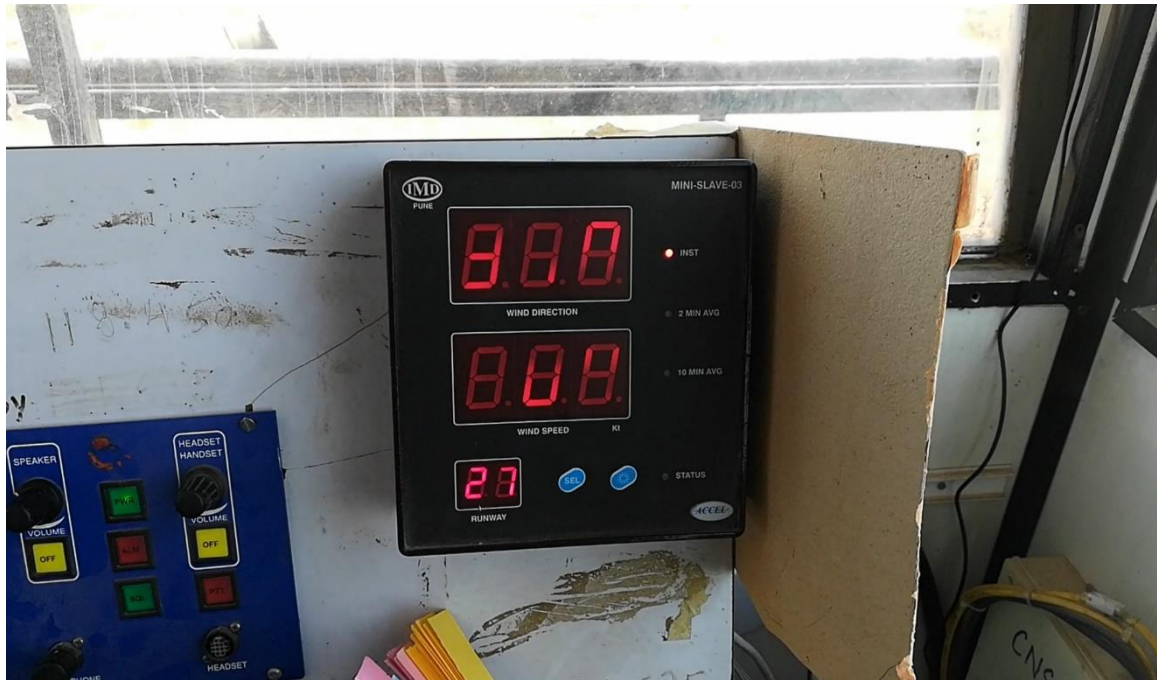
- i. Visual Wind Direction Indicator was blocked by the ATC building structure.
- ii. Digital Wind Indicator in front of controller was not clear.

Pic 6: Digital Wind Indicator in front of controller

Display of Digital Wind Indicator kept in front of ATC controller which indicates instant wind information on display was found faulty. It was quite difficult to read the figures displayed on it. This may lead to incorrect wind information being provided to the aircraft crew by the controller. This may further affect the landing configuration of the aircraft.

- 4.3.1 It is recommended that Operator may install another windsock on the other side of the runway.
- 4.3.2 It is recommended that Operator may periodically check the serviceability of the instruments available to the controller in ATC tower and develop a procedure for immediate replacement of unserviceable instruments in ATC.

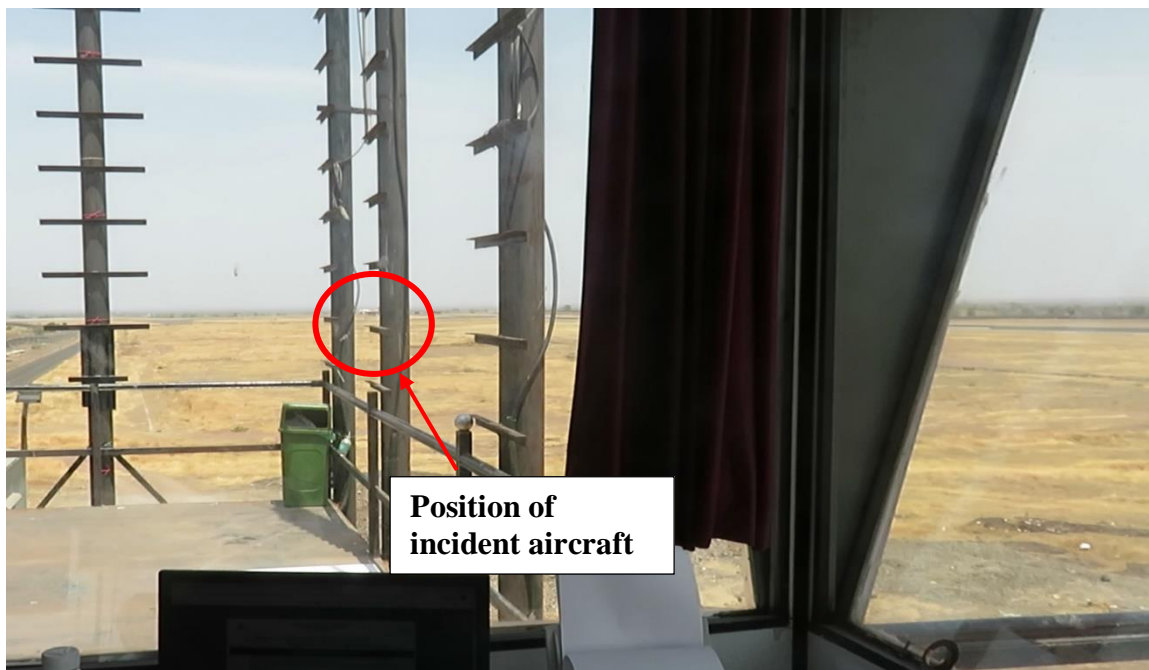
- iii. Scientific assistance (MET) digital readout had incorrect runway direction from source.
- iv. Both runways 09 & 27 were used for operations, but the “Digital Current Weather Indicator” system was located only on the 27 side and the only “Wind Sock” was also located on the same side.
- v. The runway 27 side is not clearly visible from the ATC tower, i.e. though the aircraft is visible, but the controller cannot observe the position of the aircraft on ground when it is on runway 27 side.

Pic 7: View of Runway 27 side from ATC.

It was observed that from the controller's position in ATC, the runway 27 side is not completely visible. Though the aircraft is visible, but the controller cannot ascertain the position of the aircraft on ground when it is on runway 27 side. The investigation team visited ATC when the incident aircraft was still lying at its final resting position on the unpaved surface i.e. 160 m away from runway 27 threshold. Though the incident aircraft was visible but its position could not be ascertained i.e. whether it was on the runway or out of it (Refer Pic 7). Further, the view was obstructed due to three Antenna pillars installed on the left of tower.

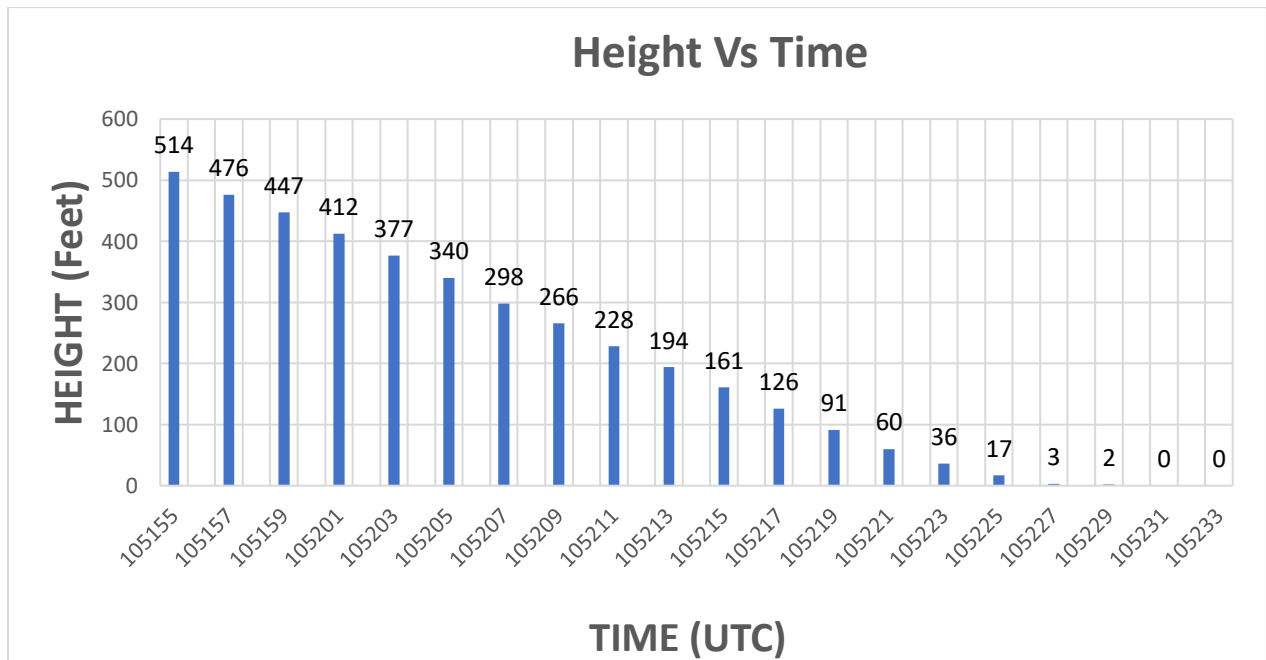
- The autopilot was disengaged at radio height of 1043 feet at 105127 UTC and the aircraft made touch down at 105233 UTC, i.e. the aircraft took 66 seconds to descent from 1043 feet to ground.
- The aircraft was at Radio height of 165 feet with Vapp of 152.8 knots and Pitch of 0.5° Down while overflying runway 09 threshold.
- The aircraft rolled for a distance of about 1216 meters and for duration of 29 seconds after touchdown before coming to its final halt.

Pic 8: Graph showing Change in height with Time (500 feet to Touchdown).

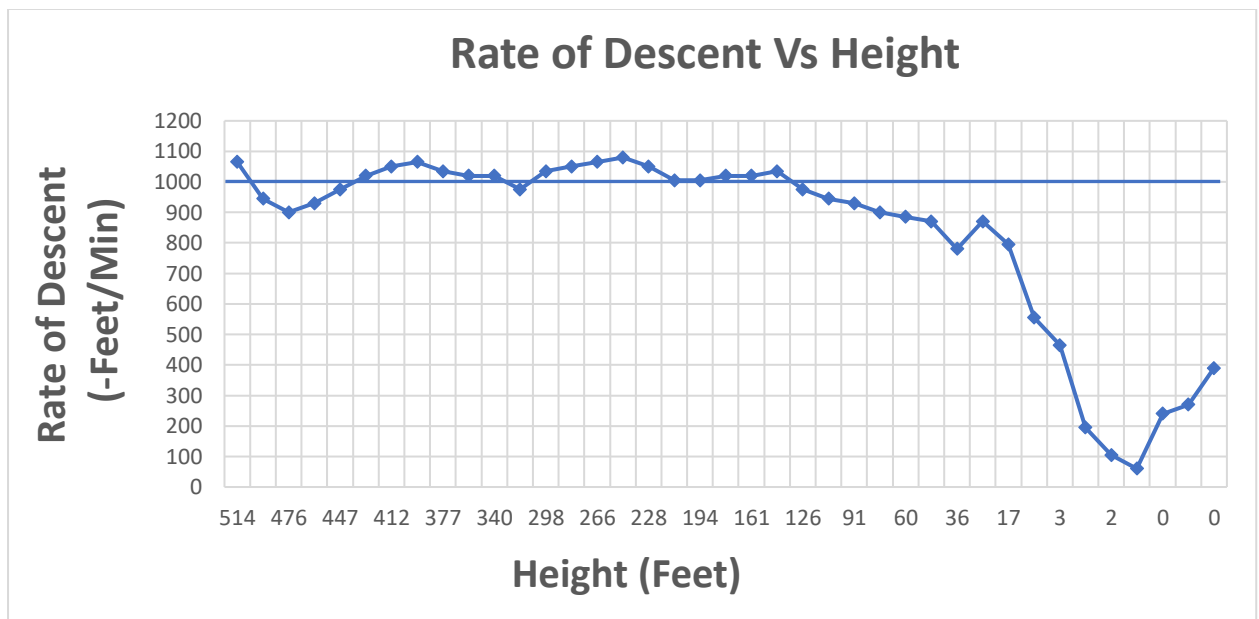
- The ROD varied between 300 and 1400 ft/min from Radio height of 1011 feet (at 105133 UTC) till touchdown (at 105233 UTC) with value of 1065 ft/min at radio height of 514 feet and 390 feet/min just before touchdown.

Pic 9: Graph showing Change in Rate of Descent with height (500 feet to Touchdown).

Hence, the aircraft was not stabilized by 500 feet AGL as per the minimum requirement for landing at VMC conditions.

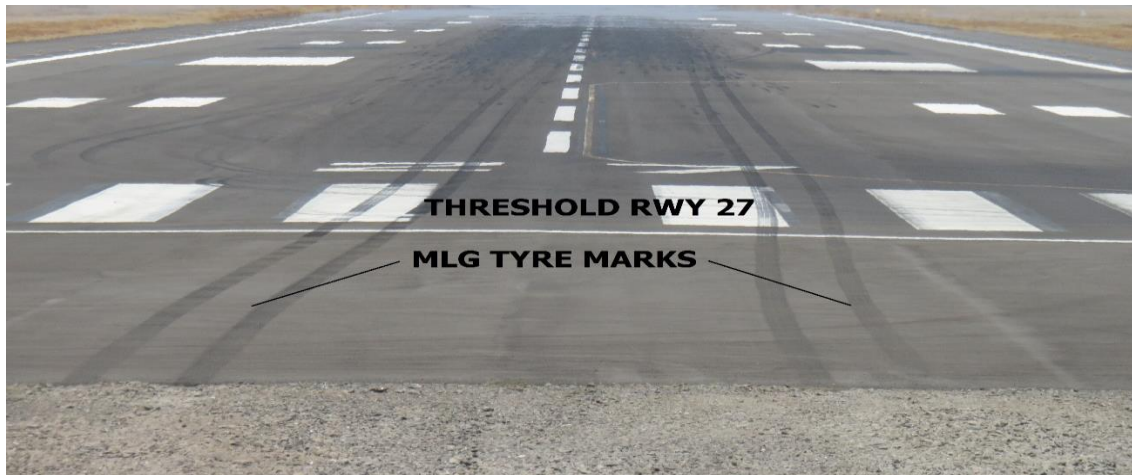
The aircraft was high on approach and made a delayed touchdown on runway abeam ATC tower at a distance of about 1445 meters ahead of runway 09 threshold. The aircraft rolled for about 1055 meters on the runway before exiting from runway 09 end (Runway

27). Tyre marks of the aircraft were observed before the runway 09 end which makes it evident due to heavy application of brakes by the crew.

Pic 10: Main Landing Gear Tyre marks on runway

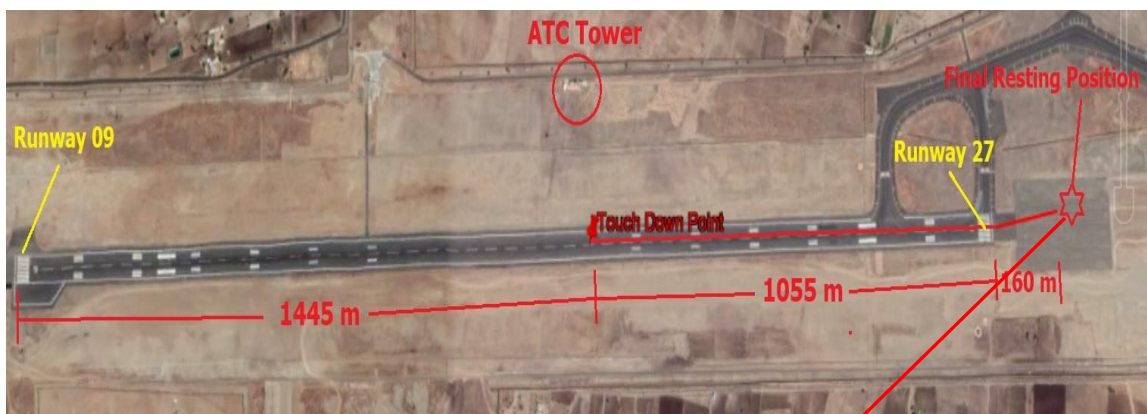
The aircraft travelled for about 100 meters on the unpaved surface (which was full of gravels) before coming to its final halt. The aircraft was resting on the unpaved surface heading 57° and about 14 meters to the left of runway centerline.

Pic 11: Touchdown and Final Resting Position of Aircraft.

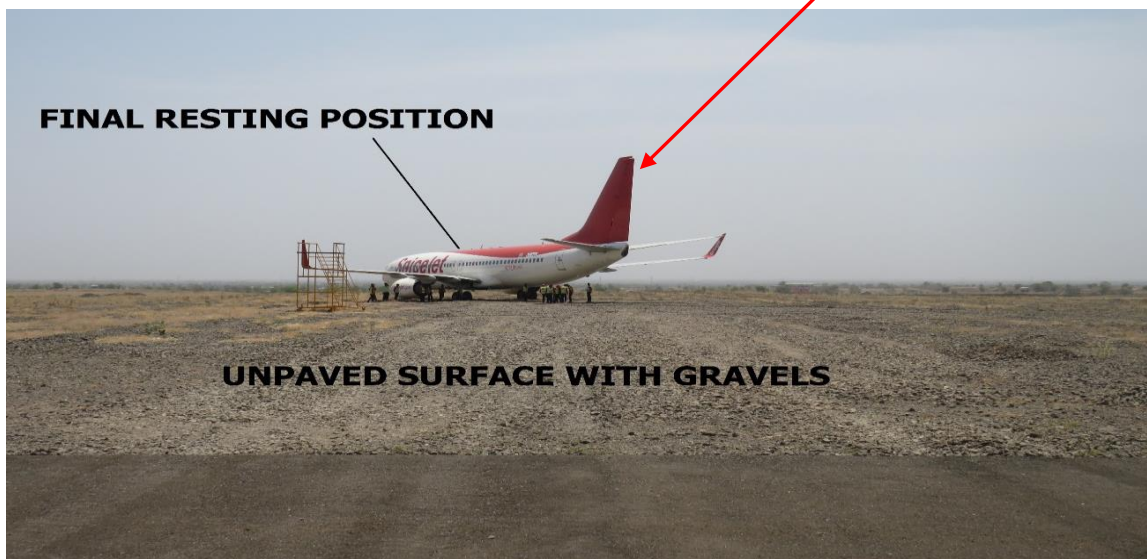
Pic 12: Final Resting position of the aircraft.

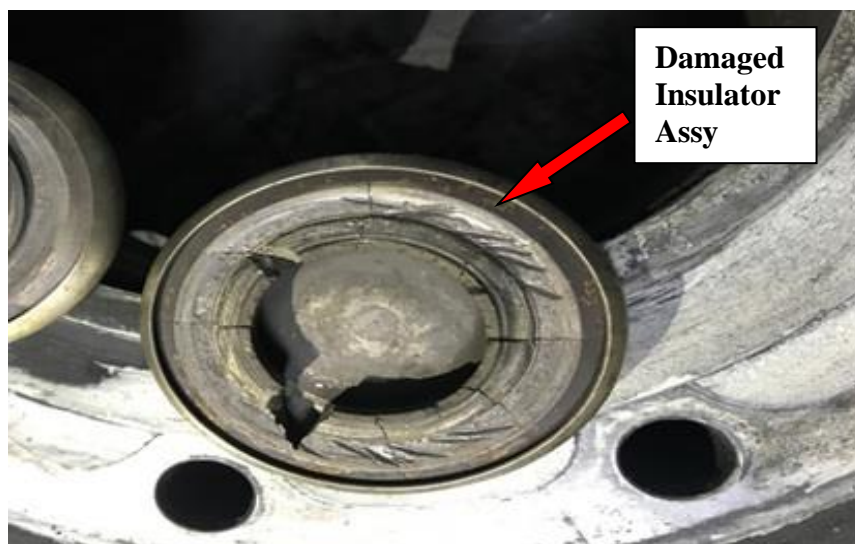
- Leakage of Hydraulic fluid observed all around thrust plate assembly and hydraulic fitting.
- 01 of grease fittings was found missing.
- 01 of the 06 Insulator assembly found damaged and disconnected from adjuster assembly, clip retainer found missing, retainer ring found missing and the guide spring was observed to have come out.

Pic 13: Damaged Insulator Assembly

During inspection of the brake assembly fitted at #4 wheel i.e. on the outer wheel of right MLG, it was observed that spring guide had come out because retaining ring was missing from adjuster assembly, which holds the spring guide under spring compressed condition so that when brake is released, the piston can move back with the force of compression spring and there is running clearance in the brake to rotate the wheel freely. But in this case, piston will not move back after the brake is released and spring guide will continue to press the thrust plate and wheel will not be free to rotate and there would be a case of brake jamming/dragging.

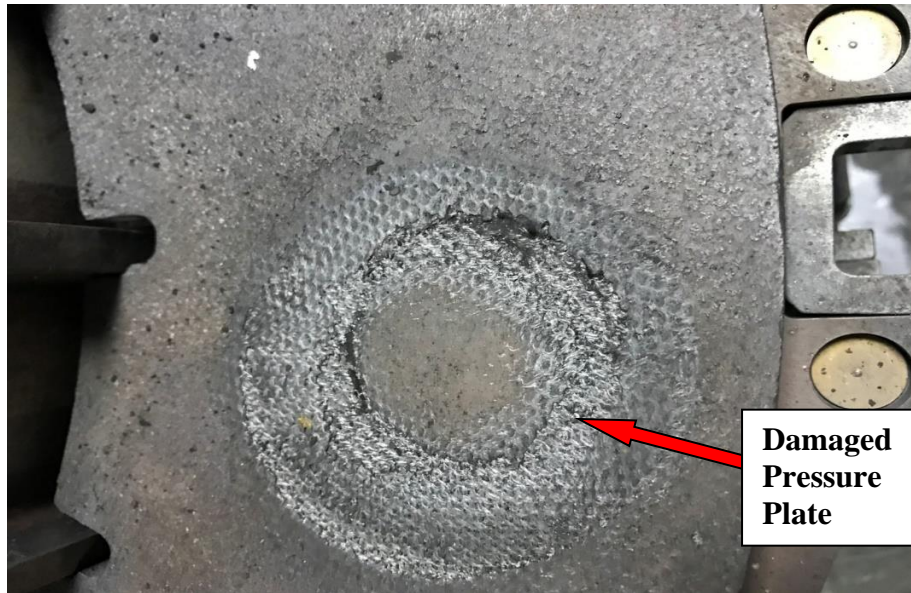
Pic 14: Damaged Pressure Plate

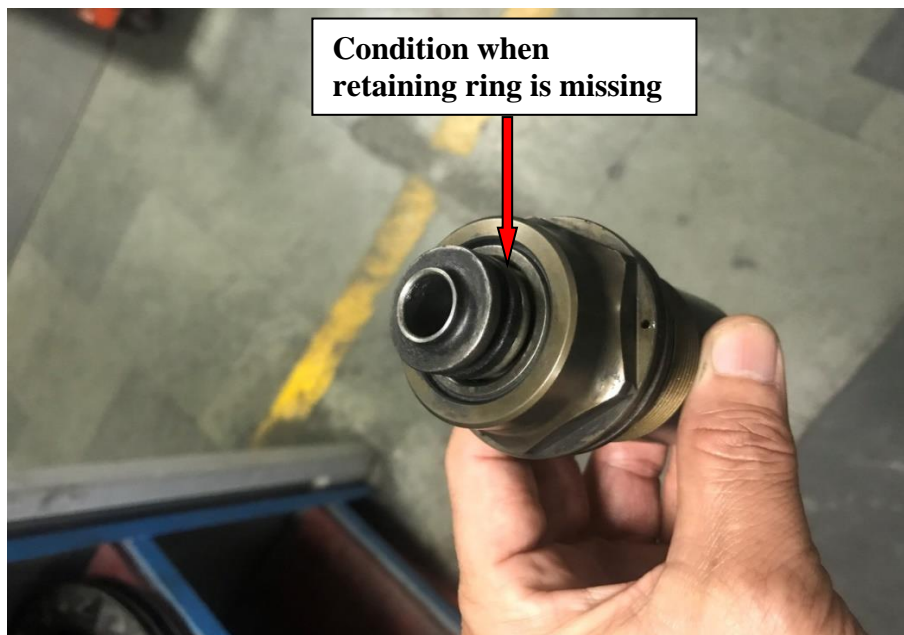
Pic 15: Retaining ring found missing in one of the insulator assembly

Reason: Retaining ring was either defective or not installed properly at the time of assembling the brake.

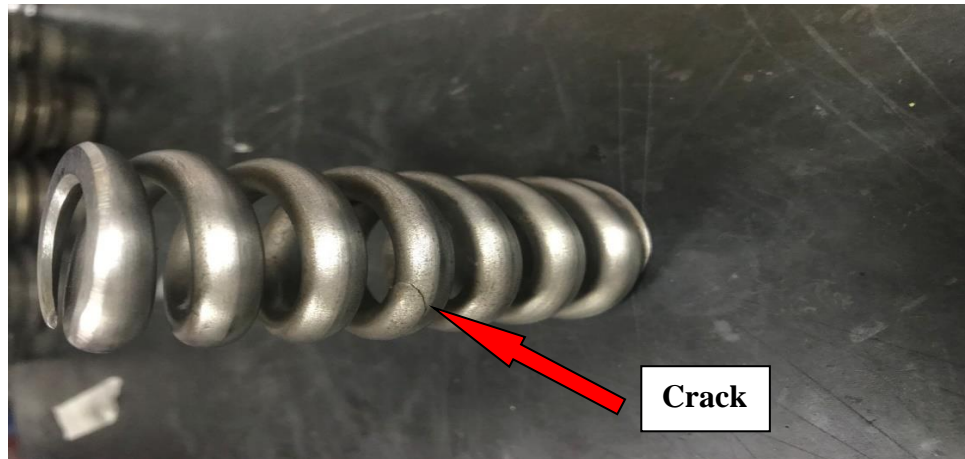
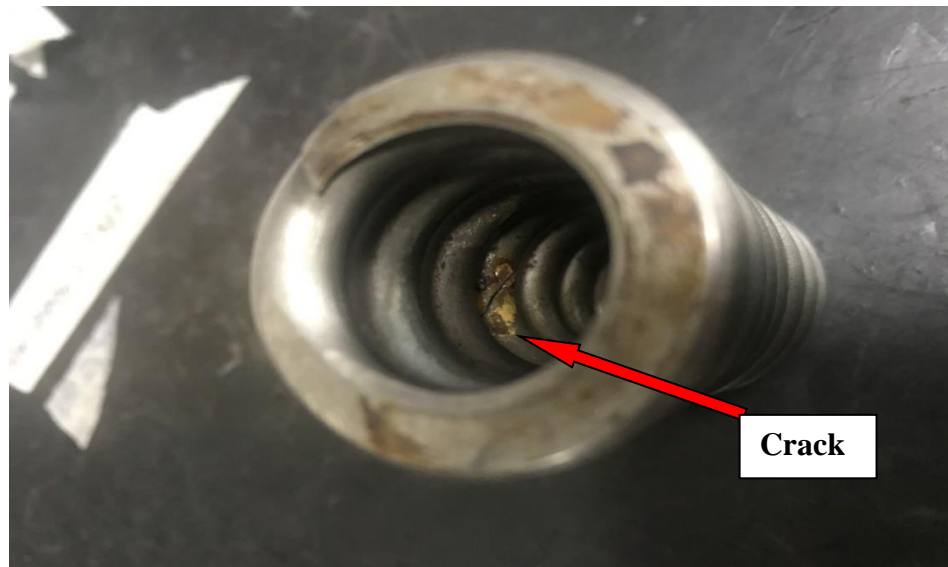
- Crack was observed in the spring removed from one of the adjuster assembly where the clearance between insulator and thrust plate assembly was found to be 0.012 inch.

Pic16 &17: Crack found in the spring of one of the adjustor assembly

Reason: The spring was cracked which resulted into the less clearance.

In brake assembly fitted at #2 wheel i.e. on the inner wheel of left MLG, it was observed that the running clearance between one of the insulator assembly and thrust plate assembly was only 0.012 inch against the minimum permissible value of 0.050 inch. Because of less clearance, there could be a situation of brake dragging and wheel may not be free to rotate even after brakes are released.

The weak compression strength of the spring which was found cracked could result into not maintaining of the prescribed running clearance in the brake.
