FINAL INVESTIGATION REPORT

SERIOUS INCIDENT TO M/S AIR INDIA LTD.

AIRBUS A320 AIRCRAFT VT-EXM

AT CHENNAI ON 13TH NOVEMBER 2020.

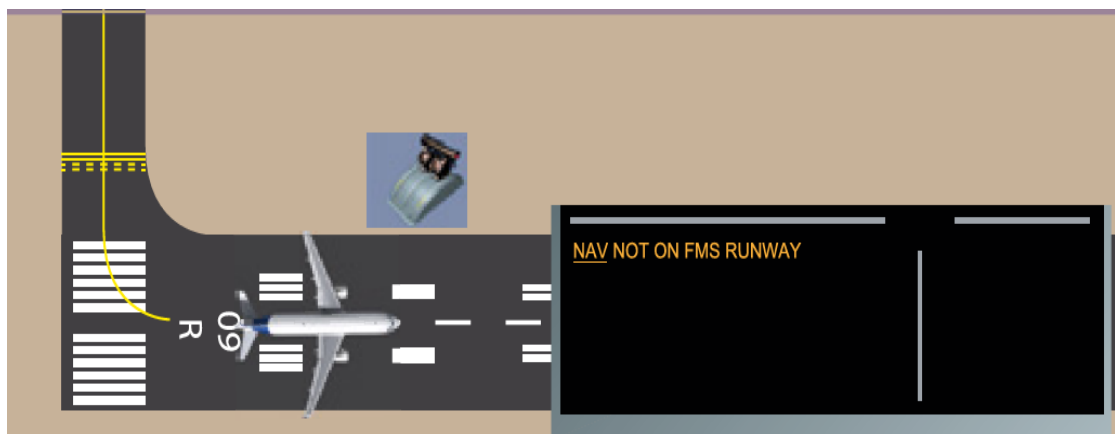
Figure 2: TOS2 - ECAM Caution of NAV NOT ON FMS RUNWAY.

TOS2 checks that the aircraft is positioned on the intended runway and that the expected take-off performance – based on data entered in the FMS by the crew is compatible with the runway distance available.

When the crew applies take-off thrust, TOS2 checks if the aircraft is positioned within an area that contains the take-off runway entered in the FMS. If the flight crew applies take-off thrust when the aircraft is still on a taxiway and outside the runway area, this will trigger the red ECAM warning NAV ON TAXIWAY.

The alert can also be an amber caution depending on the FWS standard. If the flight crew applies take-off thrust while the aircraft is positioned on a different runway from the one entered into the FMS, this will trigger the ECAM caution NAV NOT ON FMS RUNWAY. TOS2 function is available as an option on Airbus A320 family aircraft.

- 4.5 It is recommended that, DGCA may advise all aircraft operators operating A320 family of aircraft to analyze the feasibility of installing Take-off Surveillance and Monitoring Functions (especially TOS2 function) in their A320 family fleet or at least in future if any A320 family aircraft is inducted, it may be ensured that TOS2 function (which is available as an option) is installed in it.

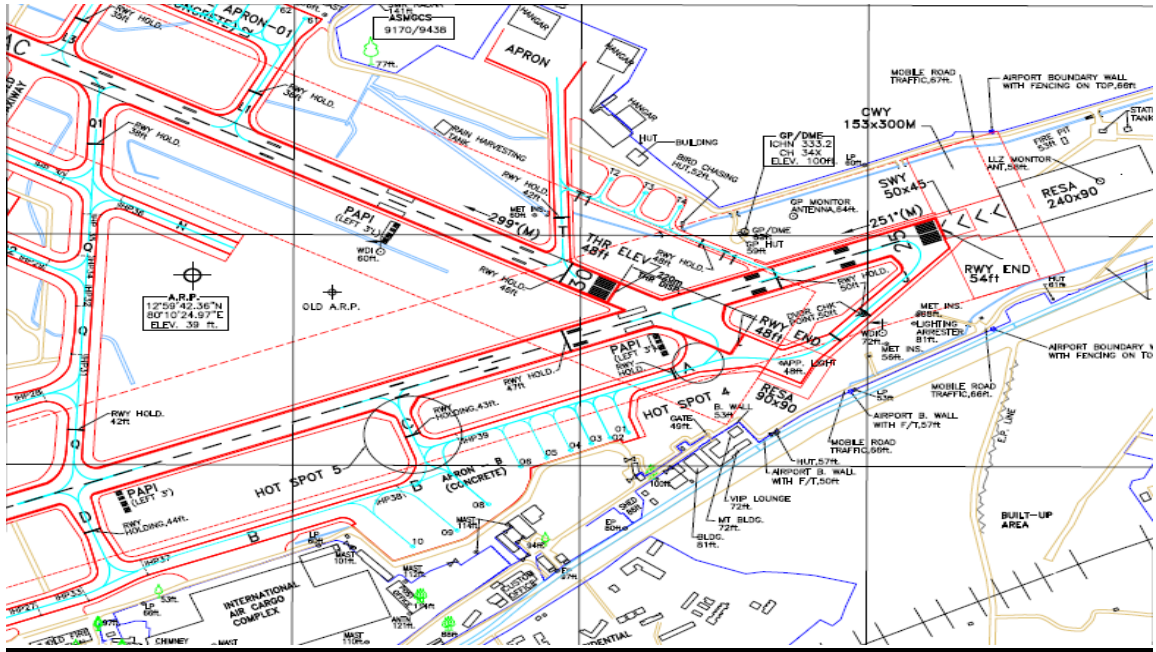
Figure 4: Layout of Runway 25 & Runway 30 intersection.

Both the runways, runway 07/25 and runway 12/30 intersects at almost start of runway 25 & Runway 30 (Refer Figure 4 below). If the aircraft is cleared for departure from runway 25, generally the departure clearance is given from intersection 'C'. However, if the crew assesses that for better take-off performance (as in this case) more runway length is required, then that can be achieved by opting for Intersection 'A' departure. Intersection 'A' is connected to start of Runway 30. Therefore, in order to line up on runway 25 the crew is required to cross the holding point at 'A' turn the aircraft and enter Runway 30 via 'A' intersection then turn again to enter runway 25. There is all probability that a crew might get disoriented and may line up on runway 30 (irrespective of available visual cues). As per the SOP issued by AAI it is mentioned that there have been number of runway incursion occurrences due to this misunderstanding. Keeping this safety hazard in mind the Aerodrome Operator had identified this Intersection 'A' to runway 12/30 as one of the hotspots, Hot Spot 4 (HS 4). The crew did not discuss 'HS4' during briefing.

The runway intersection 'A' has been identified as one of the hotspots "Hotspot 4" by the Aerodrome Operator and the same is appended in the aerodrome layout. The crew opted Intersection 'A' departure (In place of Intersection 'C' initially given by the ATC) in order to have better take-off performance. However, the crew did not discussed Hotspots (especially Hotspot 4) during the taxi briefing. Had they discussed this during the briefing the PF would have been cautious about the departure via runway25/runway 30 intersection and this unsafe situation could have been averted.

- 4.4 It is recommended that, DGCA may advise the Aerodrome Operator (Chennai Aerodrome) and all other aerodrome operators where departures from runway/runway intersection is carried out to analyze the feasibility of installing additional visual cues such as Lead-in runway lights, Stop Bar lights at the beginning of unassigned runway, etc., at Runway/Runway intersection points to enhance the safety of flight operations.

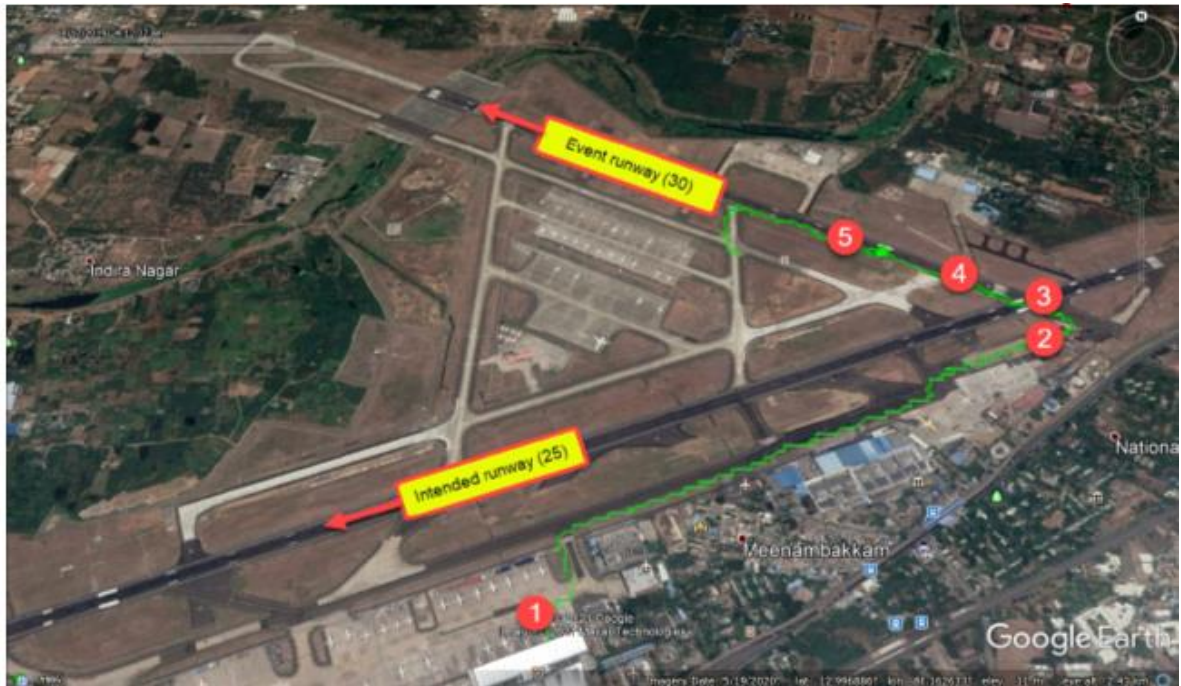
Figure 5: Path followed by Aircraft beginning from parking bay.

- Taxiing from the gate to holding point A (1 to 2 on the map)
- Aircraft GW was 69.7T (MTOW = 79.0T)
- CG was 29.3%
- Autobrake was set to MAX mode
- Slats/Flaps CONF 2 was selected
