**FINAL INVESTIGATION REPORT
OF SERIOUS INCIDENT
TO BOEING 737-800
AIRCRAFT VT-SZK
AT HYDERABAD
ON 20/01/2020**

**AIRCRAFT ACCIDENT INVESTIGATION BUREAU
MINISTRY OF CIVIL AVIATION
GOVERNMENT OF INDIA**

FINAL INVESTIGATION REPORT ON SERIOUS INCIDENT TO B737-800
AIRCRAFT VTSZK AT HYDERABAD ON 20/01/2020

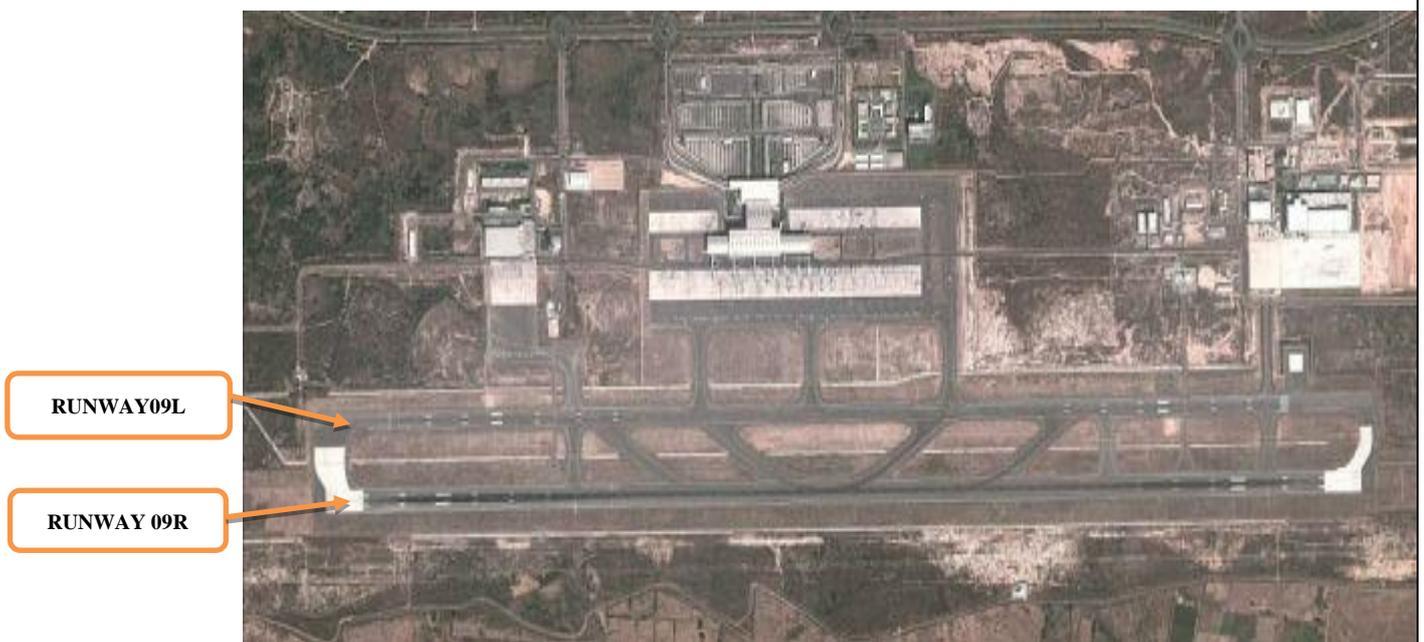
The airport is having two parallel runways. The distance between these two runways is only 225 meters. Thus, they can never be used as Parallel runway. Only one runway can be used at a time. Runway 09L is having VOR only and Runway 09R is equipped with ILS.

FIGURE SHOWING PARALLEL RUNWAYS i.e. RUNWAY 09L AND 09R

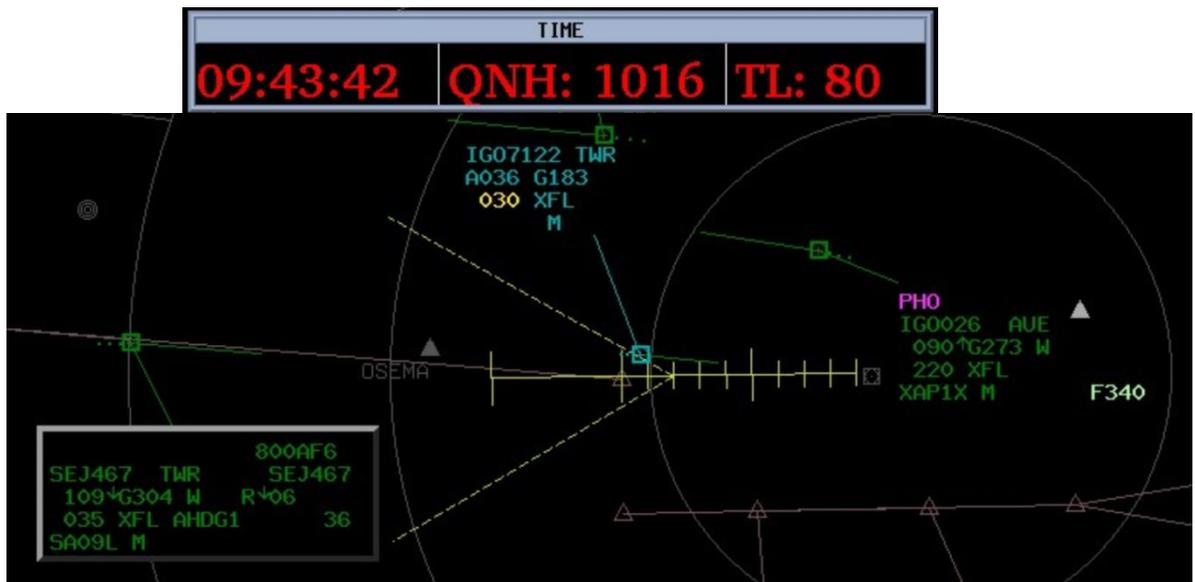
While at 10900 feet, the flight was on track for runway 09L

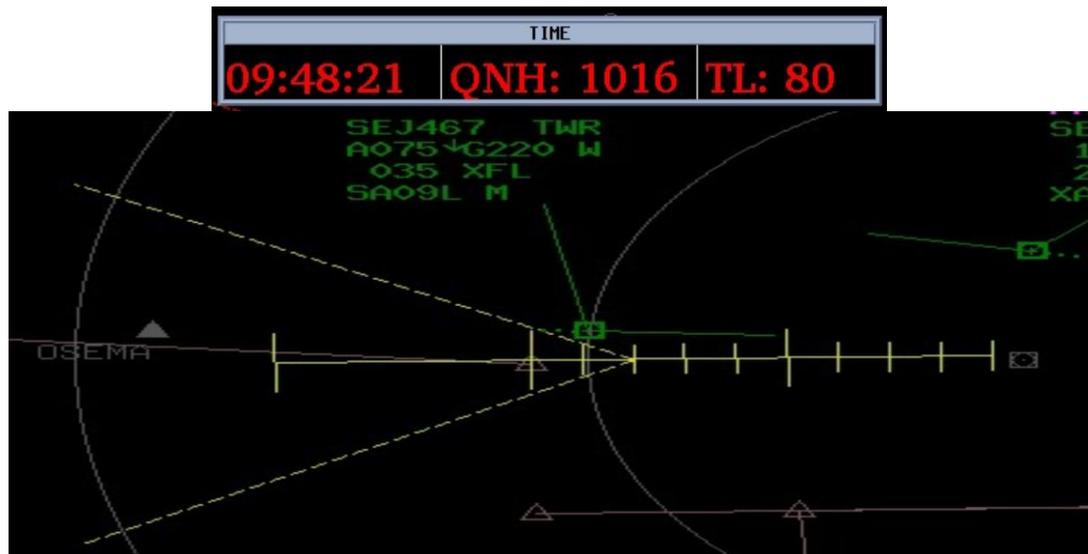
As the aircraft was high on approach, ATC advised him that they are high on approach. ATC prompted twice, first at 09:46 UTC and next at 09:48 UTC. At 09:48 UTC, the aircraft was 10 miles to touch down and requested Approach Radar Controller for a heading so that they can adjust their rate of descent. Controller accordingly assisted the aircraft.

At 7500 feet, the aircraft was high on approach and was given vectoring as requested

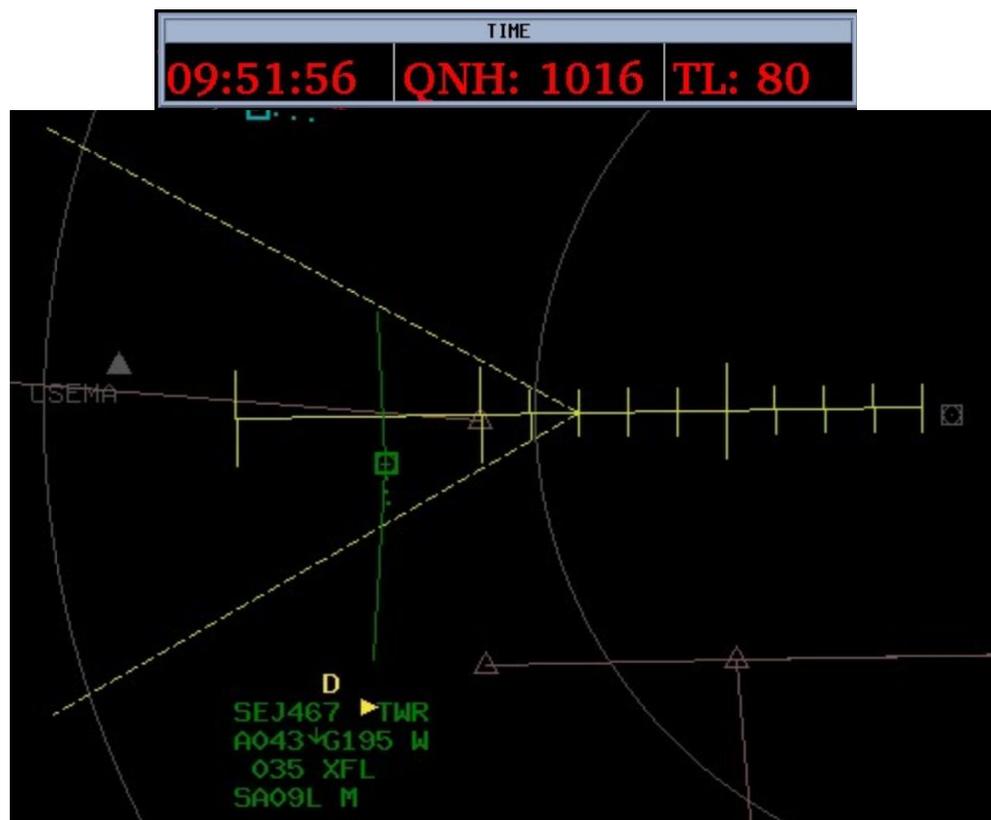
At 09:51:56 UTC, aircraft was re-cleared for runway 09L after it attained the desired altitude (ATC recording)

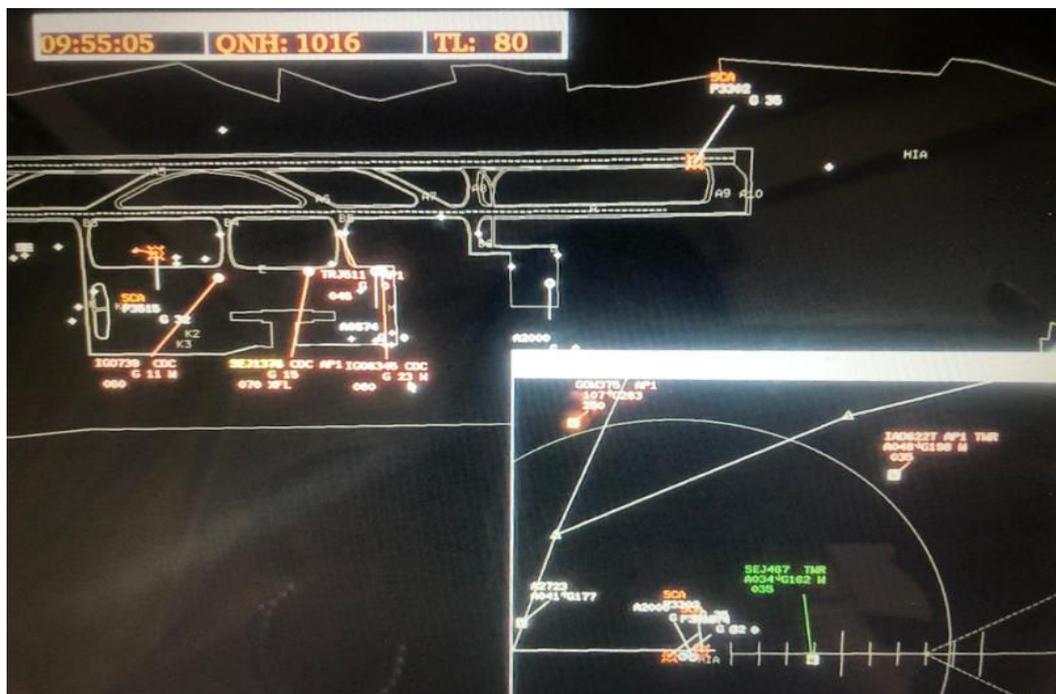
Leader jeep was still on runway, when aircraft was at 04 NM to touch down

At 09:56 UTC, Leader jeep informed ground controller that “*Runway inspection has been completed just now but he is seeing an aircraft approaching 09R*” to which the Ground controller replied as “*They are on*”

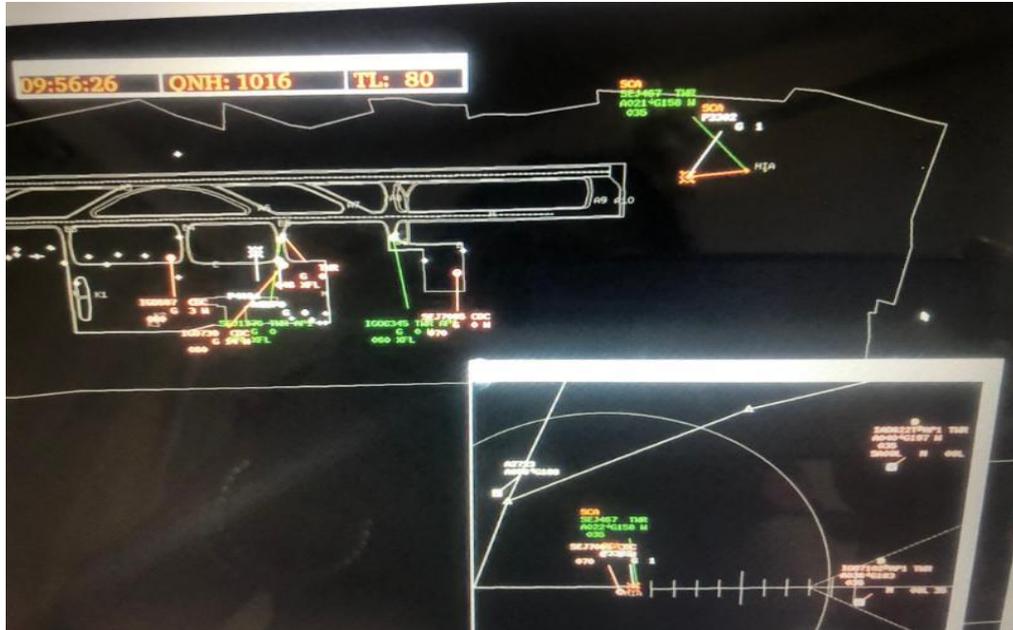
09L". From the tower, it is not possible to identify as to which runway i.e. 09L or 09R, the aircraft is approaching as the distance between these two parallel runways is only 225 m apart. As per the ASMGCS recording, aircraft started maneuvering to right so as to align with the runway 09R.

The aircraft started maneuvering to right (as per ASMGCS) after crossing VOR (HIA) to align with runway 09R

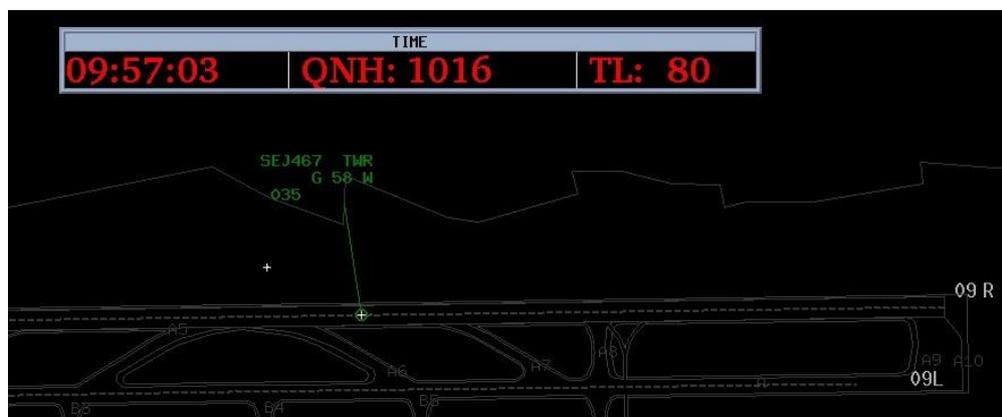
Aircraft landed on runway 09R which was still closed as per NOTAM

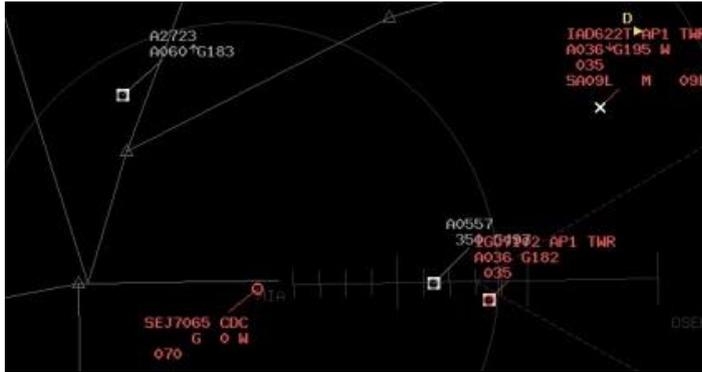
At time 09:57:03 runway 09L was operational. The succeeding 3rd flight (IAD 622) in the sequence of landing was also cleared for runway 09L
