**FINAL INVESTIGATION REPORT ON SERIOUS INCIDENT TO M/s**  
**INTERGLOBE AVIATION LTD. AIRBUS A 321 (NEO) AIRCRAFT VT-IUD**  
**AT DELHI AIRPORT ON 06<sup>TH</sup> AUGUST 2020.**

**Ms. Kunj Lata**  
**Investigator -In- charge**

**FINAL INVESTIGATION REPORT ON SERIOUS INCIDENT OF M/S INTERGLOBE AVIATION LIMITED, AIRBUS A 321 AIRCRAFT VT-IUD AT DELHI ON 06<sup>th</sup> AUGUST 2020.**

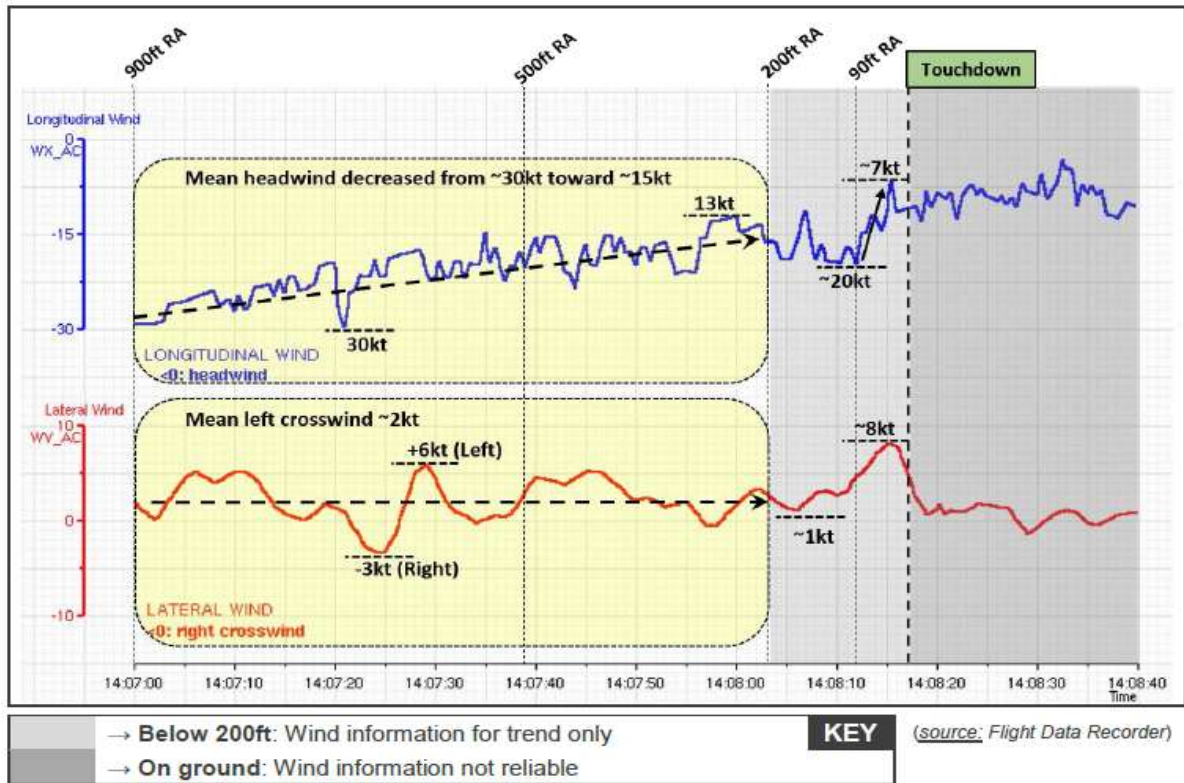
**Figure: MET Information obtained from DFDR analysis (Manufacturer).**

As per DFDR, weather information when the aircraft was between 900ft and 200ft (i.e., between 14:07:02 UTC and 14:08:02 UTC) was as Wind 095° at 20kt with gusts between 30kt and 13kt.

The headwind decreased to around 13kt in the last 90 ft, it contributed to a loss of CAS and thus to a loss of lift at low height. This led to increased rate of descent and to initiate a pitch down dynamics.

The ground effect encountered at low height contributed to maintain the pitch down dynamics and thus the rate of descent.

The flare action performed at 30ft RA with a high rate of descent (880ft/min) and a negative pitch angle (-1.5°) did not enable to sufficiently change the aircraft trajectory before the touchdown to avoid the severe hard landing

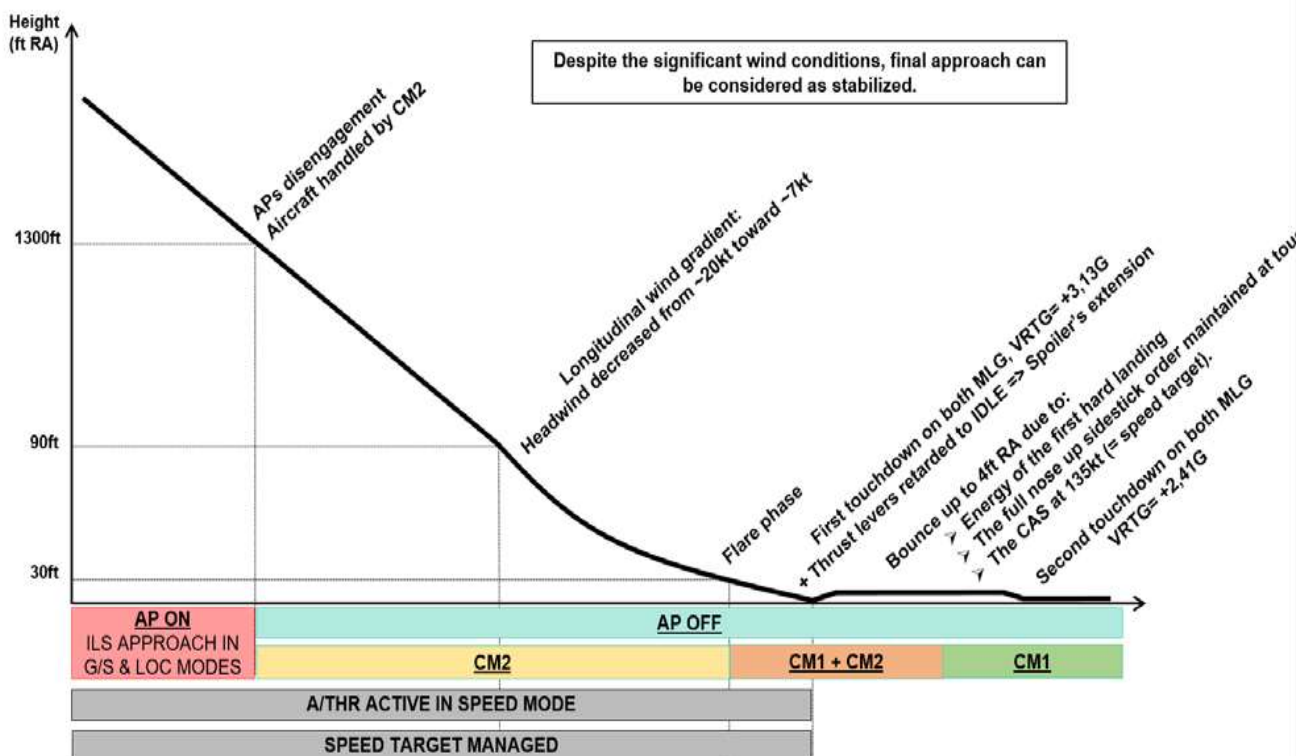
**Between 90ft RA and 65ft RA:**

Aircraft encountered a longitudinal wind gradient leading the headwind to decrease rapidly from ~20kt toward -7kt in ~3s.

- CAS decreased from ~145kt to ~135kt:
  - ✓ The lift decreased:
    - Rate of descent + Flight path angle increased
    - Pitch angle started to decrease

**Between 65ft RA and 30ft RA:**

- CM2 started to apply two pitch up orders:
  - ✓ These sidestick orders did not significantly change the pitch down dynamics reinforced by the ground effect encountered at low height. The pitch angle continued to decrease:
    - Rate of descent + Flight path angle continued to increase

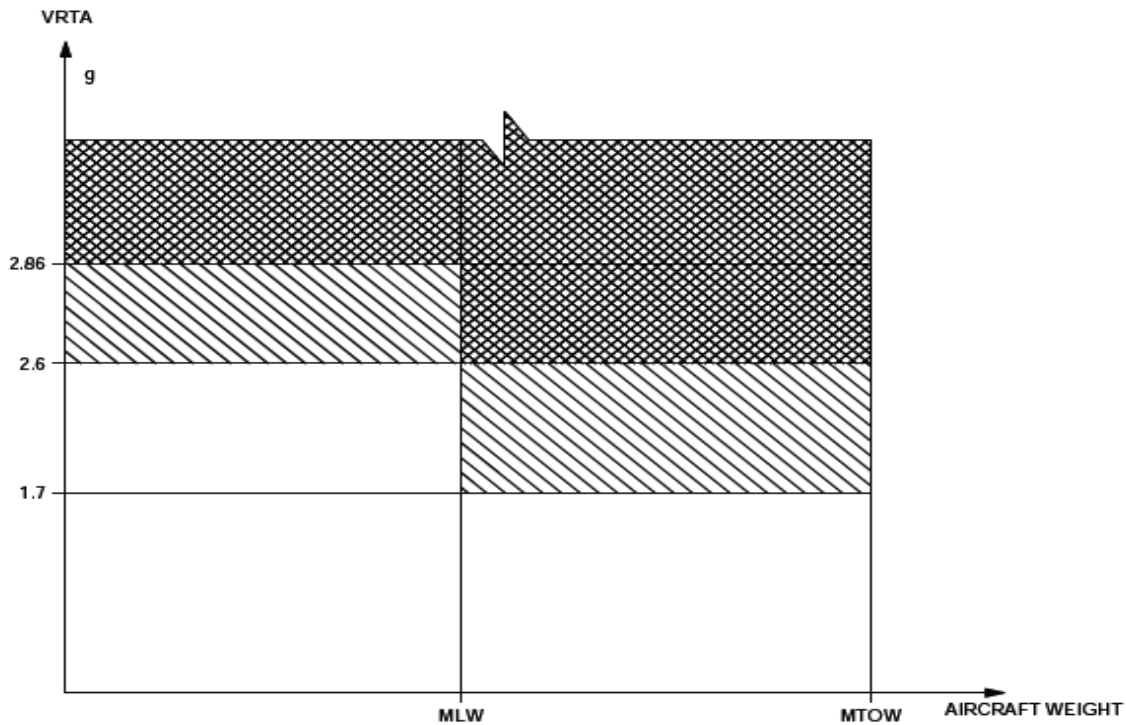
From the above diagram it is understood that:

- if VRTA is more than or equal to 2.6 G, It is considered to be hard landing or hard overweight landing.
- If  $VRTA \geq 2.86$  G, it is considered to have severe hard landing or severe hard overweight landing.

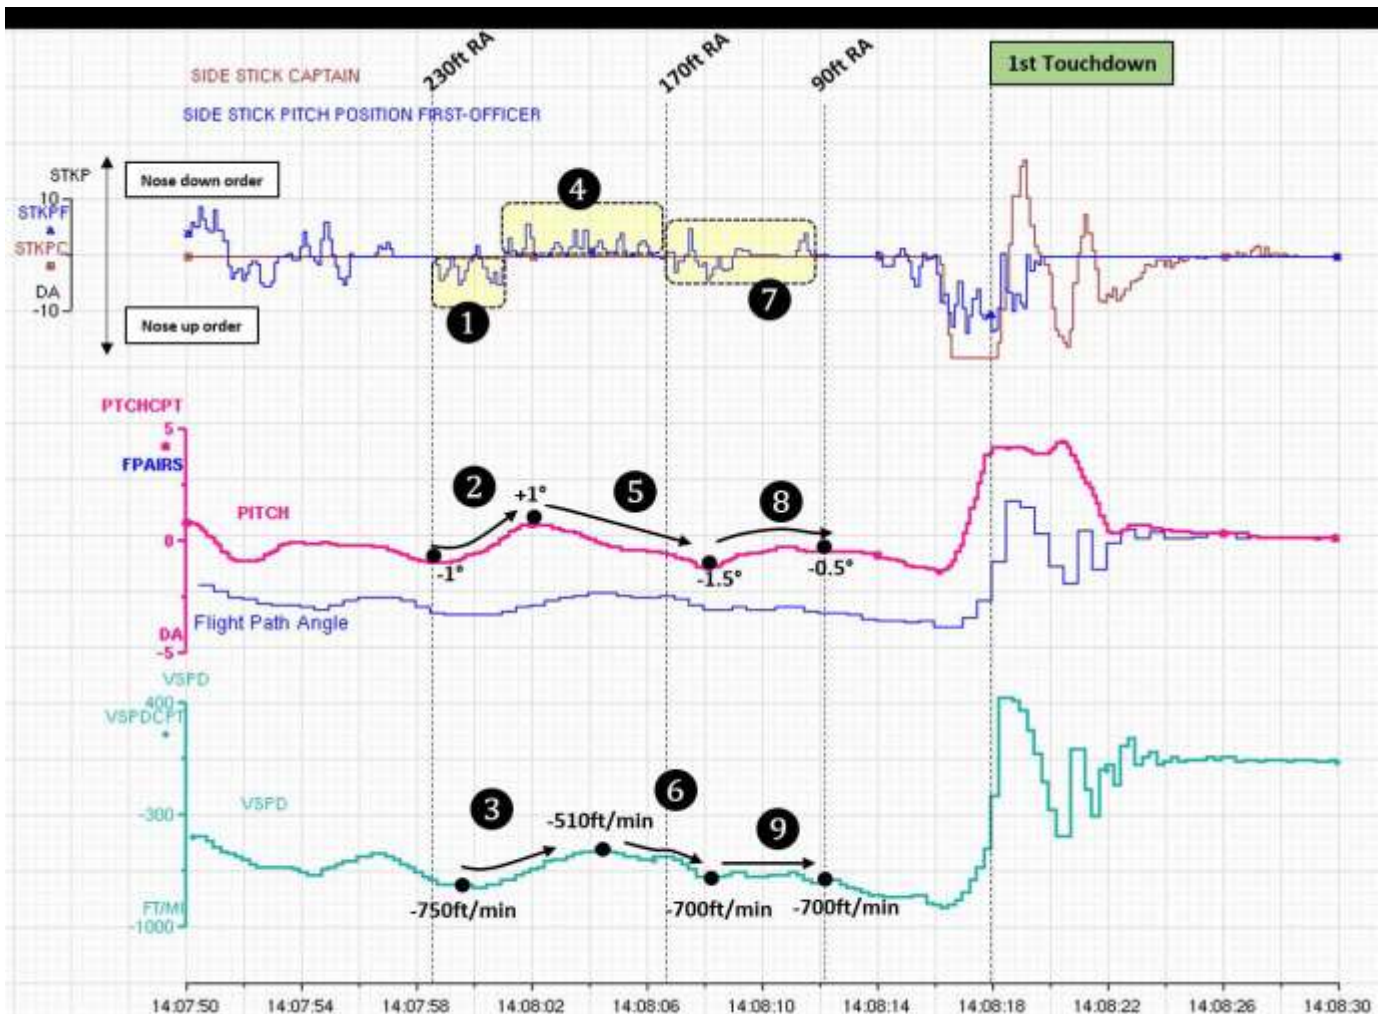
**Figure: Behavior of aircraft from 230 ft to 90 ft**

The above analysis shows the behaviour of aircraft from 230ft to 90ft RA:

- A first phase of several pitch up orders were applied as in (Point 1) which lead the pitch angle to increase from  $-1^\circ$  toward  $+1^\circ$  as shown in (Point 2) and consequently reduced the rate of descent from 750ft/min to 510ft/min as shown in (Point 3).
- Then a second phase of several pitch down orders were applied (Point 4) lasting approximately 6seconds. These action stopped the pitch increasing and led the pitch angle to decrease from  $+1^\circ$  toward  $-1.5$  as soon (Point 5). As a result, the rate of descent increased from 510ft/min toward 700ft/min as shown in (Point 6).
- Then a third phase of pitch up and pitch down orders were applied as shown in (Point 7) leading the pitch angle to decrease and stabilize from  $-1.5^\circ$  toward  $-0.5^\circ$  as shown in (Point 8) and the rate of descent to gradually stabilize at about 700ft/min as shown in (Point 9).

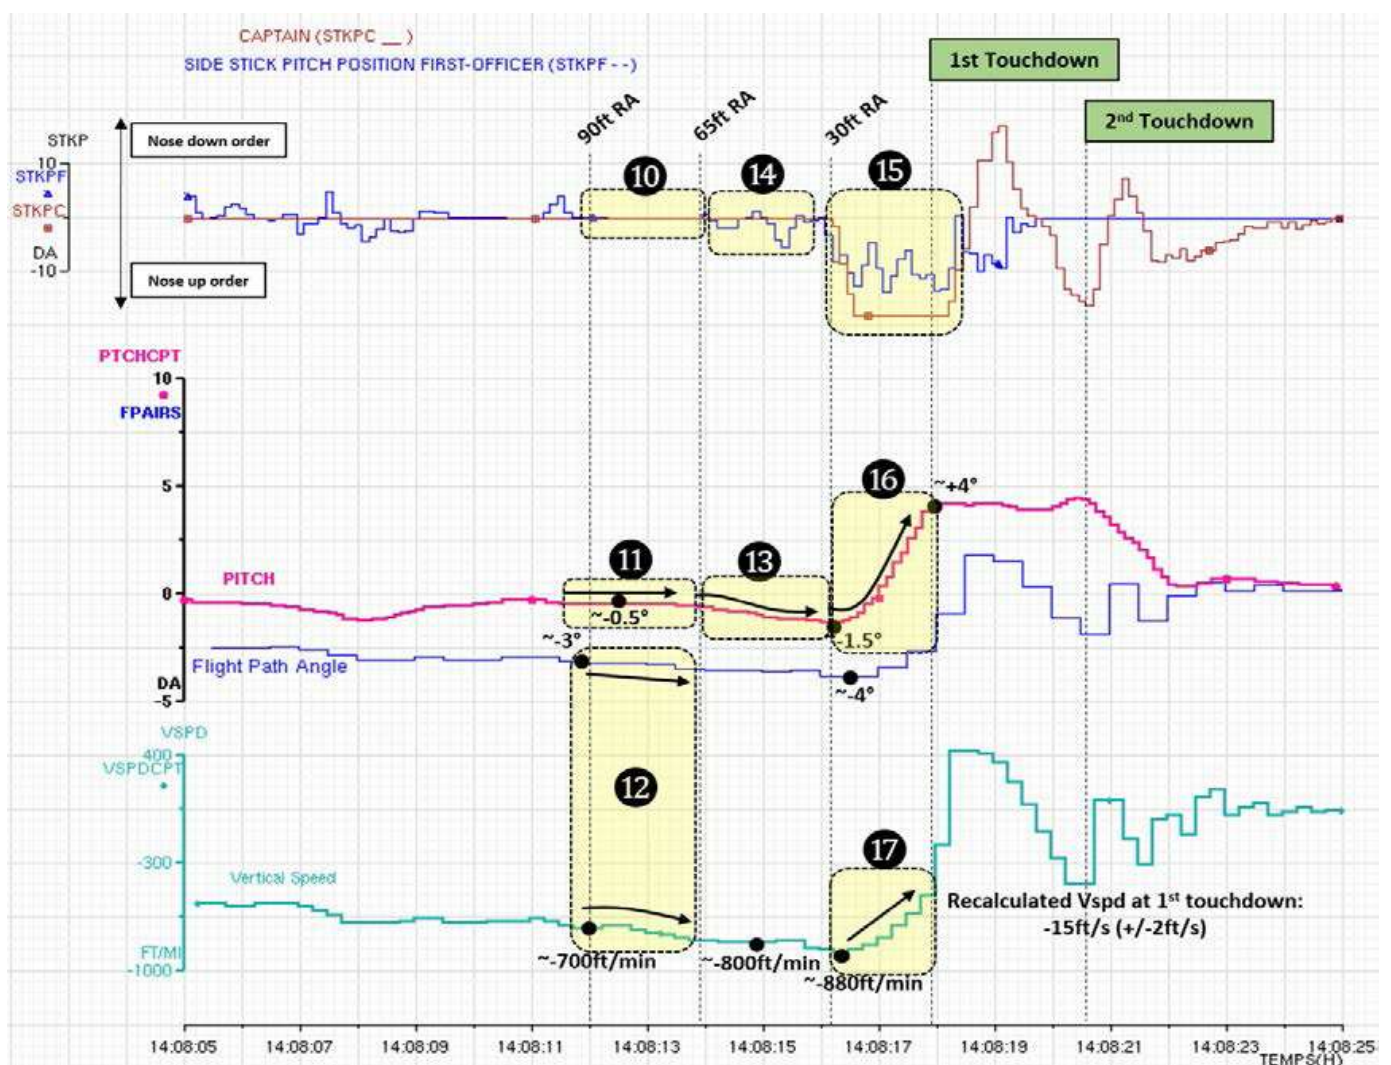
**Figure: Behavior of aircraft from 90 ft to 65 ft**

The above analysis shows the behaviour of aircraft from 90ft to 65 ft RA:

- a) It was observed that no sidestick order was applied as shown in (Point 10) leading the pitch angle to remain at  $-0.5^{\circ}$  as shown in (Point 11) However, during this period of time, the rate of descent and the flight path angle started to increase as shown in (Point 12).

- b) Due to Wind condition during Final Approach, below 90ft RA, the aircraft encountered a longitudinal wind gradient leading the headwind to decrease rapidly from 20kt toward 7kt. This decrease in wind (13kt in 3sec) led the CAS to decrease from 145kt toward 135kt and consequently decreased the lift. As a result, this loss of lift explains why the rate of descent and the flight path angle started to increase while no sidestick order was applied.

Between 90ft RA and 30ft RA, when the aircraft encountered rapid decrease in headwind and the rate of descent was increasing with negative Pitch angle, PIC could have taken call out for an early flare, to avoid under flare in such a typical operational condition.

Between 90ft RA and 30ft RA, when the aircraft encountered rapid decrease in headwind and the rate of descent was increasing with negative Pitch angle, PF could have initiated an early flare, to avoid under flare in such a typical operational condition.
