FINAL INVESTIGATION REPORT ON
SERIOUS INCIDENT TO M/S AIR INDIA LTD.
AIRBUS 321-211 AIRCRAFT
VT-PPU AT PUNE
ON 15TH FEBRUARY 2020

AIRCRAFT ACCIDENT INVESTIGATION BUREAU
MINISTRY OF CIVIL AVIATION
GOVERNMENT OF INDIA

**FINAL INVESTIGATION REPORT ON SERIOUS INCIDENT TO AIR
INDIA, AIRBUS A321 AIRCRAFT VT-PPU AT PUNE ON 15/02/2020**

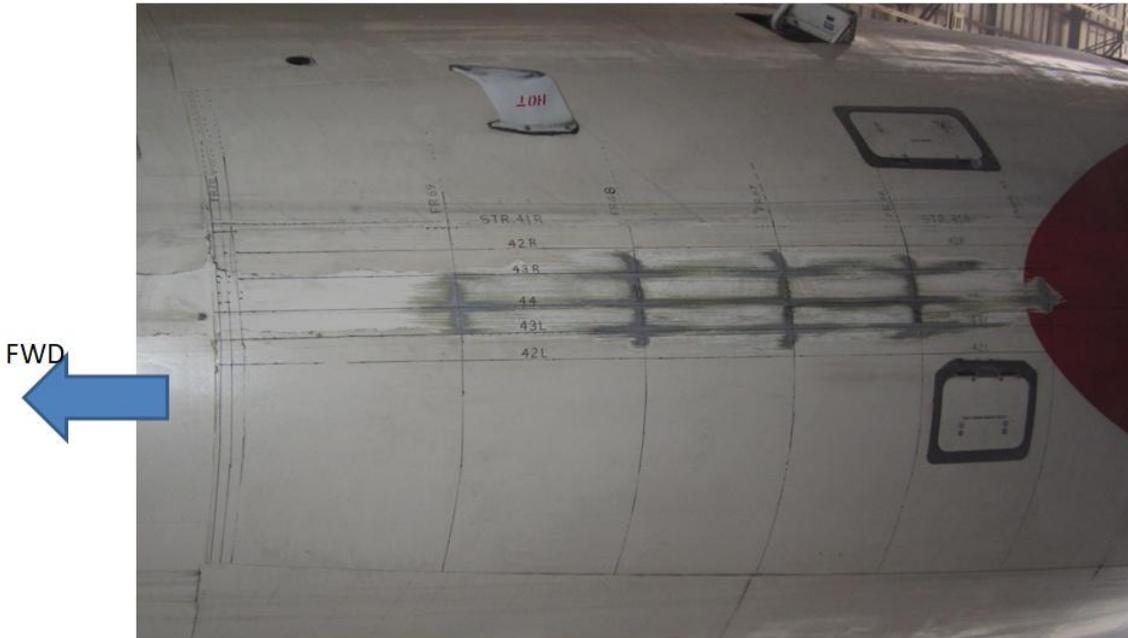
- (i) Skin scrap mark were noticed on panel area between forward of FR65 to Aft of FR 69 and between STGR 42R to 42L.
- (ii) Skin scrap marks, material loss on skin and crack were observed in the area at location FR66, FR67 and FR68 at stringer 43L, 44 and 43R.
- (iii) Cracks and material loss were observed on skin at FR 66, FR 67 and FR 68.

- (iv) Some Cleats at FR66, FR67 & FR68 and at stringer 43L, 44 and 43R were also noticed having scrap marks (Visible from outside through gaps in external skin).
- (v) Drain mast found damaged.
- (vi) Drain Tube at FR70 was found to have minor scrap mark **but no damage observed on area aft of FR70.**

Fig-1: Photo graph of area affected due scrapping Fwd of FR 65 to aft of FR69

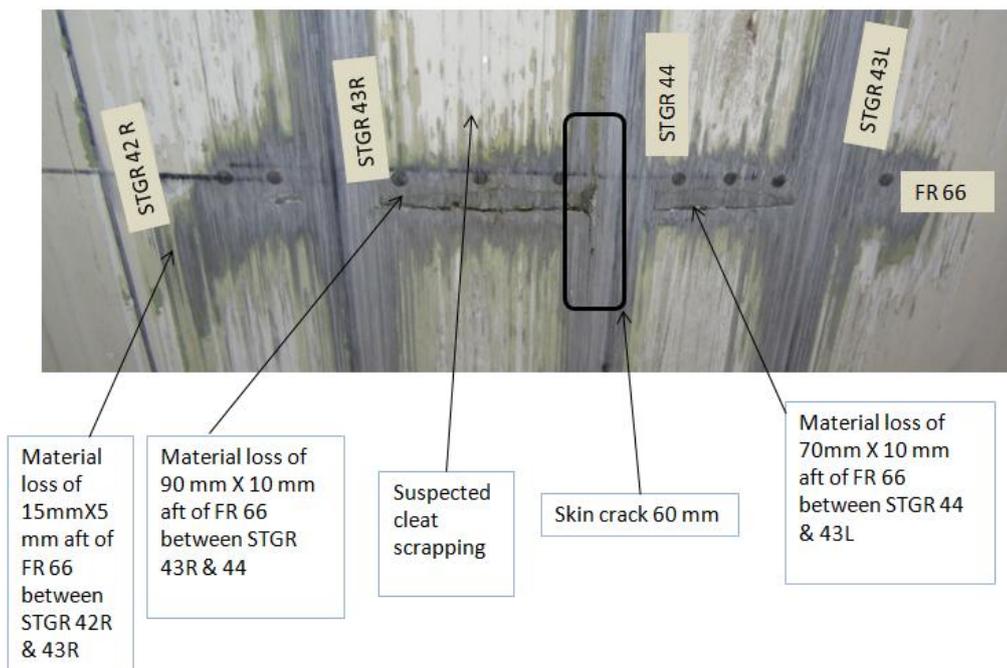
Fig-2: Photo graph of area Aft of FR 66

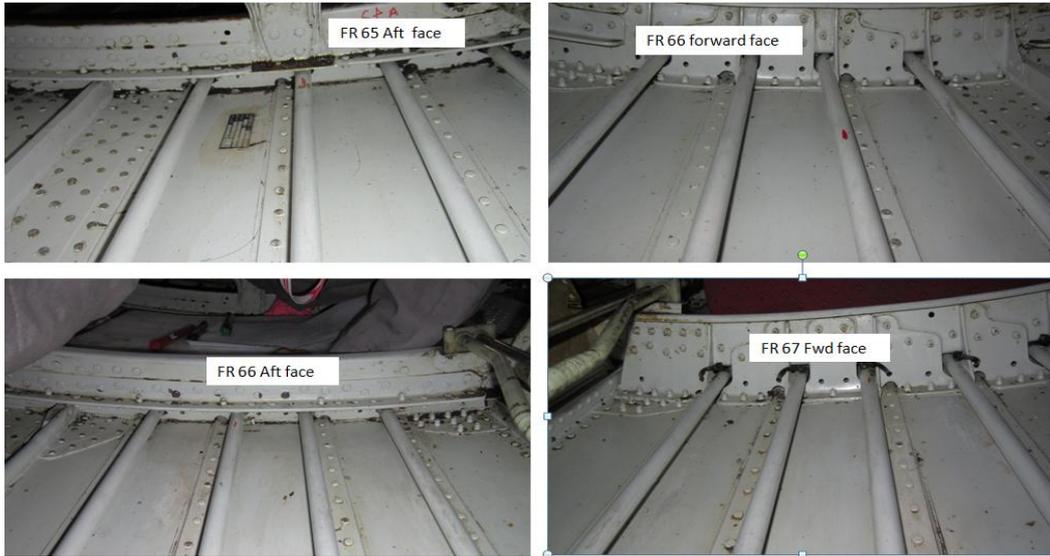
- (i) No damage observed on corresponding Frames and Stringers at all places which were affected externally.
- (ii) No bending on cleats and no cracks observed, viewed from inside while inspection of Cleats - Location FR 66, FR 67, FR68 between STGR 43L to 43R.

Fig -3: Photographs of area fwd and aft of frames 65 to 67 (Viewed from Inside)

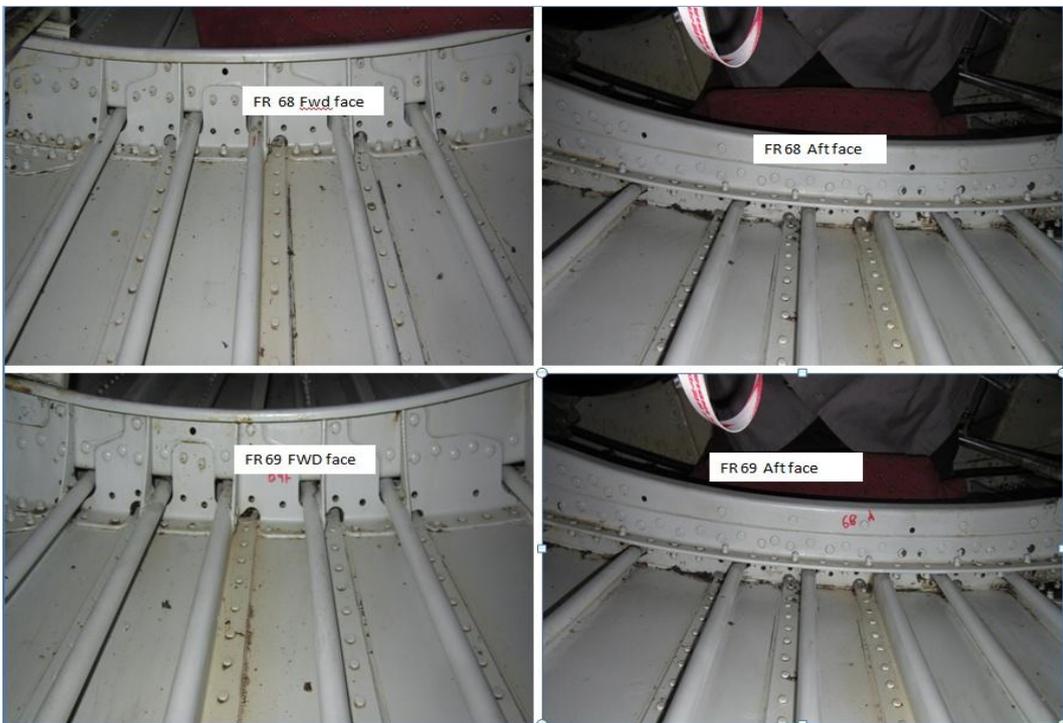
Fig -4: Photographs of area fwd and aft of frames 68 to 69 (Viewed from Inside)

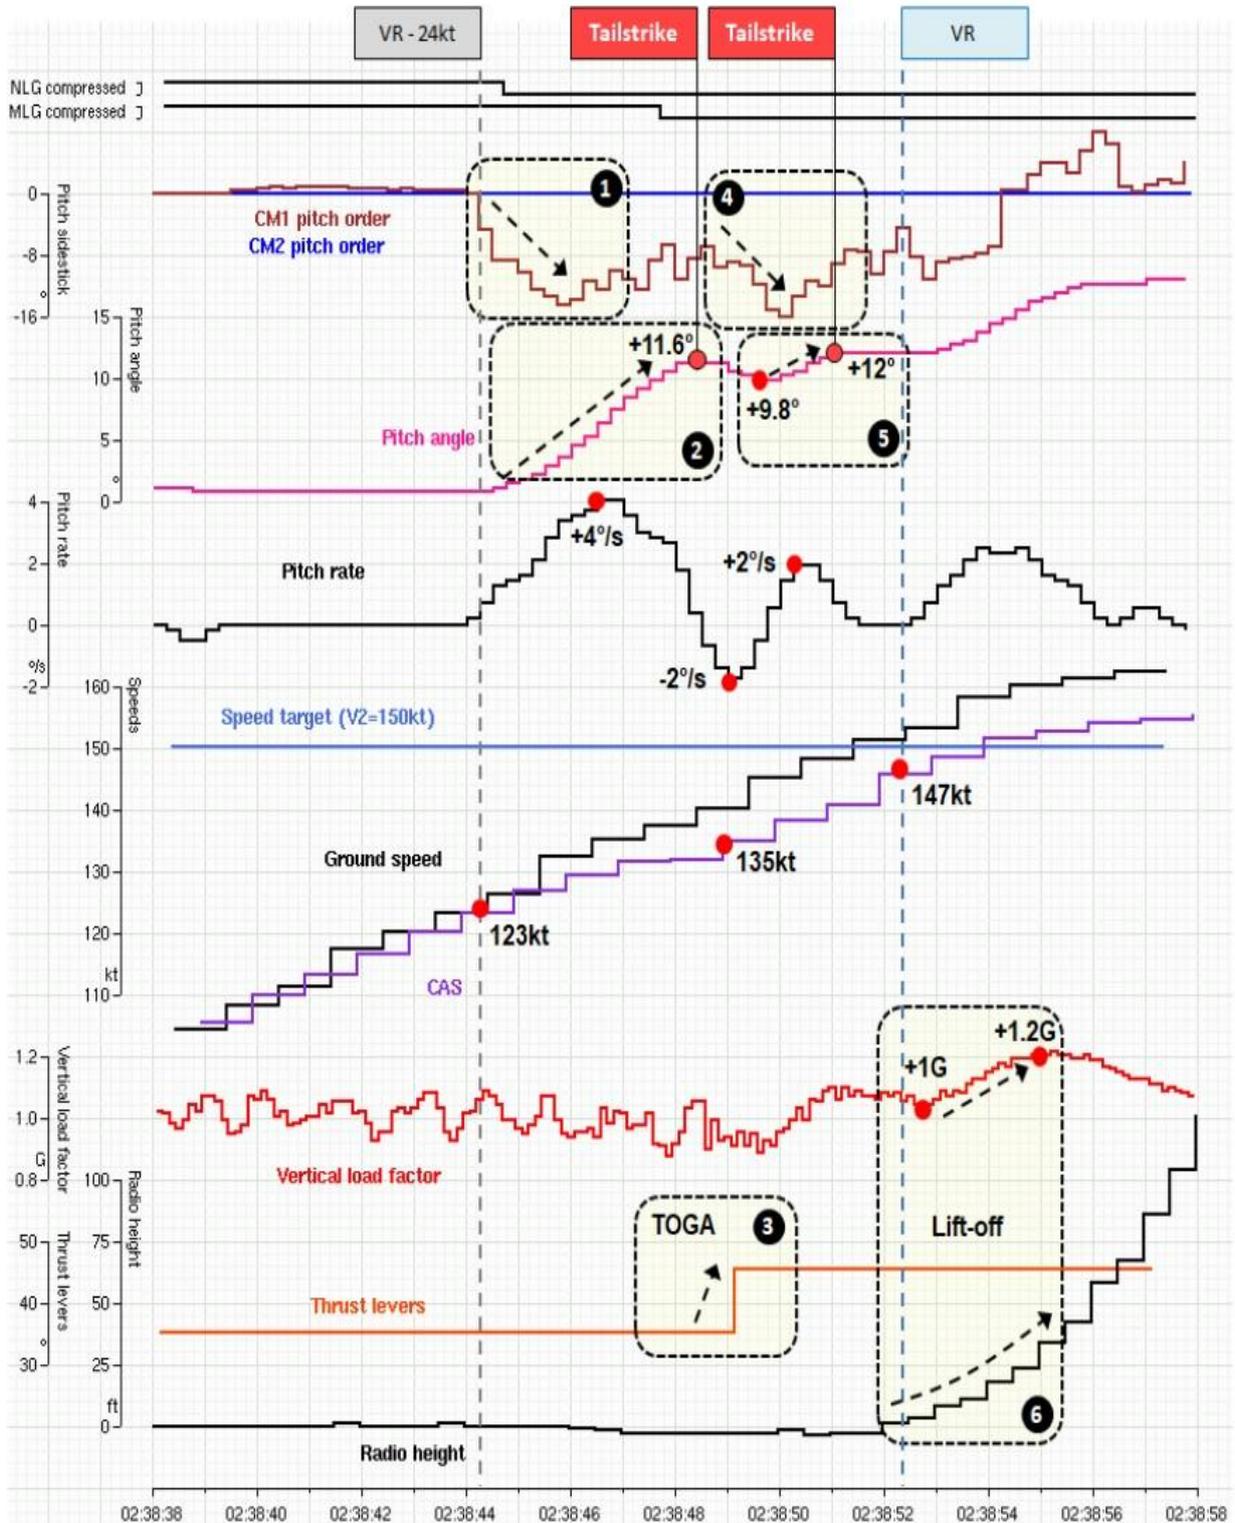
Figure 12 – Take-off analysis

Then 7 sec later, at a CAS of 123kt corresponding to V_R -24kts, rotation was initiated by PF with a back stick input up to full deflection (1 - Fig-12 refers) leading the pitch angle to increase with a pitch rate reaching $+4^\circ/s$.

At 02:38:48 UTC, pitch angle reached +11.6° with a roll angle of -0.3° (left wing down), the first tail strike occurred (2 - Fig-12 refers). Simultaneously, nose-down effect due to the contact of the rear fuselage with the ground (due to tail strike) led the pitch angle to decrease to +9.8° with a pitch rate reaching -2°/s.
