**AIRCRAFT ACCIDENT INVESTIGATION BUREAU
GOVERNMENT OF INDIA**

FINAL REPORT ON SERIOUS INCIDENT

CIRRUS SR-22 AIRCRAFT VT-VDN

ON 17.02.2020 AT ERADIKERA, ANANTAPUR, ANDHRA PRADESH

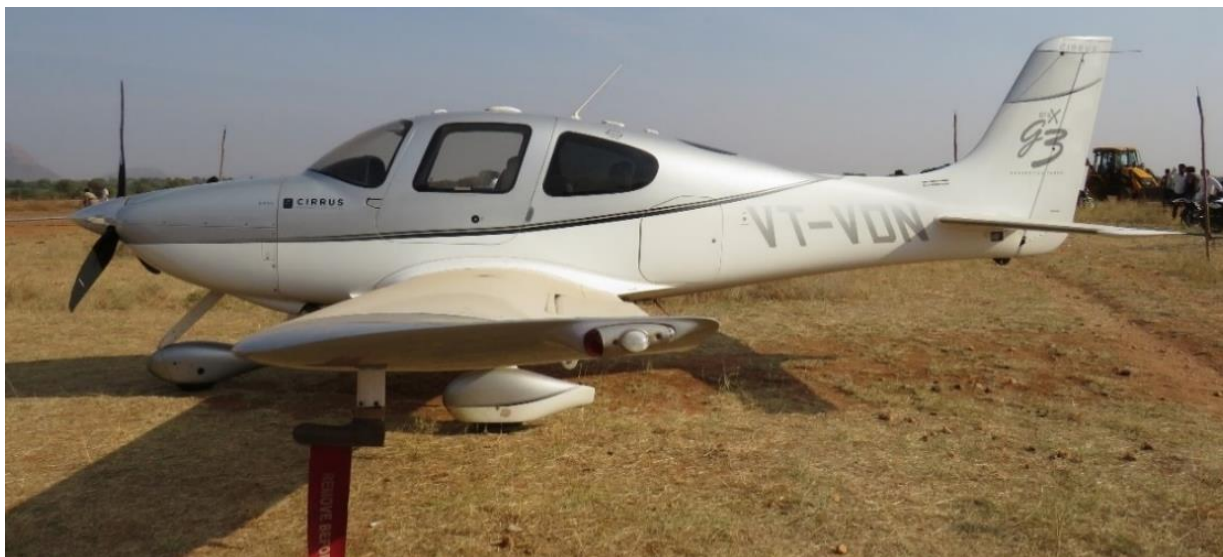
After identifying a suitable plain area and assessing its surroundings, PIC executed the forced landing. Aircraft touched down on its main landing gears and rolled for approximately 1013 feet before coming to a halt. PIC along with the passenger evacuated the aircraft safely. There was no fire or any major damage observed on the aircraft.

Fig 1: Aircraft at Forced Landing site

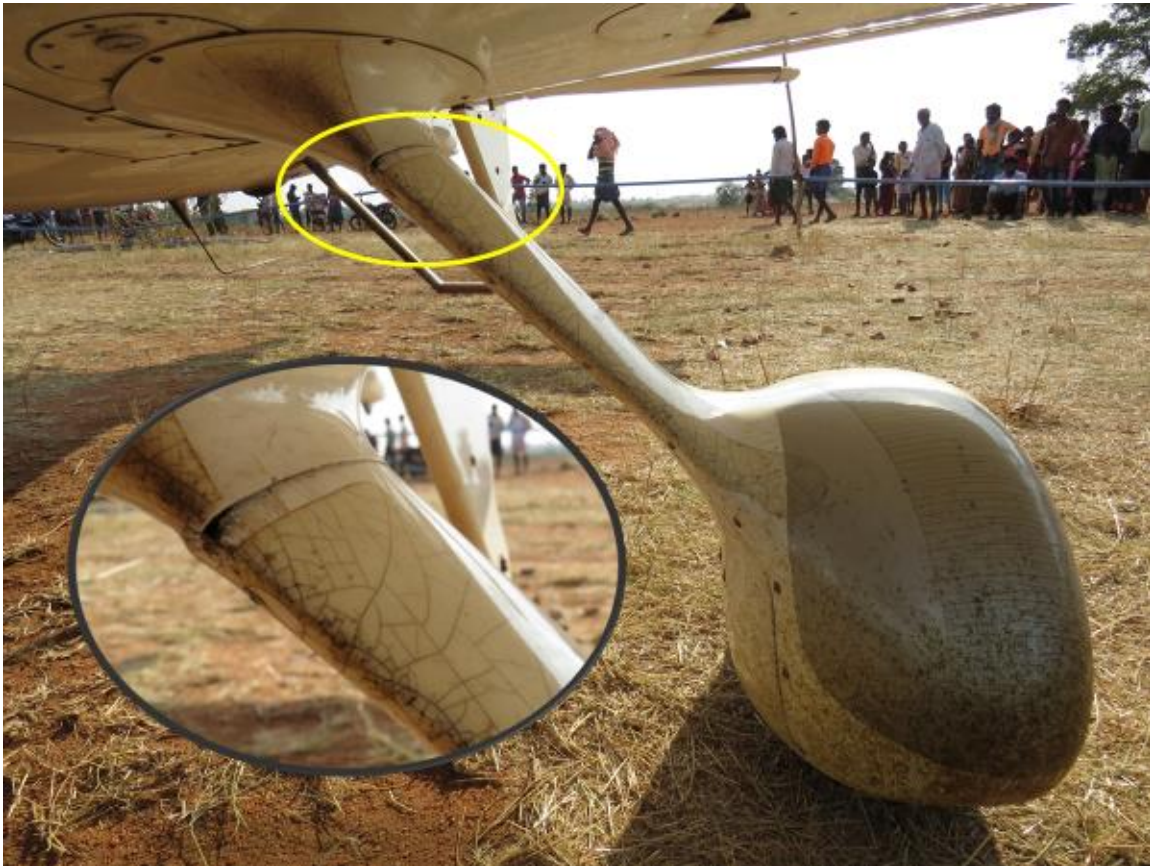
The aircraft suffered a small crack of dimension 0.5 inch approx. on the LH main landing gear leading edge fairing. No other external damage was observed on the aircraft.

Fig 2: LH Landing gear Fairing

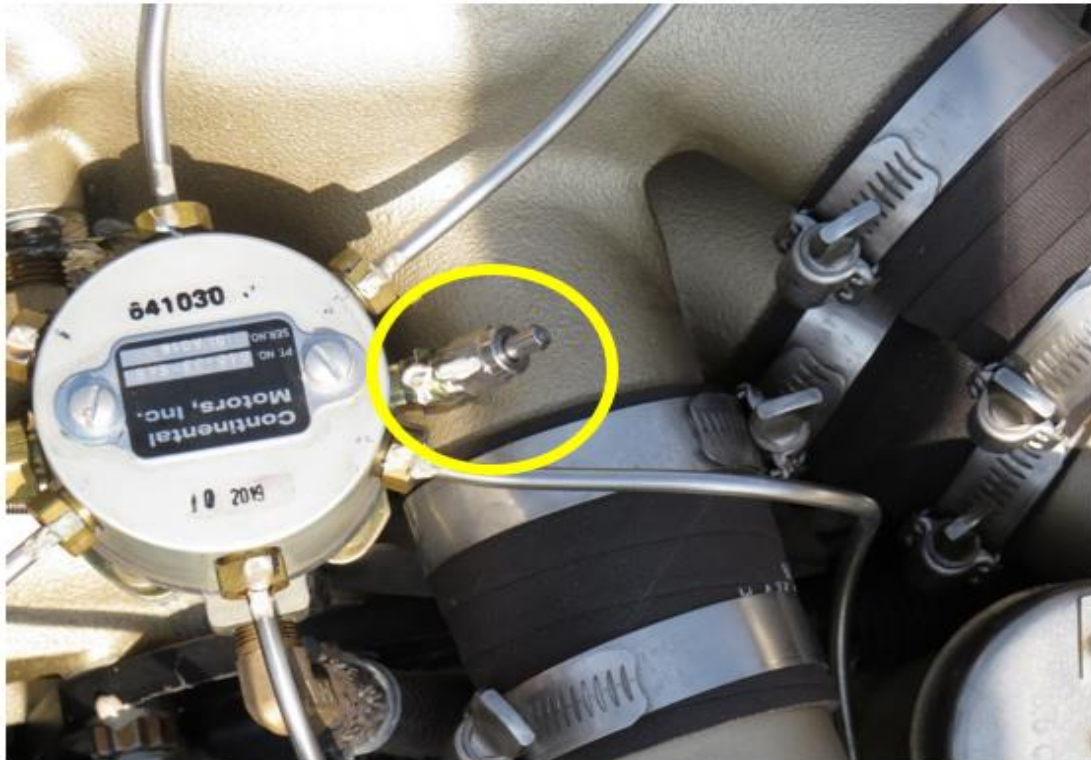
The aircraft was scheduled to fly back to its main operations base at Vijaynagar on 17.02.2020. During the said flight, aircraft made a precautionary landing at Eradikera, Anantapur, Andhra Pradesh, which is 45 NM short of Vijaynagar. After notification of incident, a DGCA officer from regional office reached the site and examined the aircraft and the site. Fuel leakage was detected from a blanking nut on the Fuel Flow Divider unit of the Engine. AAIB investigator

also reached the site on 18.02.2020 and also witnessed the leakage. During ground run, the leakage aggravated when Booster Pump was run at a high pressure. The snag was rectified by the AME and permission was obtained by the Operator from DGCA to fly the aircraft back to Vijaynagar.

Fig 4: Blanking Nut Position on Fuel Flow Divider Unit

During inspection at the site of Forced Landing, fuel seepage was observed from the blanking nut of Fuel Flow Divider Unit. This blanking nut is factory fitted and serves no purpose during any of the maintenance activity carried out on the aircraft or its Engine at its Base.

The incident was caused by fuel leakage from the factory fitted blanking nut installed on the fuel divider unit of the Engine.

4.1. DGCA and the Operator should follow-up with the OEM for preventive action to prevent reoccurrence of leakage from the Blanking Nut during operations in future.

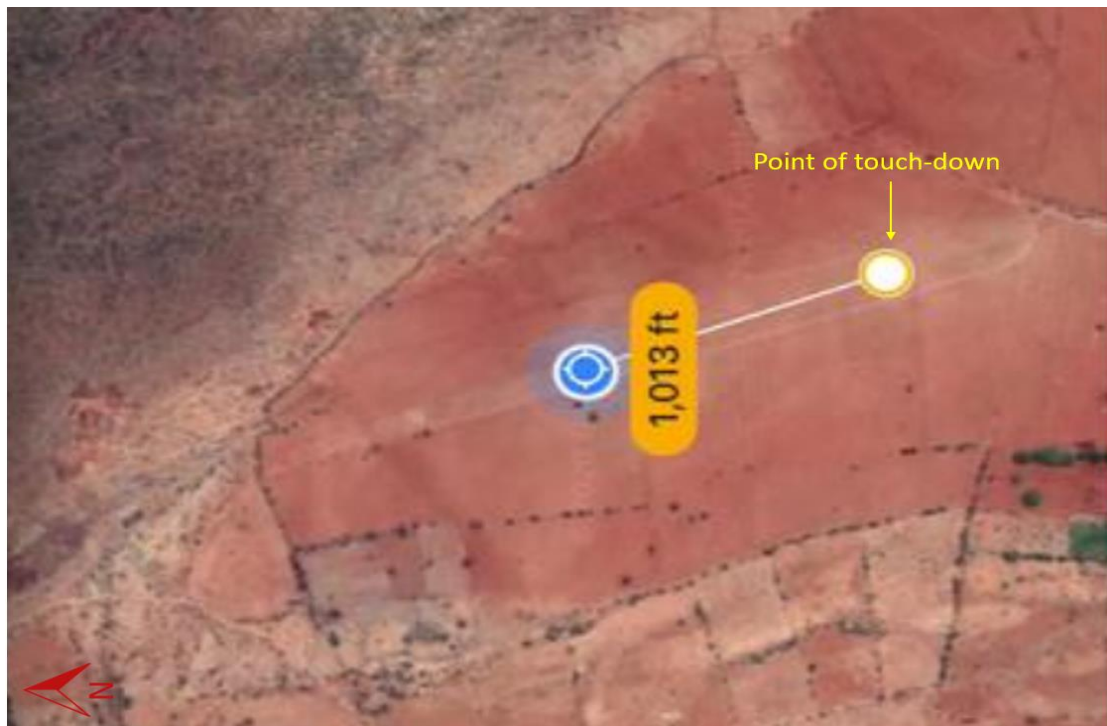
Aircraft forced landed in an open field at Village Eradikera, District Anantapur, Andhra Pradesh. The coordinates of the incident site are 14° 52' 48" N, 76° 94' 18" E. The aircraft had rolled for a distance of 1013 feet approximately after touchdown. The distance was ascertained by the operator and DGCA officer from the tyre marks available at the site.

Fig 5: Landing Site (point of touchdown)

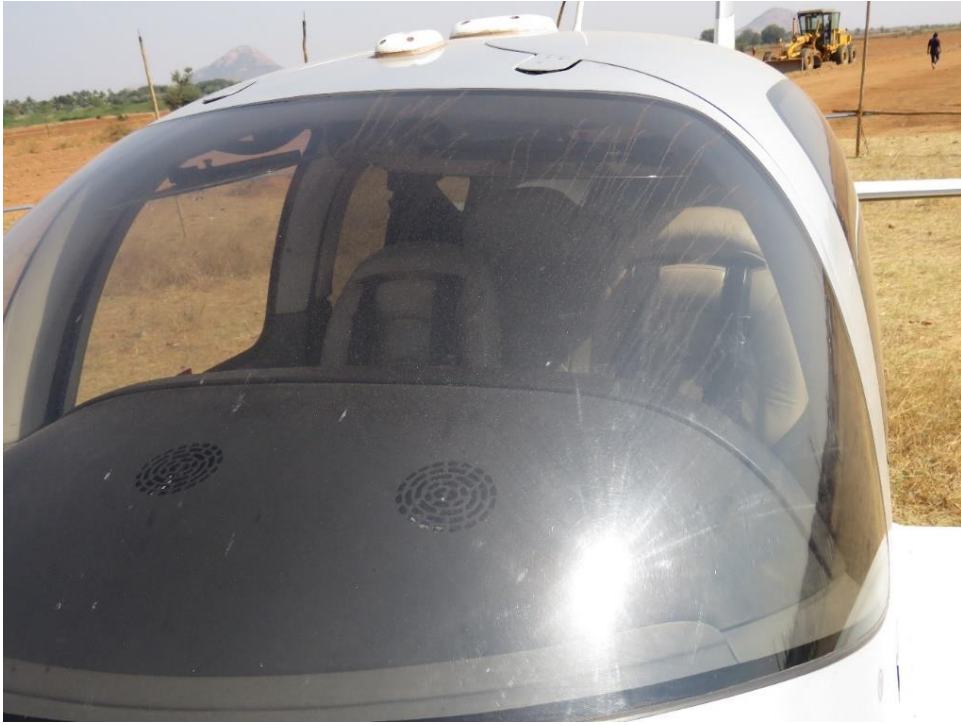
Fuel streaks similar to fuel spreading due to wind flow, were seen on the aircraft windshield, right ahead of the Oil Inspection Panel on the Engine Top Cowling. Fuel and Oil levels were found to be satisfactory.

Fig 6: Fuel streaks on Aircraft Windshield

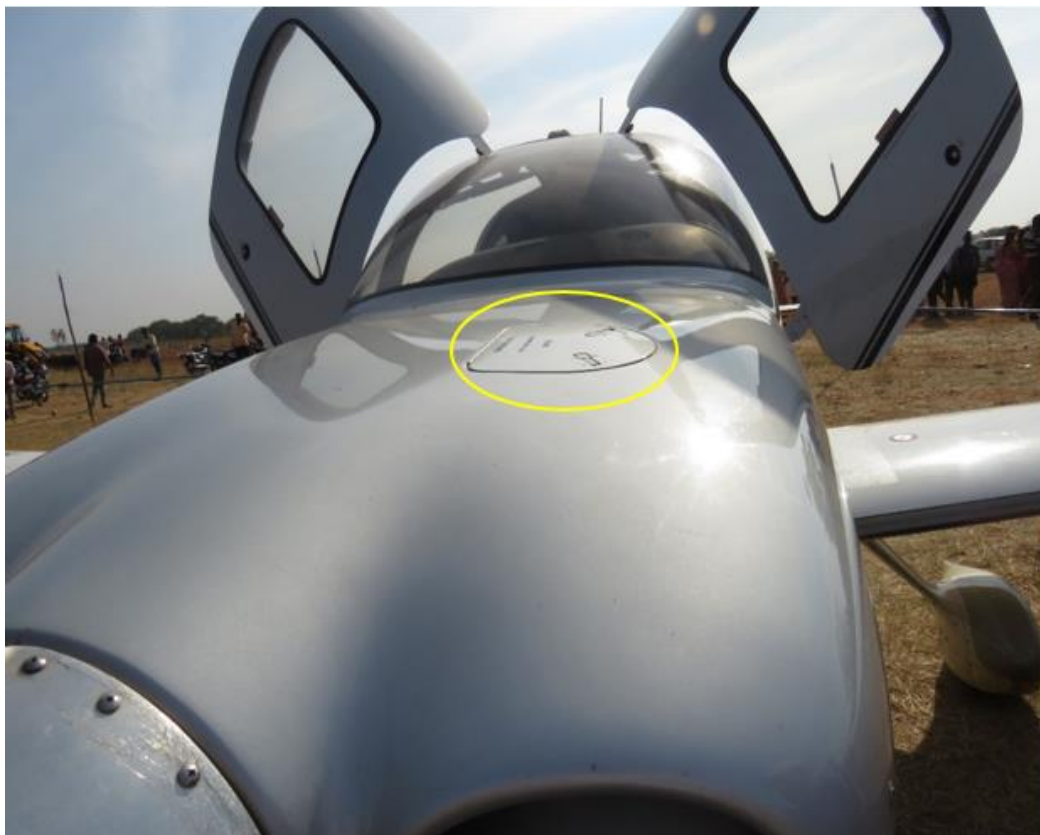
Fig 7: Oil Inspection Panel on Engine Top Cowling
