**FINAL INVESTIGATION REPORT**  
**ON ACCIDENT TO**  
**M/s INDIRA GANDHI RASHTRIYA URAN**  
**ACADEMY**  
**TB20 AIRCRAFT VT-IGE**  
**AT AZAMGARH, U.P ON 21<sup>st</sup> SEPTEMBER 2020.**

**AIRCRAFT ACCIDENT INVESTIGATION BUREAU, INDIA**

**FINAL INVESTIGATION REPORT ON ACCIDENT TO**  
**M/s INDIRA GANDHI RASHTRIYA URAN ACADEMY, TRINIDAD TB20 AIRCRAFT,**  
**VT-IGE IN AZAMGARH DISTRICT, U.P ON 21<sup>ST</sup> SEPTEMBER 2020**

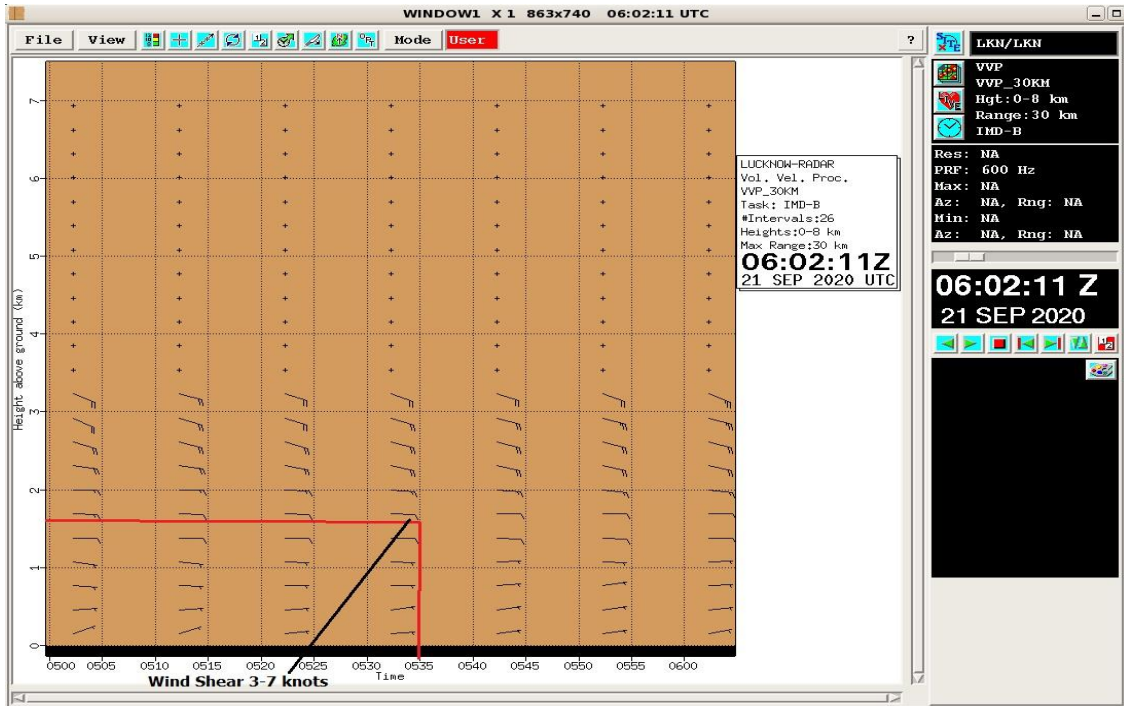
**FIG. 5 - REFLECTIVITY INDEX WITH HEIGHT FROM TIME 0500 UTC TO 0600 UTC**

The above graph shows reflectivity index (in dBZ) viz-a-viz height (altitude in Kms) from time 0500 to 0600 UTC.

The aircraft was maintaining altitude of approximately 5500 feet (1676 meters) when it disappeared from the radar. At that time as per the above graph there was no precipitation. The wind shear symbol was indicating wind shear of 3-7 knots just prior to accident.

During investigation, weather trend (variation) with altitude was obtained from MET Office, Lucknow, which revealed that at the time of accident at an altitude of 5500 feet (1676 meters) there was a wind shear of 3 to 7 knots with no precipitation. The same was also corroborated from the radar image (Refer FIG. 6 above) that the weather was building up in the area between Fursatganj (FSG) and Mau (MAU) i.e., enroute the flight path followed by the trainee pilot where the accident occurred.

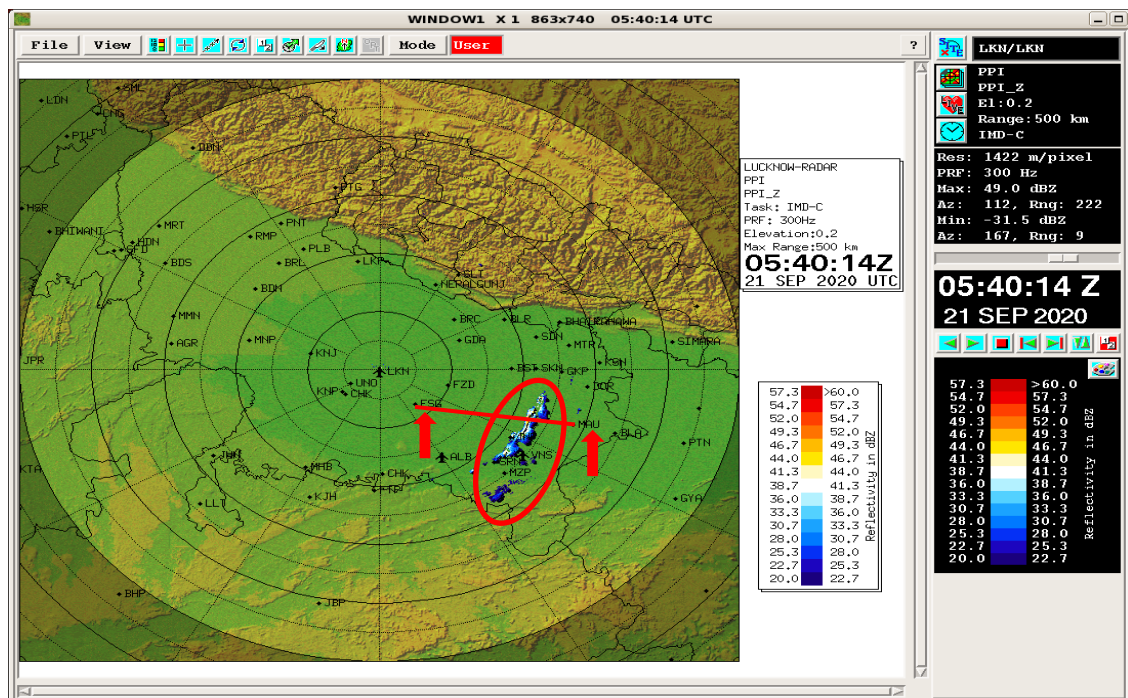
**FIG. 6 - WEATHER RADAR IN AND AROUND LUCKNOW (UPTO 500 KM) AT 05:40:14 UTC**

Areas of heavy precipitation (with big raindrops or snowflakes) return a lot of power to the radar and appear as brighter colors in reflectivity images. In this reflectivity image, the heaviest precipitation is in red, while lighter precipitation is in blue and green. The colours - yellow, orange and white shows moderate precipitation.

It is evident from the Radar image (Refer image above) that the weather was building up in the area between Fursatganj (FSG) and Mau (MAU) i.e., enroute the flight path followed by the trainee pilot where the accident occurred.

- 4.1 It is recommended that DGCA may formulate requirements/guidelines regarding weather monitoring such that the current weather and weather trends are being monitored continuously by FTOs and same is communicated to instructors & trainee pilots during flying training exercise especially in case of development of any adverse weather. The compliance of the same may be ensured during audits/surveillance of FTOs.
- 4.2 It is recommended that DGCA may advise all flying training organizations to develop a full proof system of 100% supervision of the training sorties by CFI or Dy.CFI as stipulated in the DGCA CAR on the subject.
- 4.3 It is recommended that AAI may advise all controllers to strictly adhere to the laid down SOPs to ensure that the RT calls are made by the responsible controller only.
