FOREWORD

SUMMARY

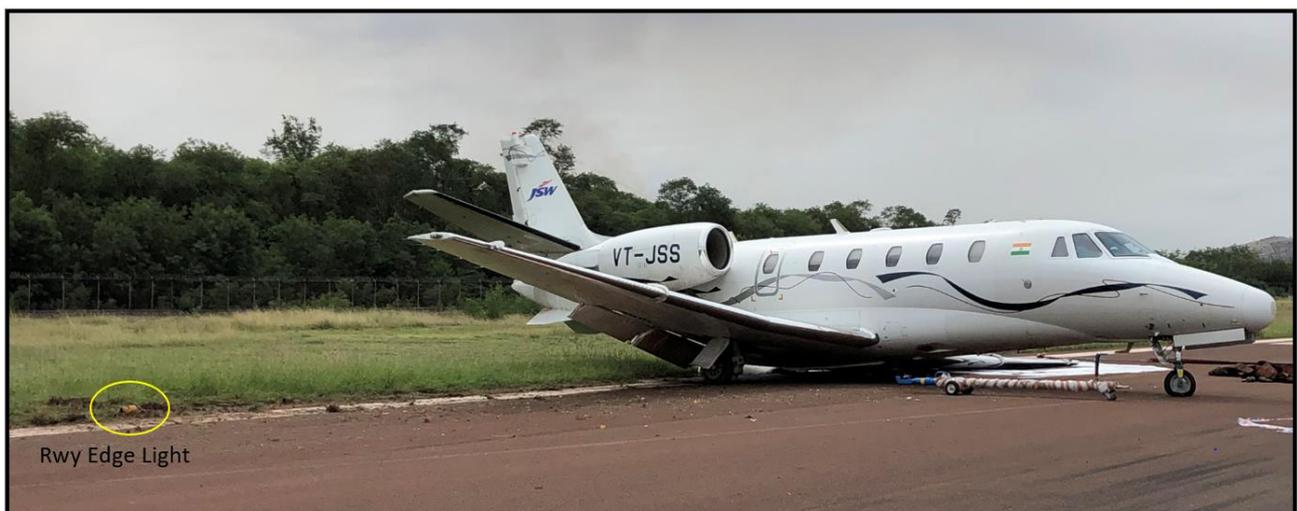
Fig 1: Broken runway edge light

One LH side runway edge light (L-18) was found broken.

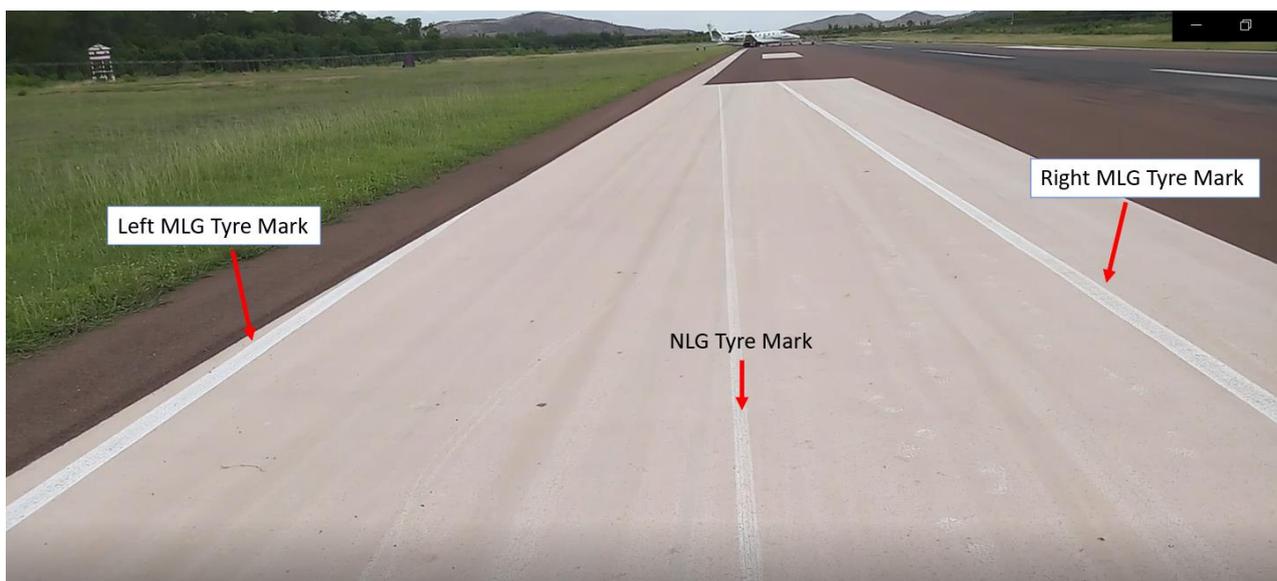
Fig 7: Aircraft Tyres marks on paved surface

Aircraft made a touchdown at approximately 143 meters ahead of threshold (on centreline) of runway 13. During initial landing roll, aircraft was directionally controlled and no significant deviation in aircraft heading was observed. The aircraft had covered a distance of about 400 meters before it started veering towards left. Thereafter, a slight drift towards left in aircraft heading was observed. The aircraft gradually started veering towards left, upto 222 meters.

Although, the deviation was slight but it was continuously moving towards left. Thereafter, deviation had increased due to which aircraft's MLG left tyre first exited

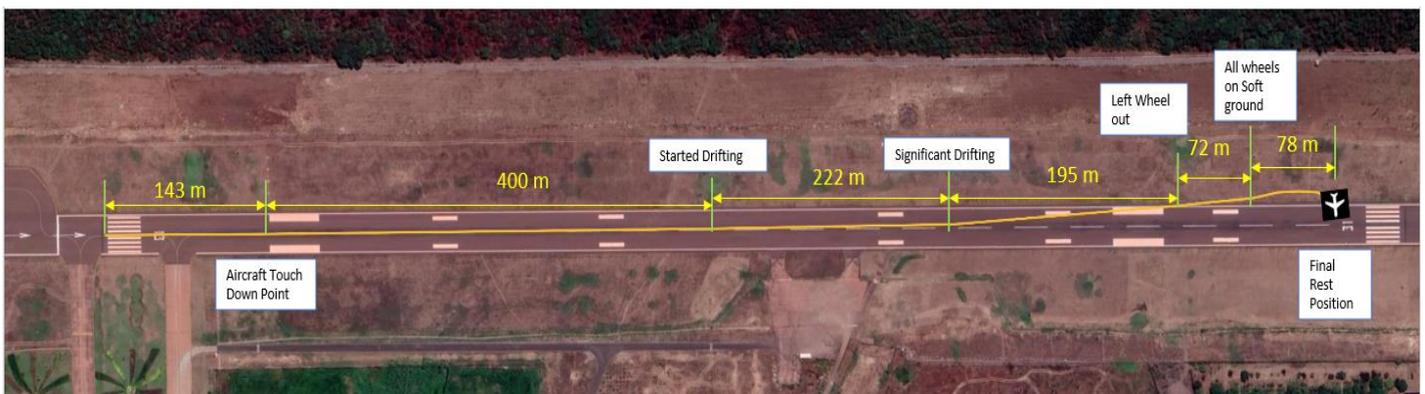
Fig 8: Ground marks plotted on Jindal Vijayanagar Airport

As per PIC statement, after comprehending that aircraft had already left the paved surface, right rudder was applied to steer the aircraft back towards the runway. Consequently, it resulted into sudden change in aircraft heading leading to skidding of aircraft. While the aircraft was skidding, nose wheel re-entered the runway first, thereafter, left MLG collapsed after hitting the runway edge. Eventually, the aircraft came to final halt travelling 967 meters after touchdown almost perpendicular to the runway (approx. 220°). The track followed by the aircraft is shown in the figure below:-

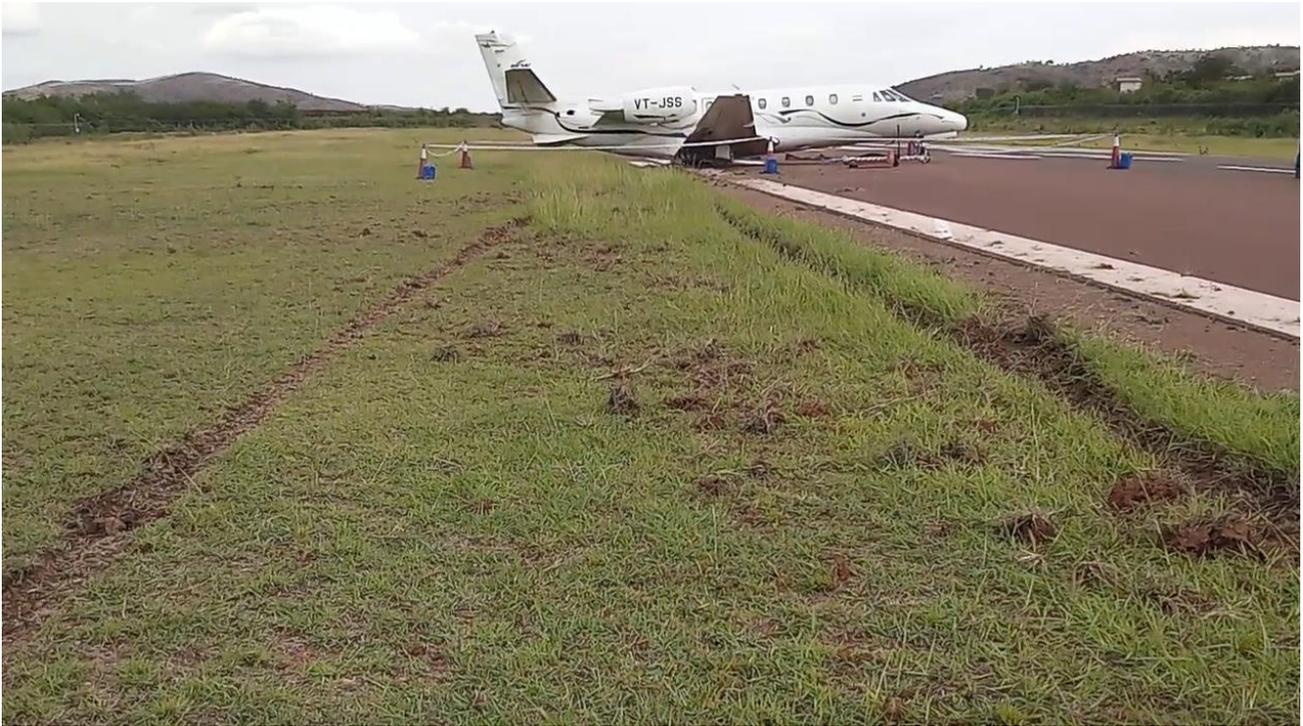
Fig 9: Aircraft Final Resting Position

A CCTV video was made available to the investigation team covering last portion of the landing roll of the accident flight. In the video, aircraft landing roll in rainy condition was captured. Thereafter, it was decided to physically measure the distance covered by the aircraft in actual which was captured by the camera. The physical distance measured was found to be around 121 meters (location was just before the aircraft left the paved surface) and frame time observed for aircraft coming in and going out was 19:45:15:382 & 19:45:20:382 (CCTV footage frame time) respectively. This shows that aircraft had covered a distance of 121 meters in around 5 seconds. This reveals that aircraft speed was around 24.2 m/s or 47 knots which

appears to be on higher side for an aircraft already had covered 622 meters of runway during landing roll.

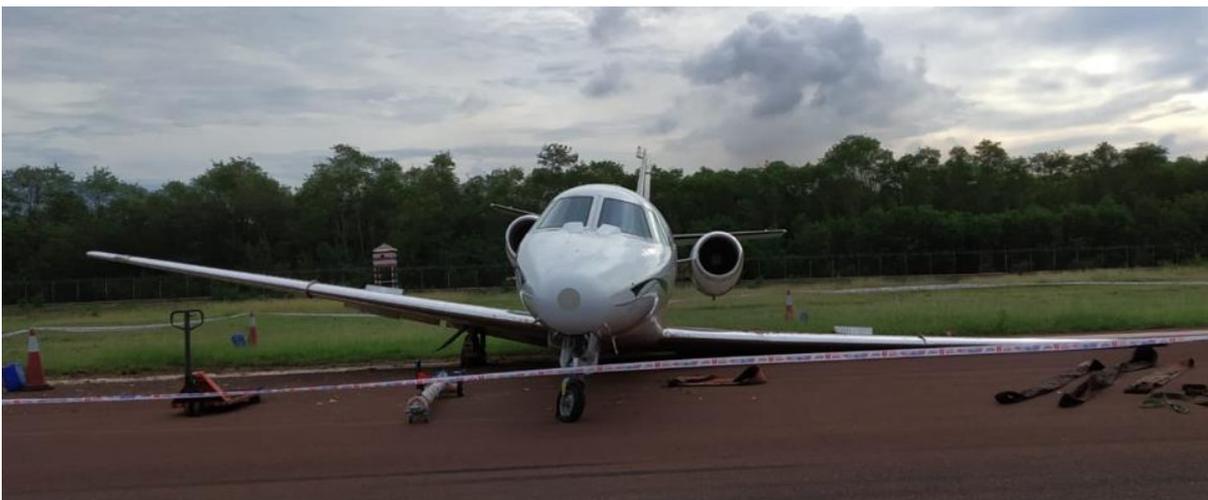
Fig 10: Aircraft settled with left wing touching the ground

As a result of the LH main gear collapse, the LH wing sustained significant damage due to subsequent rubbing/dragging against the ground. Visual inspection revealed that flaps, speed brakes assemblies, ailerons, leading edges along with wing

fences showed sign of damages and an apparent puncture in the fuel tank was also observed.

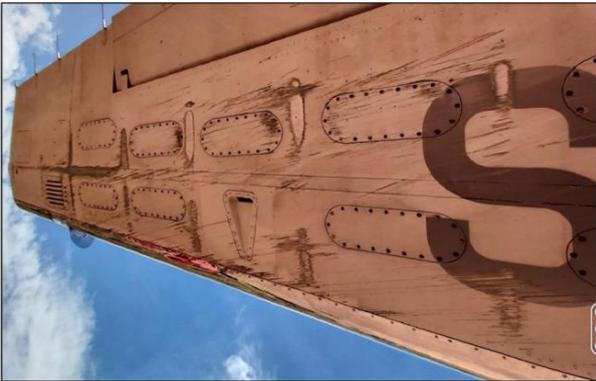
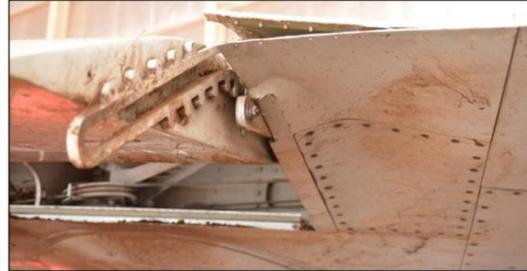
Fig 11: Lower LH Wing Surface

Fig 12: Skin separation on LH wing

The lower surface of LH wing was found extensively damaged in the form of deformation, gouges and scuffing ensuing rubbing against the ground. Lower skin was found detached from wing ribs, especially in proximity to flaps and supporting structure.

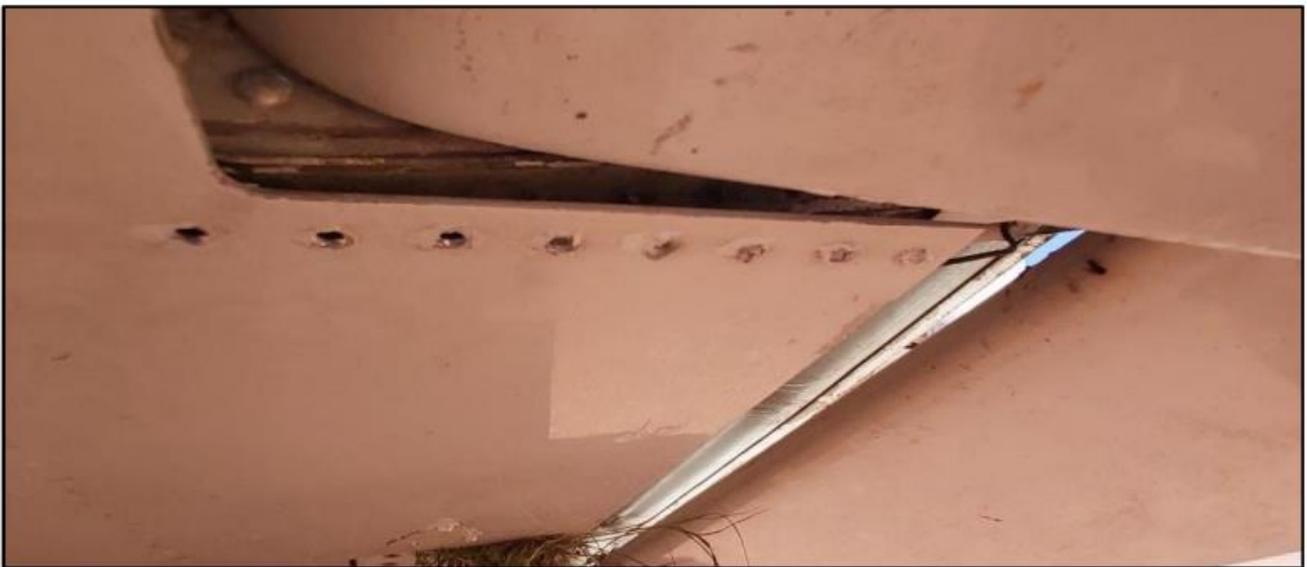
Fig 13: Holes on lower surface

Lower wing skin was found separated around LH aileron support structure due to fasteners got separated from the skin leading to holes elongation or cracks in nearby areas.

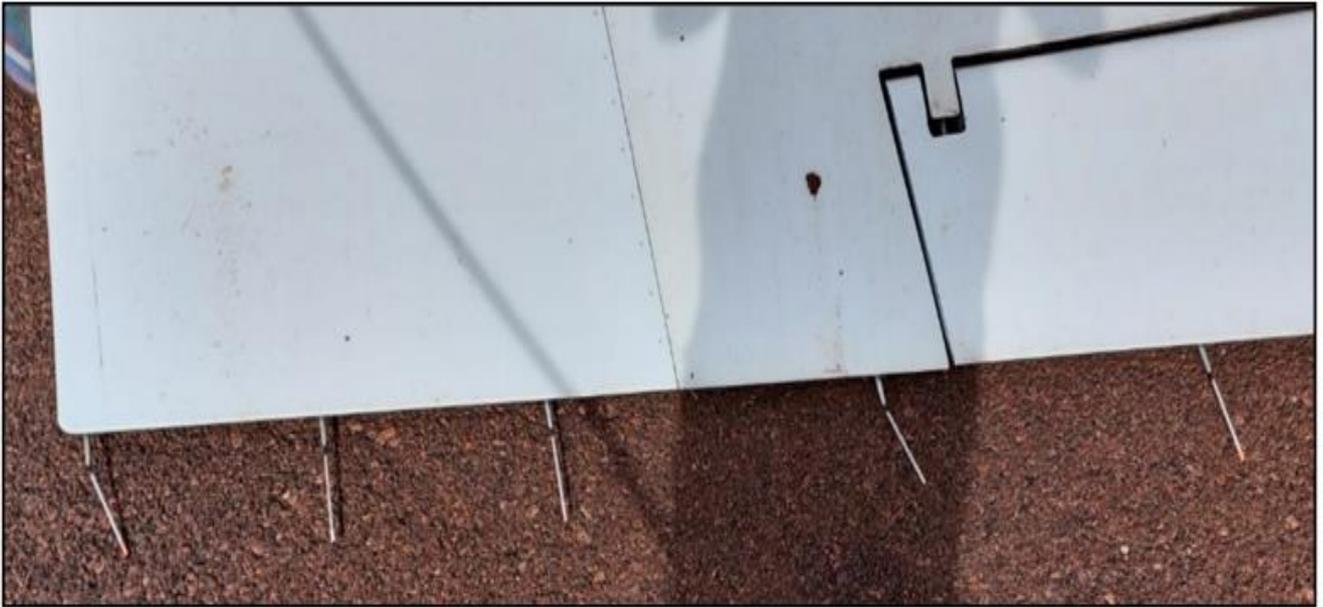
Fig14: Damaged Static Wicks

The LH wing static wicks were found damaged.

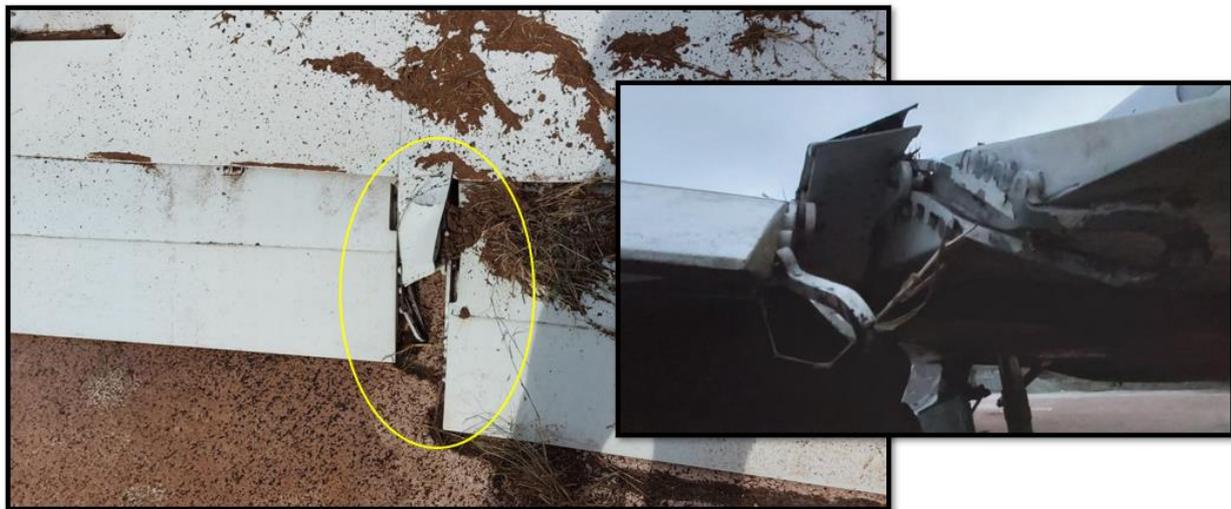
Fig 15: Damages on LH Flap

- i. LH wing inboard and outboard flaps were found damaged.
- ii. Flap tracks and supporting wing structural components were observed bent.
- iii. Upper as well as lower skin of LH flap was found separated and deformed.

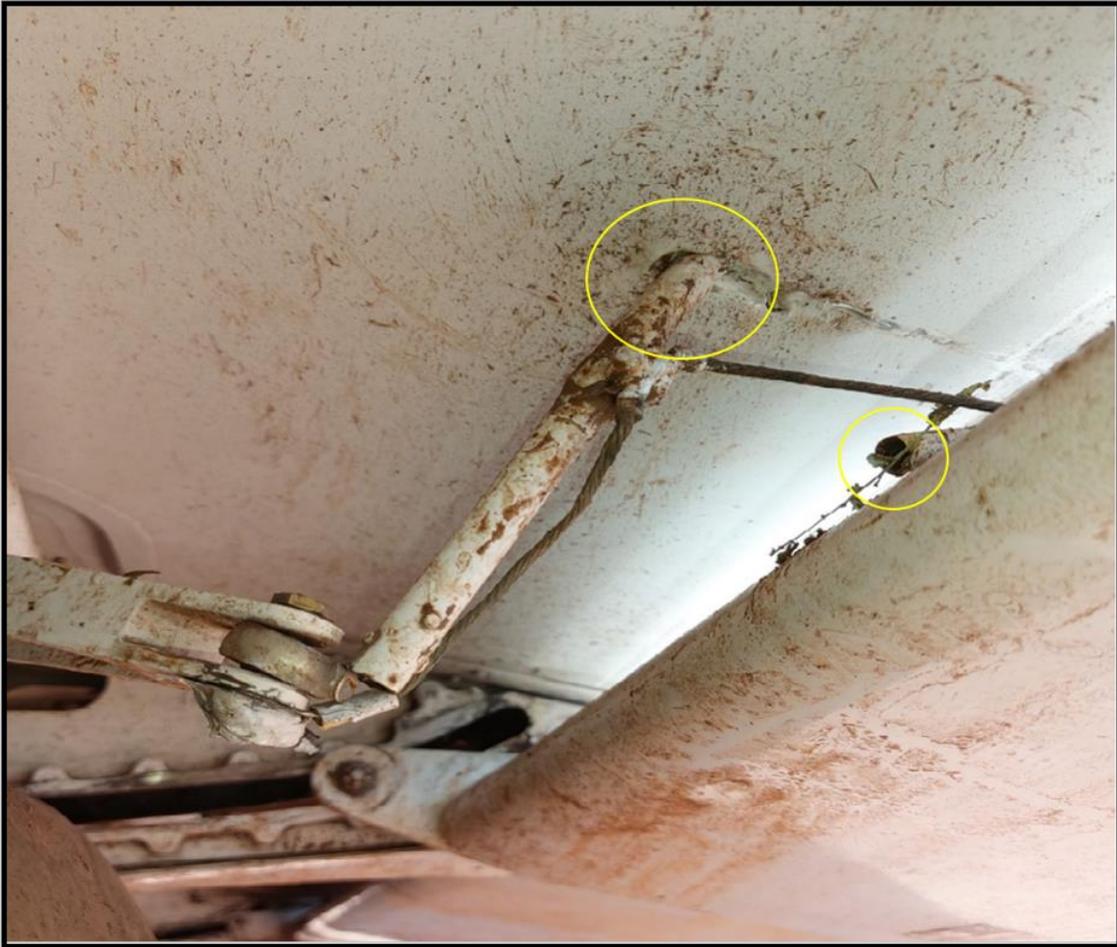
Fig 16: Flap Bell crank & Pushrod

Bellcrank and pushrods of flap extension mechanism sustained severe damage. Pushrod was found protruded from upper wing skin.

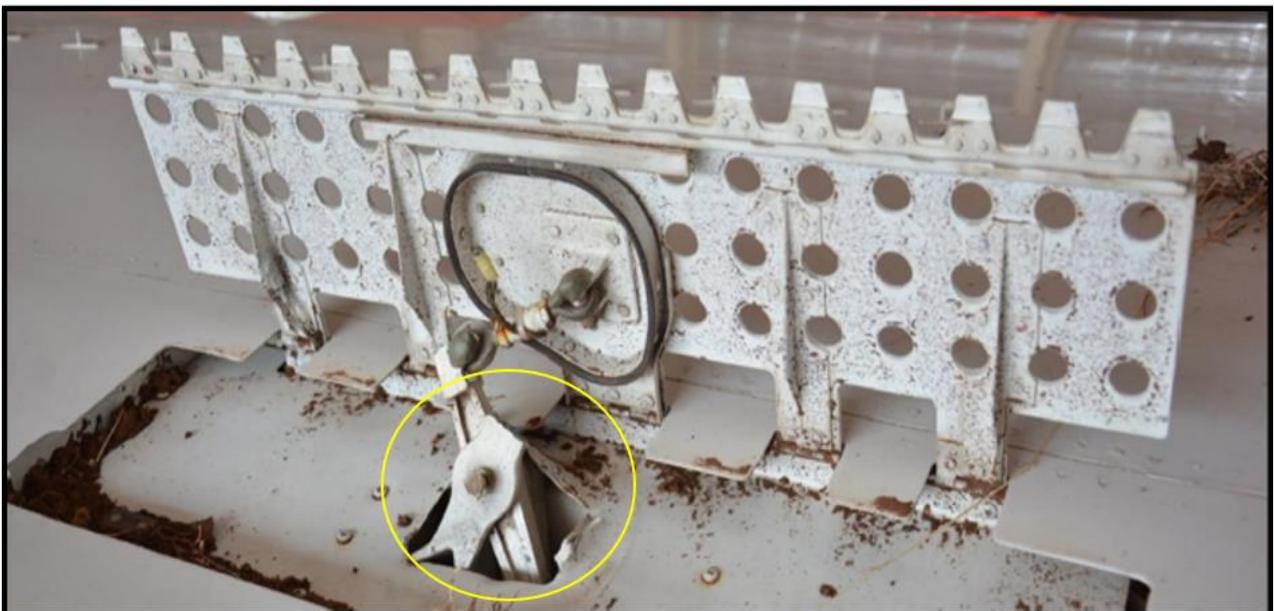
Fig 17: LH Speed Brake (failed bellcrank and damaged surrounding skin)

- i. The LH speed brake assembly was found severely damaged.
- ii. Trunnion support was found snapped and Bell crank forced through the skin.

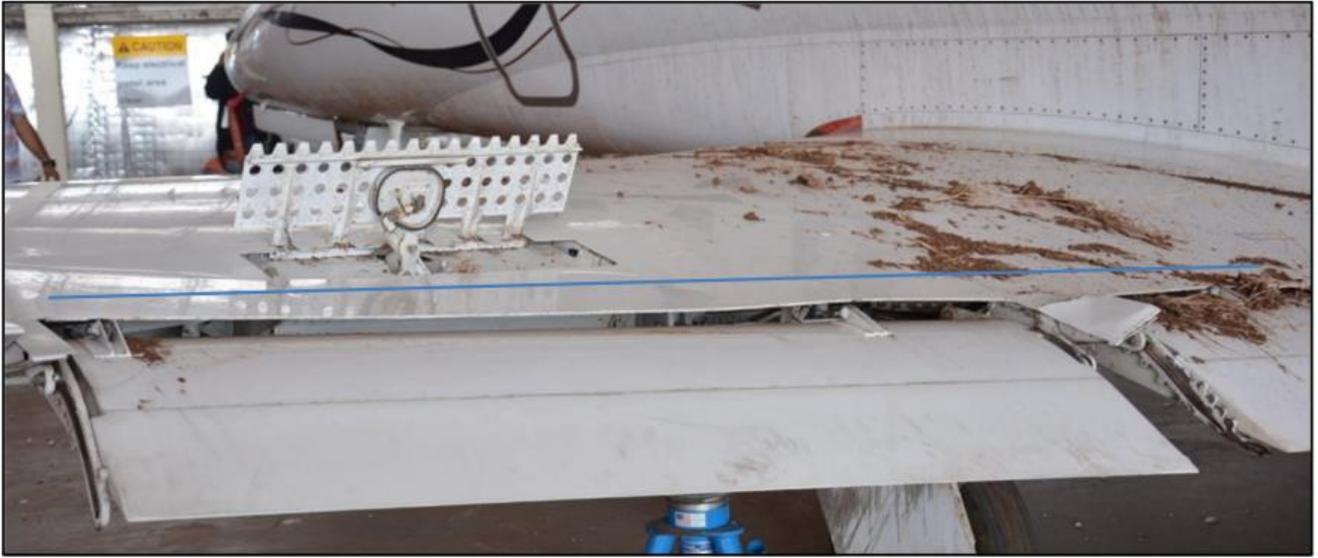
Fig 18: LH upper wing skin bent in flap area (blue line for reference)

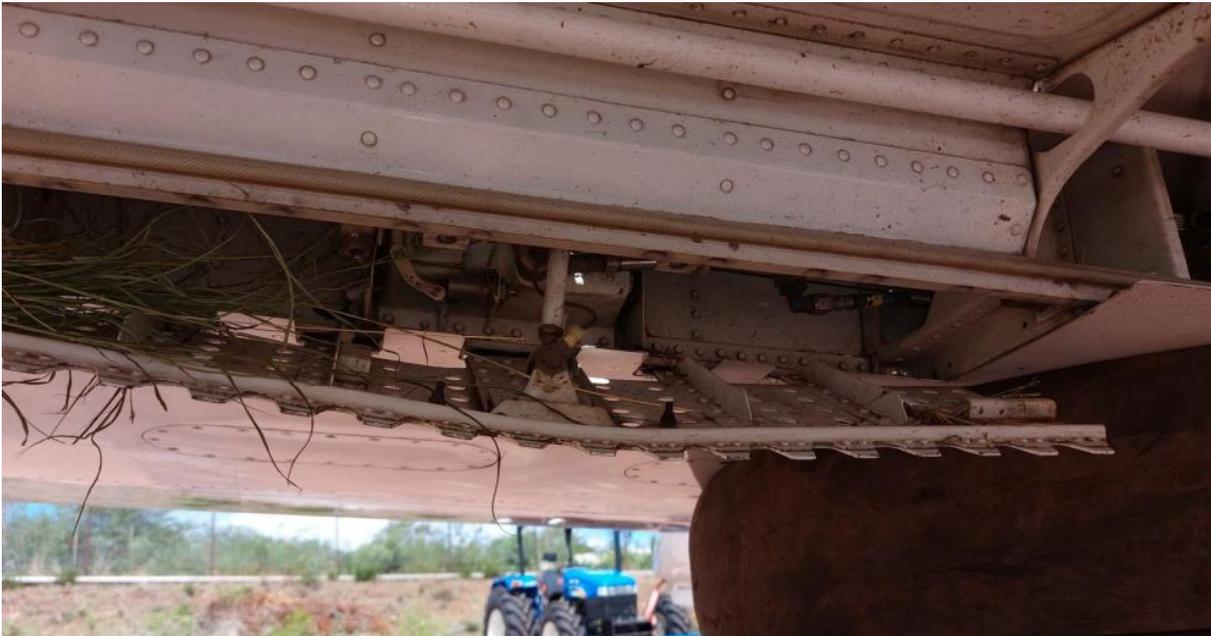
Fig 19: Lower Speed Brake

Lower LH speed brake heavily damaged and nearly stowed with extended bellcrank linkages

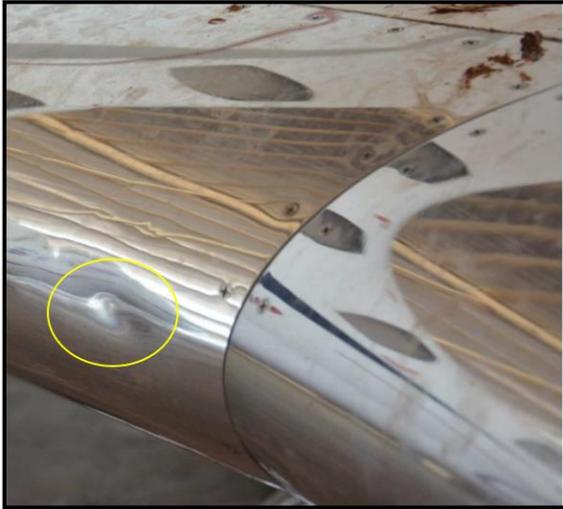
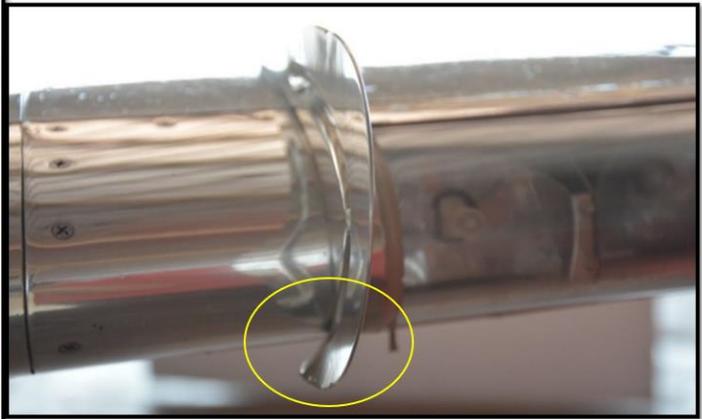
Fig 20: Dent on leading Edge

Fig 21: Leading Edge Fence

- i. Dents and scratches were observed on leading edges.
- ii. The outboard LH wing fence was found deformed & damaged as a result of contact with the ground.

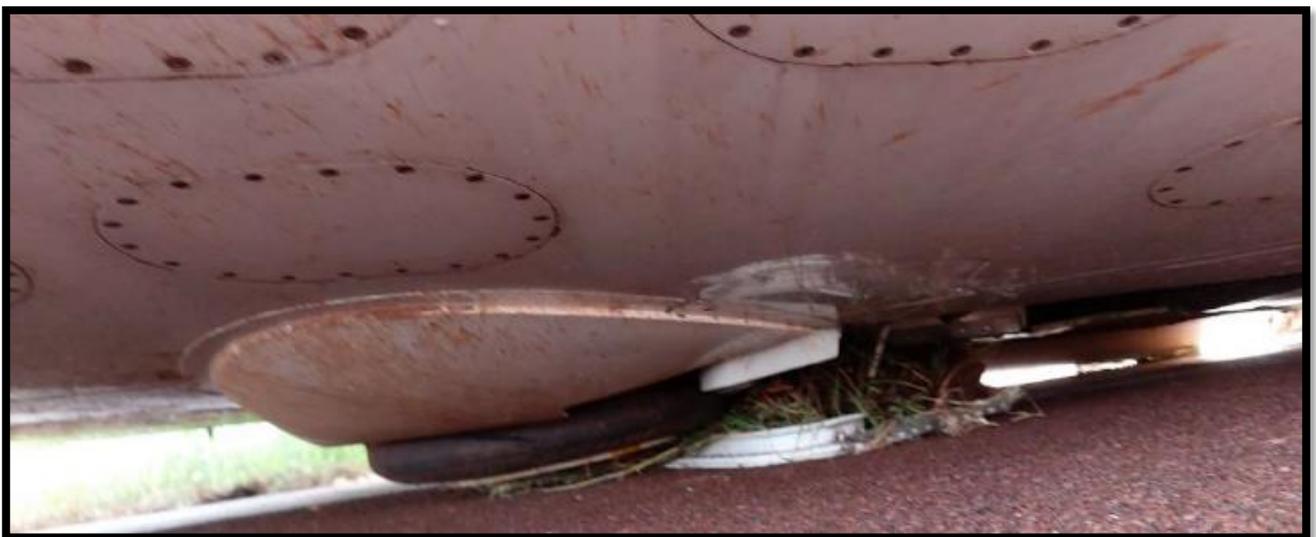
Fig 22: Collapsed LH MLG

Due to LH MLG hitting the edge of the runway, the left main landing gear collapsed.

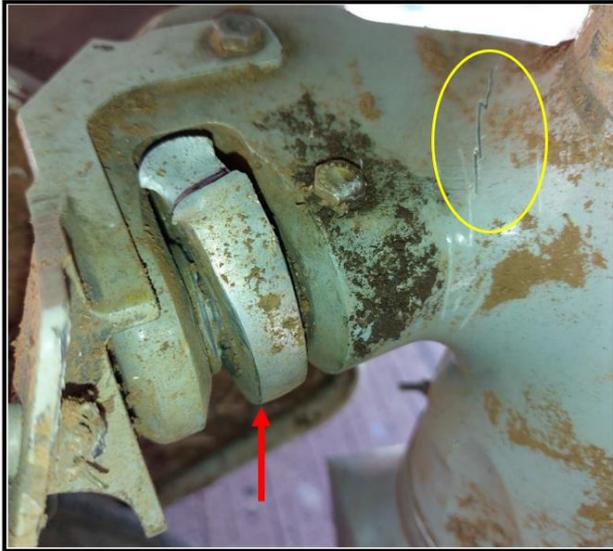
Fig 23: LH MLG actuator eyelet broken off

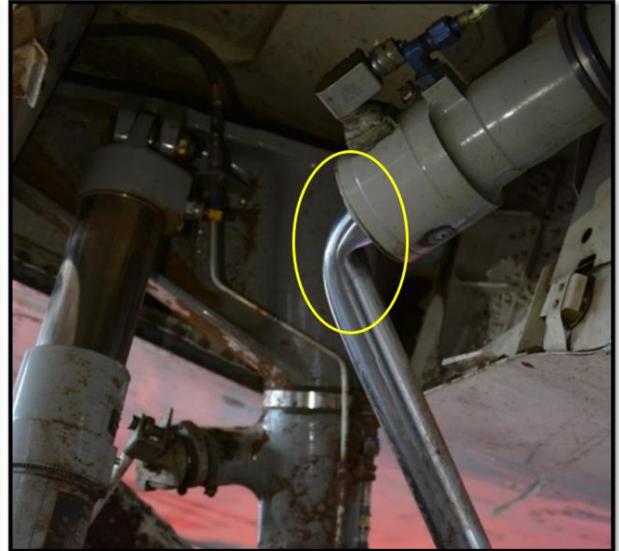
Fig 24: Piston Rod bent

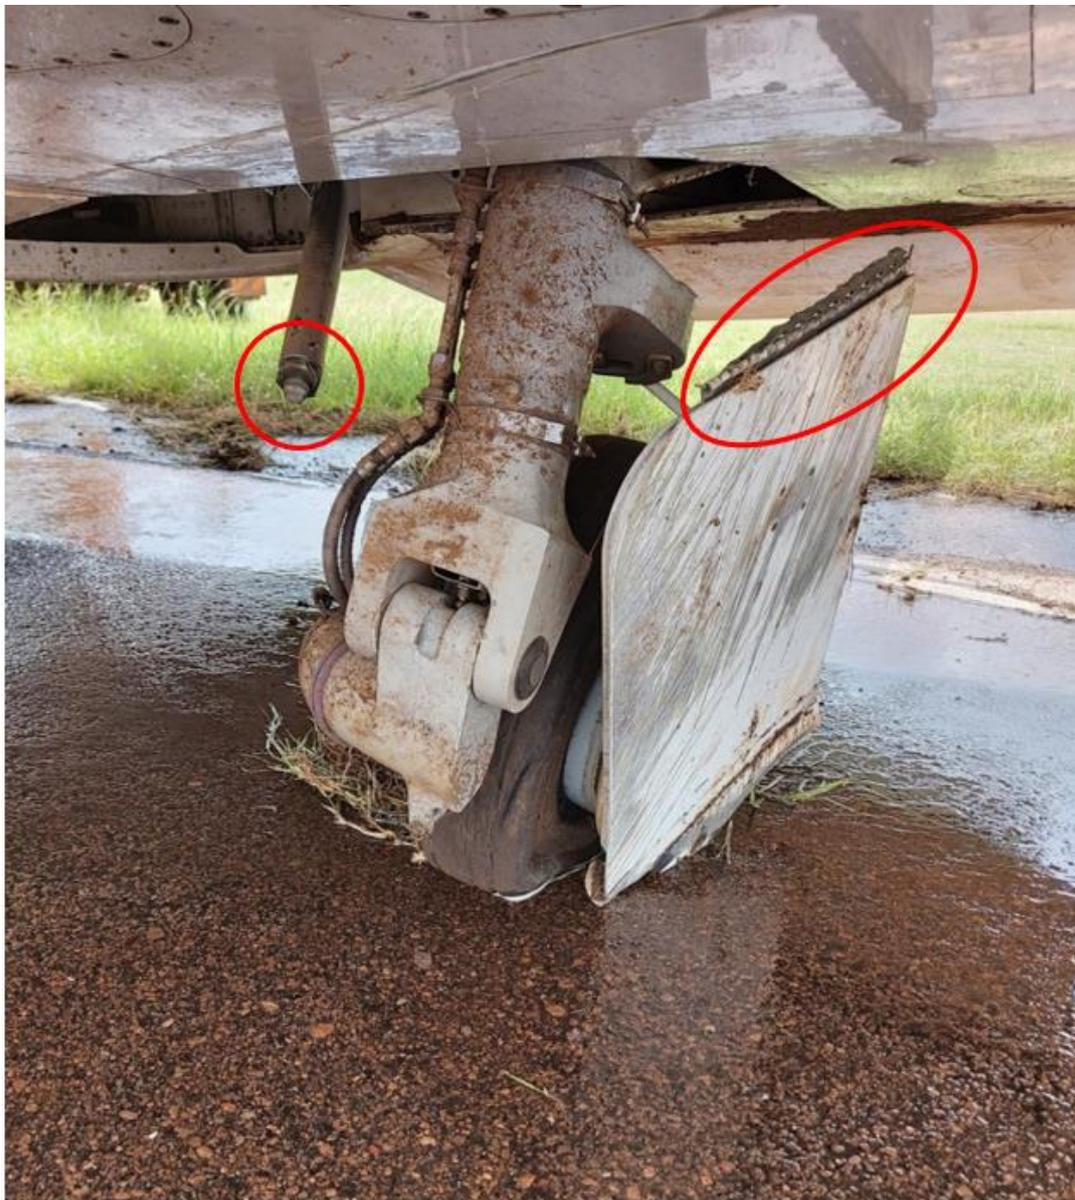
Fig 25: Detached Landing Gear Door (LH) and broken Actuator rod

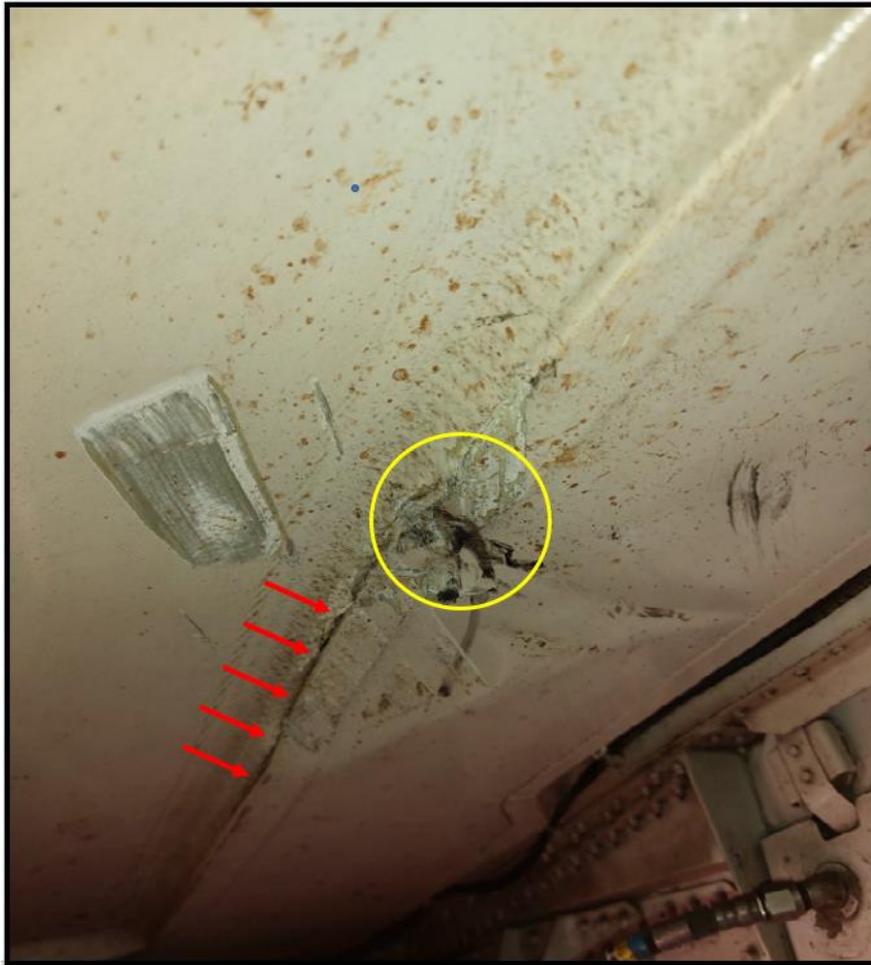
Fig 26: Hole and crack on Wheel Well upper surface

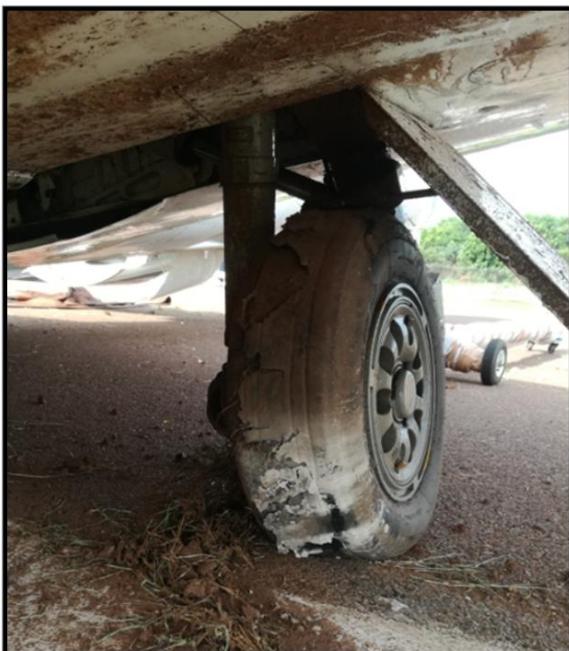
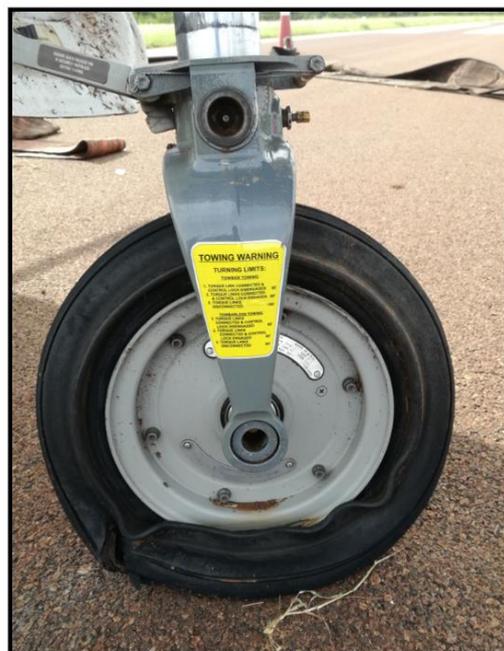
Fig 27: RH MLG tire

Fig 28: Nose Landing Gear

- i. RH MLG was found torn out and deflated.
- ii. NLG tire along with hub was found damaged.

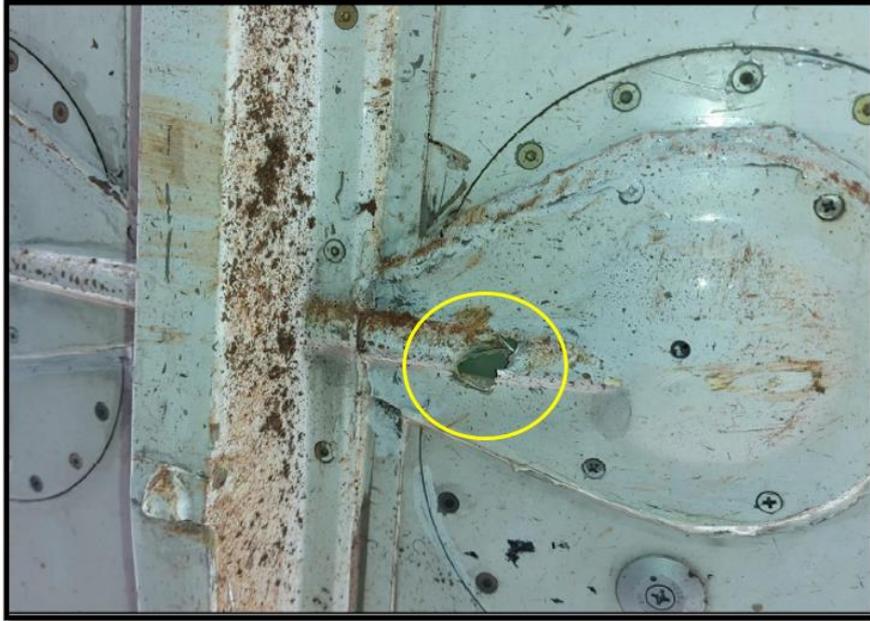
Fig 29: Damage on Keel Beam Area

Signs of apparent FOD damage and rubbing marks were observed on keel beam area of lower fuselage.

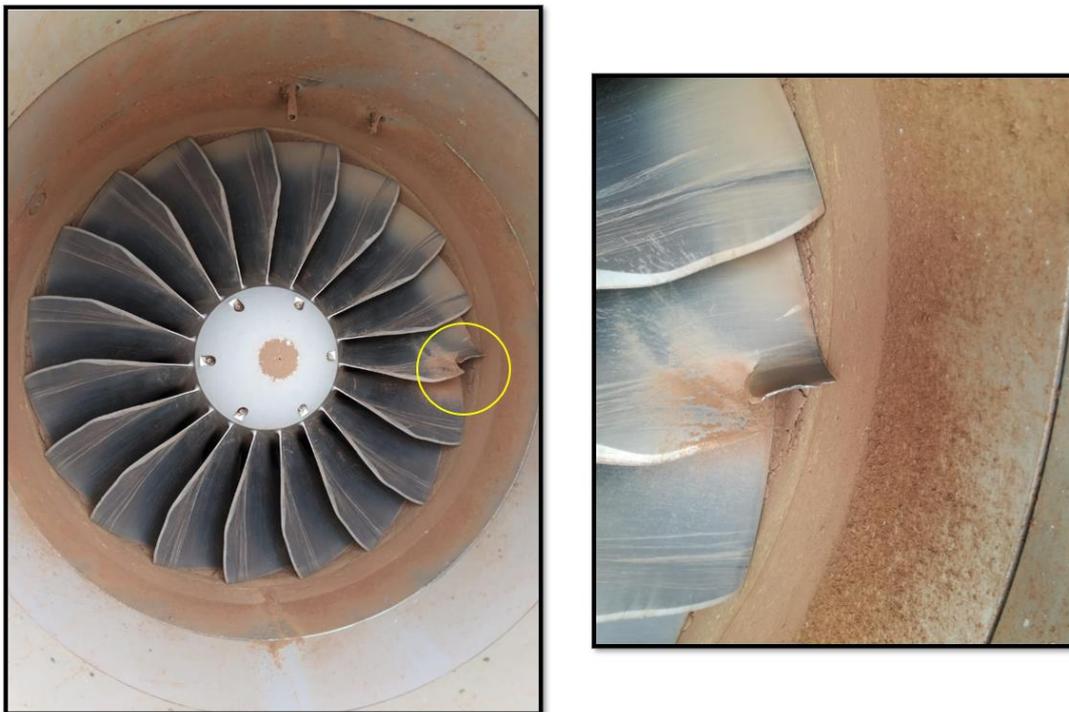
Fig 30: Left Side Engine

One fan blade of LH Engine was found damaged due to FOD ingestion resulting into Engine seize.

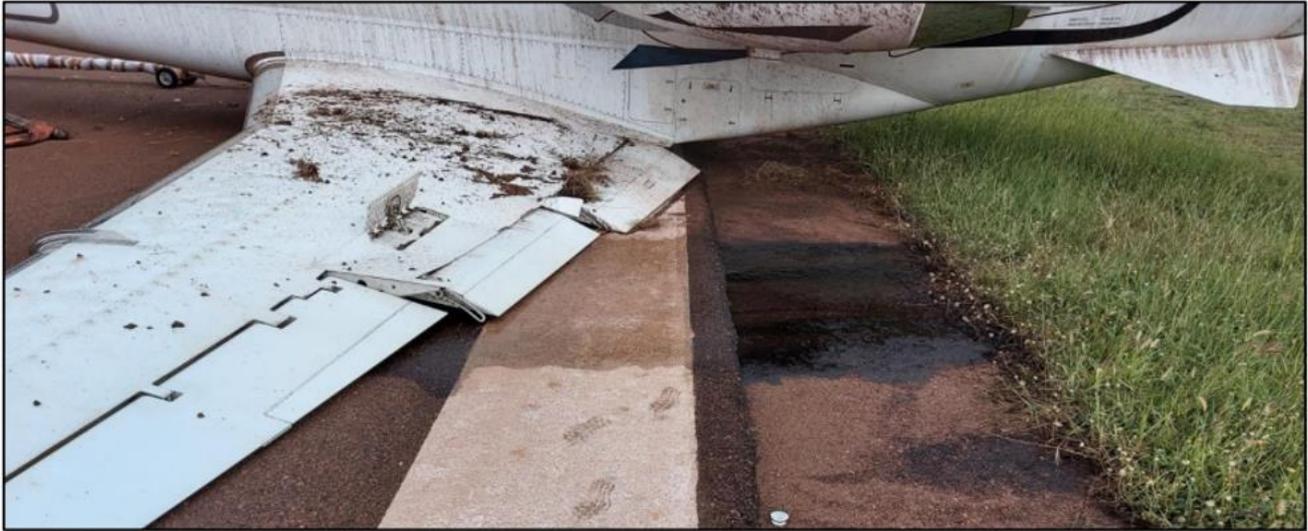
Fig 31: Fuel leaked from left Wing Tank

Fuel spillage was observed at the accident site due to left wing tank was punctured by collapse of main landing gear strut.

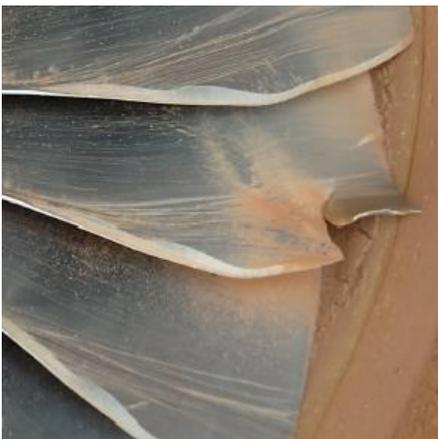
The blade is seen bent in the direction opposite to rotation indicating that this occurred with the engine running.

Fig 32: Bent fan blade

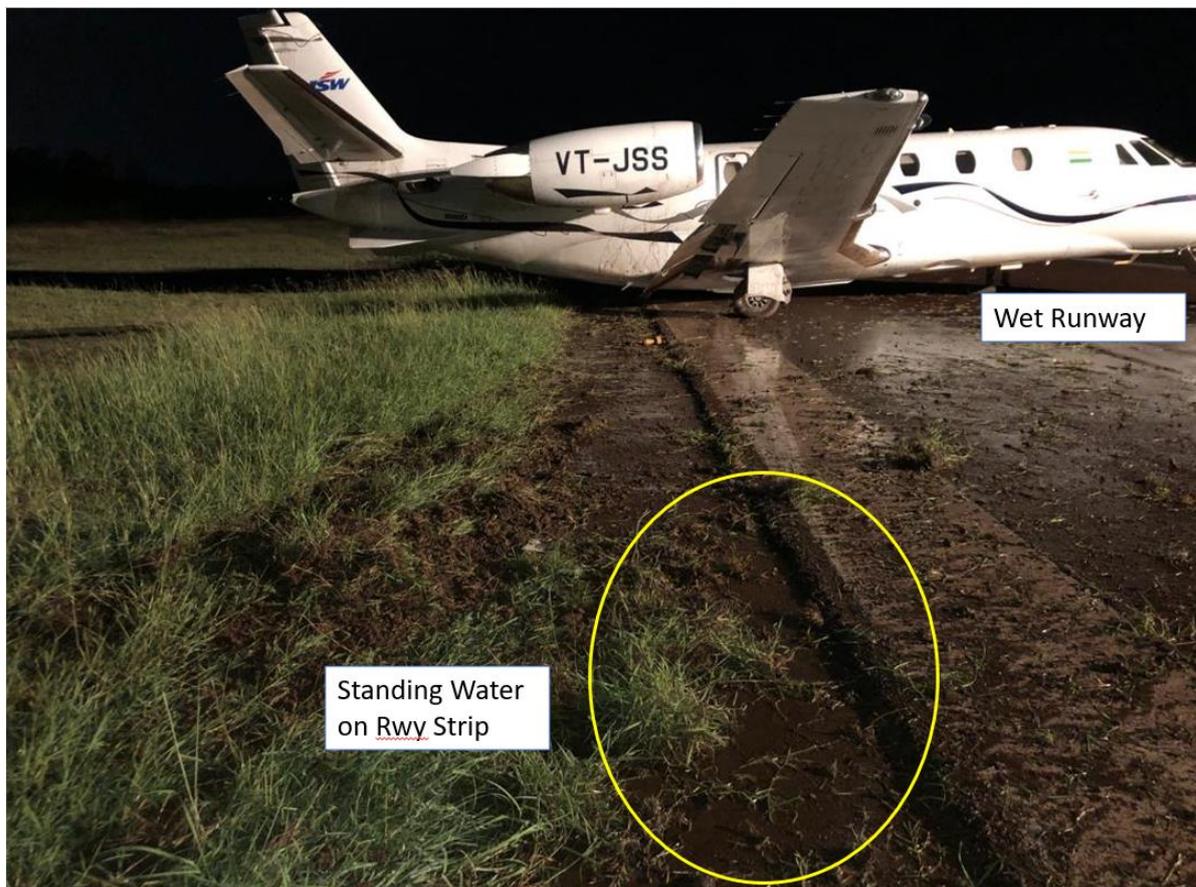
Fig 38: Photograph immediately after the accident

Photographs snapped immediately after the accident are clearly showing standing water on runway strip and even the runway surface appeared wet.
