**FINAL REPORT ON ACCIDENT INVOLVING CESSNA FA152 AIRCRAFT
VT-ENF OPERATED BY M/S GOVERNMENT AVIATION TRAINING
INSTITUTE AT BIRASAL, ODISHA
ON 08 TH JUNE 2020.**

**Dinesh Kumar
Investigator -In- charge**

FINAL REPORT ON ACCIDENT INVOLVING CESSNA FA152
AIRCRAFT VT-ENF OPERATED BY M/s GOVERNMENT AVIATION
TRAINING INSTITUTE ON 08/06/2020 AT BIRASAL, ODISHA

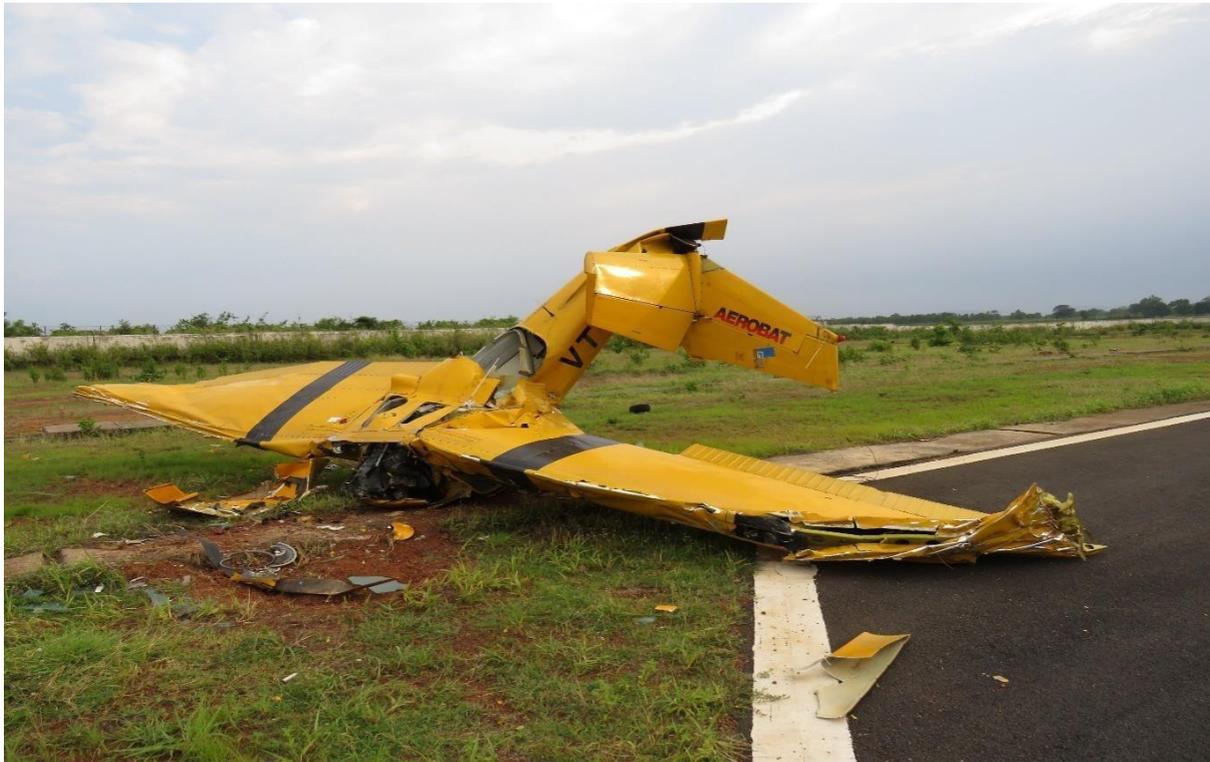
The aircraft was substantially damaged during the accident.

Fig 1: Aircraft at Crash Site

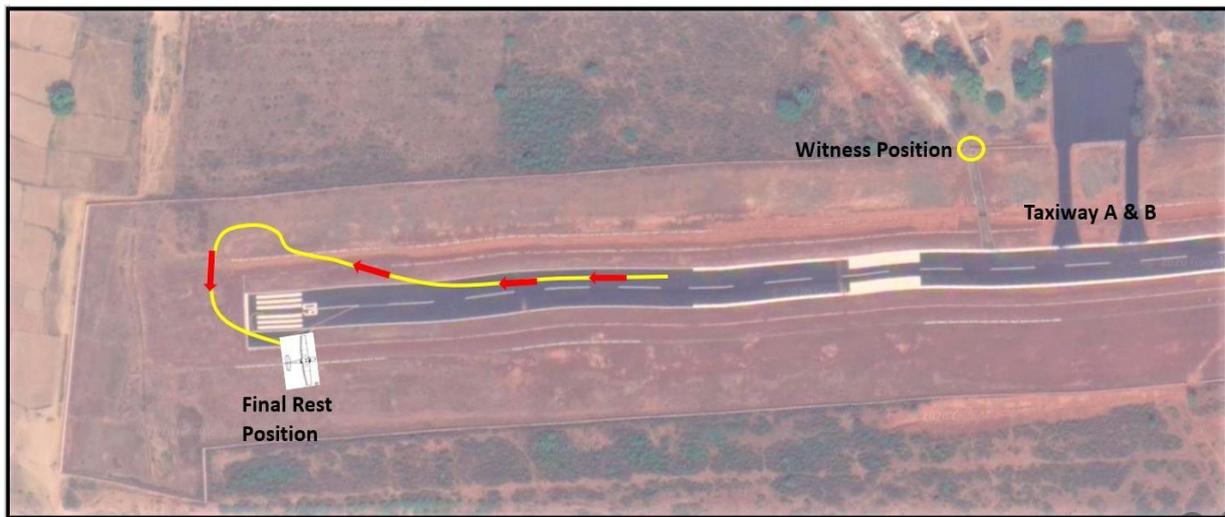
As per the witness statement, aircraft was rolling significantly on right of runway centreline and after takeoff from runway 27, aircraft made a 180° turn. Based on eye witness statement, the path followed by the aircraft for the accident flight is projected on the google map which is shown below.

Fig 4: Track followed and final rest position

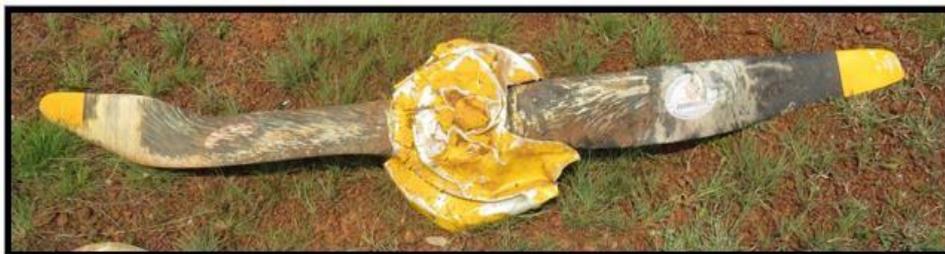
From the wreckage examination, it was ascertained that during impact, aircraft had hit the ground in nose dive condition, consequently propeller blades disintegrated from propeller hub (Ref. Fig 5). A crack was also observed on the head of Engine Crankcase which implies that a very heavy load was transferred to the engine at the time of impact and could be possible only during head on collision. Moreover, rubbing marks were also present on both propeller blades and as well as on the ground which further indicates that engine was producing power at the time of impact.

Fig 5: Rubbing marks on Propeller

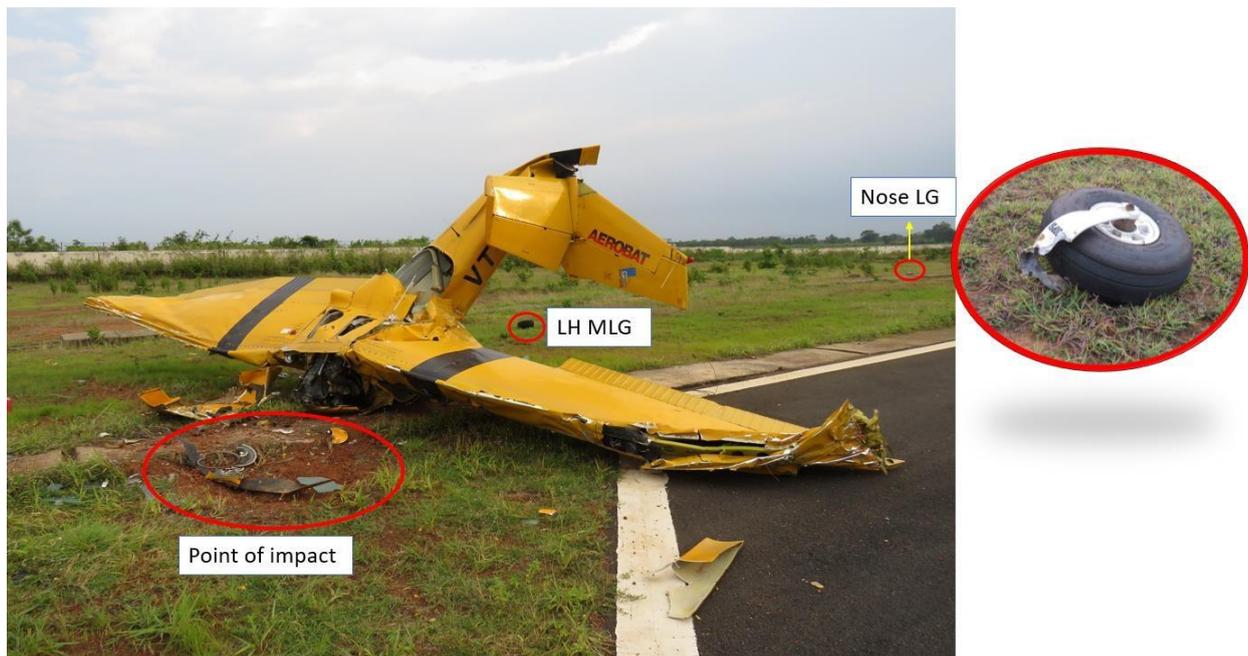
Both nose landing gear and left main landing gear got detached from the aircraft and were located at 136 feet & 24 feet respectively from the aircraft wreckage. As the nose landing gear was traced at farther distance from the aircraft wreckage, which clearly indicates that primary impact was experienced by the nose landing gear and aircraft was not in wing level condition while it impacted ground. Further, aircraft empennage was found broken and was hanging towards left. **Aforesaid conditions clearly depict that aircraft was in pitch down as well as left bank condition at the time of impact.**

Fig 6: Point of Impact

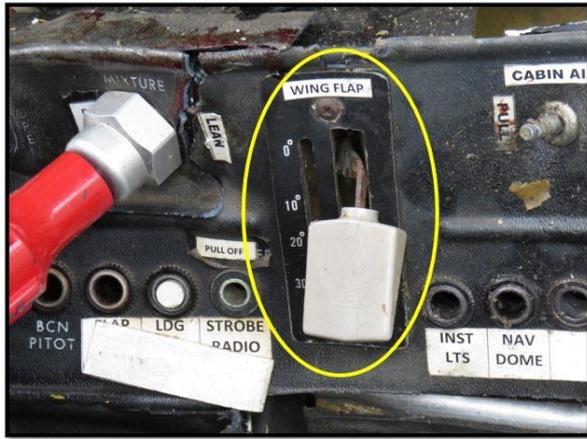
During wreckage examination, cockpit control positions were also photographed. Wings flap selection lever at the time of accident was set at 0. However, flap lever had shifted slightly down from its original position and had stuck between 0° to 10°. Further, Flap lever was also found bent, which was most apparently due to hard hitting on the lever at the time of impact.

Fig 7: Wing Flap lever position

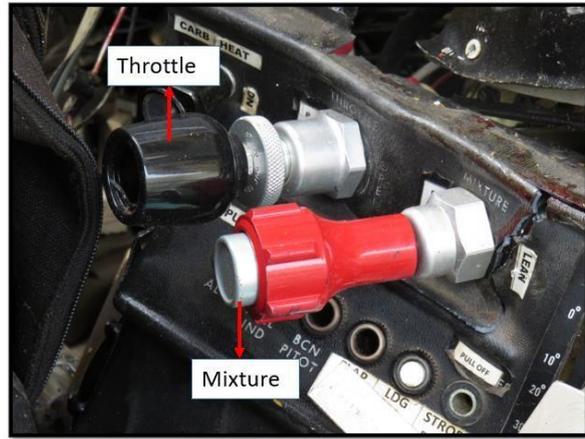
Both, throttle as well as fuel mixture knob were present at fully forward position indicating that aircraft throttle was fully open and fuel mixture was rich at the time aircraft impacted the ground.

Fig 8: Throttle & Mixture Position

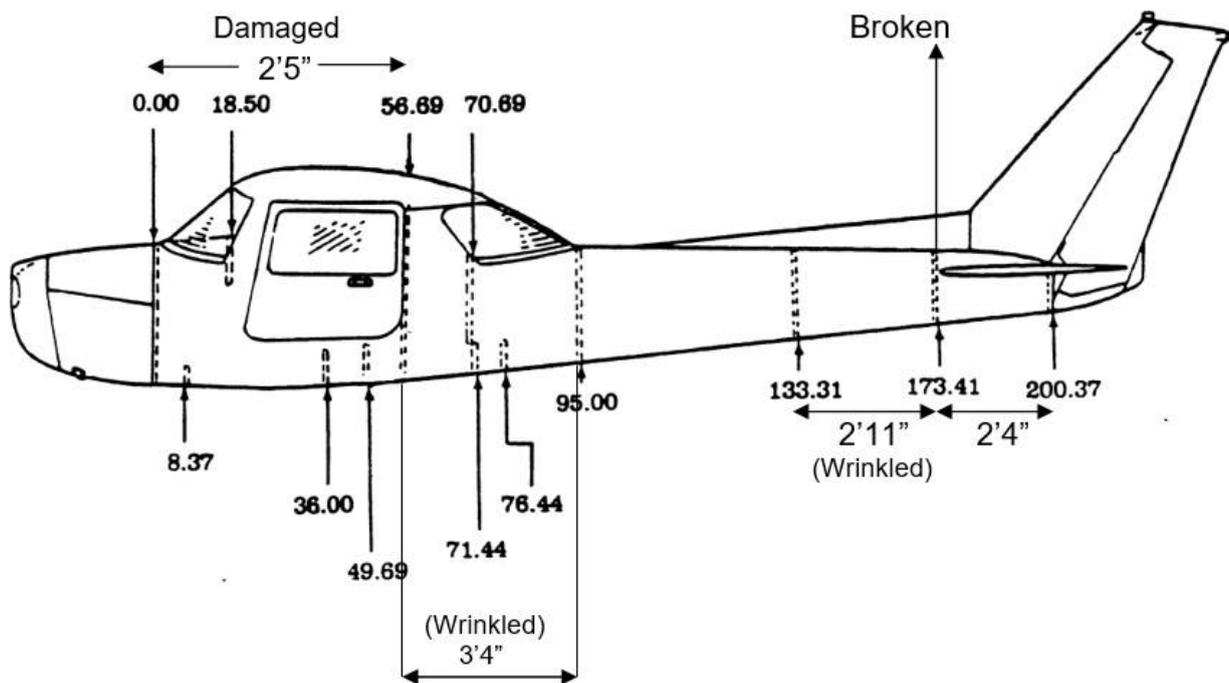
Damage assessment of the aircraft was also carried out to identify major impact bearing areas and resultant damage on the aircraft structure. Aircraft received following damages at different stations which are shown below:

Fig 9: Damages observed at fuselage sections

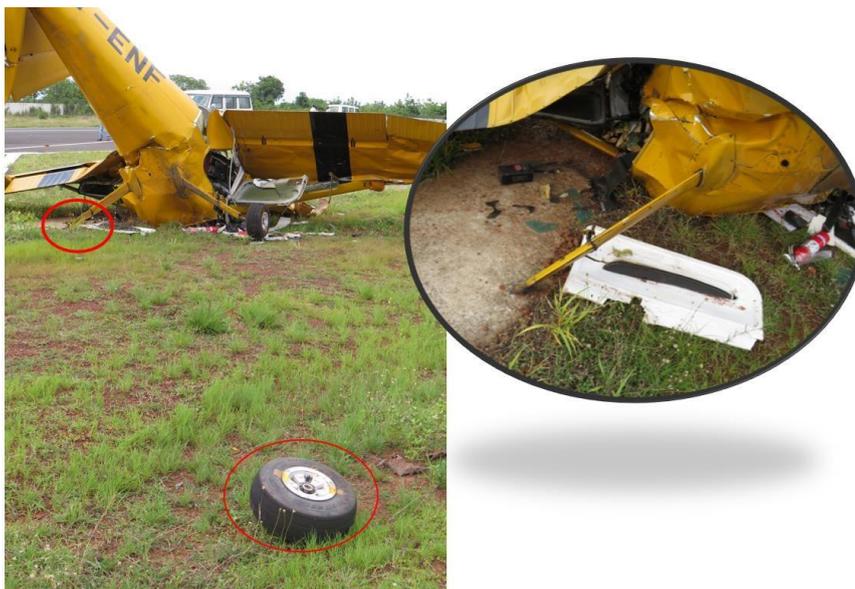
- a) Nose landing gear was found extremely damaged and Nose wheel was found at a distance of more than 100 feet.
- b) LH main landing gear was found broken at axle and wheel assembly.

Fig 10: LH Main Landing Gear

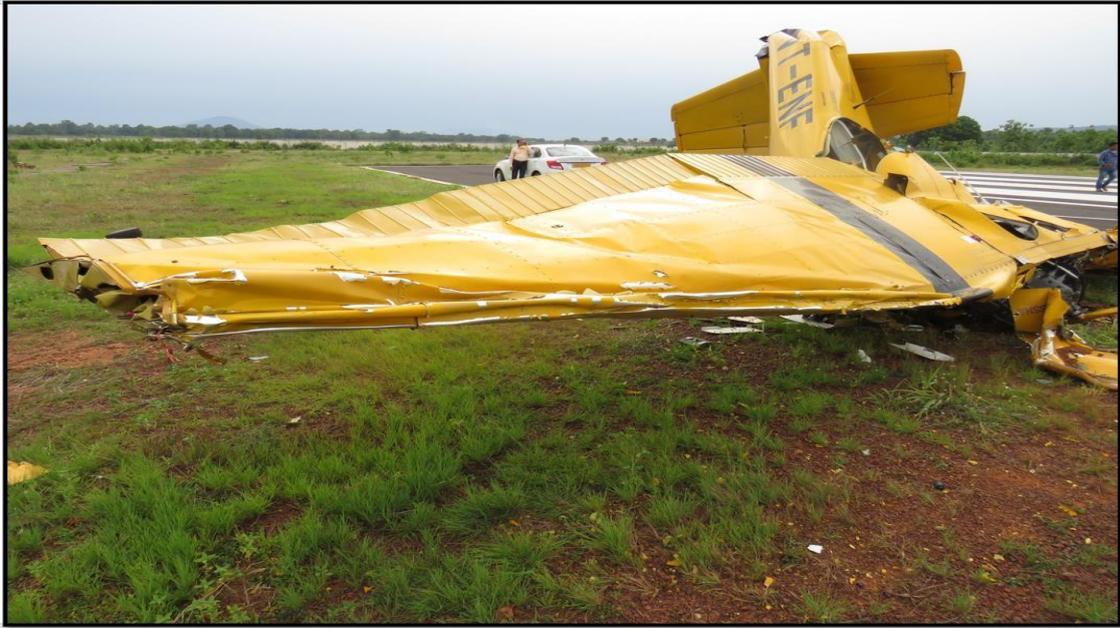
Fig 11: RH Side Wing

Both upper and lower skin of the right-side wing was found wrinkled. Entire leading edge from root to tip was found crushed. Aileron Assembly was bent and distorted.

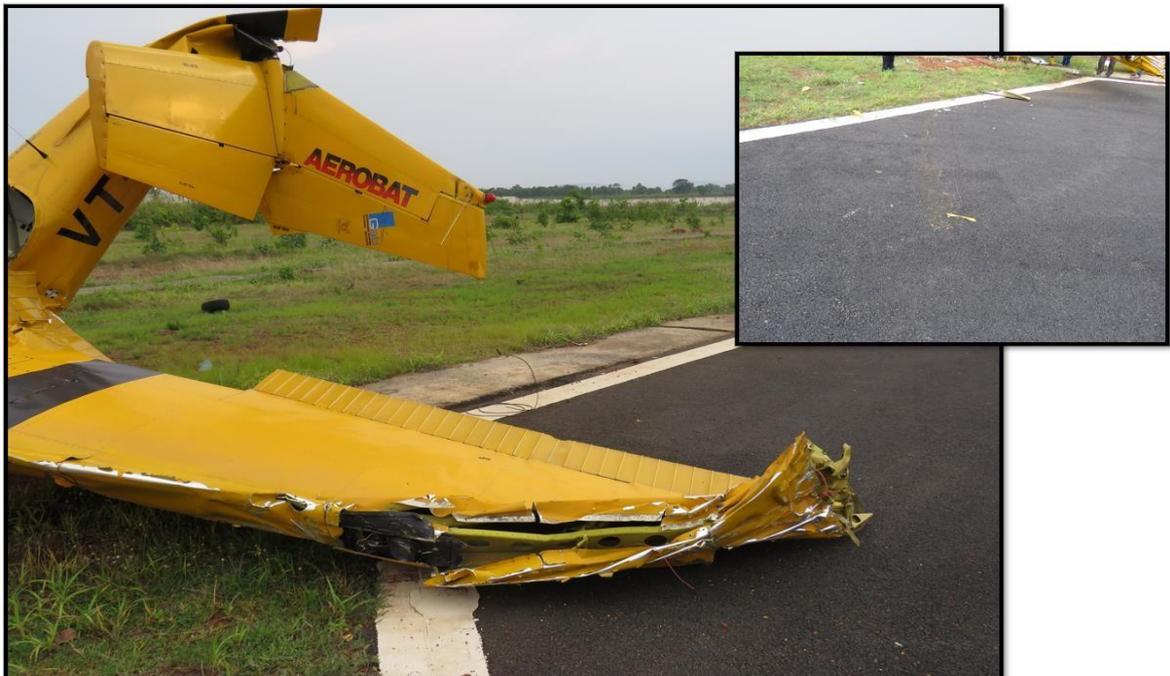
Fig 12: LH side Wing

Both upper and lower surface of inboard wing of left-side was found distorted, wrinkled & damaged. Entire leading edge from root to tip was found

crushed and wrinkled. Outboard leading-edge rivets had sheared off and wing tip was found crushed & damaged. Flap and aileron were found excessively damaged and distorted.

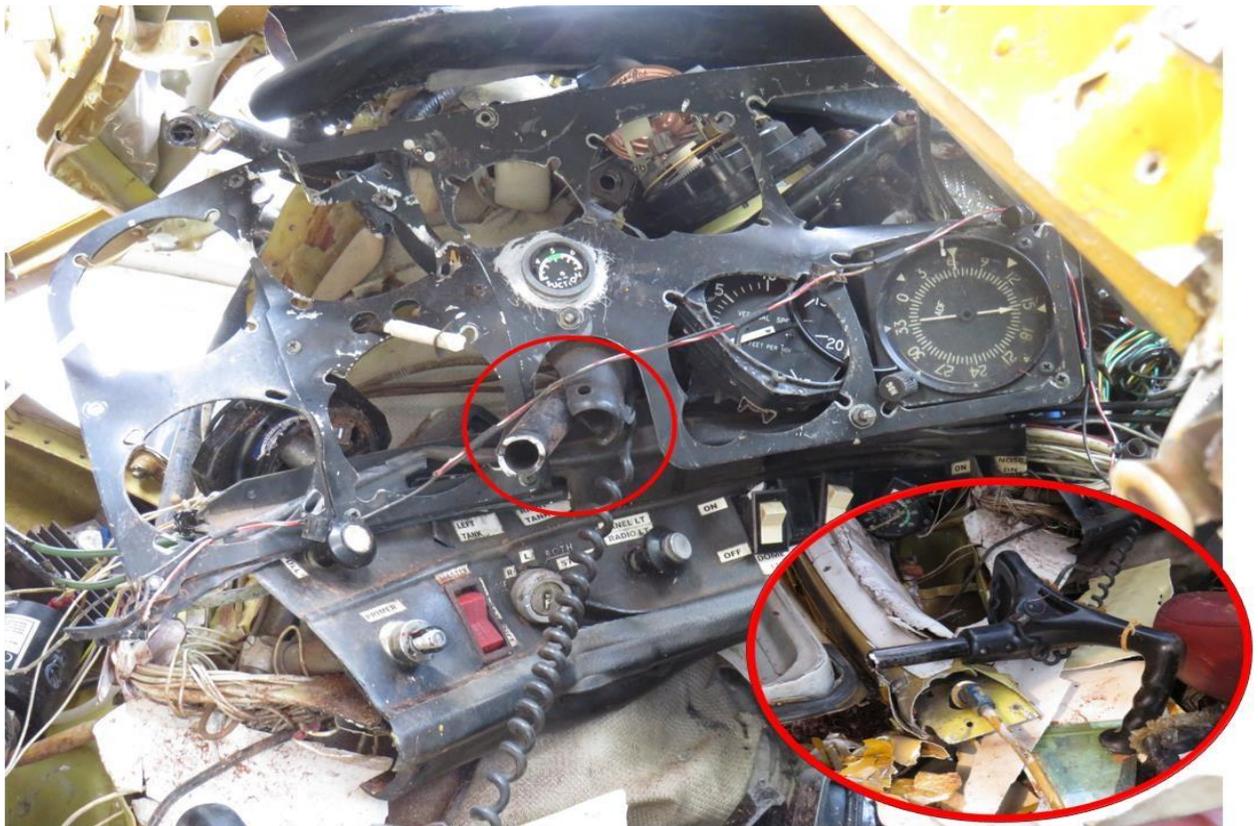
Instrument panel was found crushed & dislocated and radio rack also crushed.

Fig 13: Instrument Panel and Broken Control Column

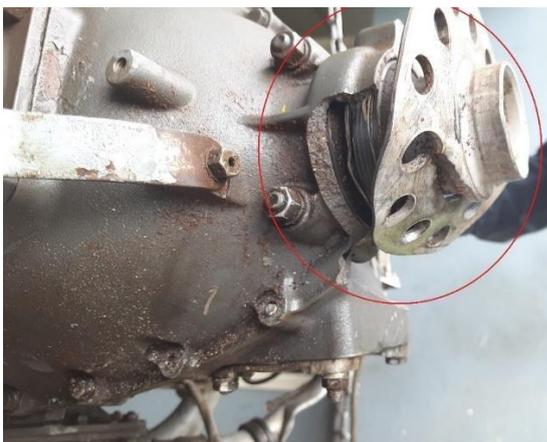
- a. A portion of crankshaft flange was found bent & sheared off at the flange base.
- b. Crankcase at the nose lower section of the both half was found broken.

Figure: 1 Crankshaft flange

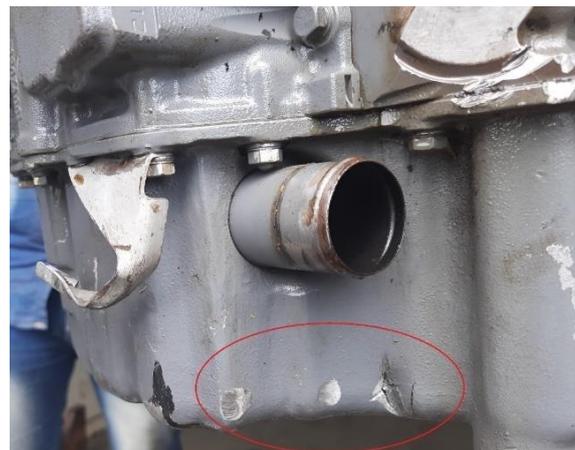
- c. Bottom surface of oil sump near drain point was found bent & cracked. Right side of sump wall had deep dent & found cracked. All four carburetor attaching stud were found sheared off.

Figure: 2 Oil sump

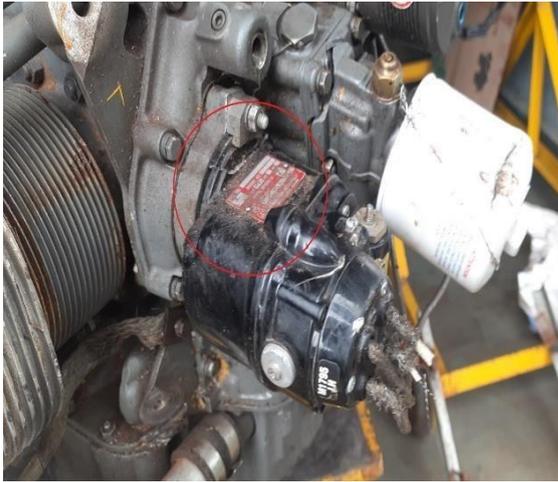
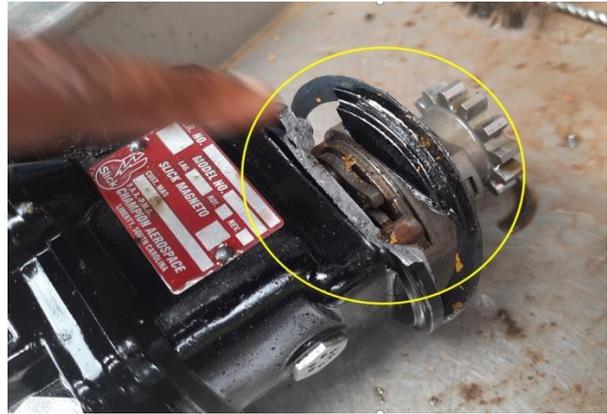
- f. Magneto (LH) were found installed on engine with cracked mounting flange.
- g. Vacuum pump inlet & outlet bend fitting was found sheared off.
- h. Ignition lead was found broken & damaged.

Magneto-Functional test has confirmed that both magnetos were working satisfactorily, however, flanges were broken.

Figure: 3 Magneto (LH)

Figure: 9 Magneto (LH)

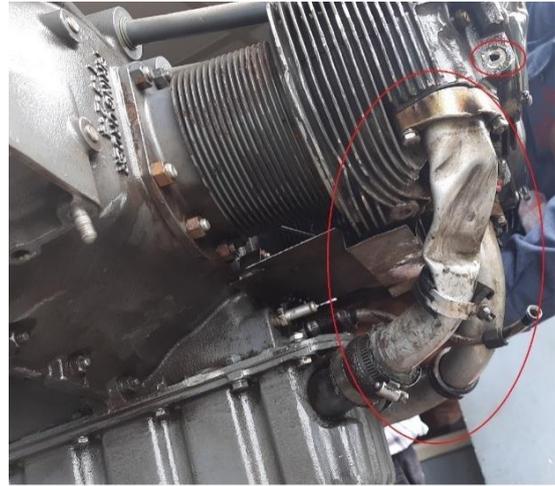
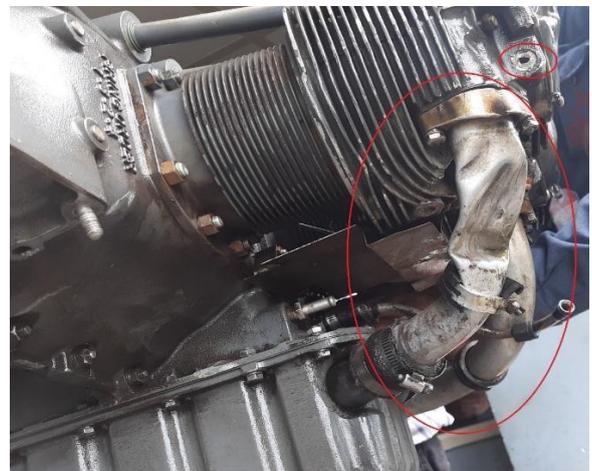
- k. Induction tube of cylinder no.1,2 & 4 were found damaged & bent whereas Induction tube of cylinder no.3 was found missing.
- l. Oil return line from Rocker Box of cylinder no.2 & 3 to crankcase was found with dent & broken at their elbow.

Figure: 4 Induction tube (Cylinder 2 & 4) and sheared rocker box oil elbow.

Figure: 7 Induction tube (Cylinder 2 & 4) and sheared rocker box oil elbow

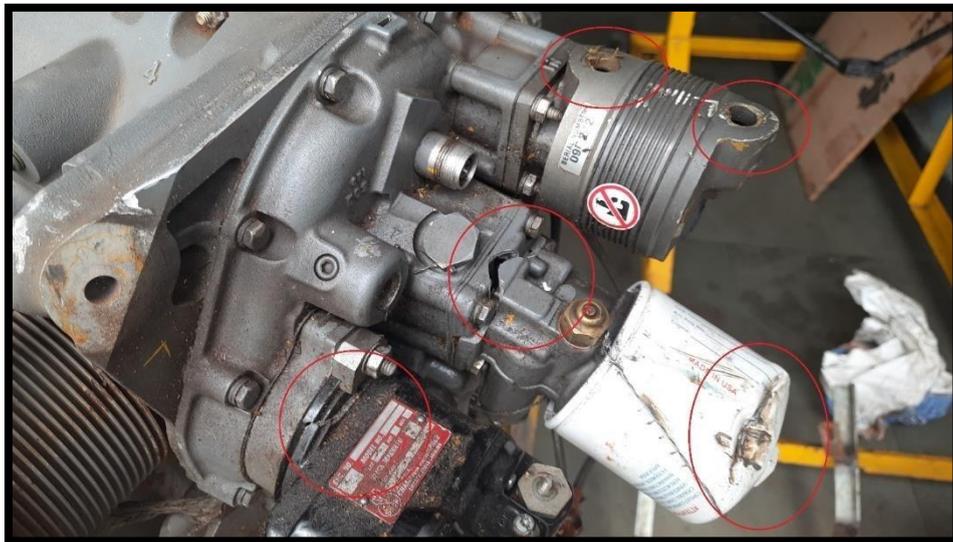
- 1) Both magneto flanges were found broken.
- 2) Oil filter adopter was found cracked.
- 3) Vacuum pump inlet and outlet vents were sheared off.
- 4) Elbow of oil transfer hose was found broken.

Oil Filter & its Adapter-Filter element of oil filter was removed, inspected and no metal particles, debris or any objectionable particles were found into oil filter. Hence, it confirms that there was no internal engine component (partial or full) failure and engine was operational.

Figure: 5 Magneto (LH), Oil filter adapter, oil filter & Vacuum pump.

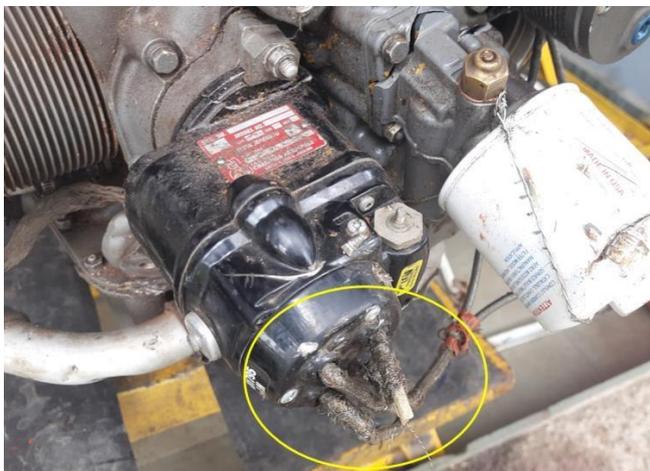
- m. Ignition harness leads were found broken & top spark plug of cylinder no.1 & Bottom spark plug of cylinder no. 2 found broken. Bottom spark plug of cylinder no.3 & 4 were found bent.

Figure: 6 Ignition leads

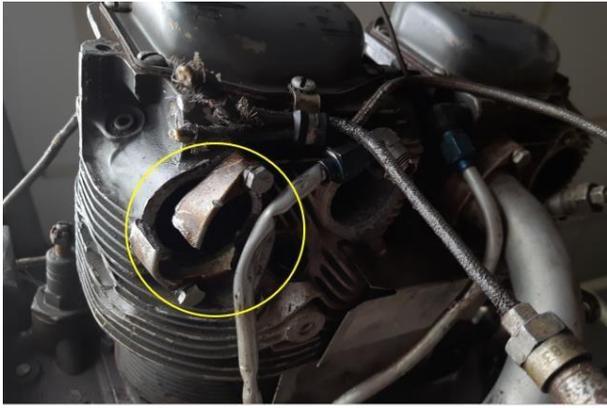
Figure: 8 Induction tube (Cylinder no. 1) and broken mounting flange with missing tube

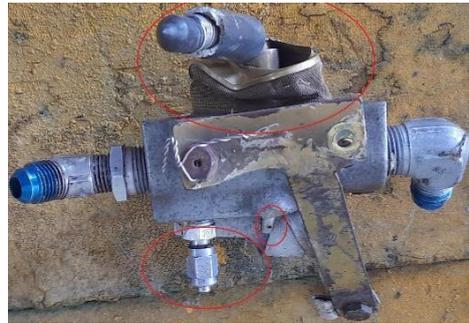
- a. Fuel filter assembly was found badly damaged, broken, crushed.
- b. Fuel supply hose to carburetor was found satisfactory.
- c. Carburetor & assembly were found broken in to pieces & crushed.

Figure: 11 Fuel filter assembly

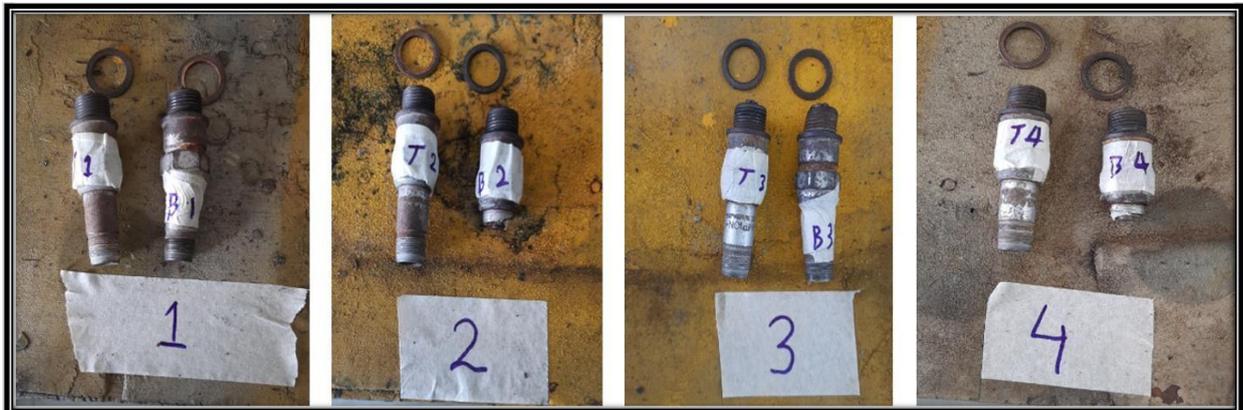
Figure: 12 Spark plugs

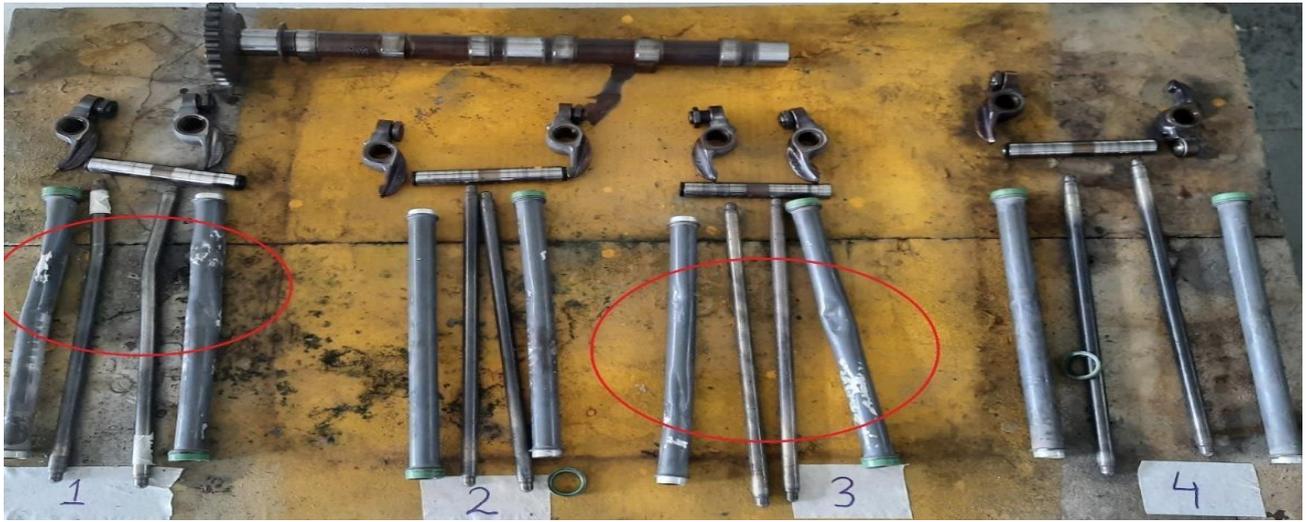
Pushrods & shrouds of cylinder no.1 & 3 were found bent & damaged due to external impact.

Figure: 13 Push rod, shroud, rocker arm, rocker pin & camshaft

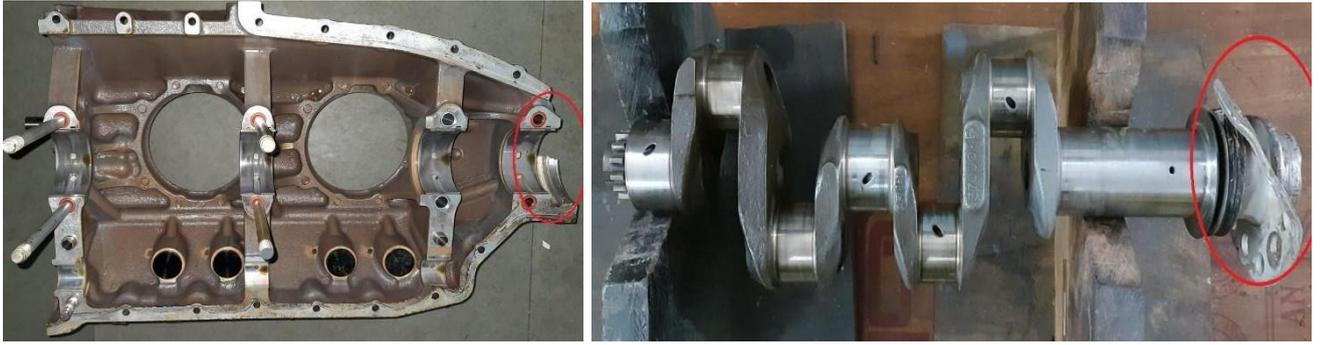
Figure 16: Crankcase and crankshaft
