**FINAL INVESTIGATION REPORT ON**  
**ACCIDENT TO**  
**M/S INDIGO AIRBUS A320 AIRCRAFT**  
**VT-IJT AT COCHIN**  
**ON 14<sup>th</sup> JUNE 2020**

**AIRCRAFT ACCIDENT INVESTIGATION BUREAU**  
**MINISTRY OF CIVIL AVIATION**  
**GOVERNMENT OF INDIA**

**FINAL INVESTIGATION REPORT ON ACCIDENT TO M/S INDIGO,**  
**AIRBUS A320 (NEO) AIRCRAFT VT-IJT ENROUTE TO**  
**COCHIN INTERNATIONAL AIRPORT ON 14<sup>th</sup> JUNE 2020**

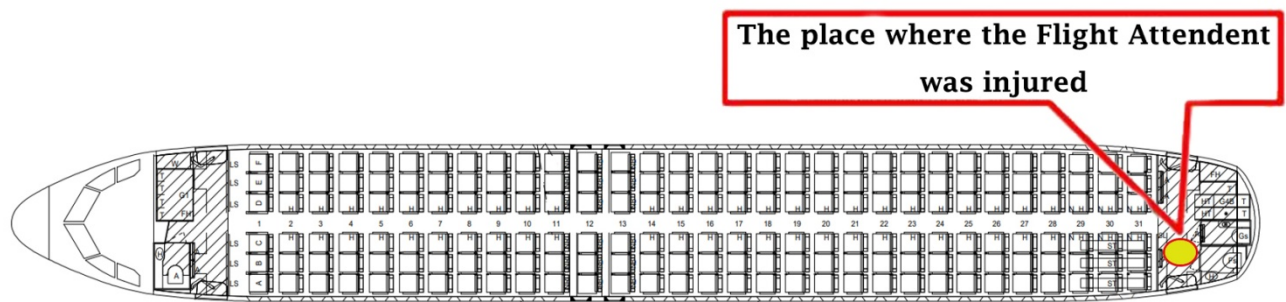
**Figure - 1: The place where the Flight Attendant was injured**

After a while, as per PIC, when aircraft was passing FL125, cockpit crew received a call from CCIC that L2 cabin crew had fallen down near the lavatory. Further, as per the L2 Cabin Crew statement, lavatory 'F' door was not properly latched / closed during the descend. L2 cabin crew got up from the jump seat to close the door as the seat belt signs were OFF. At that very moment, turbulence was felt and the cabin crew fell down on the floor near R2 door. The cabin crew could not get up immediately, however with the help of crew member positioned at R2, the injured cabin crew managed to sit on the jump seat. As the aircraft was already in descent mode, the injured crew was secured on the jump seat (L2) for landing with the help of CCIC and cabin crew R2. Aircraft landed safely at Cochin airport at 14:40:19 UTC. Upon PIC instructions, all the doors were disarmed initially by respective cabin crew before they were opened. L2 door was opened by the injured cabin crew.

After de-boarding the aircraft, injured cabin crew after administering initial medical assistance at Airport, was later shifted to a medical facility where X-Ray report confirmed that left leg has fractured in the accident.

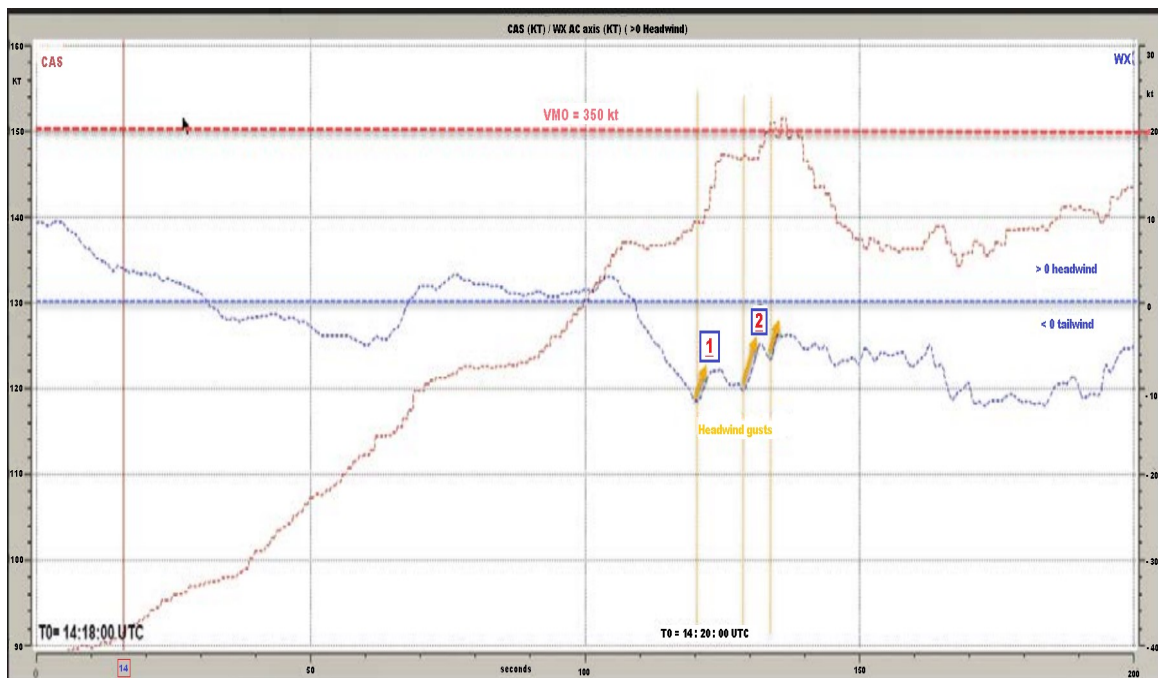
Fig-12: Longitudinal Wind Computation

- (a) On the aircraft longitudinal axis, a 4 knot headwind gust was observed at 14:20:00 UTC while aircraft was pitching up and thrust was decreasing towards to IDLE. These headwind gust was the cause of transient CAS excursion towards  $V_{MAX}$  speed around one second later.
- (b) Other 6 knot and 3 knot headwind gusts were observed at 14:20:09 UTC while aircraft was pitching up (or neutral) and thrust was still decreasing towards IDLE. These headwind gusts was the cause of CAS excursions beyond  $V_{MAX}$  speed ( $V_{MAX}+2$  knot) for one second.
- (c) No large downdraft/updraft wind gusts observed on the vertical axis.

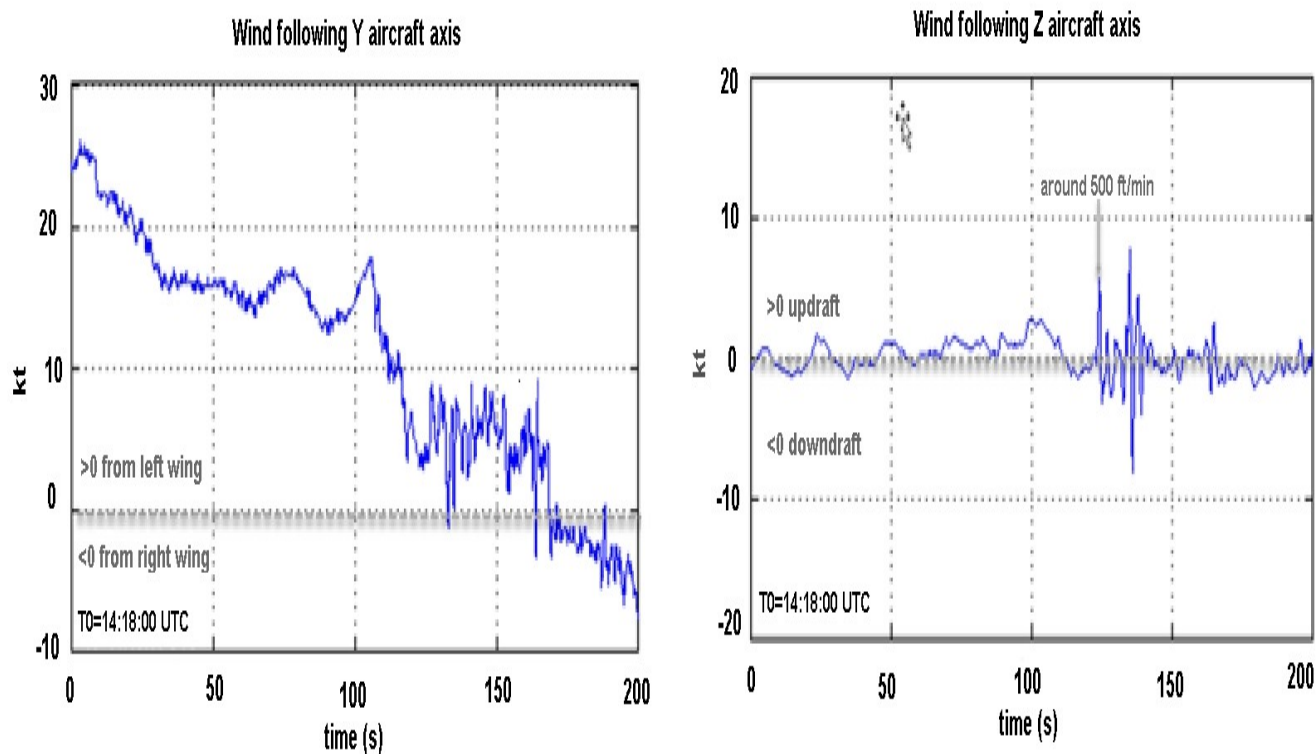
**Fig-13: Lateral and vertical Wind Computation**

(a) ***Wind Reconstruction:*** Analysis of QAR data, no large downdraft/updraft wind gusts were observed on the vertical axis.

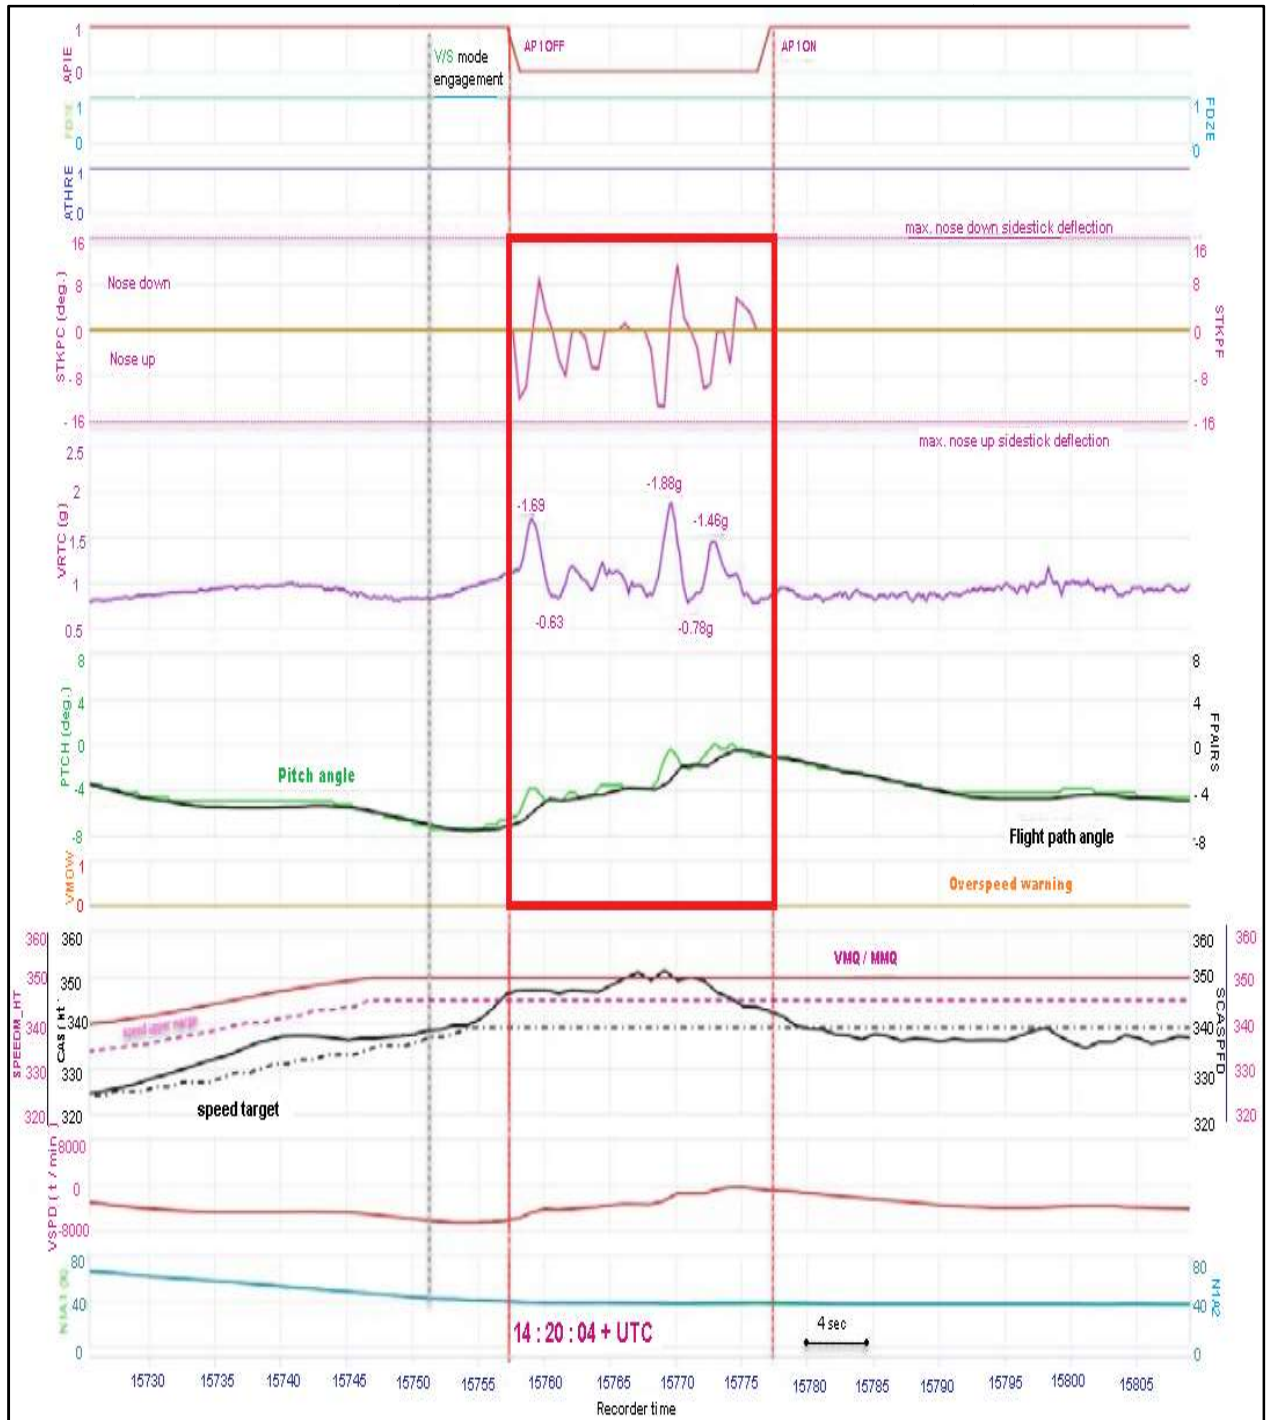
**Fig - 14: Longitudinal & Vertical Axis Plot - Summary**

(f) Between 14:20:05 UTC and 14:20:11 UTC, CAS was stable at around 347 knots (3 knot below VMAX and 8 knots above target speed). Two nose up side stick inputs of -8° (max) were applied. Further, at 14:20:17, another nose up side stick input (63% side stick deflection) was applied up to that led load factor to increase up to 1.46g. The second nose up side stick input was performed when CAS increased momentarily by 2 knot (max) beyond VMAX. No overspeed warning was triggered since the threshold of the ECAM overspeed warning had not been reached. The manual high speed protection had no or a very limited impact on the pitch axis command considering the limited short CAS excursion beyond VMAX. The speed trend arrow reached transiently VMAX+12 knot, inside the VMAX red strip.

(g) During the whole sequence of manual flying which lasted 18 sec, the aircraft response was consistent with the side stick inputs on pitch and lateral axis applied on CAPT (LHS) side. The 2 largest variations of vertical load factor +1.78g/+0.83g and +1.88g/+0.78g were mainly the result of the application of nose up/nose down side stick inputs (Two side stick deflection on pitch axis to 75% (up) / 56% (down) and 84% (up) / 69% (down) maximum). With thrust already close to IDLE, the 2 nose up side stick inputs on pitch axis were applied to contain 2 transient speed excursions towards or beyond VMO (VMO+2 kt) with the speed trend arrow reaching values beyond VMO, inside the VMAX red strip.

(h) The ECAM over speed warning did not triggered since speed excursion stayed below the activation threshold. The 2 transient speed excursions were caused by head wind gust combined with a -7.5° and - 4° descent flight path angle. The speed brakes have not been used.
