FINAL INVESTIGATION REPORT ON ACCIDENT TO
DIRECTORATE OF AVIATION,
GOVERNMENT OF MADHYA PRADESH (DoA, GoMP)
SKA B200GT AIRCRAFT VT-MPQ
AT GWALIOR AIRPORT ON 06.05.2021

INVESTIGATION TEAM VT-MPQ

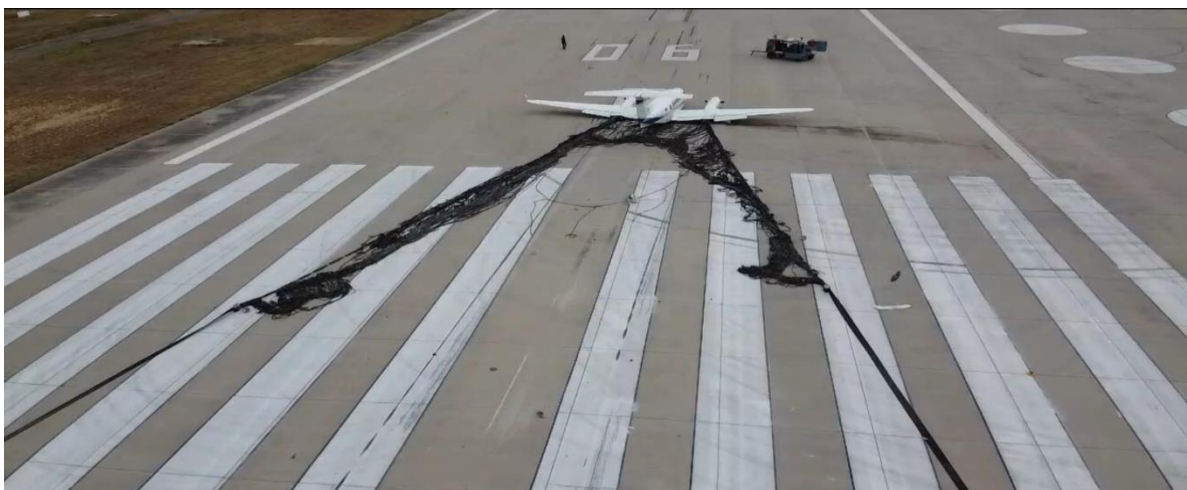
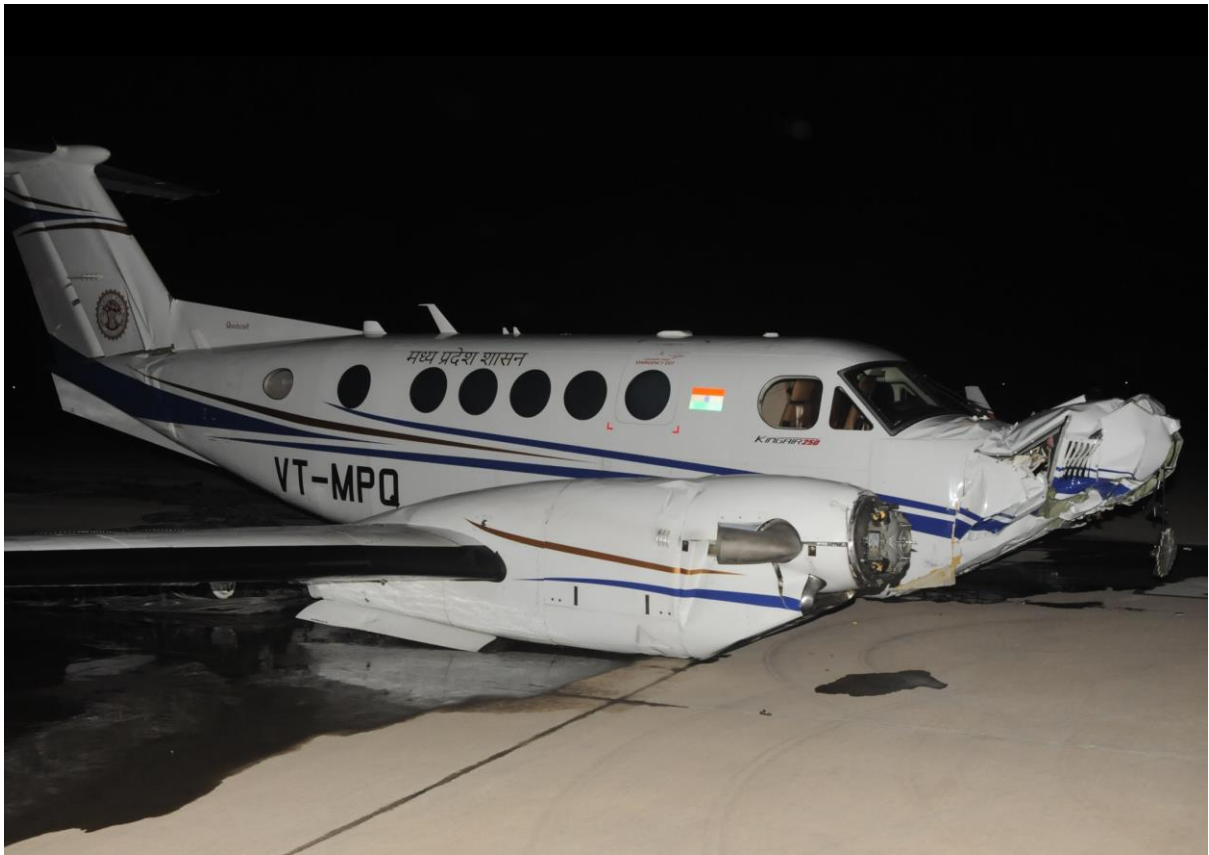
At 15ft Above Ground Level (AGL), the aircraft main landing gear collided with the raised Arrestor Barrier, which was installed at 240 ft before the landing threshold of RWY 06R. The aircraft came to a halt on the centreline just beyond the threshold markings of RWY 06R.

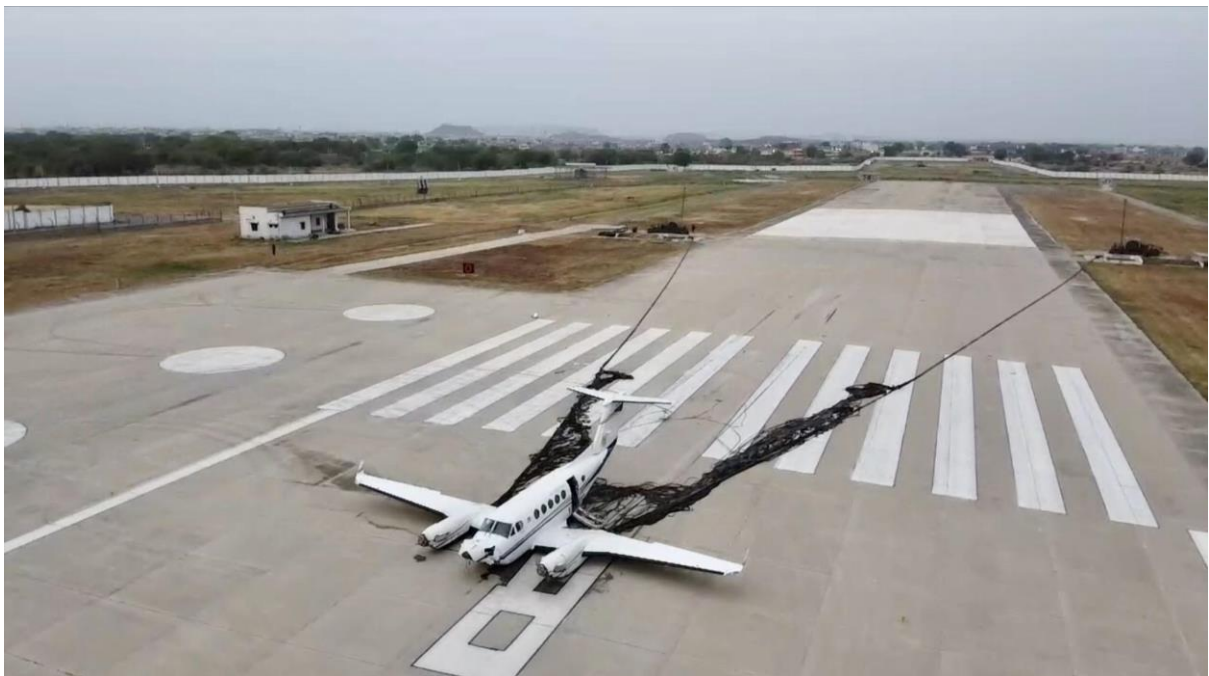
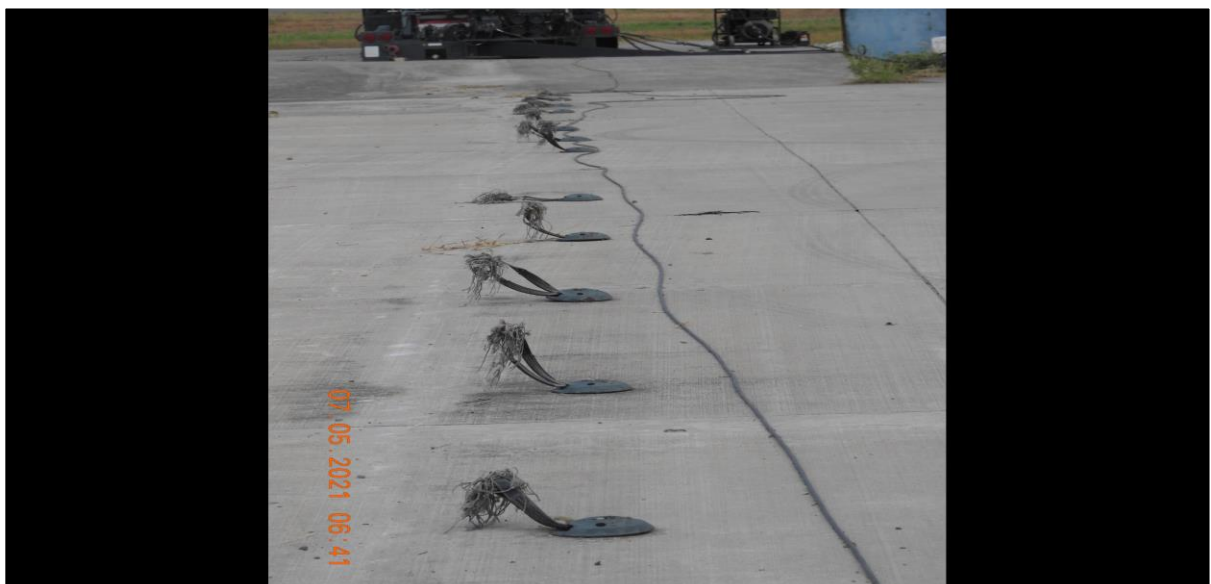
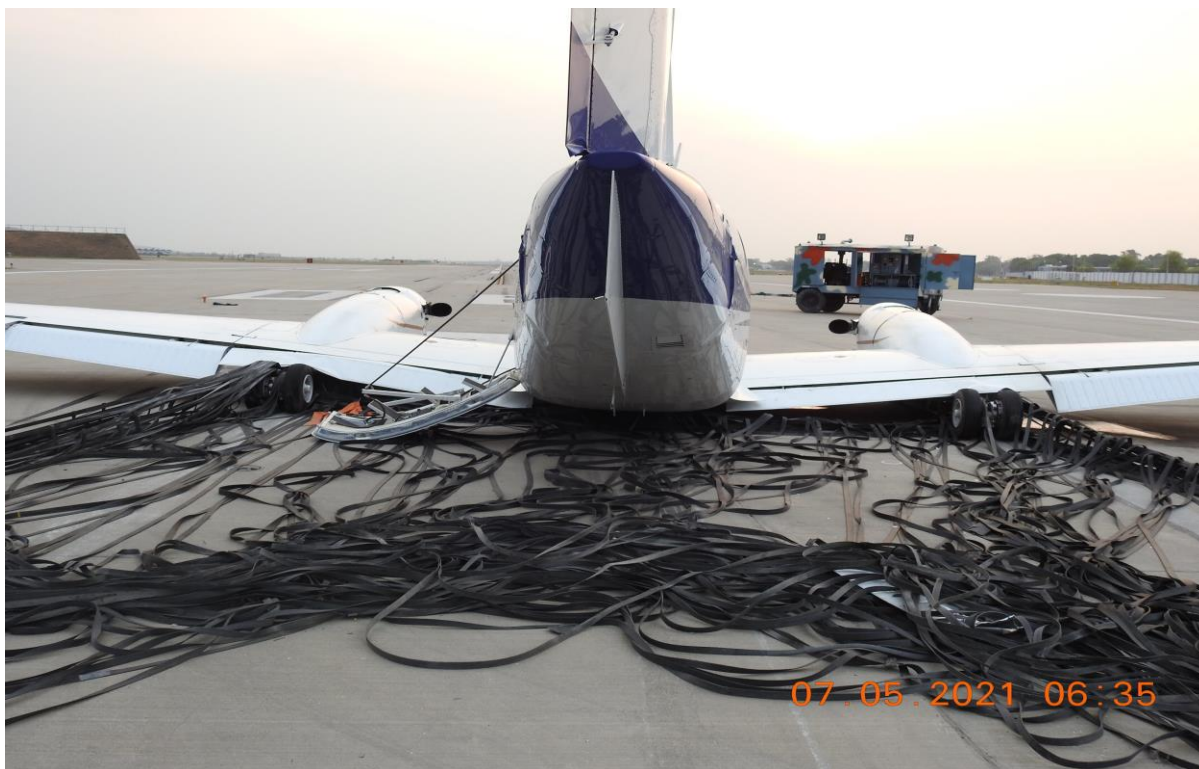
The raised Arrestor Barrier which is located 240 ft before the threshold of RWY 06R was substantially damaged and broke away from the assembly as it remained entangled with the main landing gear of the accident Aircraft.

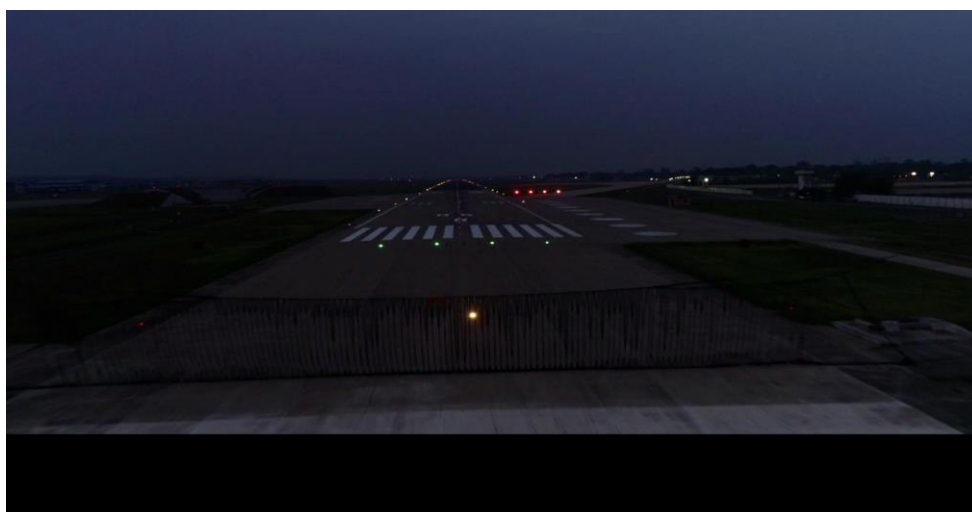
Arrester Barrier (AB): Arrester Barrier is installed at Defence airports where high performance aircraft are operating. The Arrester Barrier as the name suggests is a device which ensures that on landing if the aircraft overruns the runway or during take-off if the take-off is rejected and the aircraft is unable to stop on the runway, the arrester barrier stops the aircraft. By doing so the aircraft is not badly damaged or destroyed. AB is all along the width of the runway when raised and up to a height of 15 feet AGL (approx.). In general, the AB poles on the runway edge are at a height of “28 feet”. Arrester Barrier is only used for IAF high performance aircraft. At Gwalior base the Arrester Barrier Position Indicator lights” was not serviceable for a while in control tower.

Figure 10: Actual Photo of the Arrester Barrier at Gwalior (VIGR) at dusk.

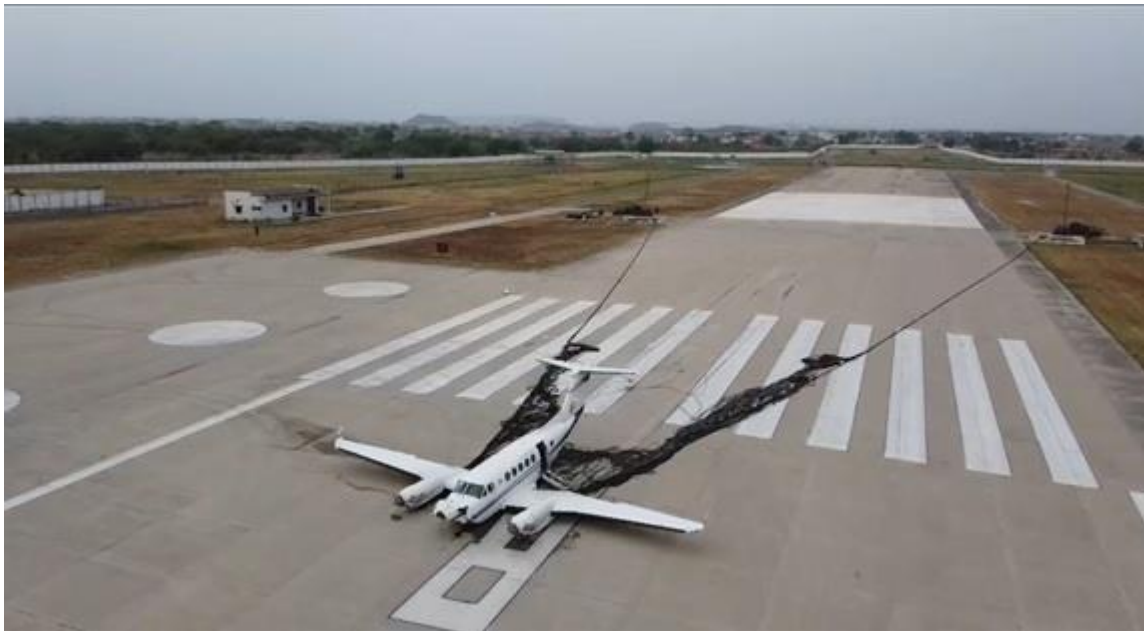
The aircraft wreckage was confined to RWY 06R just beyond the threshold markings on the centreline of the runway and short of the Runway designator.

Figure 15: Location of the Aircraft on the Runway

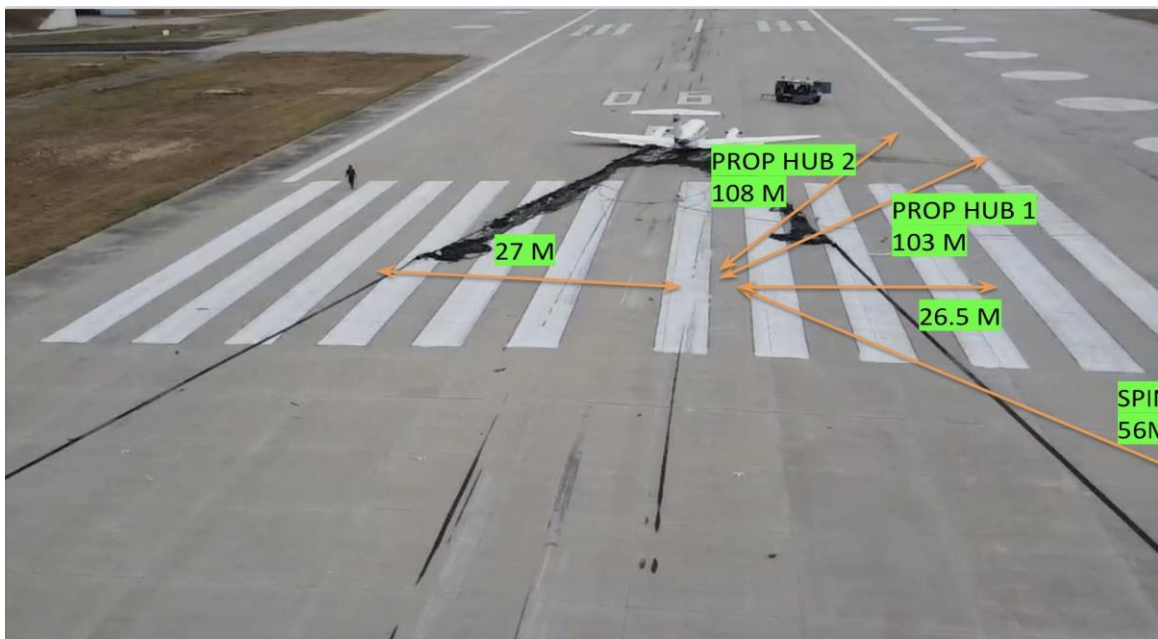
All the aircraft parts were accounted for and were contained within a small area around the aircraft's final resting place.

Figure 16: Location of Aircraft parts on the Runway

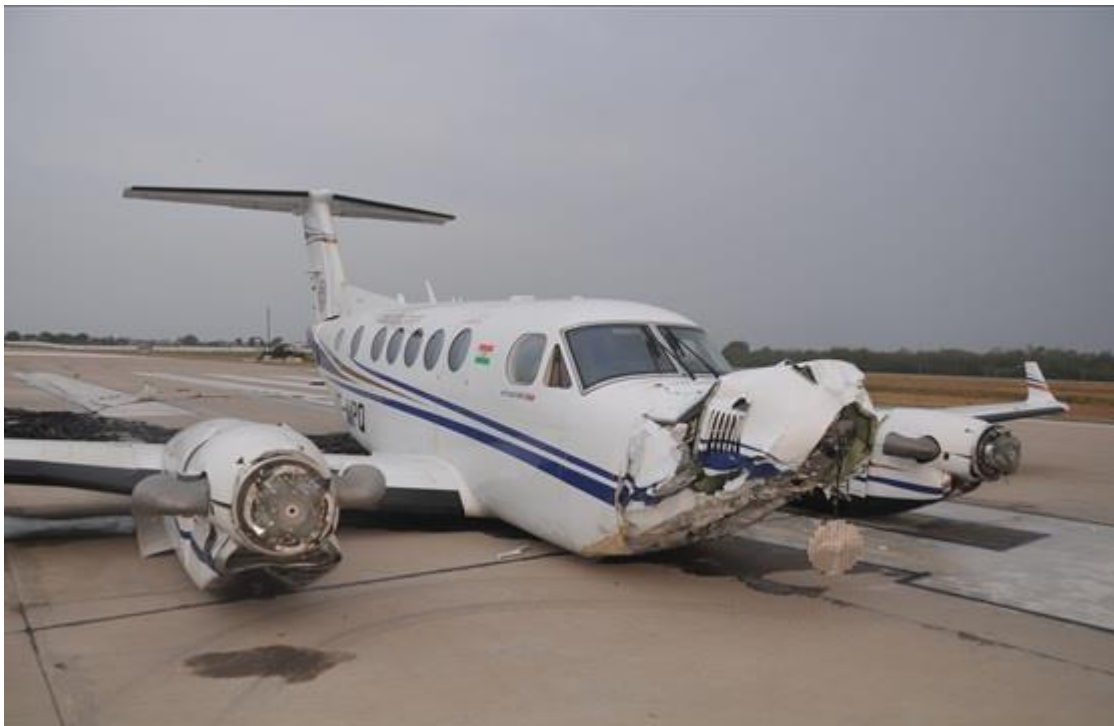
Figure 18: Damaged aircraft

The aircraft sustained significant multiple impact damage to the Nose, all landing gears, forward fuselage skin, both wings, both power plant and its cowling and nacelle structures, both flaps, dorsal fin, vertical stabilizer, rudder and empennage.

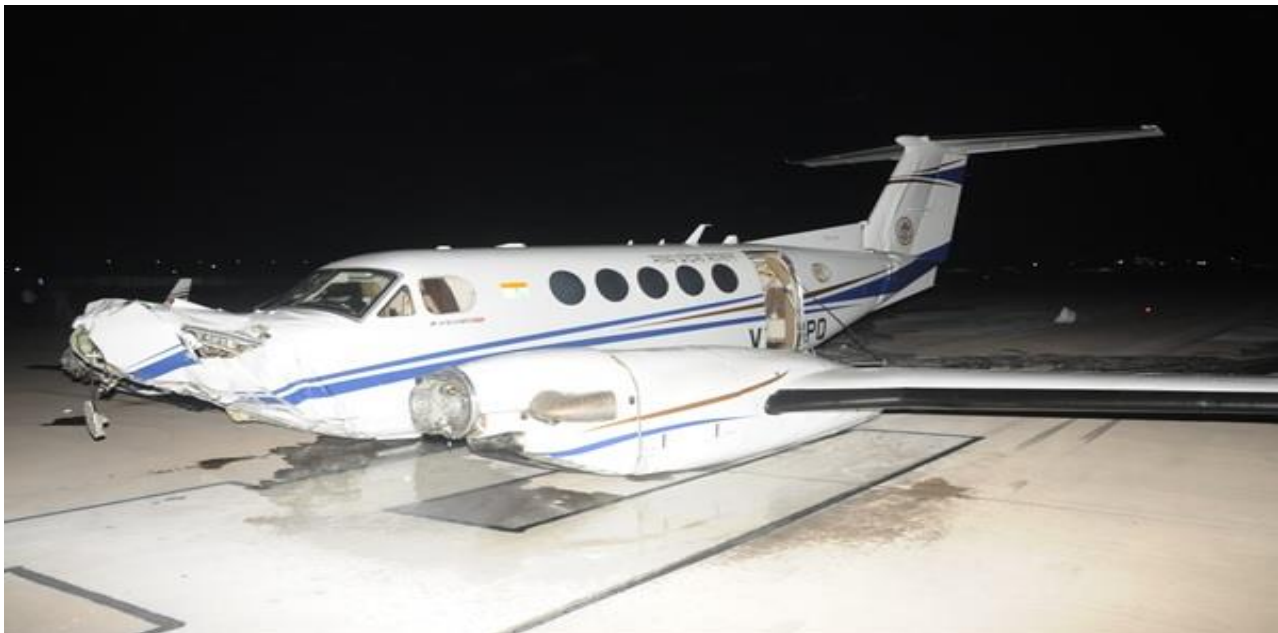
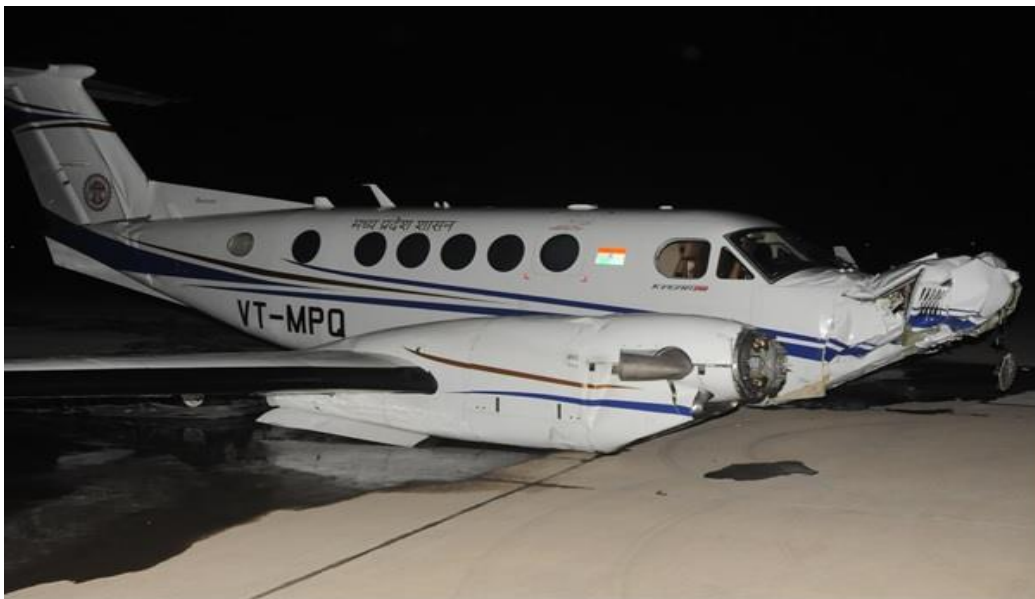
1.14.1 Photographic evidence shows that there was a severe fuel leak post the accident, but no fire was reported or any evidence of fire observed.

Figure 19: Fuel Leakage

Figure 20: Fuel Leakage

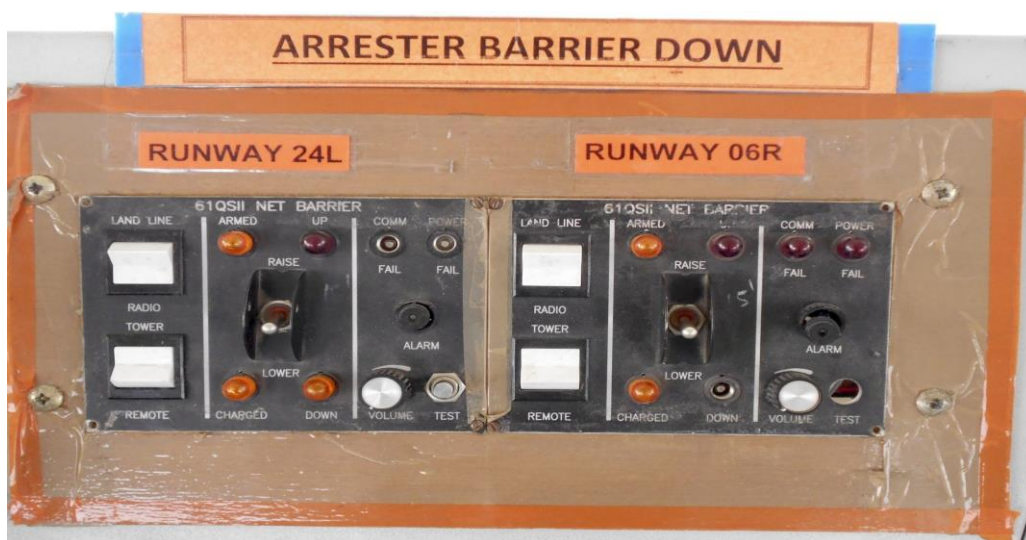
As the Station ATC staff were aware of the AB Position Indicator and Panel lights being unserviceable, the alternate procedure was that the "Arrestor Barrier Party" will cross-check the position of the AB physically provided the AB Party was notified about the change in runway.

Figure 25: Arrestor Barrier Panel
