FINAL INVESTIGATION REPORT ON ACCIDENT TO
DIRECTORATE OF AVIATION,
GOVERNMENT OF MADHYA PRADESH (DoA, GoMP)
SKA B200GT AIRCRAFT VT-MPQ
AT GWALIOR AIRPORT ON 06.05.2021

INVESTIGATION TEAM VT-MPQ

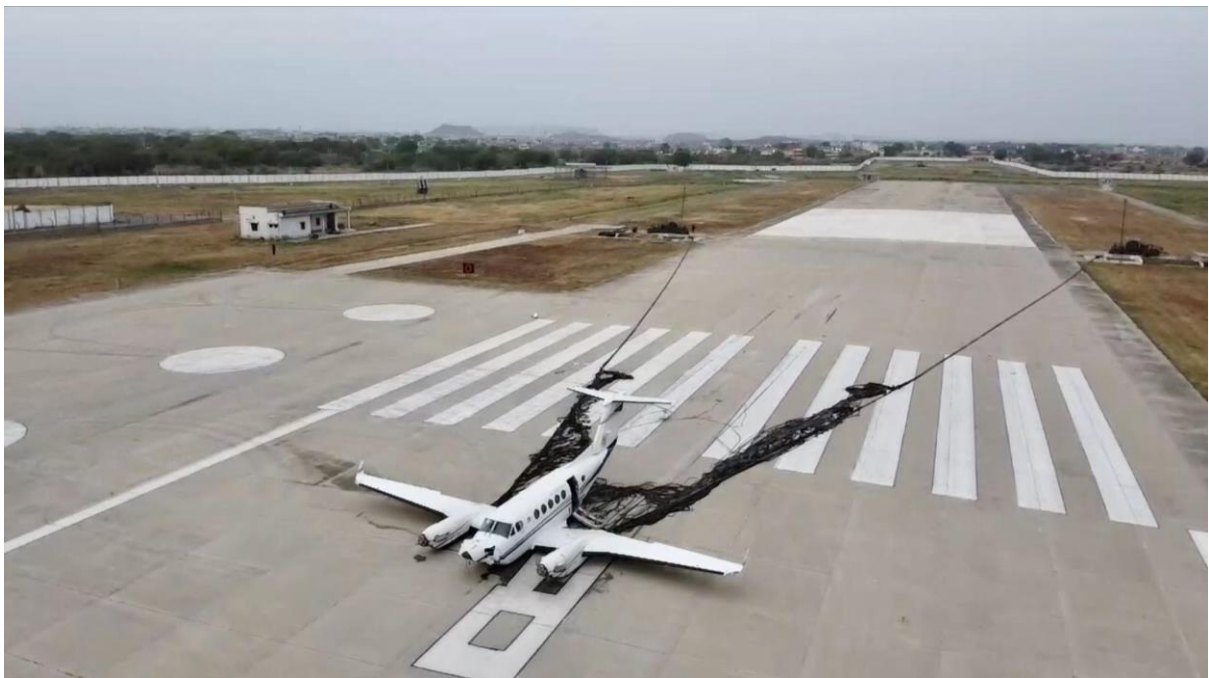
Figure: 03

The raised Arrestor Barrier which is located 240 ft before the threshold of RWY 06R was substantially damaged and broke away from the assembly as it remained entangled with the main landing gear of the accident Aircraft.

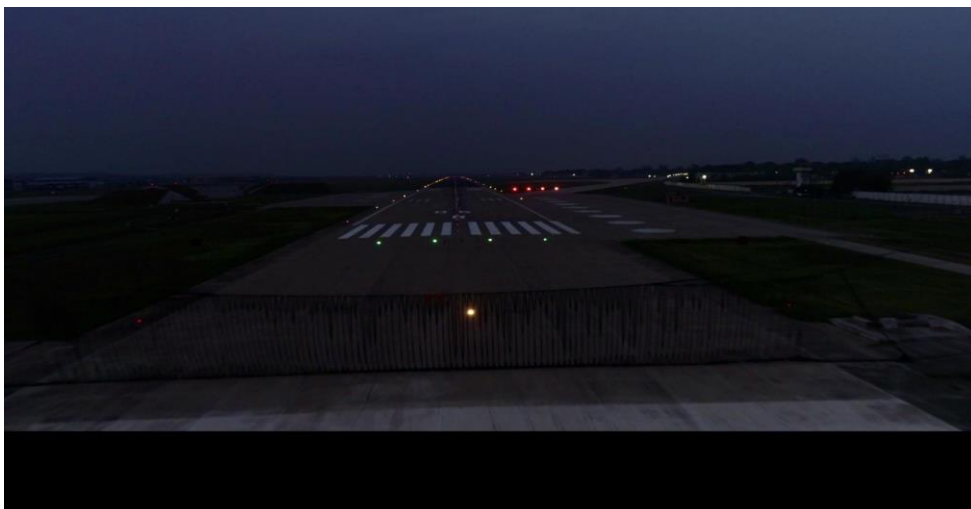
Arrester Barrier (AB): Arrester Barrier is installed at Defence airports where high performance aircraft are operating. The Arrester Barrier as the name suggests is a device which ensures that on landing if the aircraft overruns the runway or during take-off if the take-off is rejected and the aircraft is unable to stop on the runway, the arrester barrier stops the aircraft. By doing so the aircraft is not badly damaged or destroyed. AB is all along the width of the runway when raised and up to a height of 15 feet AGL (approx.). In general, the AB poles on the runway edge are at a height of “28 feet”. Arrester Barrier is only used for IAF high performance aircraft. At Gwalior base the Arrester Barrier Position Indicator lights” was not serviceable for a while in control tower.

Figure 10: Actual Photo of the Arrester Barrier at Gwalior (VIGR) at dusk.

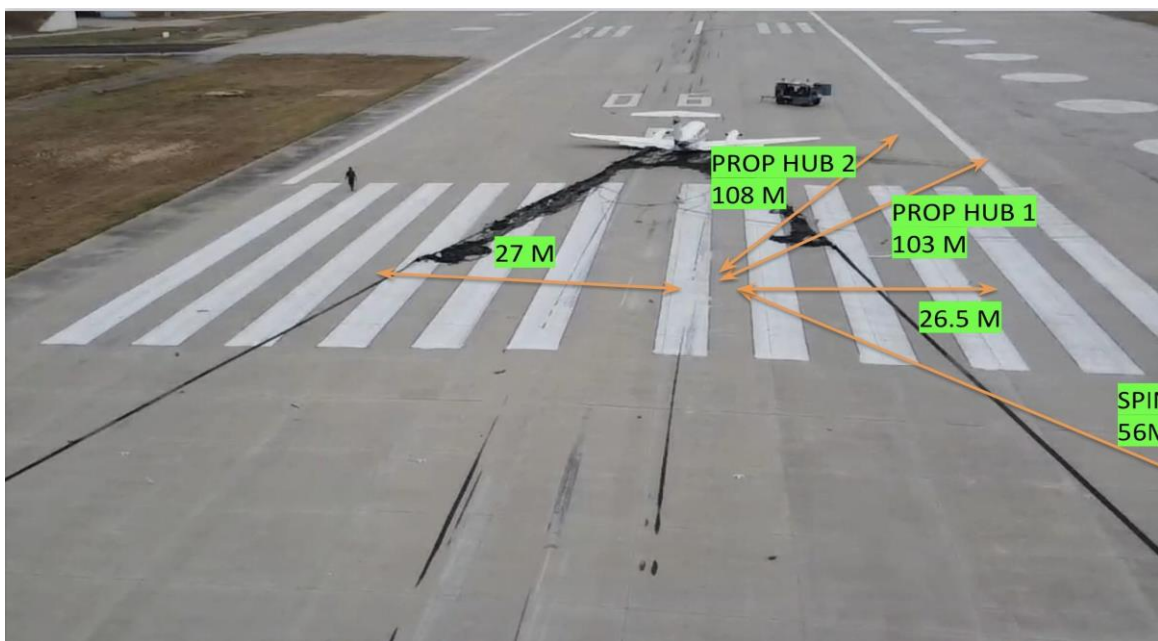
All the aircraft parts were accounted for and were contained within a small area around the aircraft's final resting place.

Figure 16: Location of Aircraft parts on the Runway

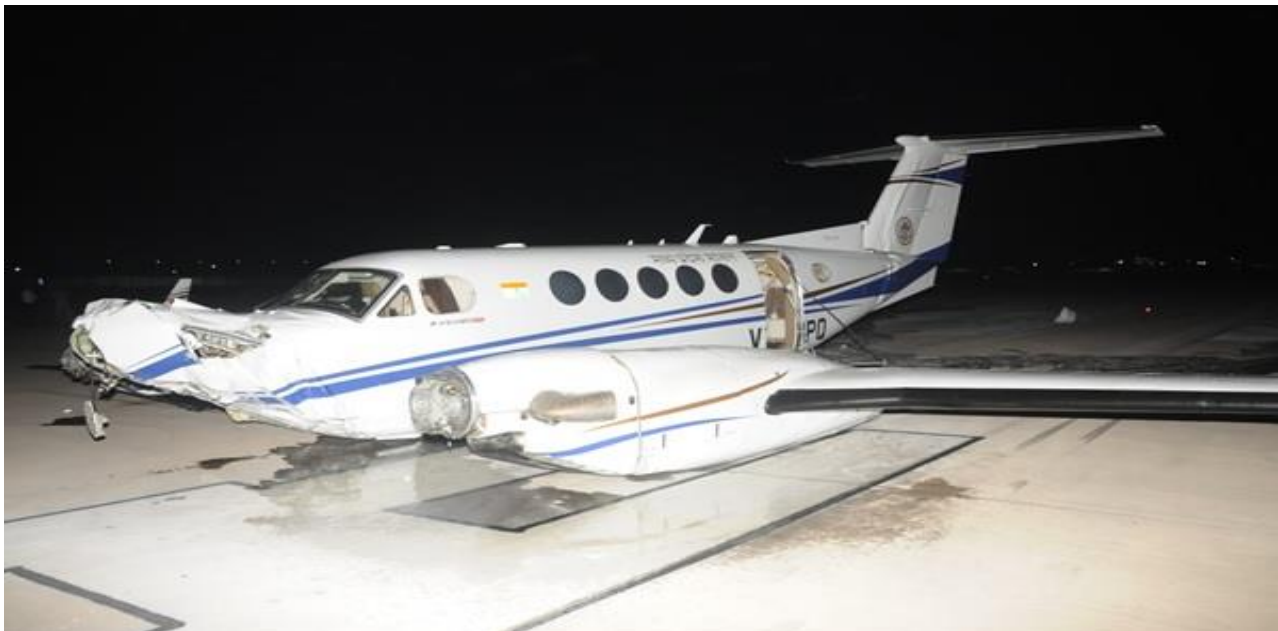
1.14.1 Photographic evidence shows that there was a severe fuel leak post the accident, but no fire was reported or any evidence of fire observed.

Figure 19: Fuel Leakage

Figure 20: Fuel Leakage

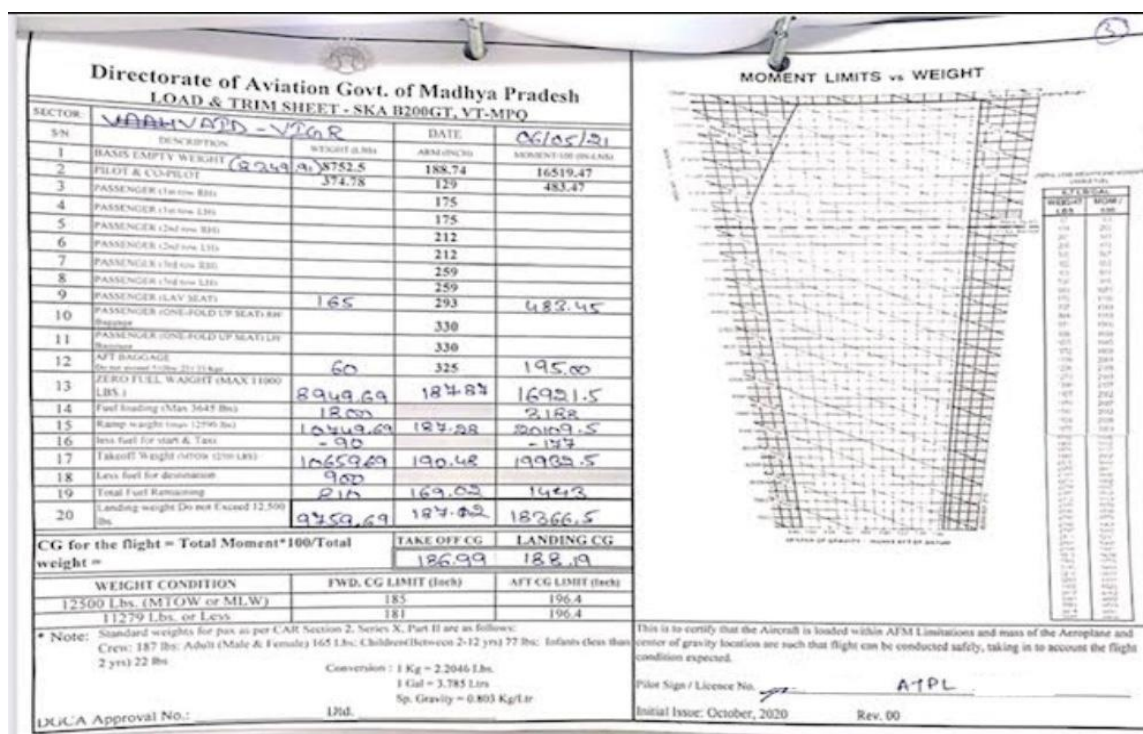
Investigation team was informed by the Continuing Airworthiness and Maintenance Officer (CAMO) that post the aircraft seats were removed, the CAMO was not informed about the removal of the seats and hence the DGCA office could not be informed about the same and no revised approval obtained from the DGCA office. CAMO only got to know about the removal of seats post the accident. Therefore, not seeking a revised approval is not in compliance of DGCA CAR Section 2, Series X, Part II “Weight & Balance Control” (Para 4.3).

Figure 32: VT – MPQ Load and Trim Sheet – Sector (Indore to Gwalior) on 06/05/2021
