**Final Investigation Report**  
**on**  
**Accident to M/s InterGlobe Aviation Limited**  
**Aircraft ATR-72-600, VT- IYX**  
**on 14 June 2021**

**Aircraft and Accident details of ATR 72 Aircraft VT- IYX  
on 14<sup>th</sup> June 2021**

On 14 June 2021, M/s InterGlobe Aviation Limited's ATR72-600 aircraft, VT IYX, while operating a scheduled flight from Kannur to Hubli, met with an accident during landing at Hubli airport.

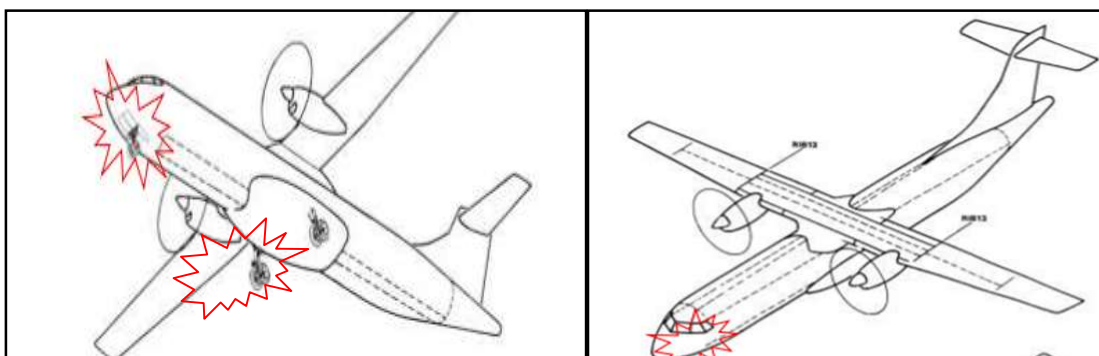
The Aircraft sustained substantial damage during the accident. Maximum damage was confined to the aircraft’s forward section skin and frames. NLG and RH MLG had also suffered severe damages.

Figure 1: Damage to the aircraft

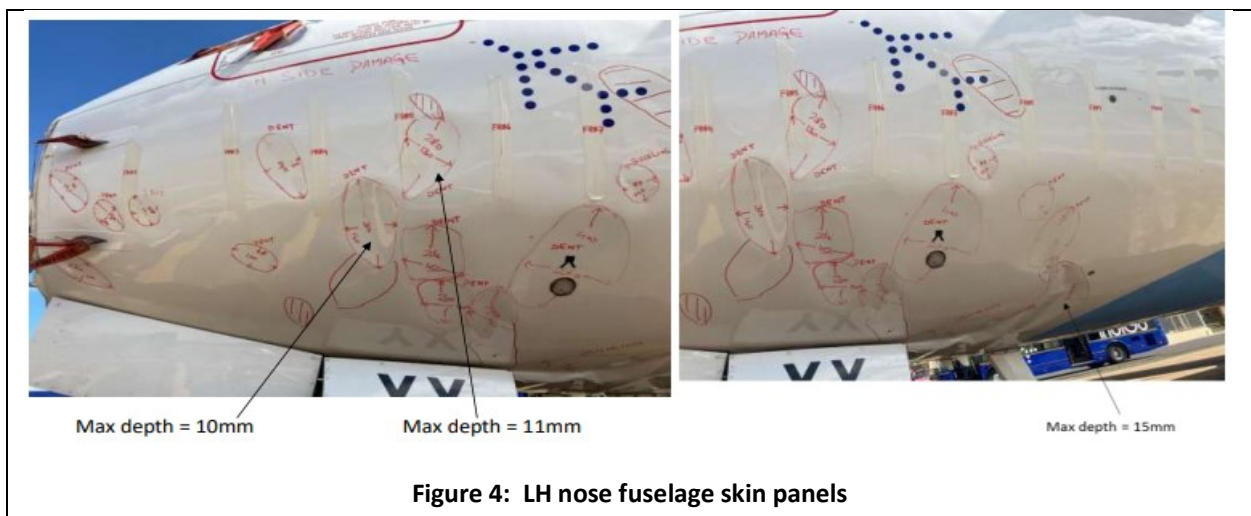
1. Skin Panel: The lower lobe panel junctions are located at stringer 11 and Frame 13. Lower lobe FWD and AFT panels were found damaged on both RH and LH sides. The damage found were dents and buckling of the skin panels. The damaged areas are located between FR1 and FR10. The maximum depths are 15mm on LH side and 20mm on the RH side. On lower area, aft of Fr7, the maximum measured deformation is 30mm (refer to below figures).
2. Cockpit: A gap was observed between the 11VU and pedestal showing evidence of movement that occurred in the cockpit.
3. Side panels of 8VU structures were found bent on both sides.
4. Side linings 211AZ and 212AZ were also found bent in their lower corners.
5. One LH cockpit floor panel 211EF was also found damaged at level of attachment holes.

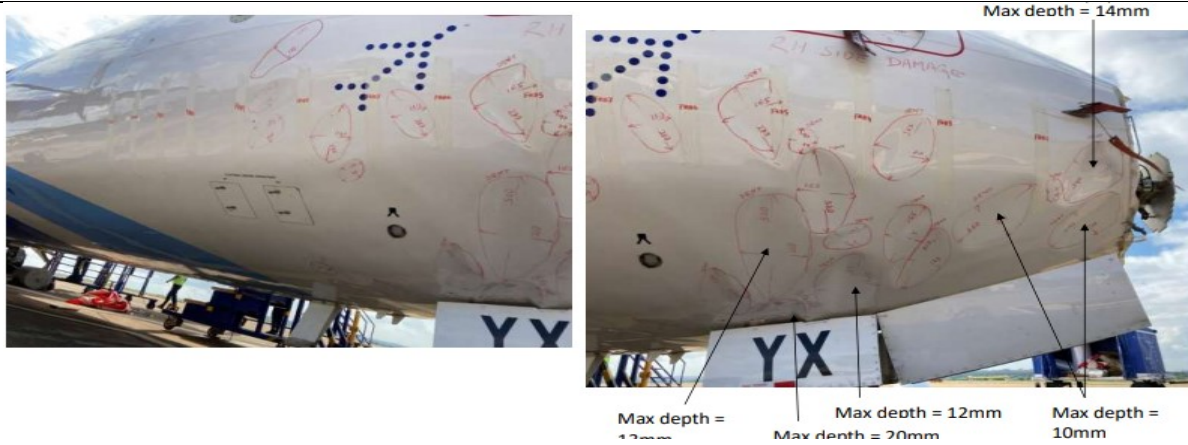
Figure 5: RH nose fuselage skin panels

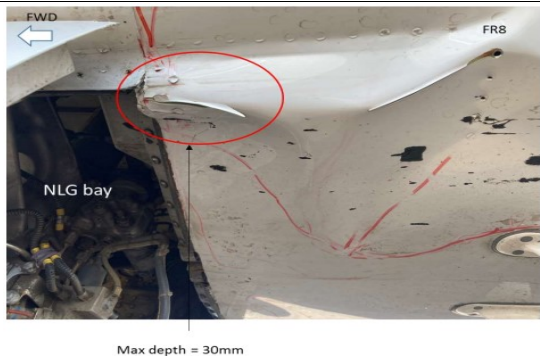
Figure 6: Lower nose fuselage skin panel (AFT of Frame 7)

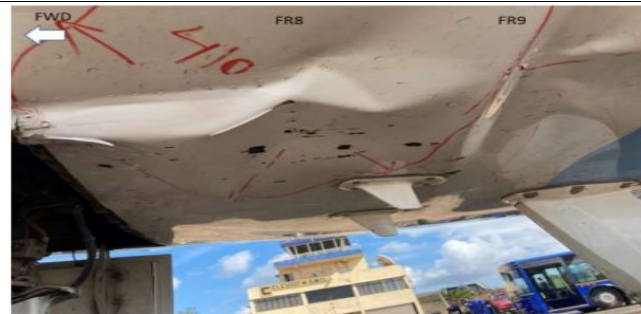
Figure 7: Lower nose fuselage skin panel (AFT of Fr 7)

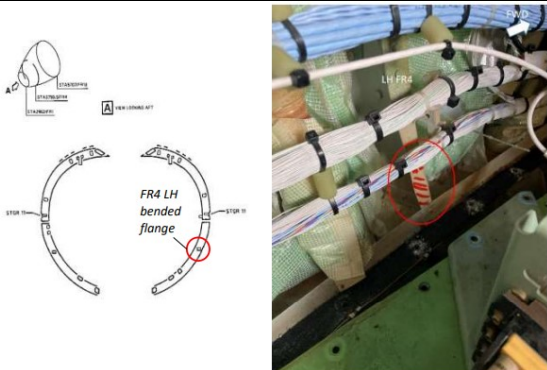
Figure 8: LH Frame 4

6. Frames: Damages were found on frames between Frame 4 and Frame 9. The damage found were deformations, cracks, bent flange. The most damaged frames found were the frames 6 and 7. On below figures, location and type of damage are detailed for each frame.

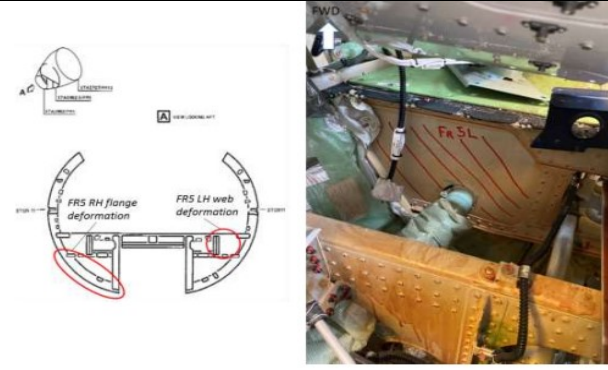
Figure 9: LH Frame 5

7. On the RH side, Frame 5 lower flange was found deformed, following high skin deformation in this area.
8. Other internal structures: LH inner chord, LH stringer 20 and RH intercostal were also found bent.

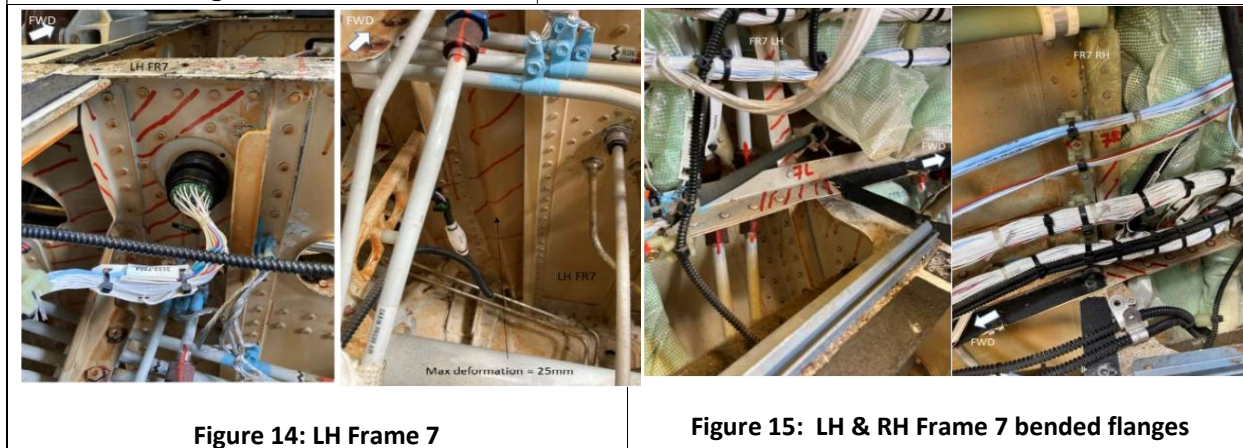
Figure 14: LH Frame 7

Figure 15: LH & RH Frame 7 bended flanges

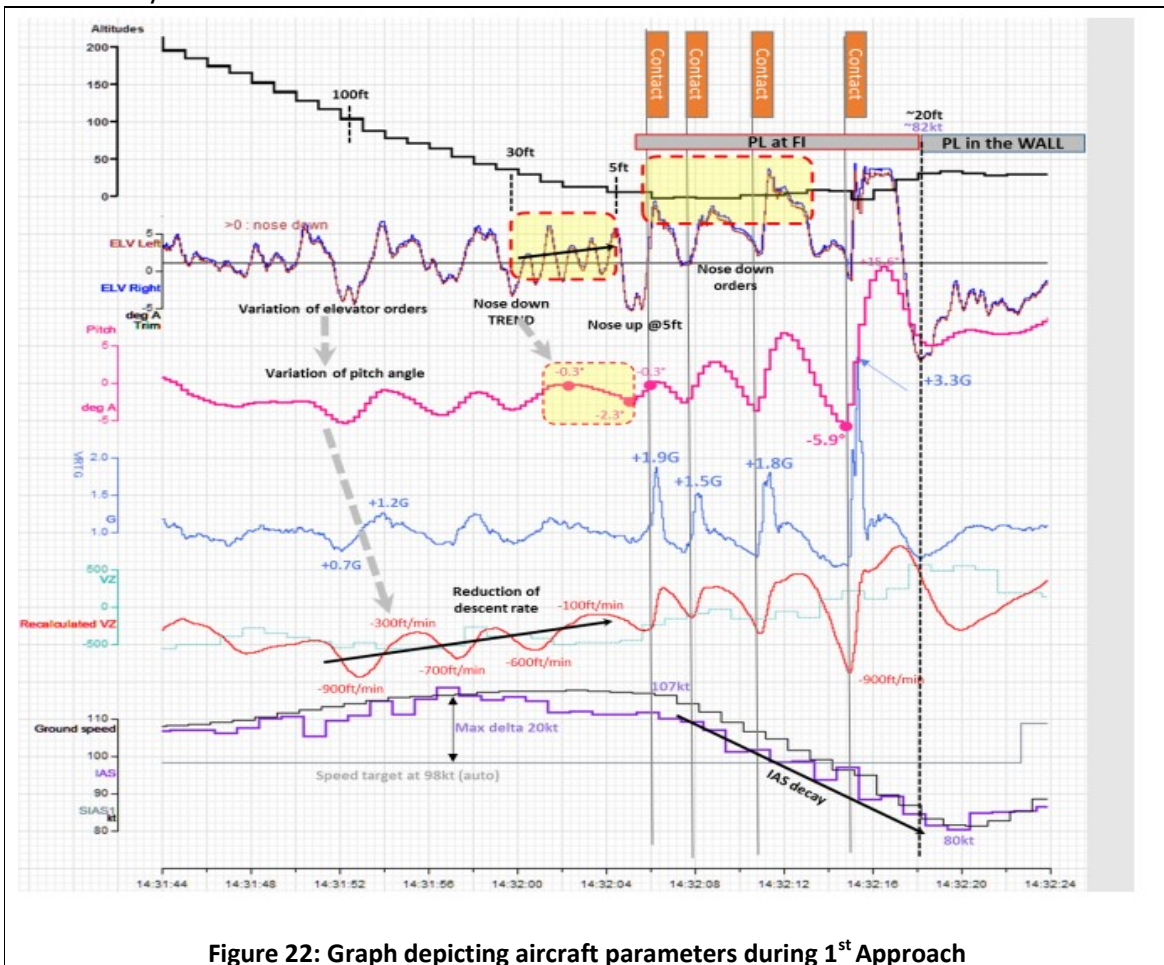
The third touchdown also occurred on nose landing gear first with  $-3.7^\circ$  of pitch angle, a VRTG +1.8 G and again elevators nose down order. A “Go-Around” call given by the PM was disagreed by PF. This further clarifies that PF was not committed to initiate a “Go-Around”. Aircraft encountered another bounce.

The fourth touchdown occurred. The aircraft touched down on nose landing gear first a third time. This time pitch angle was  $-5.9^\circ$ , a 3.3 G vertical and 0.4 G lateral. Then a dual input registered in the DFDR indicates PM took the control to initiate a much awaited “Go-Around”. However, the dual inputs were mainly in the same direction. This time aircraft bounced and “Go-Around” was initiated simultaneously.

Figure 22: Graph depicting aircraft parameters during 1<sup>st</sup> Approach

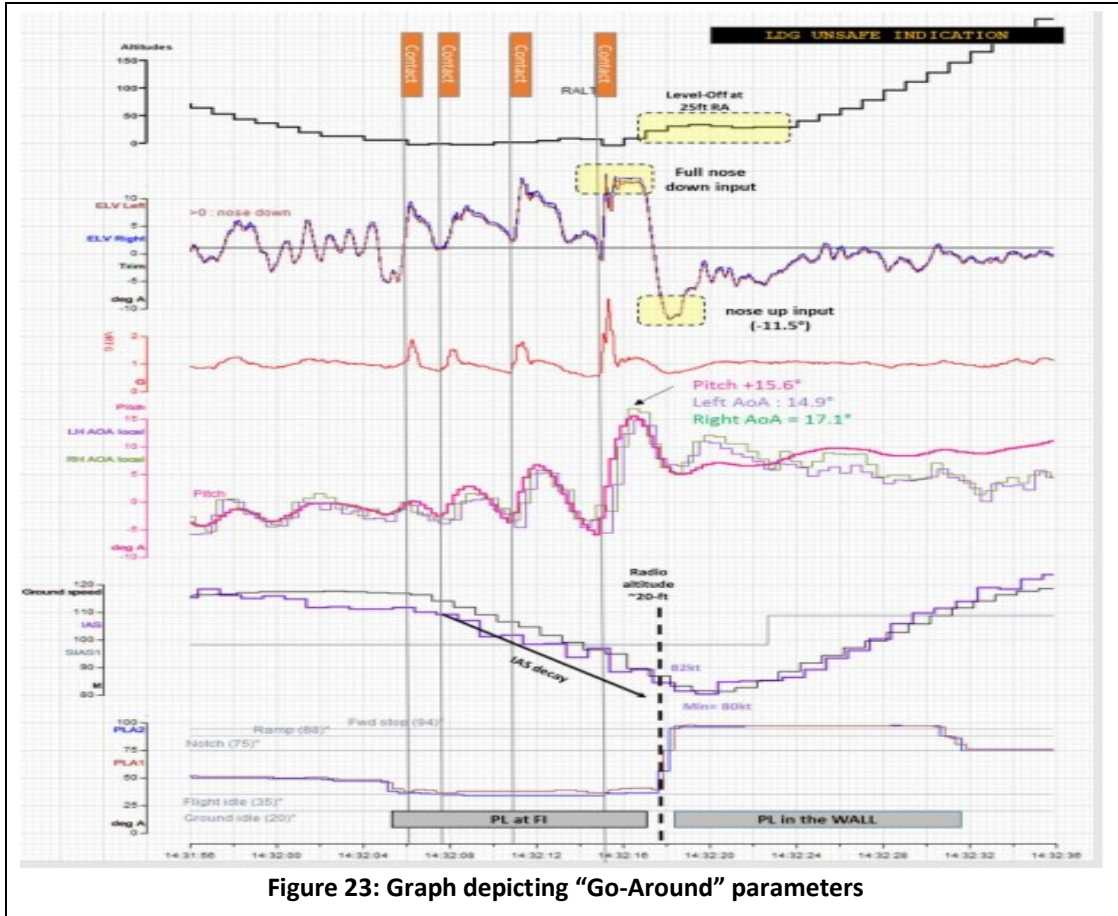
The crew initiated a “Go-Around”, only after the fourth touchdown. During “Go-Around” landing gear unsafe procedure was displayed for 20 sec. However, the indication was not noticed by the crew. When the landing gears were selected up, the landing gear unsafe indication cleared automatically. Aircraft climbed as per ATC instruction and entered a holding pattern and carried out two right orbits. During hold crew discussed diversion to Bengaluru and also enquired the weather from ATC Hubli. ATC Hubli reported raining over the field and runway wet.

Figure 23: Graph depicting “Go-Around” parameters
