**FINAL REPORT ON ACCIDENT INVOLVING BOEING  
737-800 AIRCRAFT VT-TGE BELONGING TO M/s  
VISTARA ON 07.06.2021 WHILE OPERATING  
SECTOR MUMBAI KOLKATA.**

**Dinesh Kumar  
Investigator**

**Shilpy Satiya  
Investigation-In-Charge**

**FINAL INVESTIGATION REPORT ON ACCIDENT TO M/S VISTARA B737-800**  
**AIRCRAFT VT-TGE ON 07 JUNE 2021 WHILE OPERATING FLIGHT**  
**FROM MUMBAI TO KOLKATA**

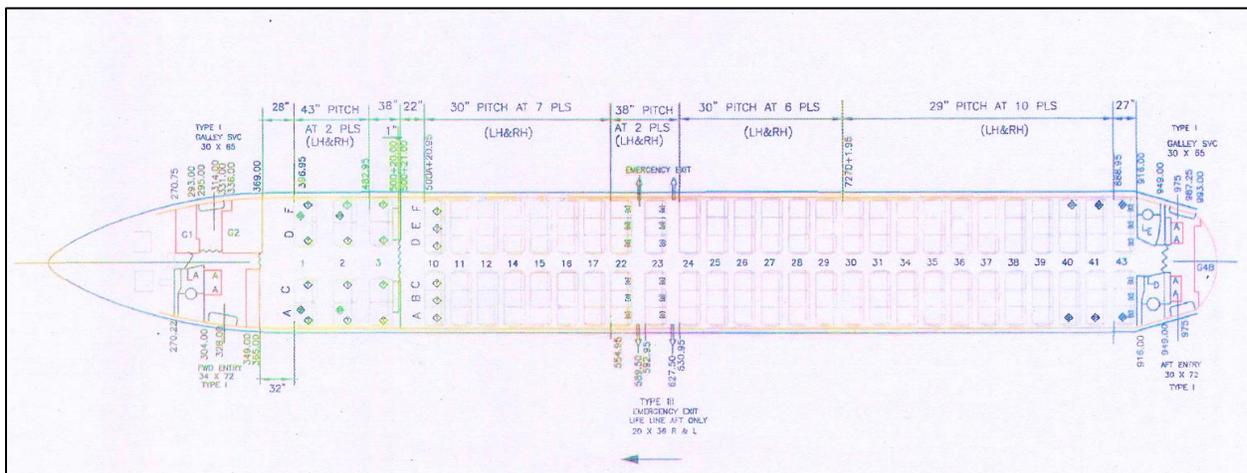
### LOPA of the aircraft B737-800

Passengers sitting on the Seat 39D & 26A received serious injuries and passengers sitting on the seat 26B and 30B received minor injuries.

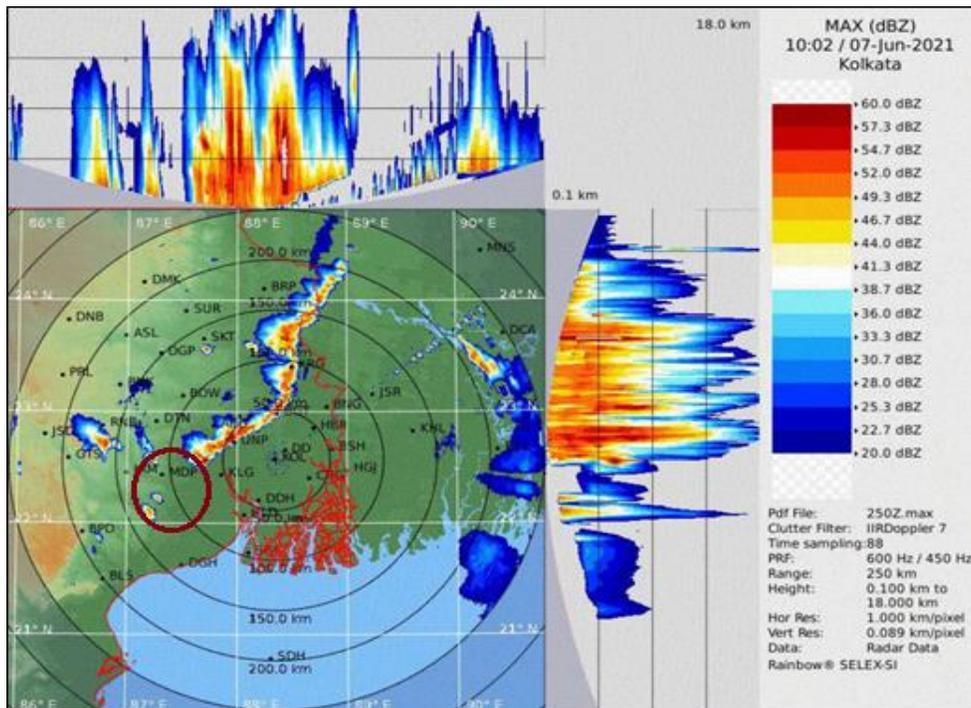
**Weather Radar Snapshot of Kolkata and around at 1002 UTC on 07.06.2021**

The Radar images provided below were obtained from Kolkata MET office around the time of the accident. As per the images, area around the Kolkata was surrounded by the line squalls and only a small gap is visible (Refer the red circle in the figures below).

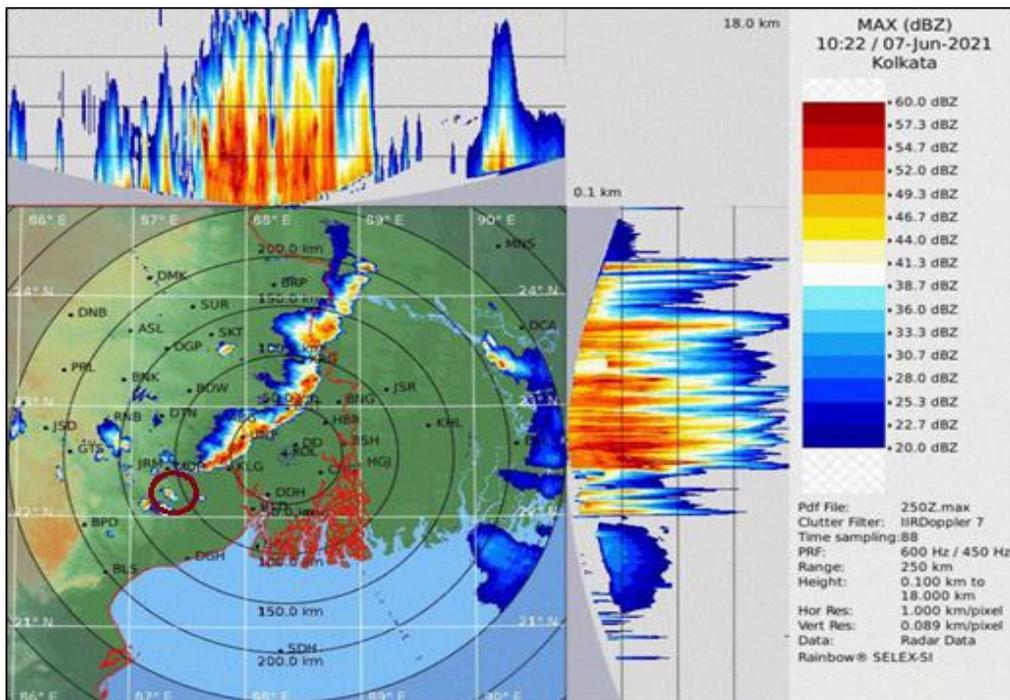
**Weather Radar Snapshot of Kolkata and around at 1022 UTC on 07.06.2021**

As the aircraft was approaching near Kolkata, it is clearly evident from the radar images (from 1002 UTC to 1032 UTC) that the gap chosen by the flight crew to enter into Kolkata was also converging with passage of time.
