**FINAL INVESTIGATION REPORT ON
ACCIDENT INVOLVING TECNAM P2008JC AIRCRAFT VT-RBE
OPERATED BY M/S REDBIRD FLIGHT TRAINING ACADEMY
AT BARAMATI ON 20TH SEPTEMBER 2021.**

FINAL REPORT OF ACCIDENT INVOLVING TECNAM P2008JC AIRCRAFT
VT-RBE OPERATED BY M/S REDBIRD FLIGHT TRAINING ACADEMY PVT LTD
ON 20TH SEPTEMBER 2021.

On 20th Sep 2021, M/s Redbird Flight Training Academy Pvt. Ltd. TECNAM P2008JC aircraft VT-RBE met with an accident at Baramati Airport, while carrying out a solo circuit and landing exercise at Baramati Airport.

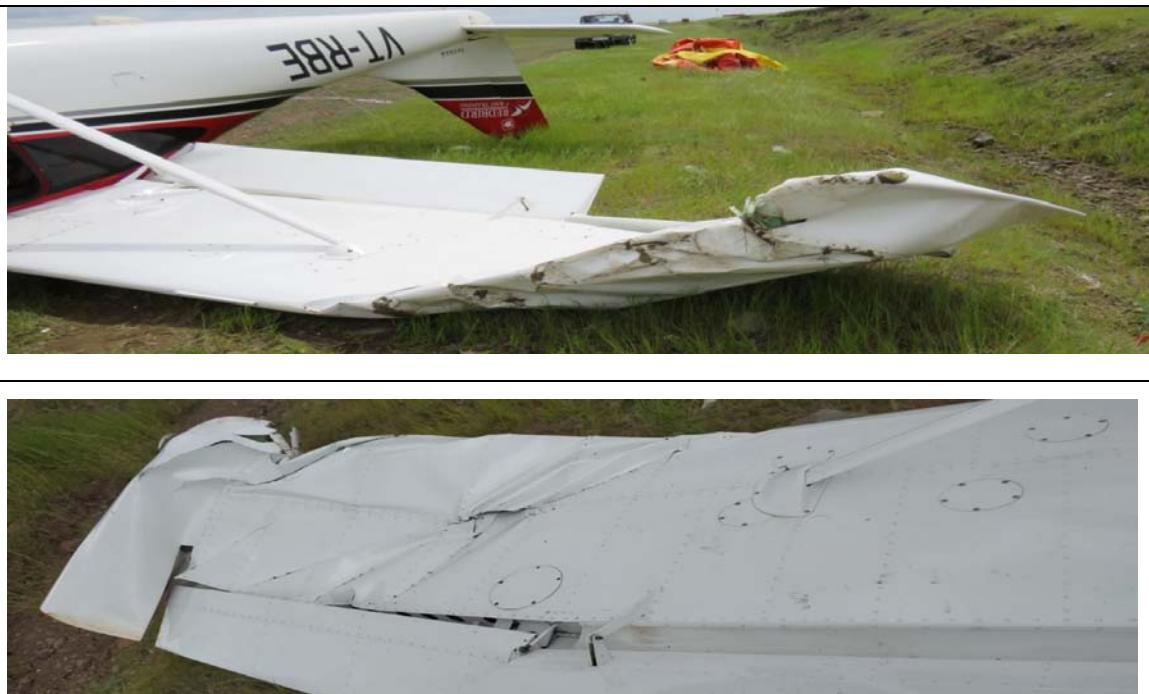
Figure 1: RH Wing

Wing leading edge was found twisted inward and downward from tip of wing to upper strut attachment. Distance measured from the wing tip to damage area on the wing was 5 Feet 8 Inches. Wing skin was found ripped out at root and at twisted portion. An approx.12 inches long cut mark was also found on the RH wing. Wing-to-fuselage attachment skin was found completely wrinkled. Wing tip was found completely broken.

Aileron was found damaged at inboard root side attachment. Flap was also found damaged at the tip on root side of wing attachment.

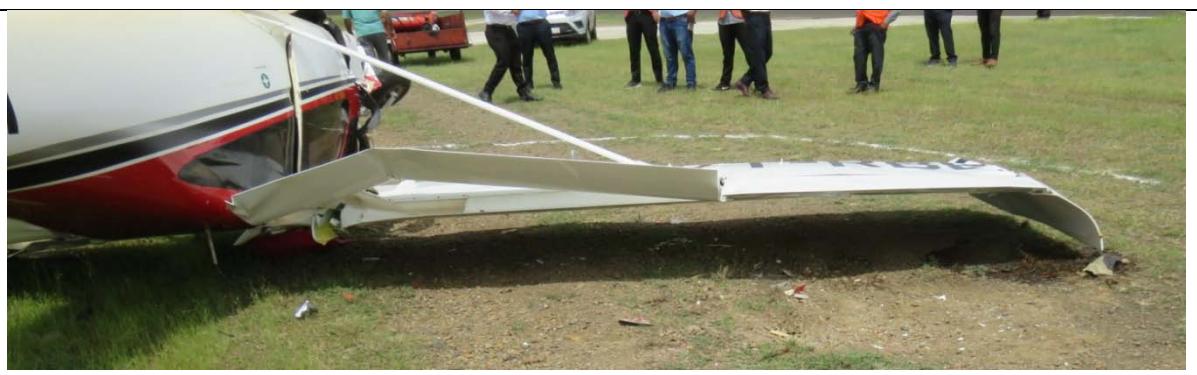
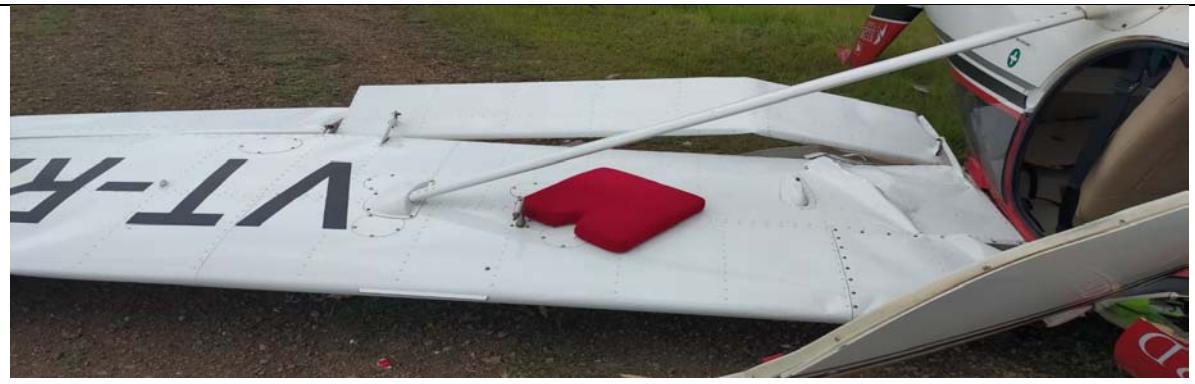
Figure 2: LH Wing

LH wing's front and aft spars were found completely damaged. Dents were found on wings leading edge. Wing skin was also found ripped out at a distance of 01 feet 10-inch from the root. A cut mark of approx. 11 inch long was found on wing skin of the leading edge at a distance of 3 feet 6 inch from wing root. Wing tip skin was also damaged. Wing tip was found completely broken and twisted outward and upward. Navigation and Strobe lights was also found damaged.

Aileron was found damaged on inboard root side attachment of aileron spar to wing attachment point. Flap was also found bent at a distance of 2feet 7 inches and completely damaged at tip of the flap.

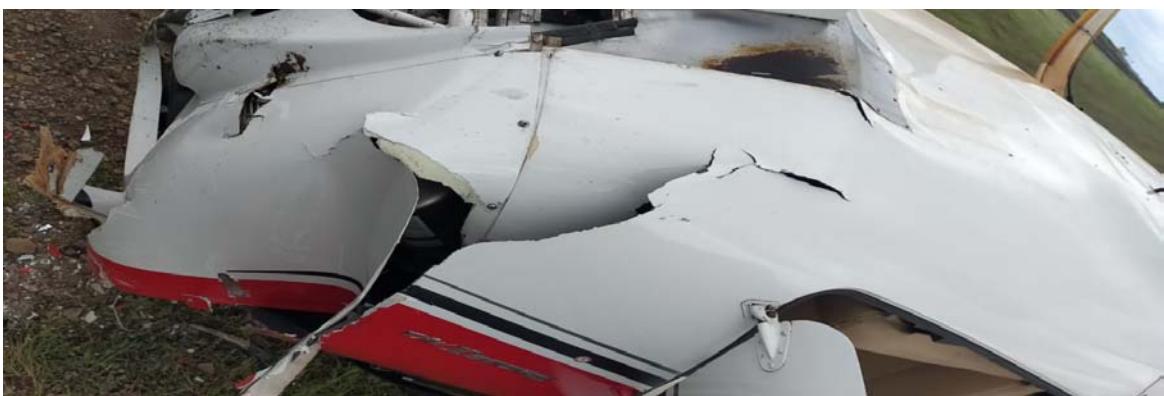
Figure 3: Fuselage section

Fuselags skin of the aircraft was found damaged from nose to front of cabin compartment, including engine cowlings. Windshield was also found completely broken.

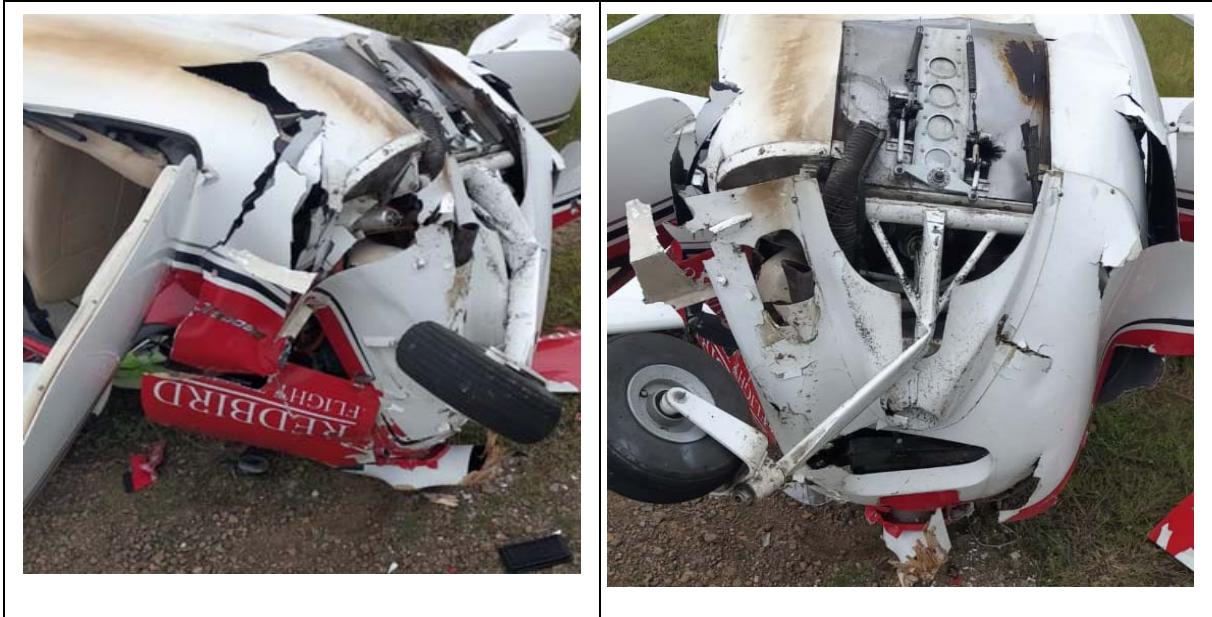
Figure 4: NLG Section

Nose section of the aircraft was found substantially damaged. Nose landing gear leg was found damaged due to ground impact. Attachment of NLG was found broken. NLG Oleo strut was also found broken.

Firewall was found completely broken at 2 feet 6 inches from the bottom of the cabin and was also found bent towards the aircraft cabin compartment. Propeller was found completely damaged and scattered.

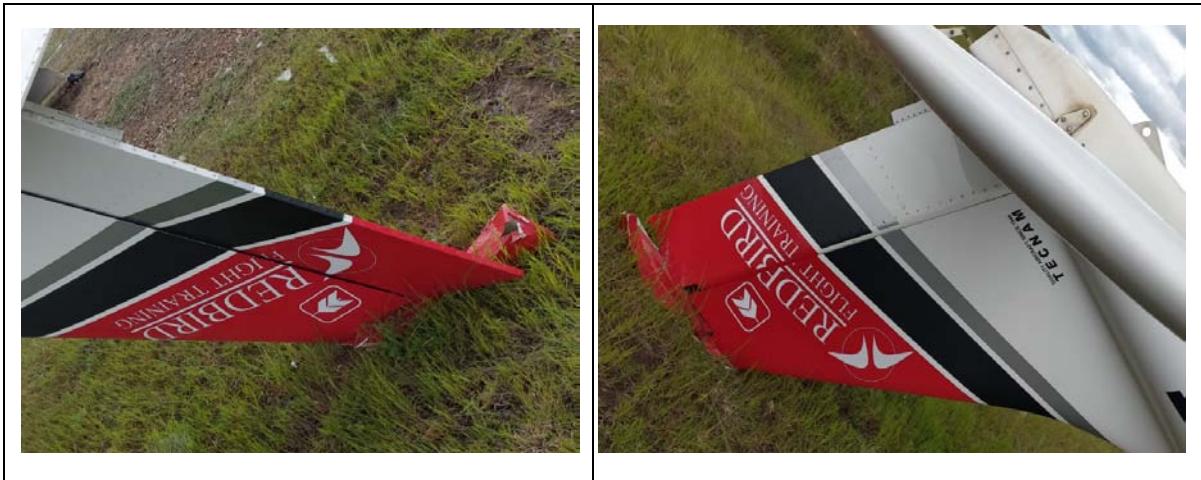
Figure 5: Vertical Stabilizer

The vertical stabilizer tip was found completely damaged and approx. 1 ' 11" long area was ruptured.

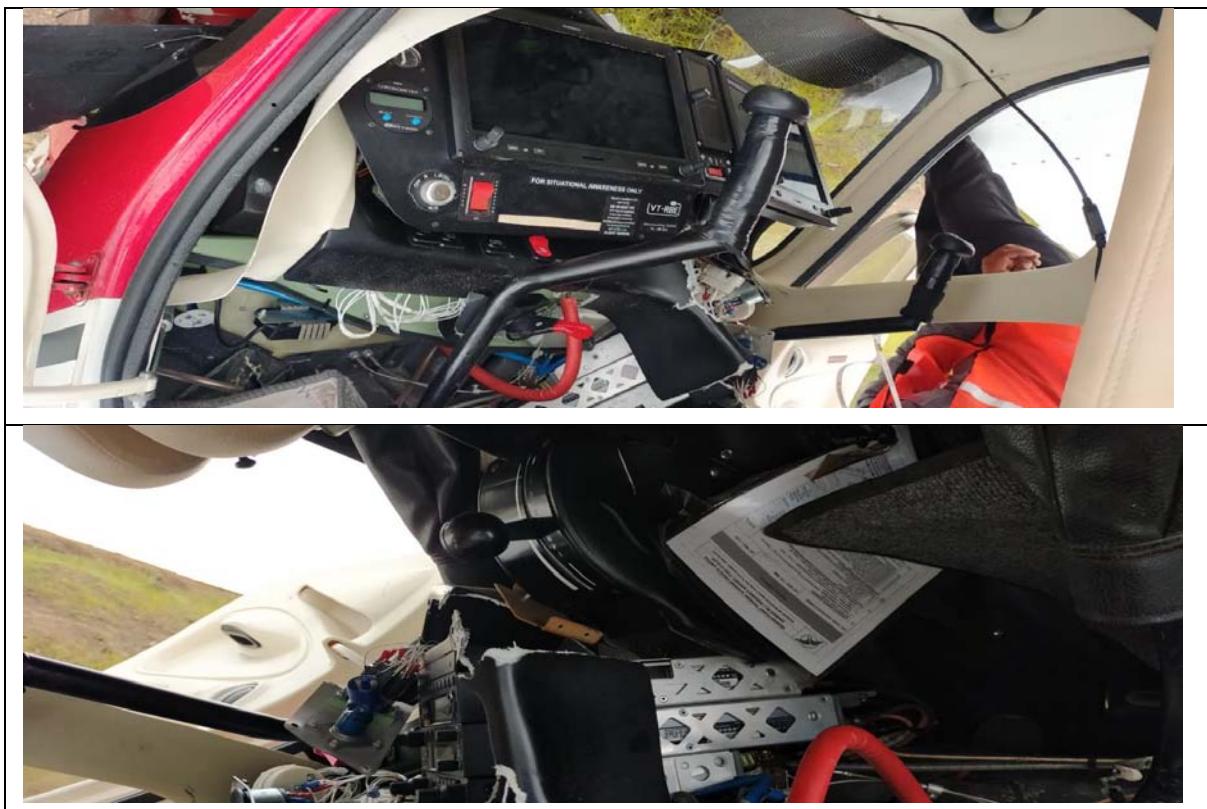
Figure 6: Cockpit

Inside the cockpit display units, Instrument panels and Radio panels were found damaged and found shifted from their original place.

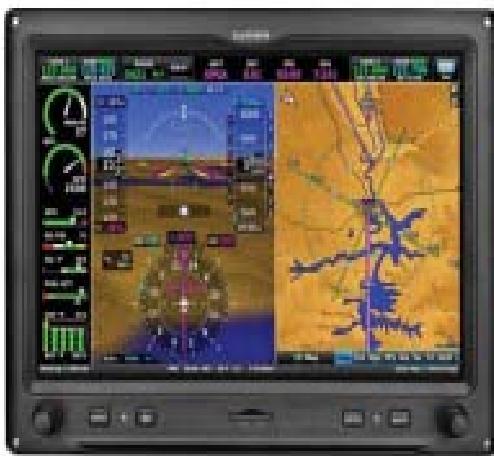
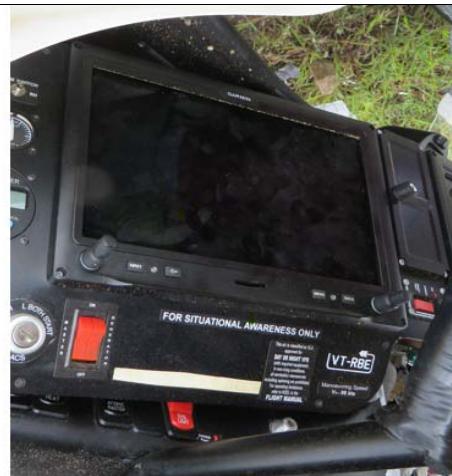
Figure 8: Garmin G3X (display units)

Although all TECNAMP2008JC aircraft operated M/s RFTAPL are equipped with Garmin G3X display units, no SD card was used by the RFTAPL.

4.3 It is recommended that DGCA should issue a circular for mandatory installation of SD cards and storage & analysis of data by the FTOs for all aircraft equipped with Garmin display units. The same can be used for monitoring purposes by the training Organization and should be monitored by DGCA officers during surveillance/Audit/ inspections of all FTOs.

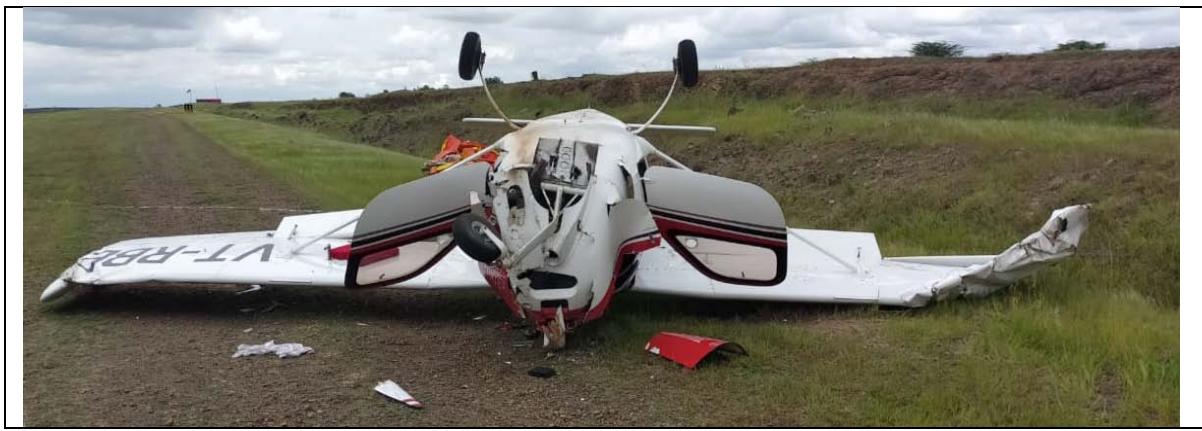
Figure 10: Aircraft final resting position

After touchdown the aircraft rolled for 3-4 seconds before getting airborne. The aircraft pitch was high and altitude started increasing. After few seconds aircraft was started sinking with LH wing drop. Aircraft then turned left. Aircraft's LH wing tip first hit the unpaved surface on the left side of the runway 29 and dragged for few feet. Then the nose section hit the ground, at that moment propeller's blades were rotating at high speed. Consequently, wooden propeller blades hit the unpaved surface and a major portion of the blades were scattered in pieces. Aircraft toppled and RH wing hit the unpaved surface before coming to rest in the upside down position. Distance between the LH wing tip to runway centre line was 123ft and 4 inches.

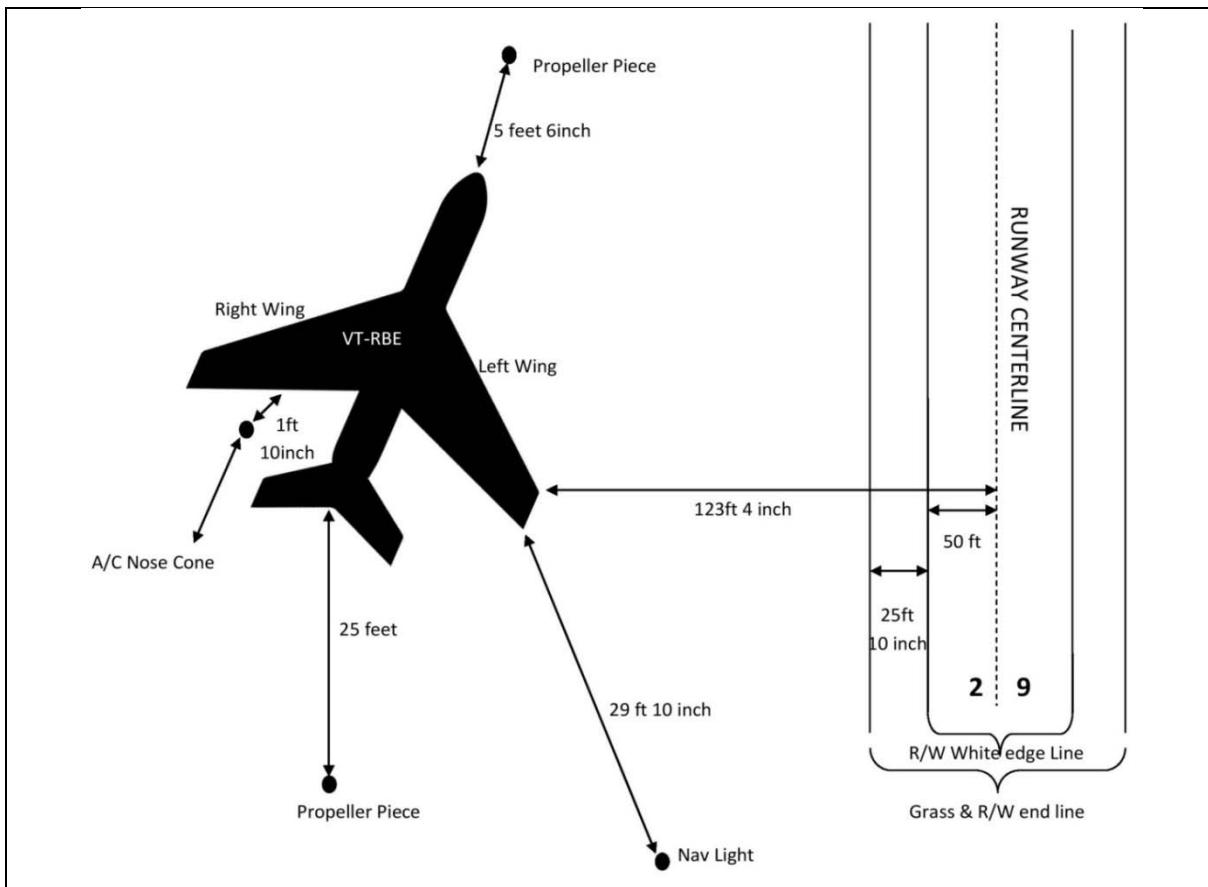
Figure 11: Aircraft (upside down) wreckage distribution.

Aircraft wreckage was mainly confined to one place. However, few parts were scattered during the accident. Few Propeller pieces were found 5' 6" ahead of its nose section and few pieces were found 25' away from the horizontal stabilizer. LH Navigation light was found 29' 10" behind the LH wing trailing edge tip. Aircraft nose cone was found 1'10" behind the trailing edge of RH wing.

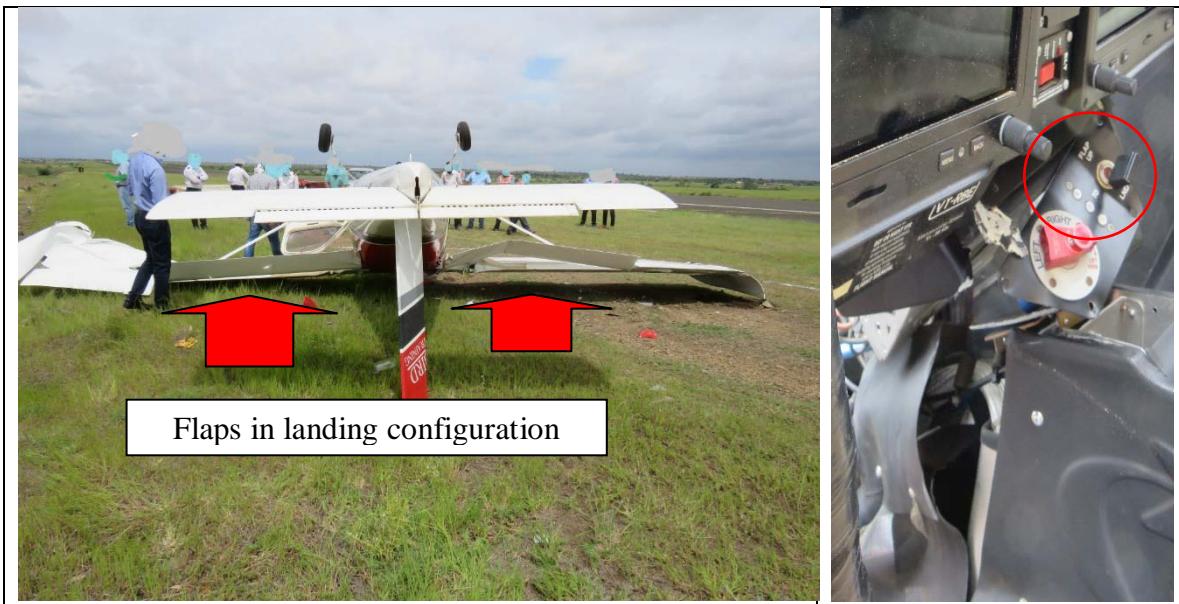
Figure 12: Flap position

During visit to the accident site, it was found that Flaps were in the landing configuration and same was corroborated by the Flap selector in the landing position as observed in the cockpit (Refer figure above). As per trainee pilot, while carrying out the Go Around, he did not change the flaps configuration to Take Off.
