**FINAL INVESTIGATION REPORT ON ACCIDENT INVOLVING
TECNAM P2008JC AIRCRAFT, VT-BRP
OPERATED BY M/S NMIMS, ACADEMY OF AVIATION
ON 16 JULY 2021 NEAR VILLAGE VARDI, SHIRPUR**

AIRCRAFT ACCIDENT INVESTIGATION BUREAU

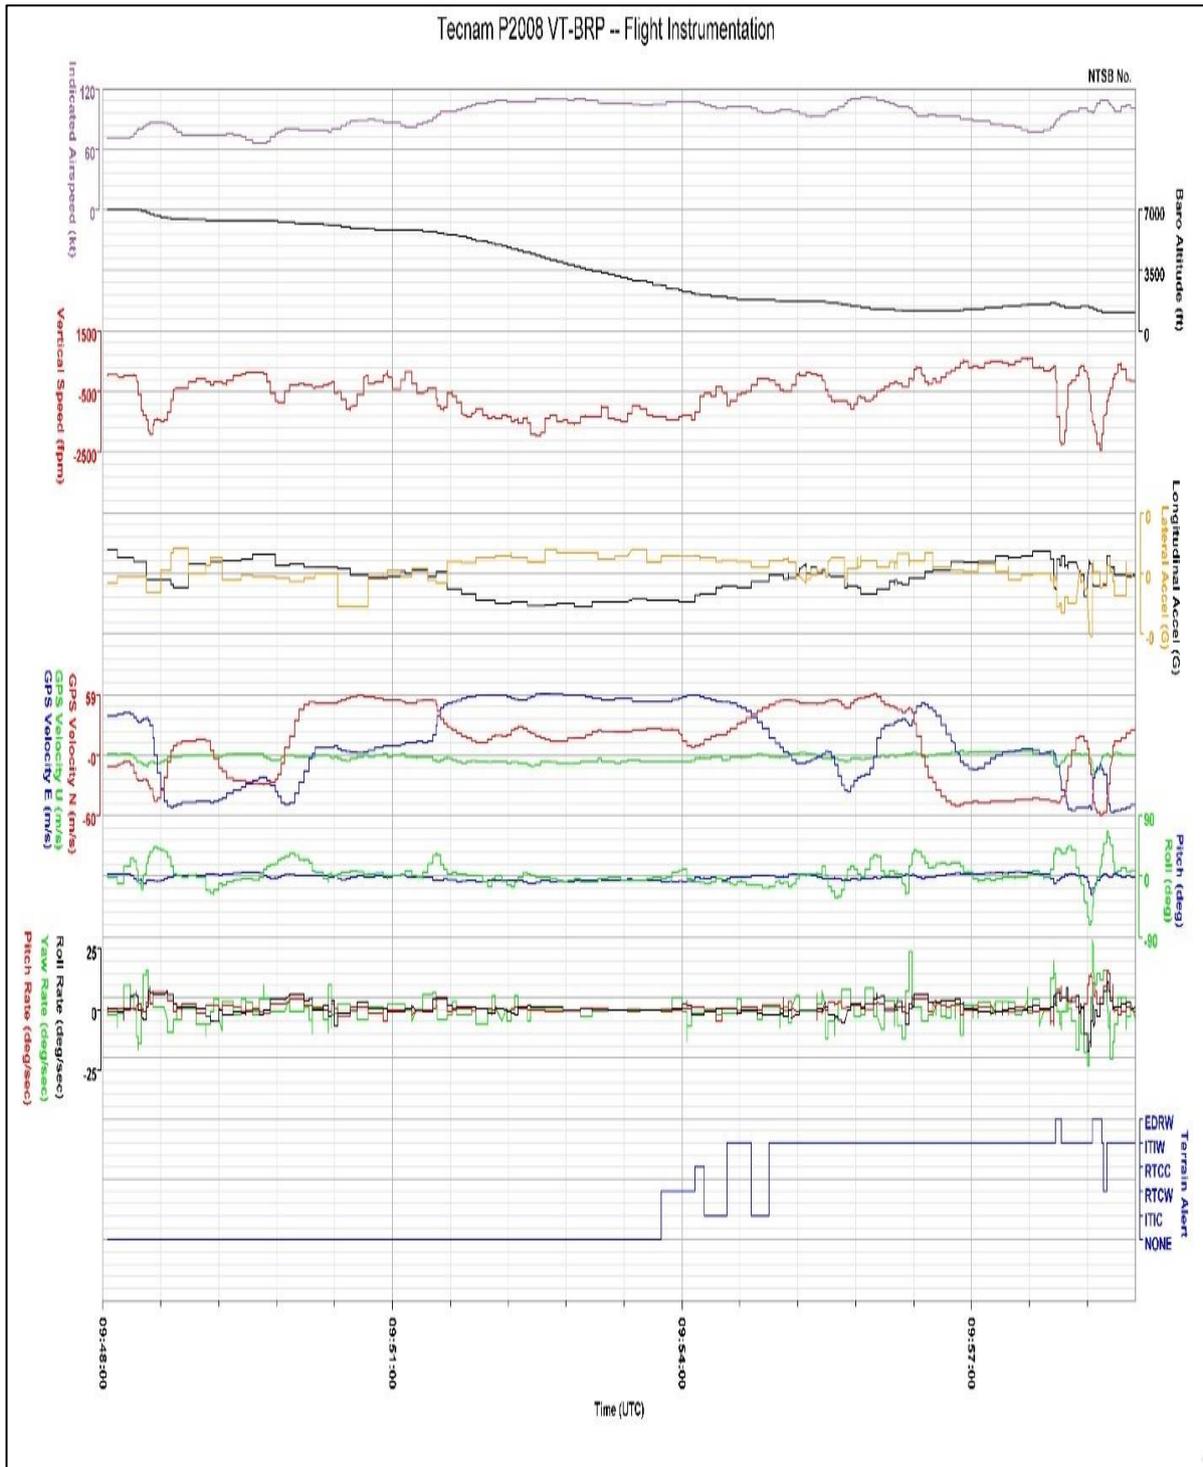
Fig 5: Graph of relevant parameters (including alerts/warnings) vs time (0948 UTC till accident)

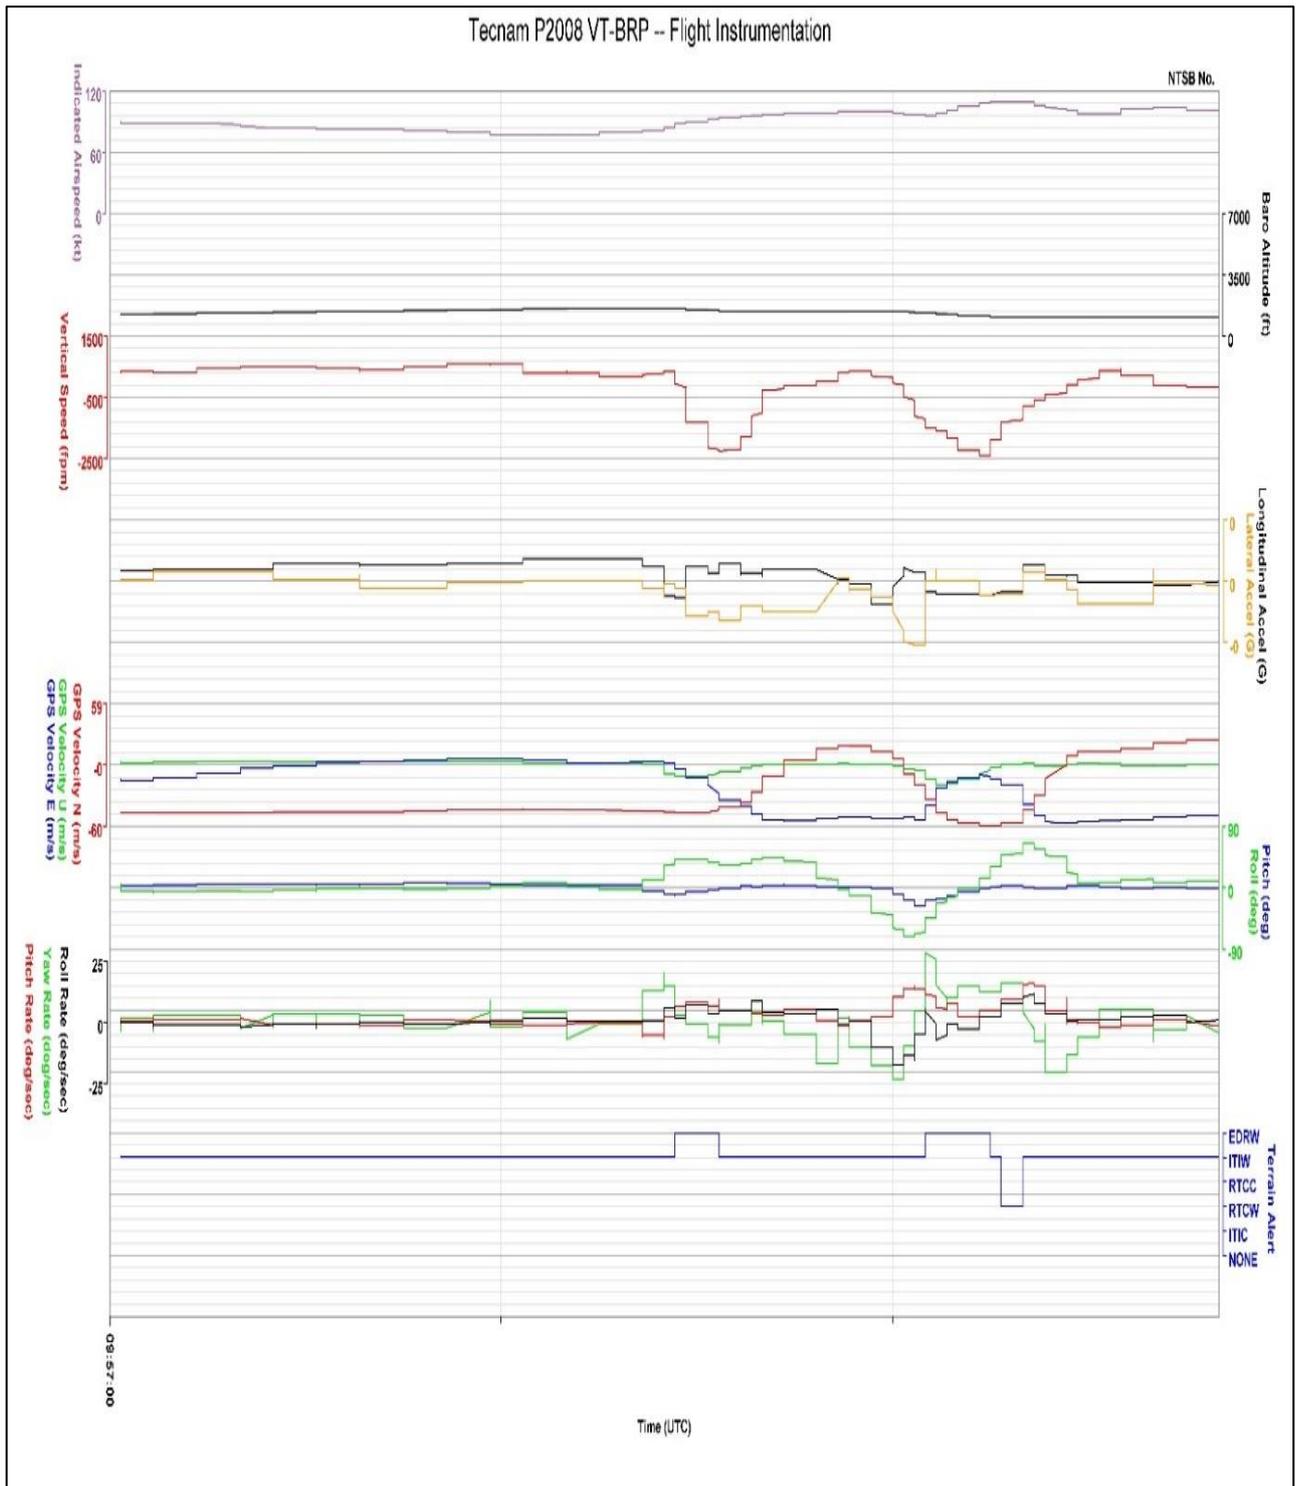
The last recorded data was TAS-105 Knots, heading 301.3°, pitch 0.36° and roll 7.08°.

Fig 6: Graph of relevant parameters vs time for final phase of flight (0957 UTC till accident)

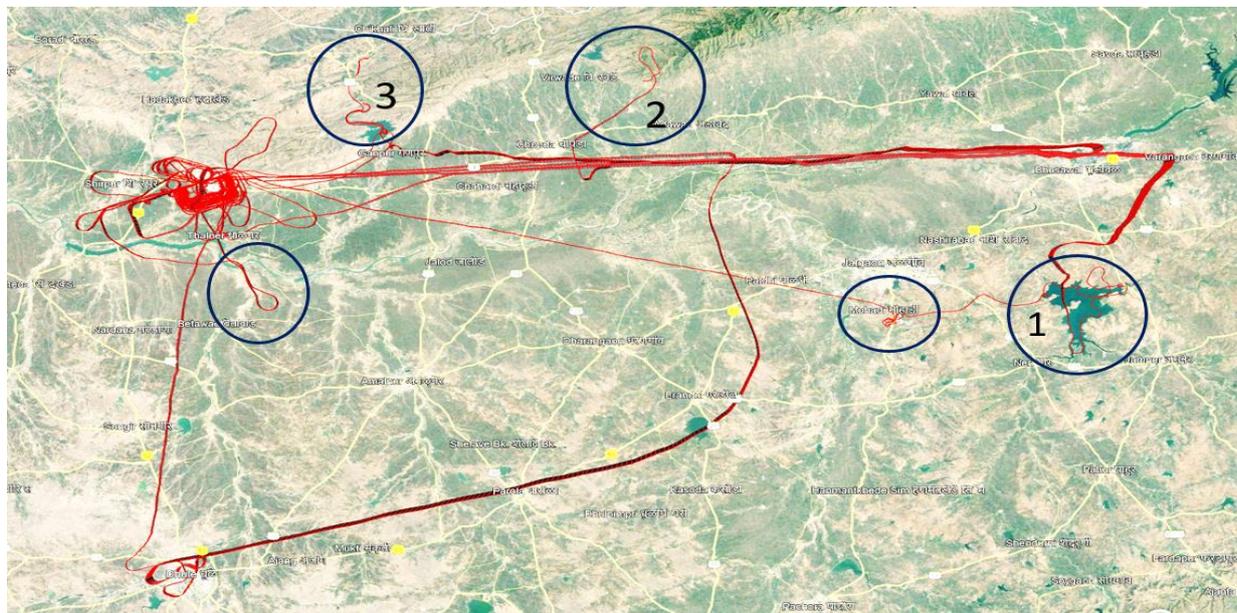
Fig 7: Routes followed by aircraft from 11 July 2021 to accident flight showing deviations from the flight path (1-Water Body, 2-Mountain Ranges, 3-River Stream)

Apart from the accident flight, there were many instances earlier also (as it can be seen from the figure 7 above) when the aircraft had deviated from the intended/assigned path. During one of its preceding flights, path followed by the aircraft clearly depicts that it had left the set assigned course when it was flying overhead Varangaon and deviated towards a water body located at south of the intended route (marked as 1 in the figure). After flying over the water body, aircraft path can be seen to have set the course for other unintended/unassigned location, Mohadi which was also not a standard route as per company assigned routes. Aircraft followed some irregular flight tracks there before it set course back for Shirpur Airport. Similarly, there have been deviation from the flight track towards some mountain ranges, river, etc. which are clearly depicted in Fig 7.

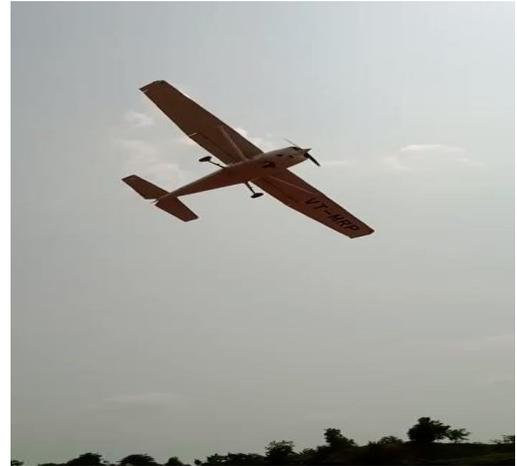
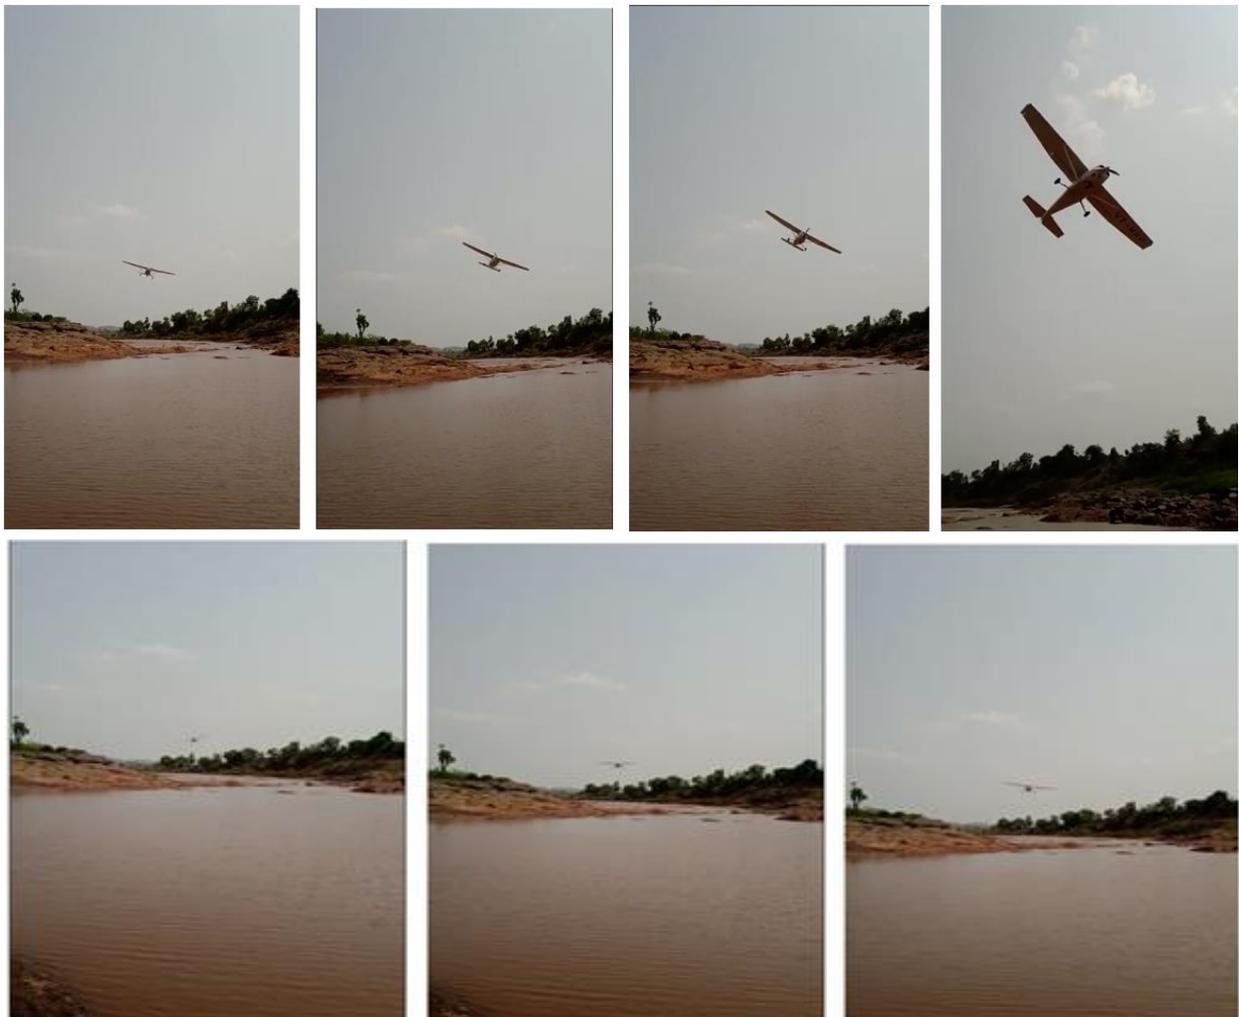
Figure 9: Snapshots from the video clip of another aircraft VT-MRP belonging to NMIMS flying low over a river

A few snapshots from the video clip are shown below (Refer fig. 9) wherein it can be seen that the aircraft is flying very low while flying overhead the river and doing acrobatic manoeuvring. The organization was not aware of this video clip.

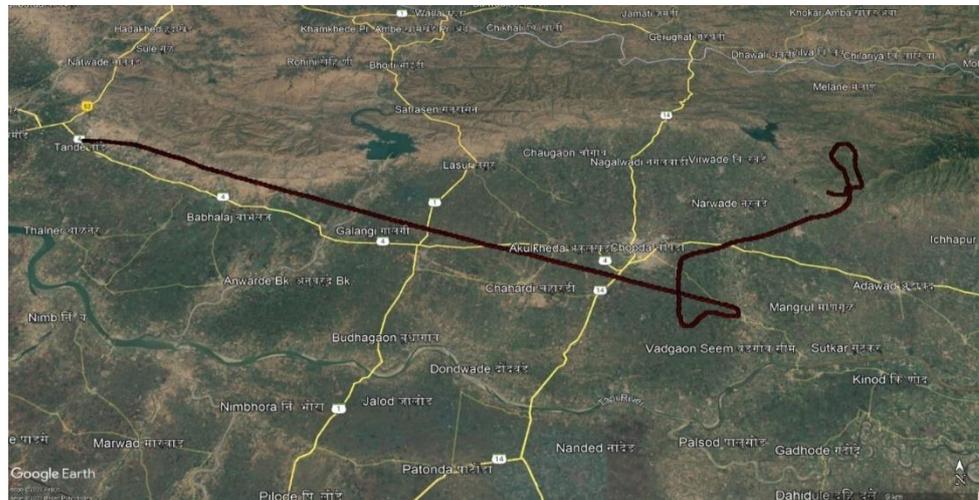
After the aircraft was set on course back to Shirpur, and at about 21.6 Nm from Shirpur, the aircraft started deviating from the intended flight path and started heading towards north of the intended flight

Fig 15: Path followed by VT-BRP during the accident flight

path on radial 350. The aircraft was heading towards the hilly region where the accident occurred which was about 26 Nm from Shirpur and 8 Nm away from the intended flight path. This deviation from the intended flight path was non-adherence to the SOP laid down in the company TPM. Further, the crew did not communicate their intention of turn back to Shirpur to ATC nor they communicated their position, which again was non-adherence to SOP.

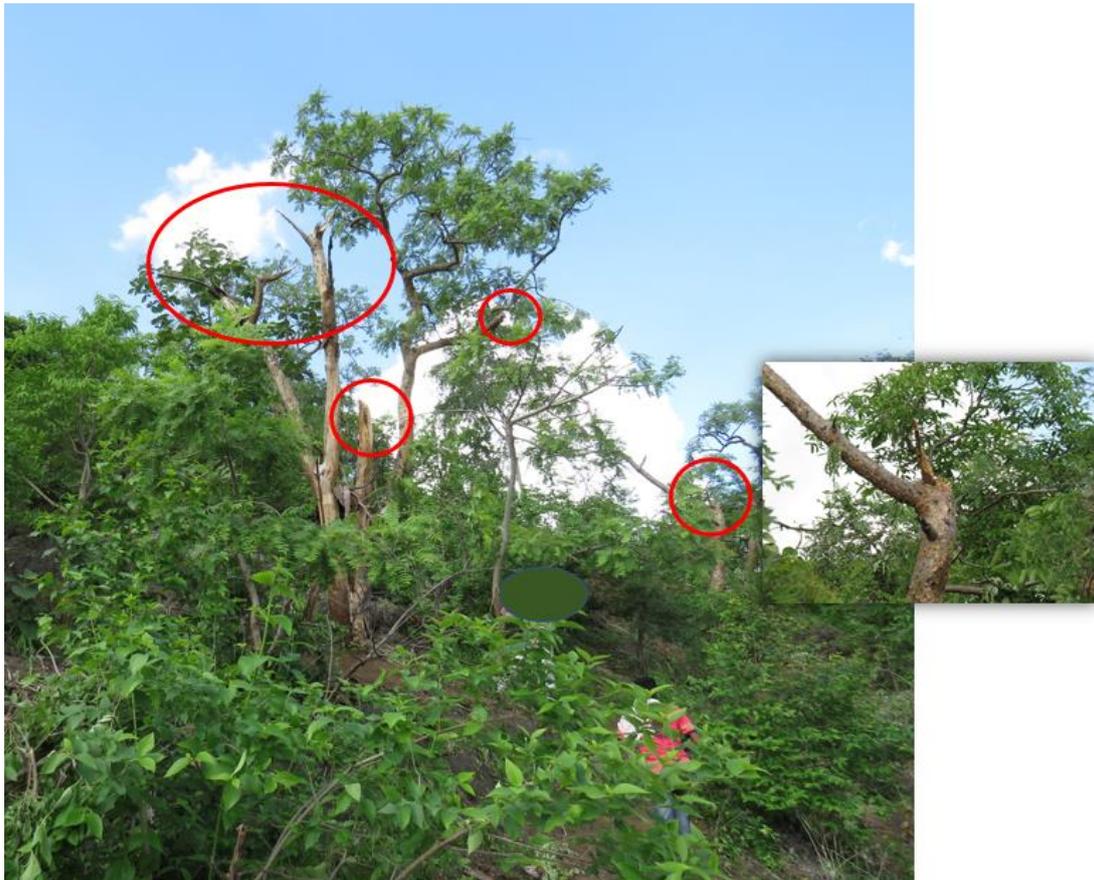
Fig 16. First impact on trees (View from aircraft wreckage)

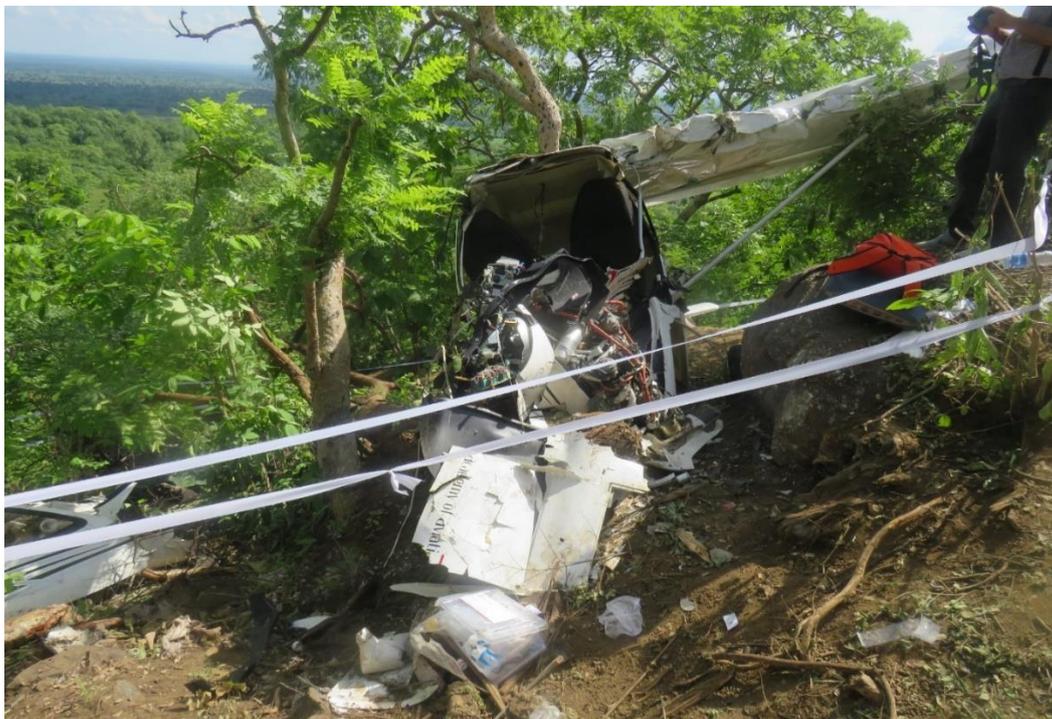
Fig 17. Front view of the aircraft with damaged cockpit and sheared RH wing

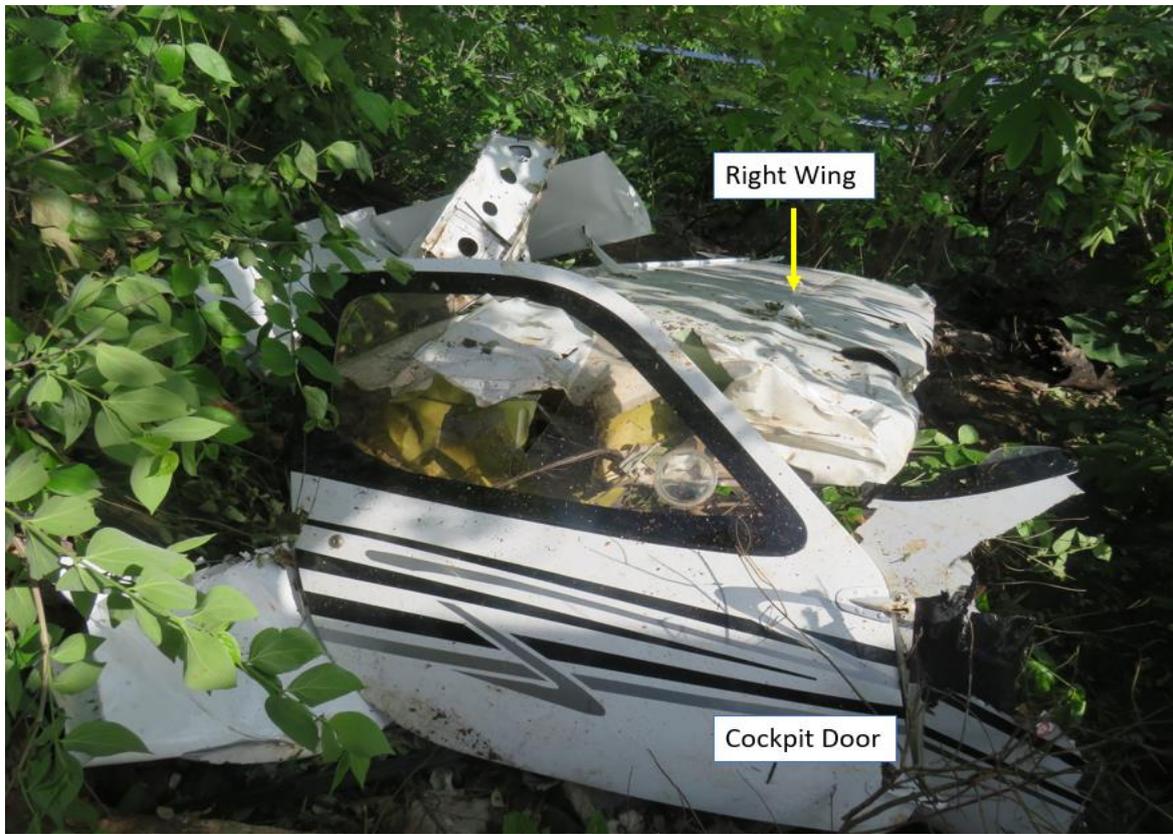
Fig 19. Detached Right Wing and Right Side Cockpit Door
