**FINAL REPORT ON ACCIDENT INVOLVING BOEING**  
**737-800 AIRCRAFT VT-GHE OPERATED BY M/s AIR**  
**INDIA EXPRESS AT VIJAYAWADA AIRPORT ON**  
**20TH FEB 2021.**

**FINAL REPORT ON ACCIDENT INVOLVING BOEING 737-800 AIRCRAFT VT-GHE OPERATED BY M/S AIR INDIA EXPRESS AT VIJAYAWADA AIRPORT ON 20TH FEB 2021.**

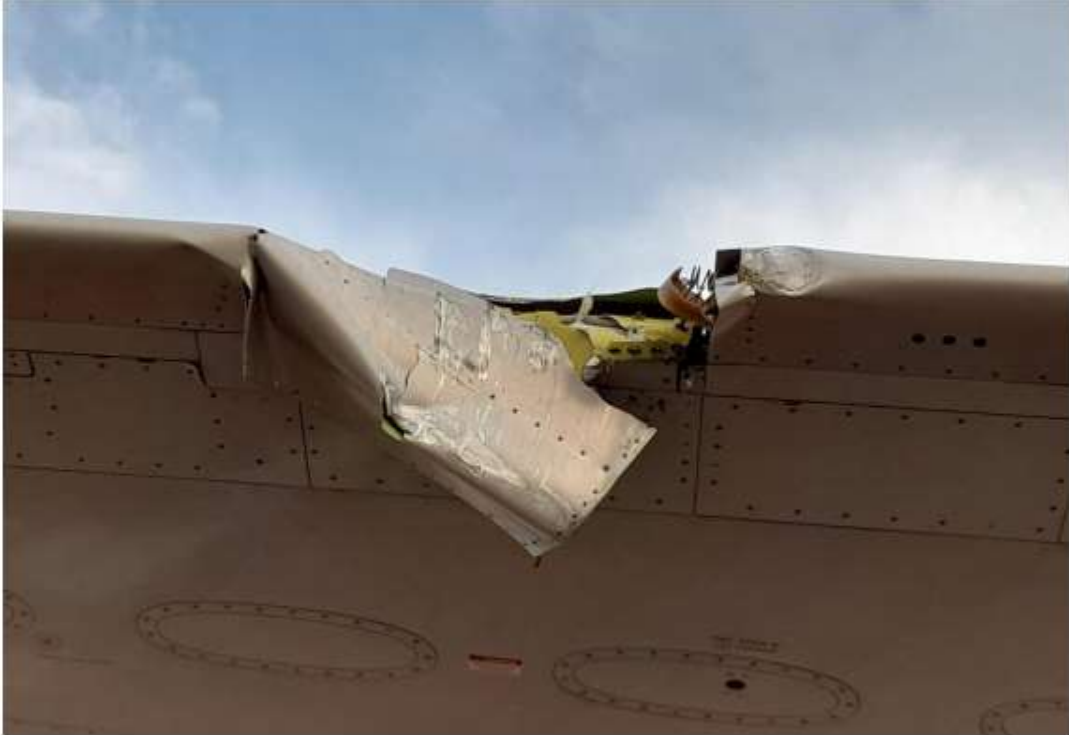
- i. Aircraft RH wing Slat #7 & Slat# 8 found damaged.

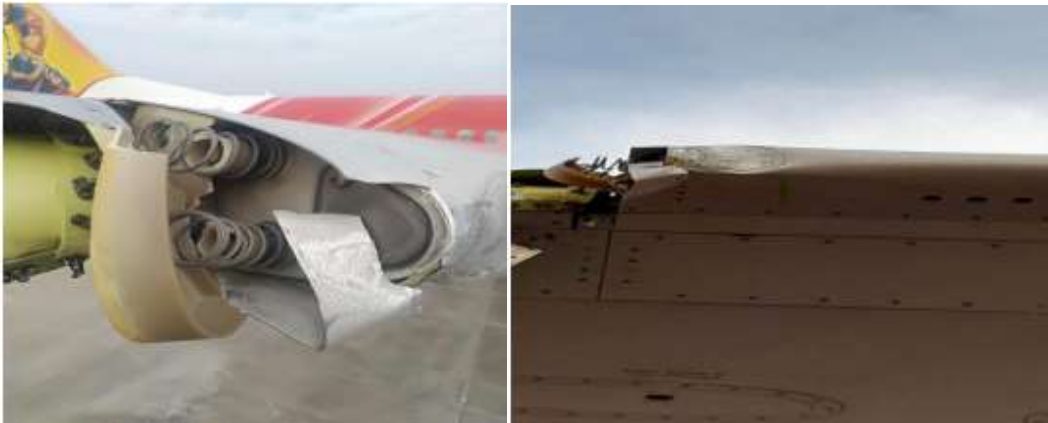
ii. Slat #7 Seal rib area was found cracked. Outboard end was found torn with 6" long, 305" wide and 0.75" deep dent.

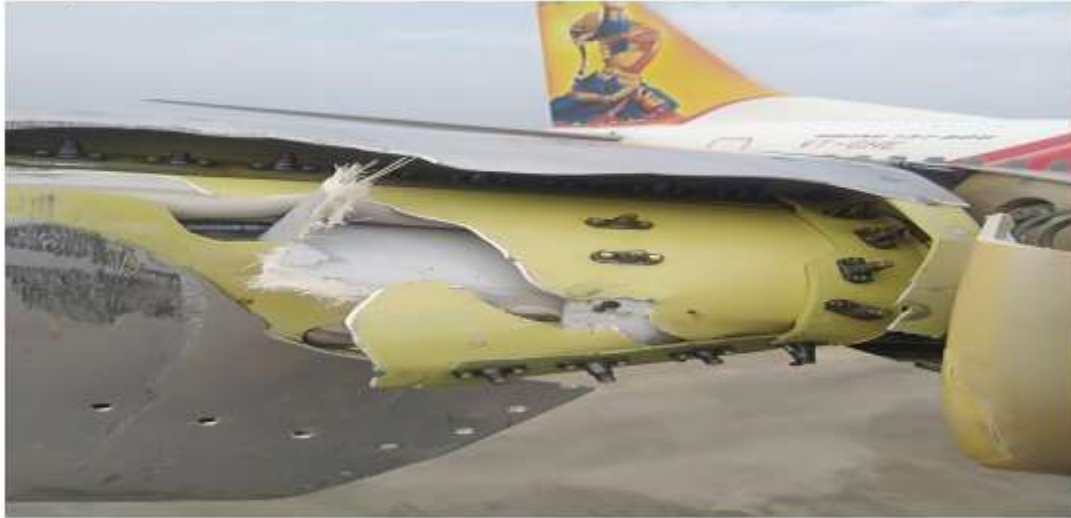
iii. Slat# 8 inboard end Aluminum nose skin curved cove skin both were found cracked. Approx. 27" long and 17" wide skin portion of Slat#8 was found torn.

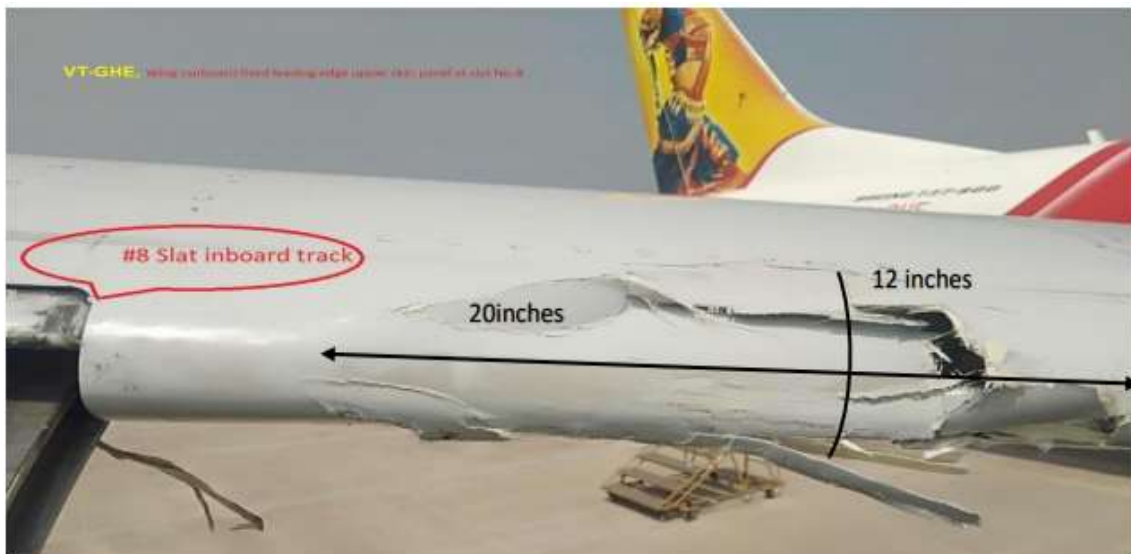
iv. Three Leading Edge access panels were found damaged.

v. Slat#8: wing outboard fixed leading edge upper skin panel was found damaged.

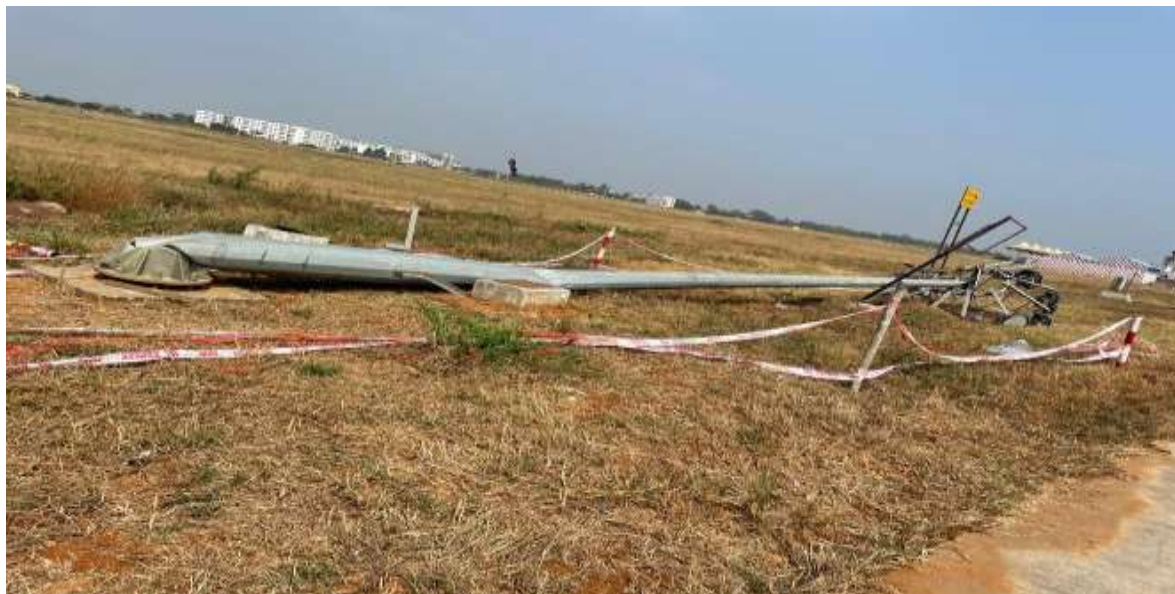
A flood light mast was found to be damaged as shown in the figure below.

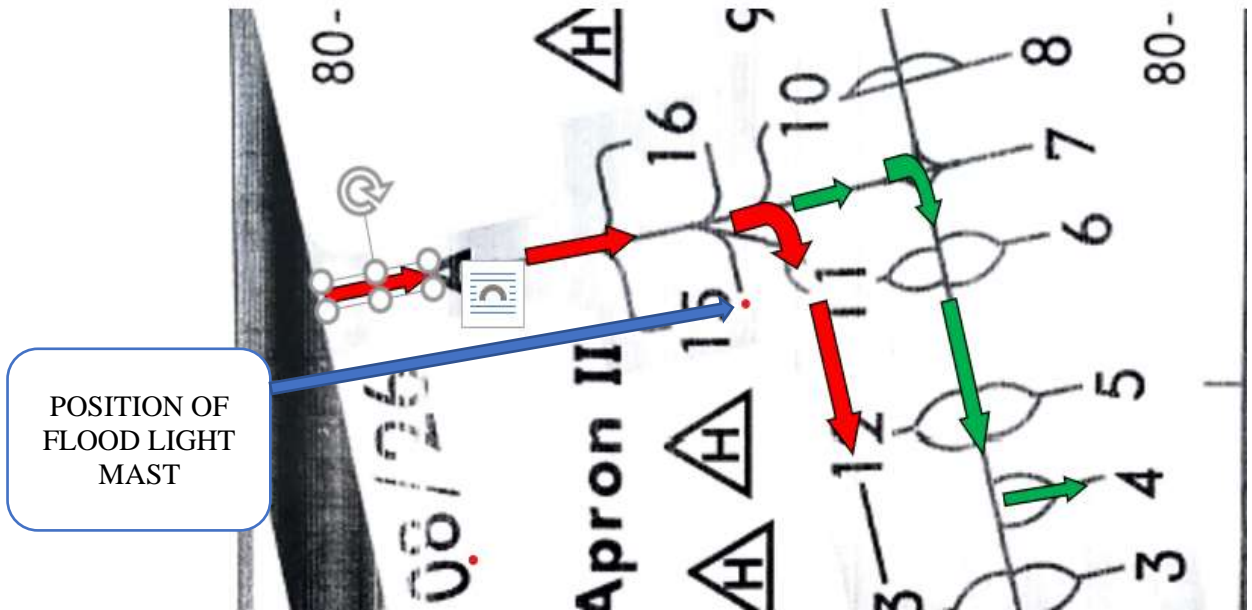
**Figure: Desired and Path Followed by Aircraft.**

Aircraft was assigned Parking bay no 4, for which aircraft has to take a right turn from taxiway A. Soon after entering the taxiway ‘A’, aircraft took a right turn (as shown in red in the figure below) instead of going straight (as shown in green in the figure below) .

- (a) Red arrows indicates the original path followed by the aircraft.
- (b) Green arrows indicates taxiway needed to be followed for assigned parking stand 4.

While turning, aircraft followed taxiway edge markings instead of centerline markings. Hence, the major portion of aircraft RH wing had protruded outside of the Apron movement area. Subsequently, the RH wing leading edge of the aircraft hit one of the flood light mast standing beside the Apron edge. Due to the impact leading edge slat No. 7 & 8 of the aircraft got substantially damaged, whereas the flood light mast bent down and fell on ground.

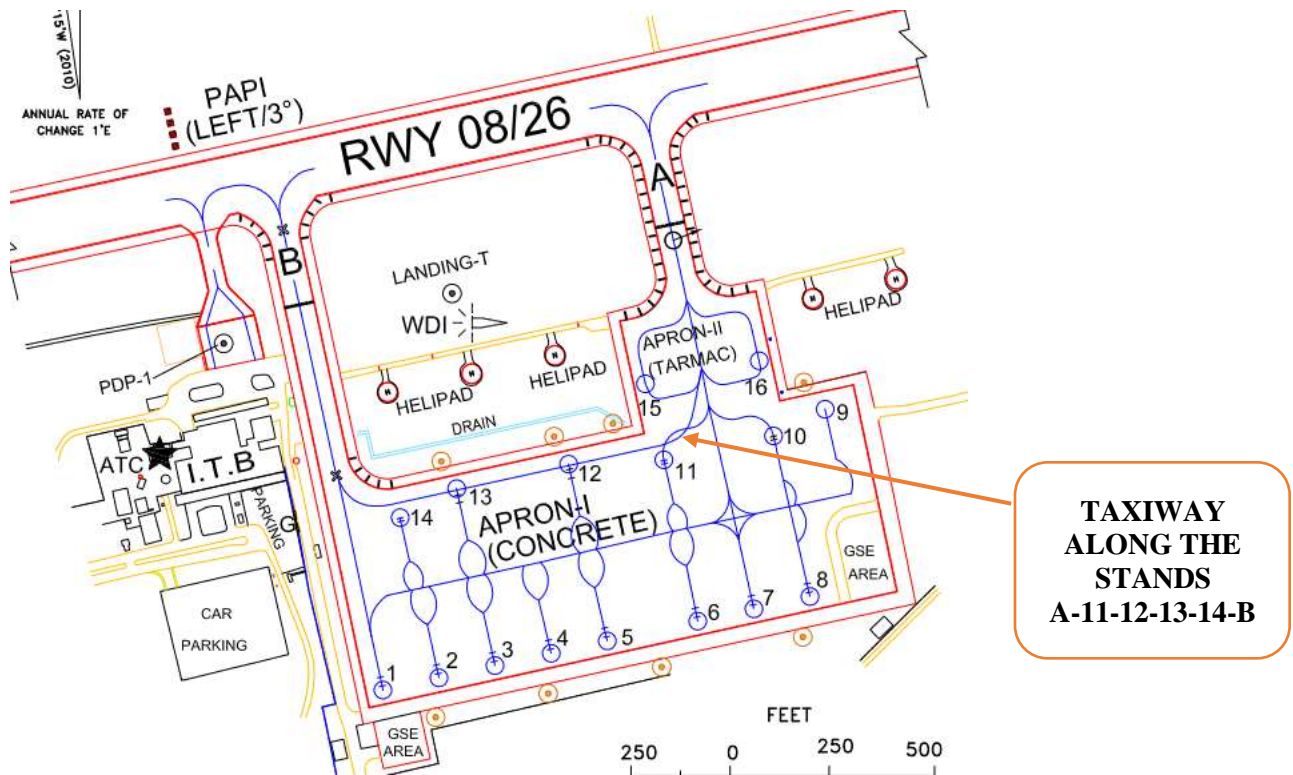
**Figure: Shows wrong Taxiway marking**

Airports authority of India has published an Apron layout which shows the taxiway routing within the parking bays as A-11-12-13-14-B. Although there is no such taxiway. This gives a wrong information about the apron Layout.

Vijayawada Airport is an International Airport. Crew operating here follow the aeronautical charts published by AAI. The layout on aeronautical chart of AAI found not updated during course of investigation. Non updation may create confusion in the mind of crew operating in and out of apron.

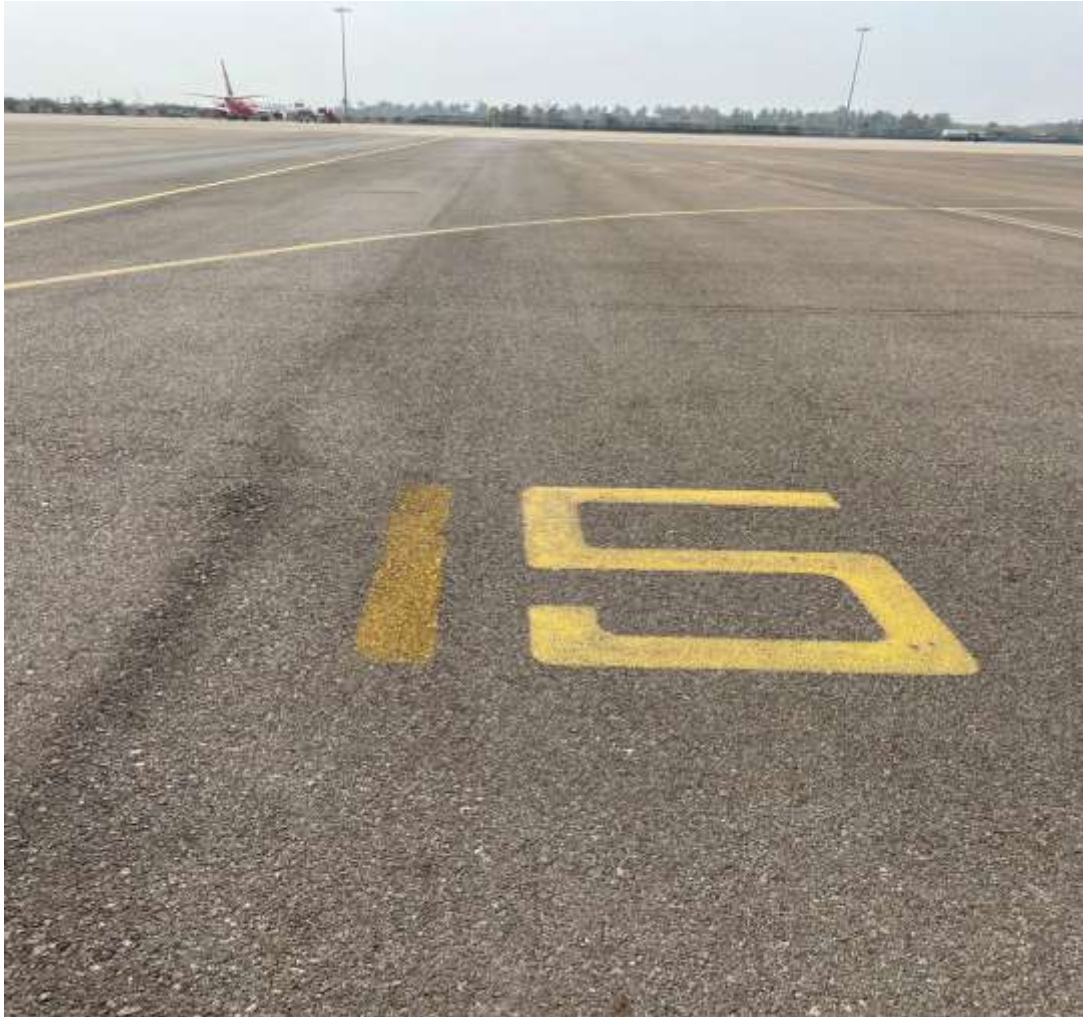
**Figure: Existing apron marking at Vijayawada Airport (as on date of accident)**

It was found during investigation that the markings at the Apron were not as per laid down the standards.

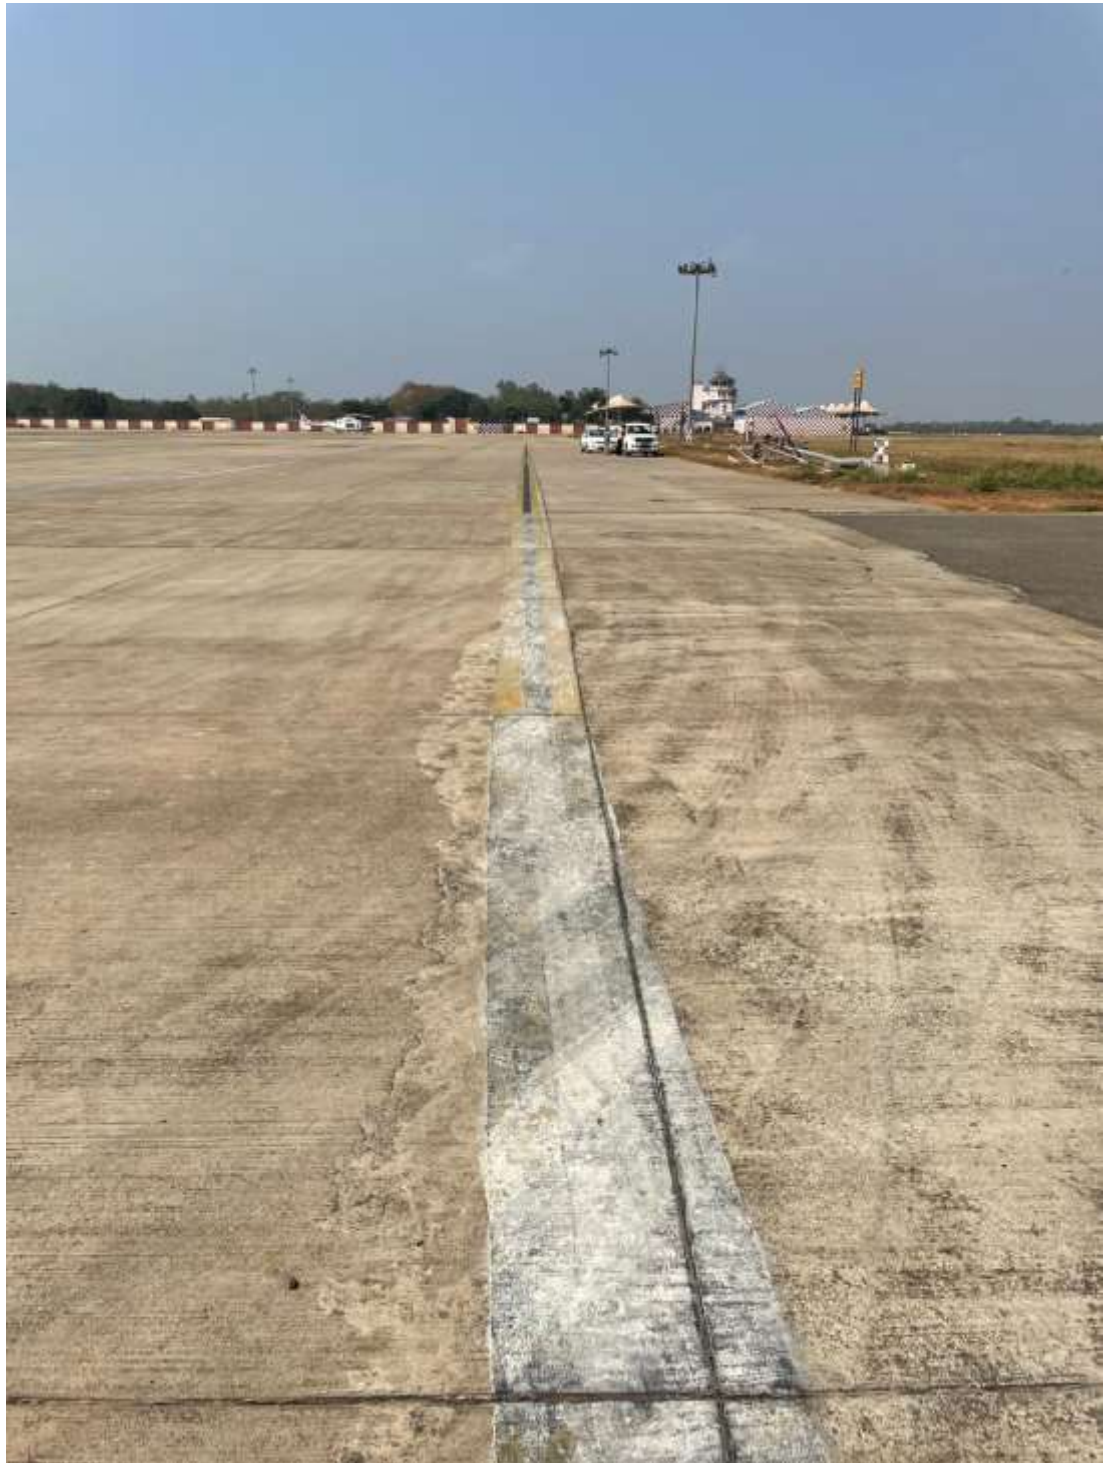
**Figure: Existing marking of erased portion at Vijayawada Airport**

The erasing of markings on rigid pavement has to be in matching colour with pavement i.e. Grey. During investigation it was found that the erased portion of taxiway was blur and were not as per laid down standards.

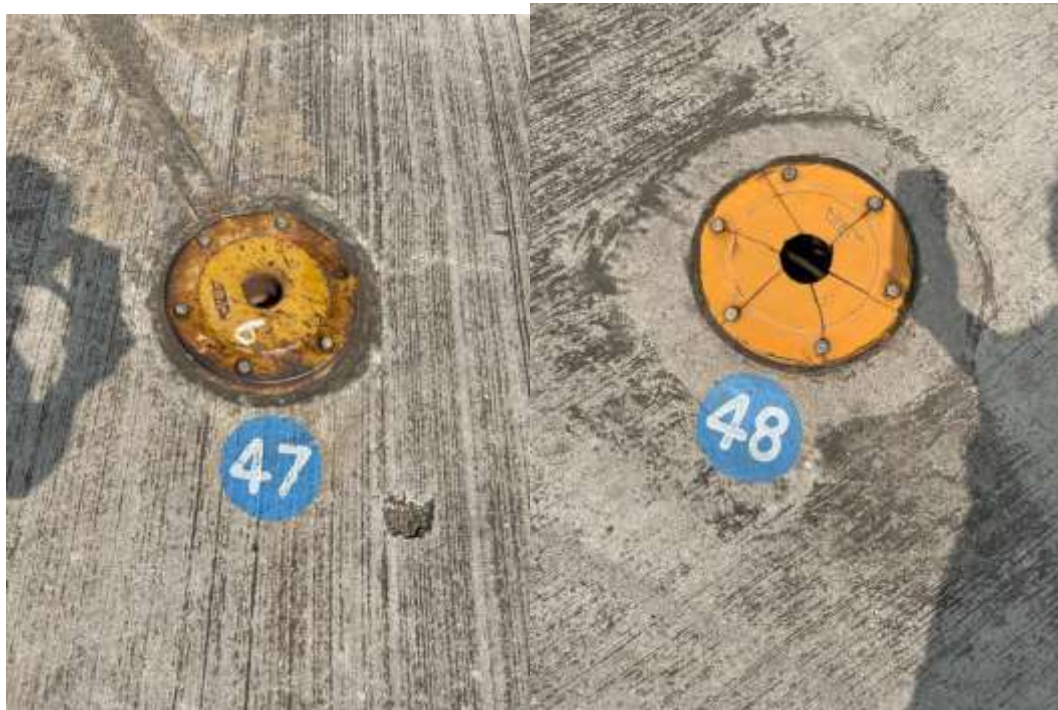
**Figure: Missing Edge lights in point of accident**

After exiting from taxiway 'A' to the right in between a few lights were found to be broken. Further, number 47 and 48 edge lights were not available but all the other lights are available before and after it. In absence of edge lights, it looks like to be an uninterrupted taxiway. The point in question is about accident site where apron edge lights were missing.

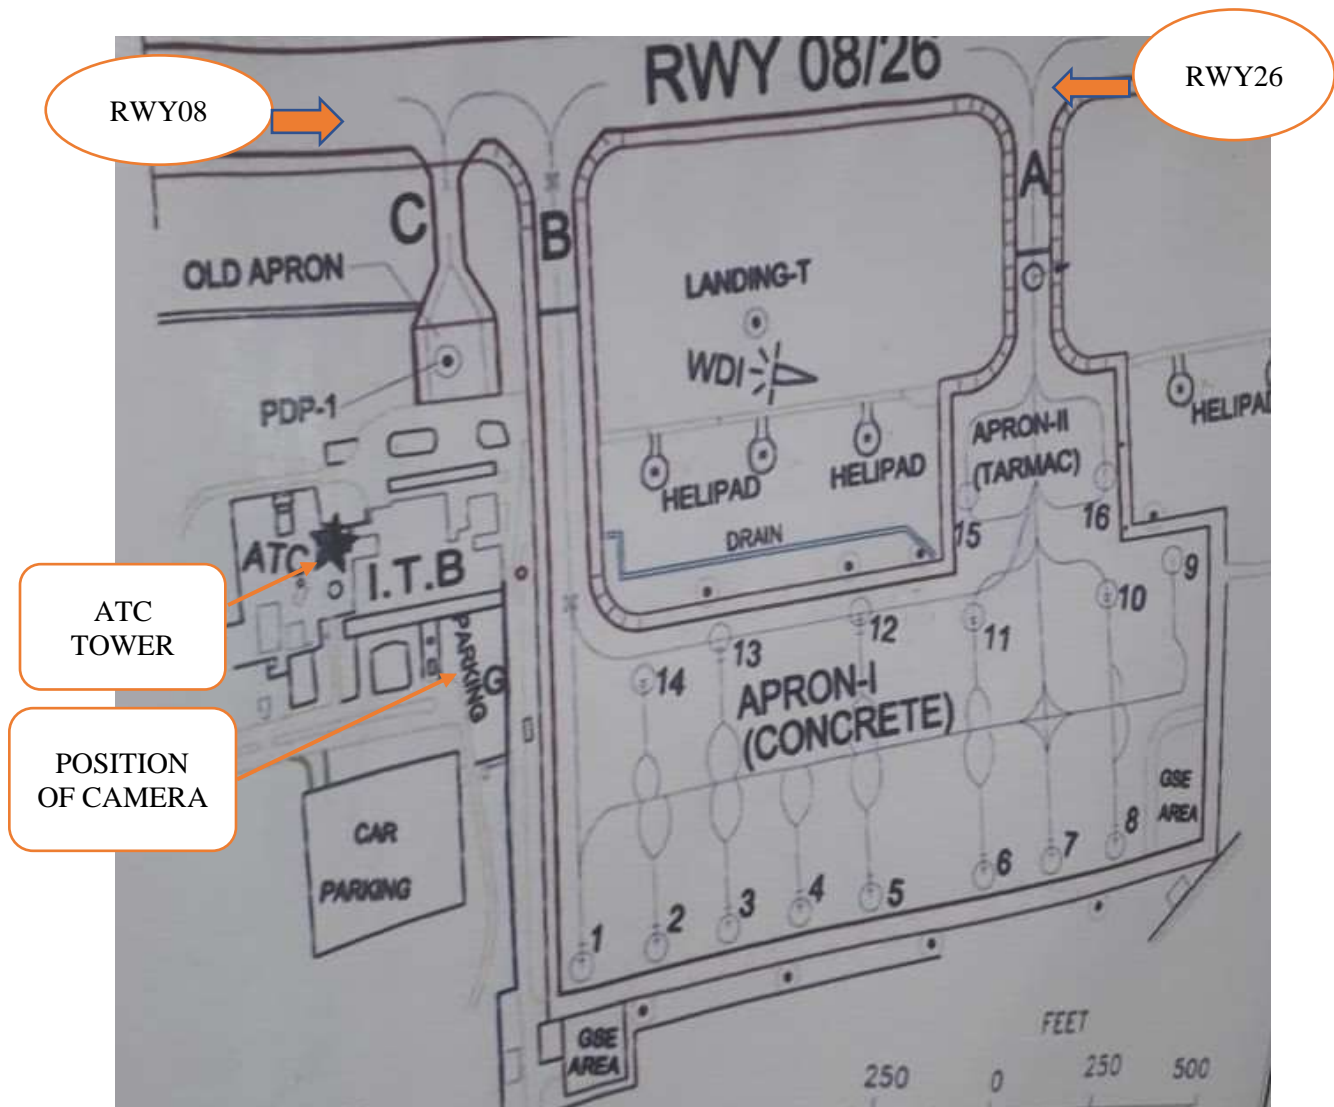
**FIGURE: THE POSITIONS OF ATC TOWER, CAMERA AND RUNWAY OREINTATIONS**

side of apron and towards Runway 08 threshold. This restricts controller to monitor both arrivals on runway 08 and aircraft movement on Apron simultaneously . Controller cannot monitor complete apron area due to blind zone viewed from ATC tower.

A CCTV camera is installed for monitoring vehicular movements on a road running along the taxiway B. The feed of the camera is available inside the tower. The aircraft movement on the taxiway B is also being monitored by this CCTV. However, there is no CCTV coverage available for taxiway A.

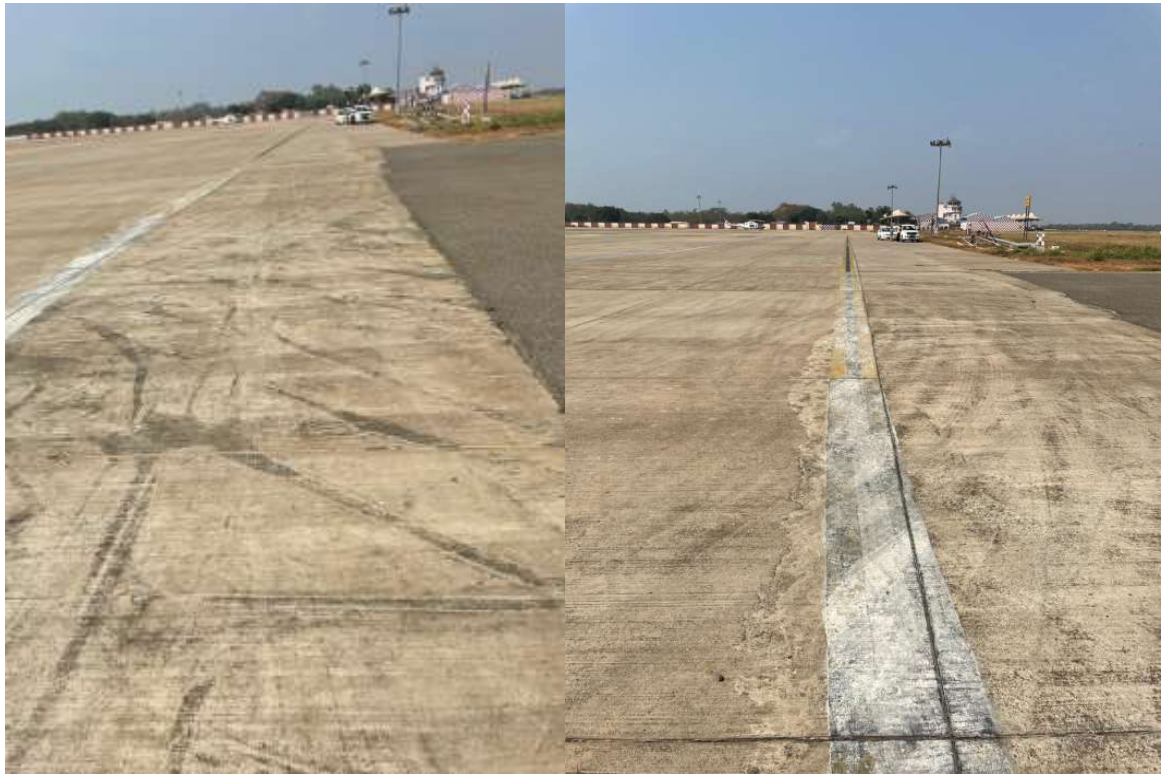
**FIGURE: SHOWING PERMANENT REMOVED MARKINGS AT APRON**

As per ICAO DOC 9157 (Aerodrome Design Manual), if any portion of marking needs to be erased on tarmac, it shall be completely erased by applying paint of color matching with the tarmac or grey color, so that it is not visible. At Vijayawada Airport, Taxiway marking were found faded and were not as per standards laid down in DOC 9157. At few places, taxiway marking were erased permanently but they were not in the color matching the tarmac. They were in white color paint. However, the markings erased were visible. It might create doubt in mind of the Crew.

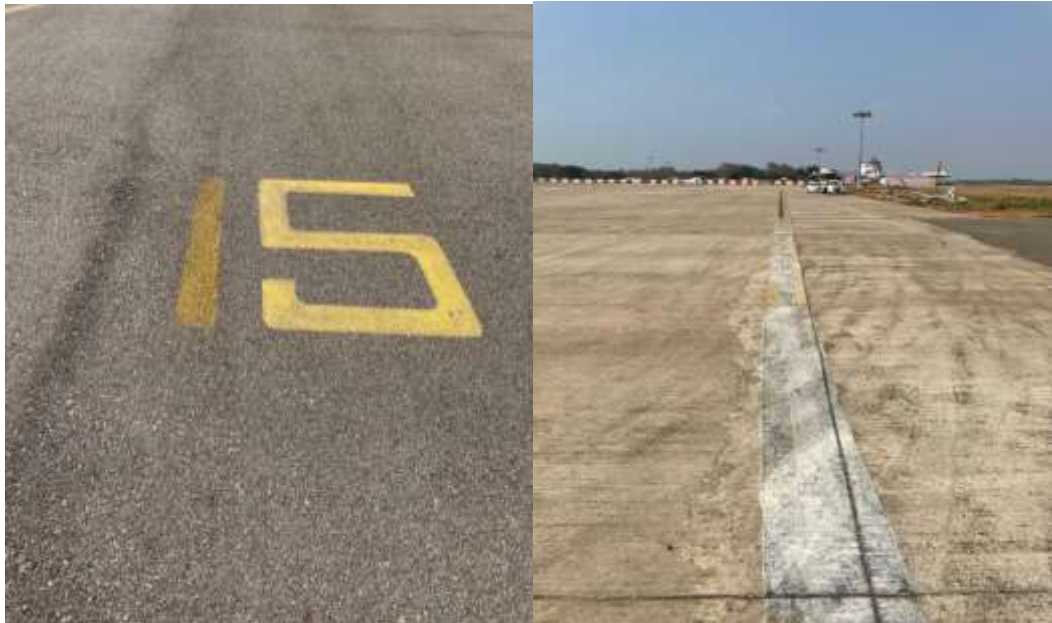
**FIGURES: NON STANDARD MARKING AT AIRPORT (at the time of accident)**

Vijayawada Airport is an International airport. The markings done on taxiway and at apron were not meeting the standard laid down in DOC 9157.

Alphabets and Digits are not as per standard sizes. Marking which are not in use were either not erased properly or were blur. It has been noted in the past that ambiguity or confusion for the markings were raised by the pilots to ATC.

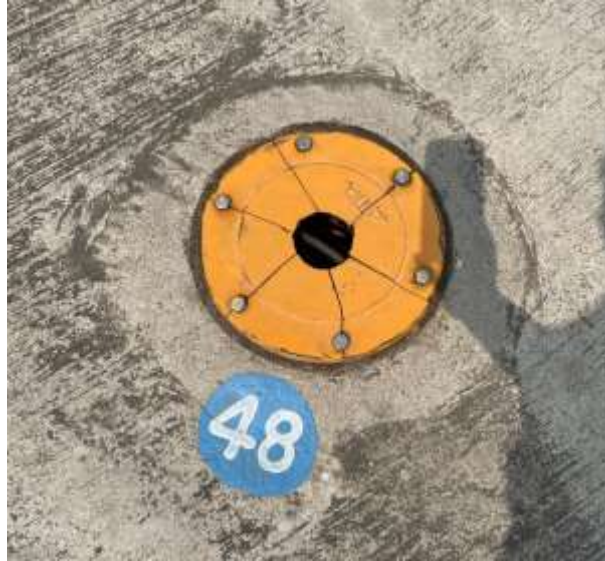
**FIGURE: MISSING TAXIWAY SHOULDER LIGHTS (at the time of accident)**

Few taxiway lights were found broken/missing intermittently. Irregular lights on taxiway shoulder create confusion in the mind of Pilot flying. As it seems to be a clear way for maneuvering.

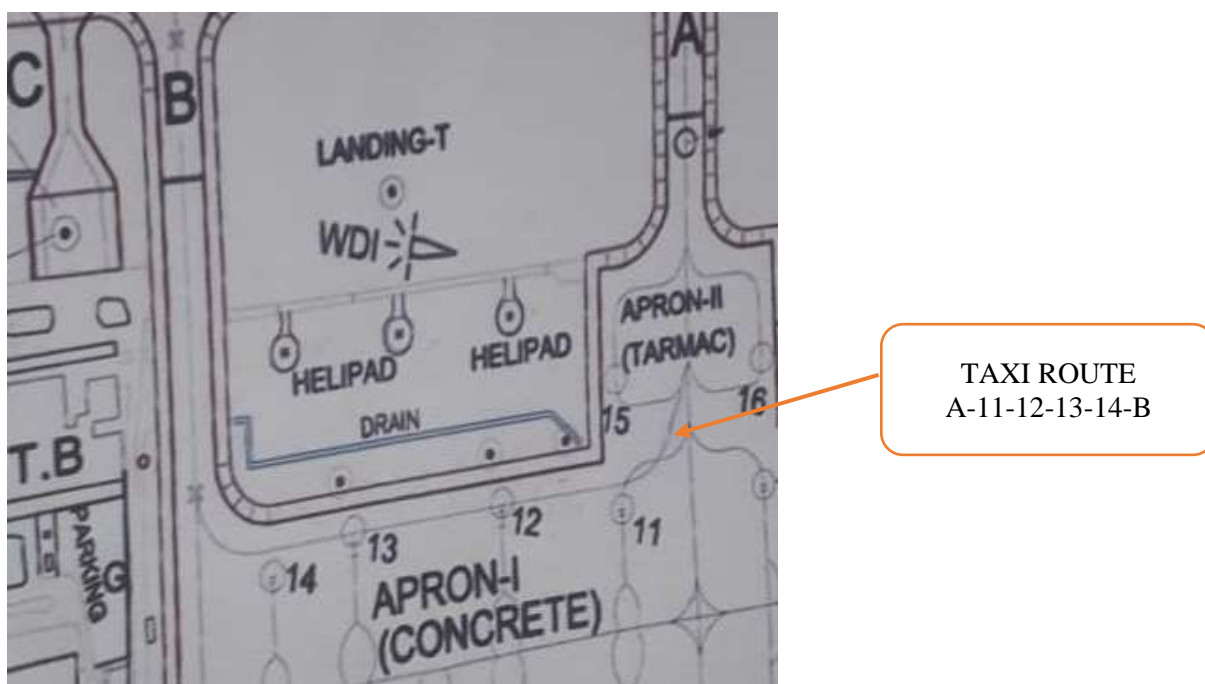
**FIGURE: SHOWING PUBLISHED TAXI ROUTING WHICH IS NON OPERATIVE**

Aerodrome layout published by AAI was also not updated. It is showing a taxiway connecting stands 11-12-13-14. However, at the time of accident this taxiway did not exist but, the same was not updated in the Aeronautical chart.
