Final Investigation Report
on
Accident to Interglobe Aviation Ltd.
Aircraft ATR 72-212A (600 version), VT-IYM
Enroute Trichirapalli, Tamilnadu to Bengaluru, Karnataka
on 04 Sep 2021

Aircraft and Accident details of Interglobe Aviation Aircraft VT-IYM on 04 September 2021			
1.	Aircraft	Type	ATR 72-212A (600 version), MSN1512
		Nationality	Indian
		Registration	VT-IYM
2.	Owner	M/S Truenoord Yamuna Limited	
3.	Operator	M/S InterGlobe Aviation Limited	
4.	Country of Manufacture	France and Italy	
5.	Pilot	ATPL and CPL	
6.	No. of Persons on board	52 passengers+02 Flight crew+02Cabin crew	
7.	Date & Time of Accident	04 Sept 2021	
8.	Place of Accident	During Cruise	
9.	Co-ordinates of Accident Site, AMSL	N11 44.504'N/78 18.590 E	
10.	Last point of Departure	Tiruchirapalli, Tamil Nadu, India	
11.	Intended landing place	Bangalore, Karnataka, India	
12.	Type of Operation	Scheduled Operation	
13.	Phase of operation	Cruise	
14.	Type of Occurrence	TURBULENCE	
15.	Extent of Injuries	Nil

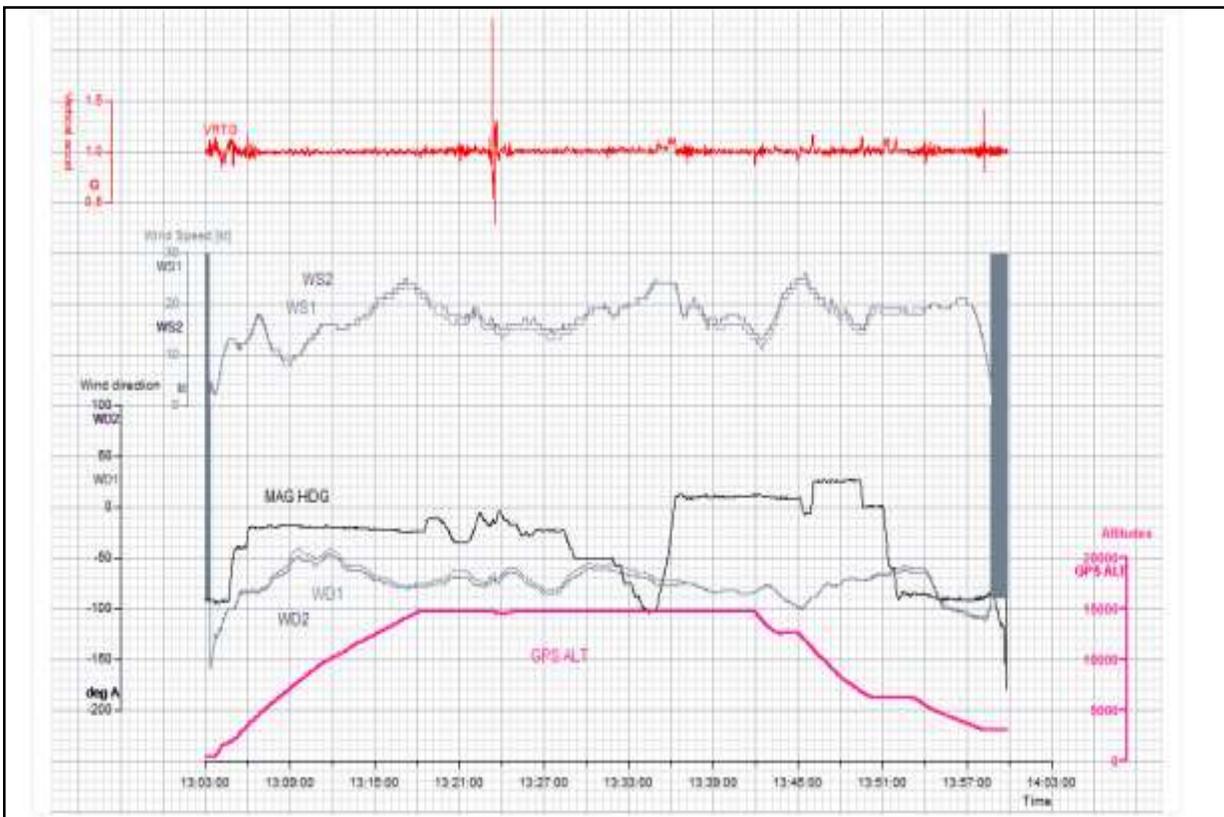
Figure 5: Recorded wind and context parameters during flight

The FDR wind speed and direction recorded from DU(FMS) during flight was between 260 to 315 degrees with a speed of 10 knots to 25 knots. Around the time of the event the wind speed was recorded from 285 degrees with a speed of 16 knots. The graph below shows that during most of the flight the estimated wind was from the west.

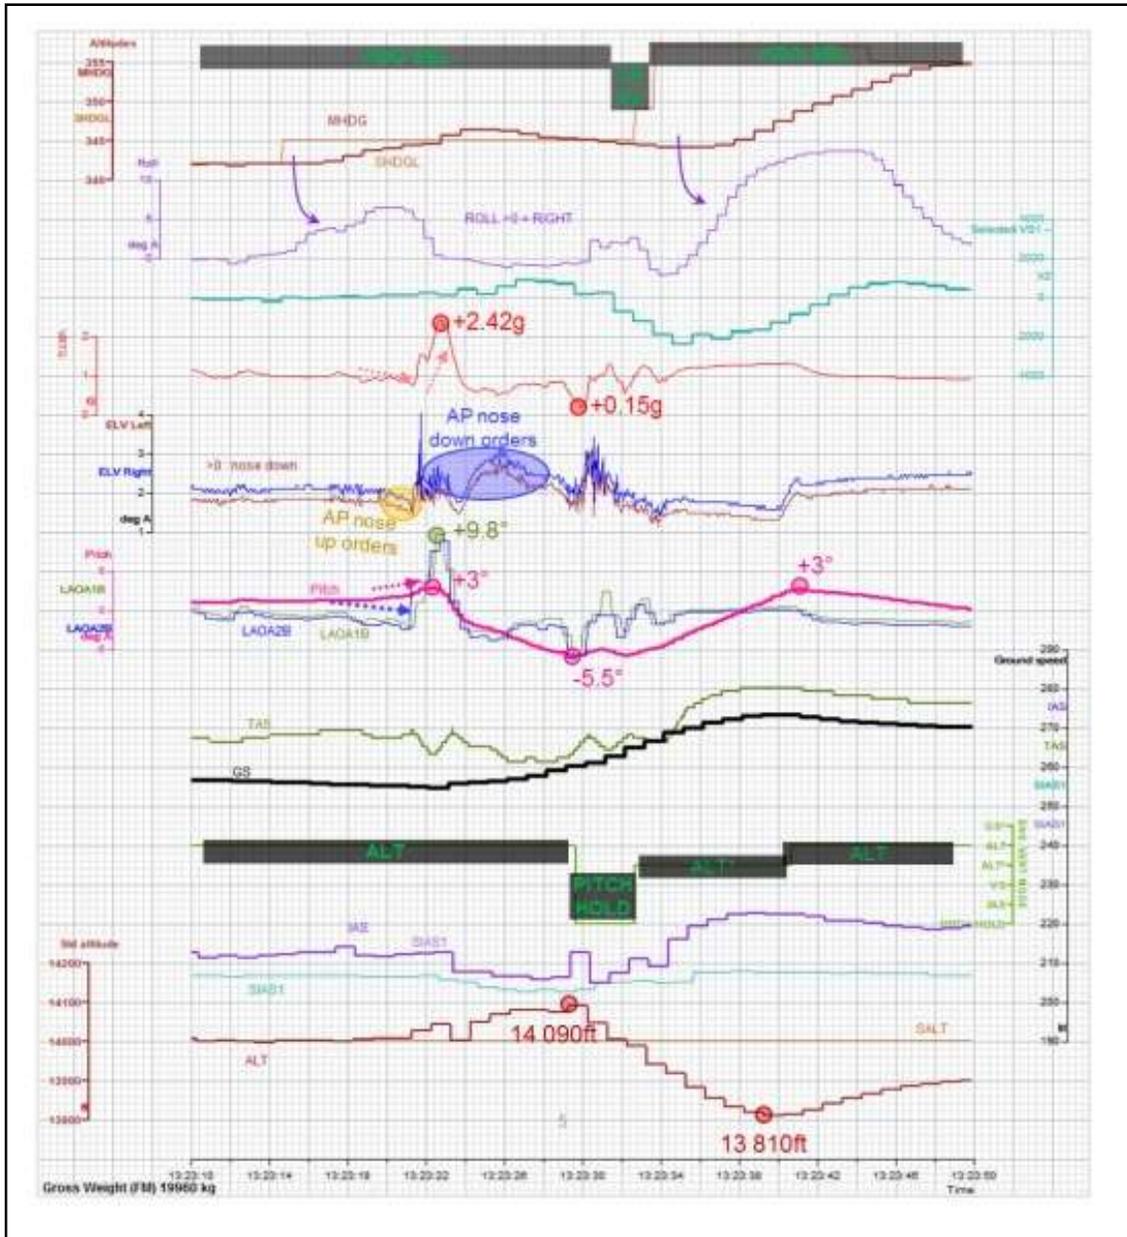
Figure 6: Main Parameters during the turbulence

The main parameters during the turbulence can be seen in the **Figure 6**. At 13.23.23 UTC, VRTG was maximum at +2.42g(2.419) and the aircraft experienced a decrease in altitude from 14060 feet to 14000 feet. LAOA1 reached a maximum of +9.8° and LAOA2 reached +8.9°. AP was commanding mainly nose down orders through elevators, pitch angle started to decrease from +3.0°. Difference between GS and TAS indicated that there was a probable decrease in the head wind. IAS decreased by 5kt within 1 second. The standard altitude increased towards altitude target +90ft. based on VRTG, on the difference between pitch angle and true angle of attack and on the difference between TAS and GS, significant horizontal and vertical wind changes most probably occurred around this time. The aircraft climbed back to 14060 ft at approximately 13:23:25 UTC. At 13:23:28, the aircraft altitude started to decrease and reached 13910 ft at 1323:39. The IAS continued to remain between 207 – 212 knots throughout this period. The Autopilot modes remained in the HDG SEL and the ALT modes throughout the turbulent area and remained engaged throughout.

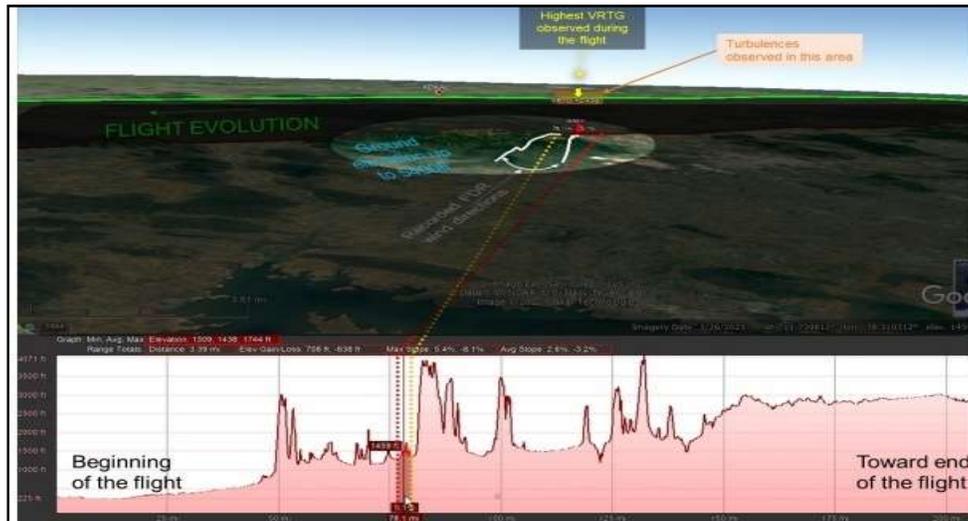
Figure 8: Location of turbulence area as per Google Earth

The turbulent area was observed during approximately 26 seconds, from 13.23.09 UTC to 13.23.35 UTC. Based on GoogleEarth ground elevation, the turbulent area was located downwind and western of mountains with ground elevation up to 5400ft. Aircraft was flying at FL140.
