Final Investigation Report
on
Serious Incident of Airprox
between
A320-251N aircraft VT-EXQ of M/s Air India Ltd
and
King Air 65-C90B aircraft VT-NKF of M/s Pinnacle Air Pvt. Ltd.
on 5 October 2021 in Mumbai FIR

GOVERNMENT OF INDIA
MINISTRY OF CIVIL AVIATION
AIRCRAFT ACCIDENT INVESTIGATION BUREAU

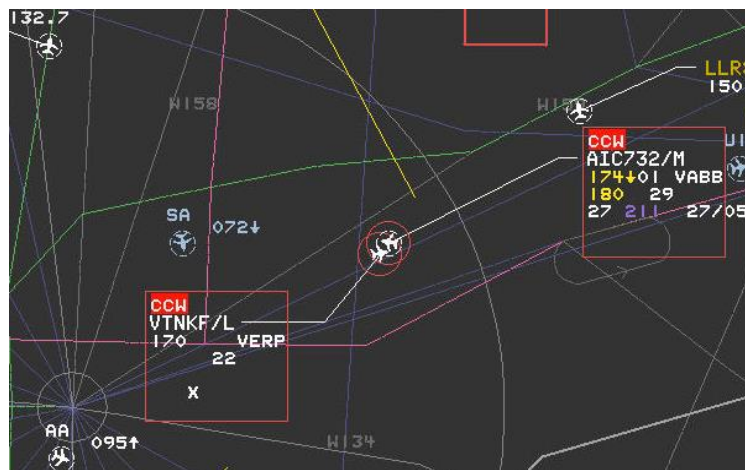
Figure 1

Approximately 40 NM North East of Mumbai Airport

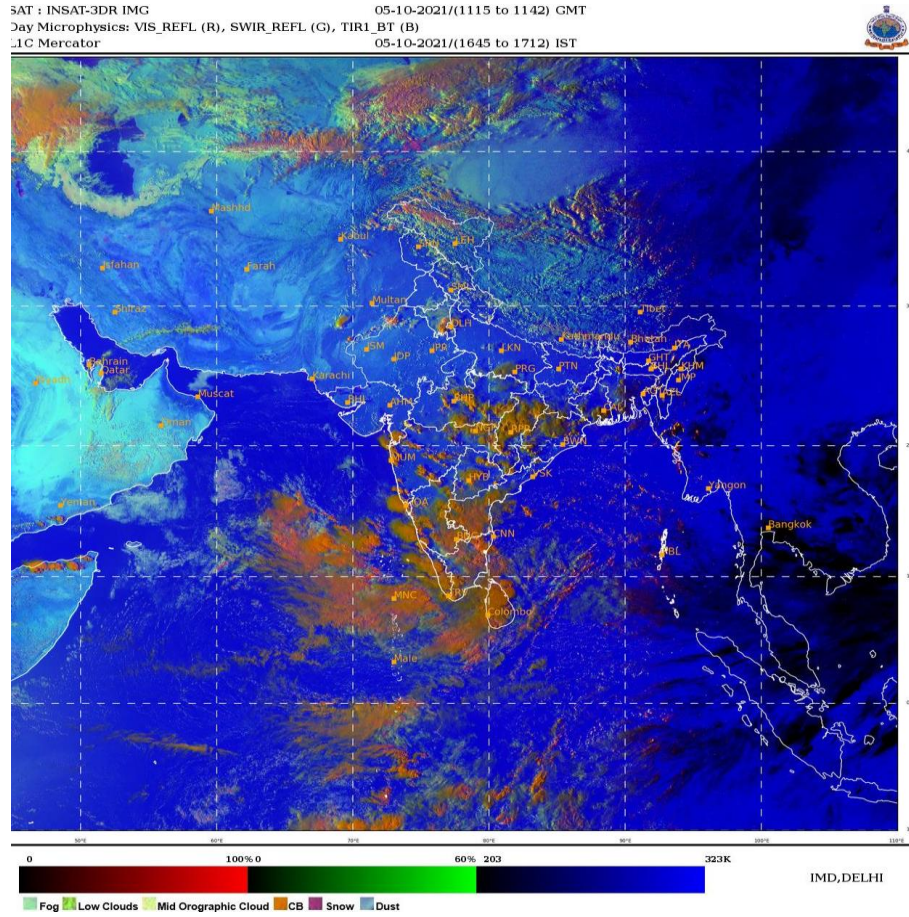
Figure 2

The local forecast for Mumbai and 100 NM around Mumbai issued at 05:30 UTC valid from 06:00 UTC to 14:00 UTC clearly indicated that there might be few cells of CB during the period 06:00 UTC to 14:00 UTC in North East of Mumbai. Satellite image of the period 11:15 UTC to 11:42 UTC was clearly showing that there were few CB cells enroute from Patna to Mumbai. Doppler radar (Mumbai) image 11:02:35 UTC also showing CB cells in the NE of Mumbai, in the airspace where AIC732 and VTNKF were flying. The flight crew of AIC732 aware of adverse weather conditions, particularly about CB cells requiring weather avoidance action.

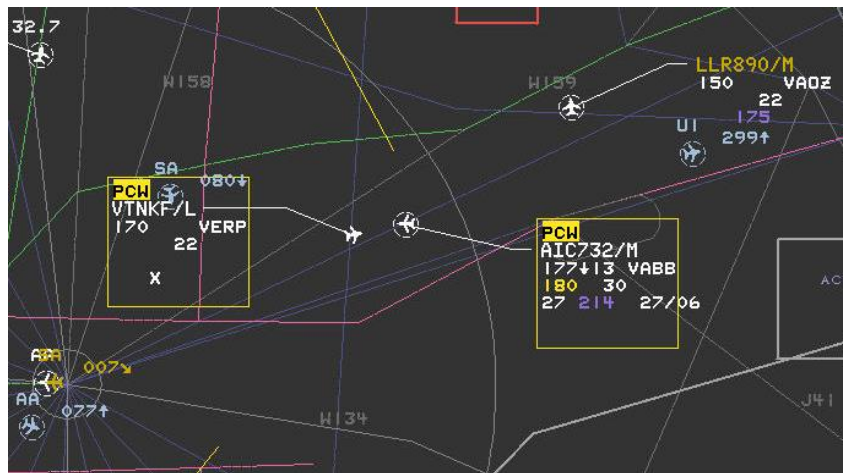
Figure 4

A conflict warning generated for potential infringement of separation minima is known as PCW (Predicted Conflict Warning). On the day of the incident, PCW for AIC732 and VTNKF was generated on the controller's situation display in yellow colour as depicted in figure 4 below:

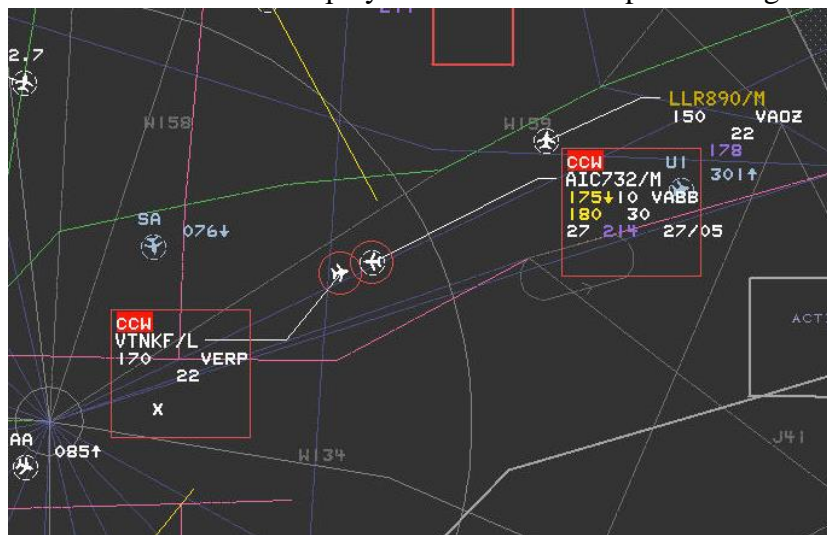
Figure 5

A conflict warning is generated for the actual infringement of separation minima is known as CCW (Current Conflict Warning). On the day of the incident, a CCW for AIC732 and VTNKF was generated on the controller's situation display in red colour as depicted in figure 5 below:

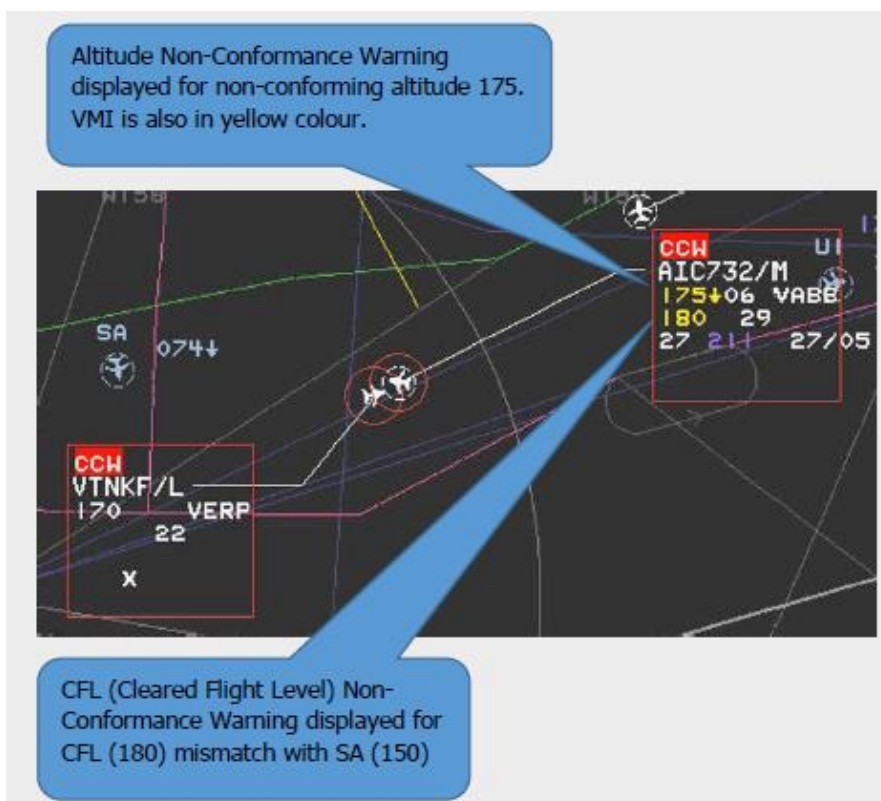
Figure 6

On the day of the incident, the above warnings were generated for AIC732 on the controller's situation display having visual depiction in same colour (yellow) as given below in figure 6:

- c) **CFL (Cleared Flight Level) Non-Conformance Warning:** In spite of all of the above failures of safety net, had CFL (Cleared Flight Level) Non-Conformance Warning was optimized to generate warning in prominent colour to the controller within few seconds say 5 sec after difference in FCU selected altitude and CFL input by the controller, the incident could have been averted by the controller.

- 4) It is recommended that AAI should review of the time (interval) parameter for generation of CFL Non-Conformance Altitude Alert and its visual depiction on the situation display of an air traffic controller when such condition exists.
