Final Investigation Report
on
Serious Incident to M/s SpiceJet Limited
Aircraft DHC-8 Q-400, VT- SUW
on 22 November 2021

SYNOPSIS

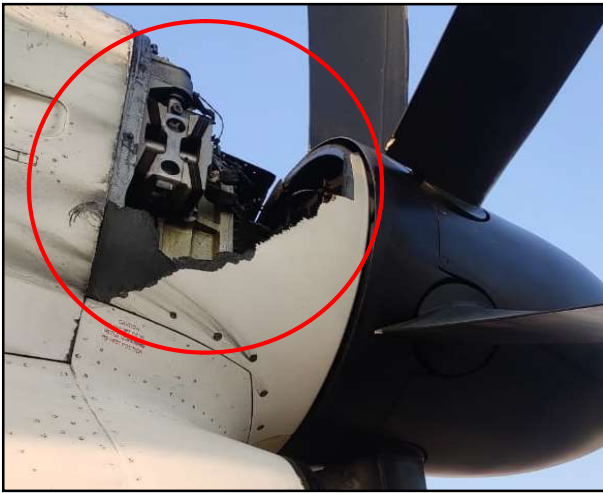
1.12.2 Damage occurred during incident was confined to the RH engine's forward upper cowls, propeller blades and to the propeller's back plate. The RH engine's outboard upper forward cowl had fragmented into 3 pieces (Refer fig 10 & 11) and the inboard upper forward cowling sustained a significant crack in mid section (Refer fig 9). One hole was found on the outboard UFC forward section. All propellers got minor damage in the trailing edges of blade root section (Refer fig 13) and 3 ribs of back plate in hub assembly found to have sustained damages (Refer fig 12) due to pieces of UFC pierced through them.

Fig 8: Missing outboard upper forward cowling

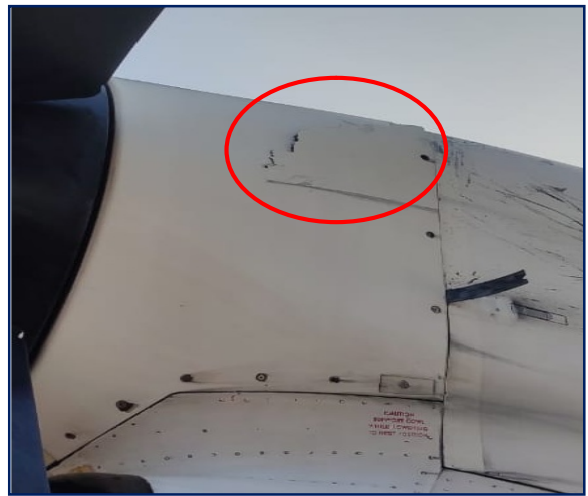
Fig 9: Cracked inboard upper forward cowling

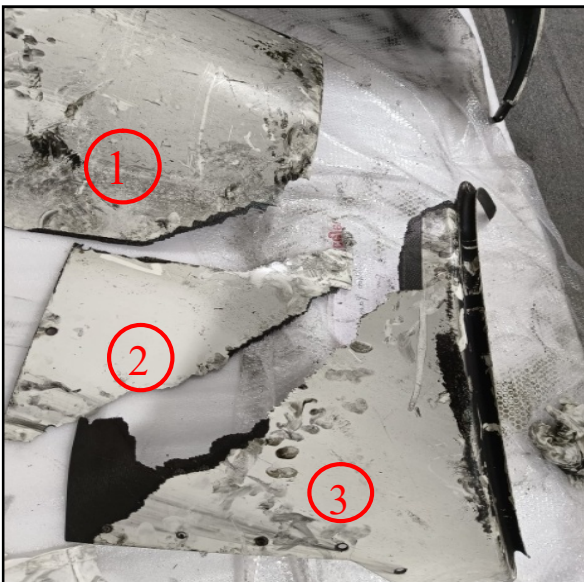
Fig 10: Three pieces of the outboard UFC

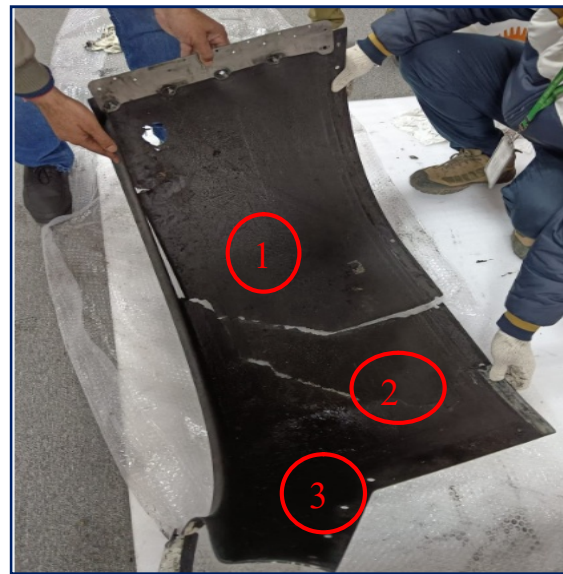
Fig 11: Inside view of the outboard UFC

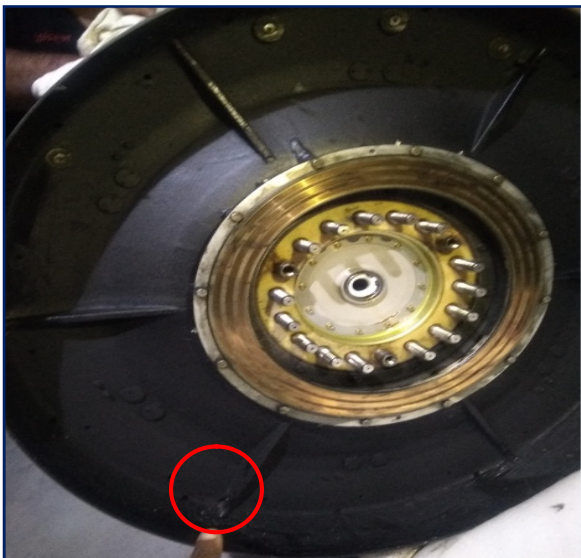
Fig12: Back plate hub assembly damages

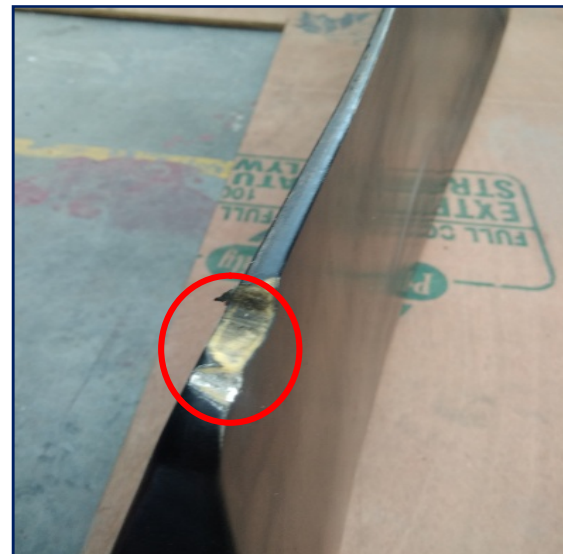
Fig13: Damages in the propeller blade

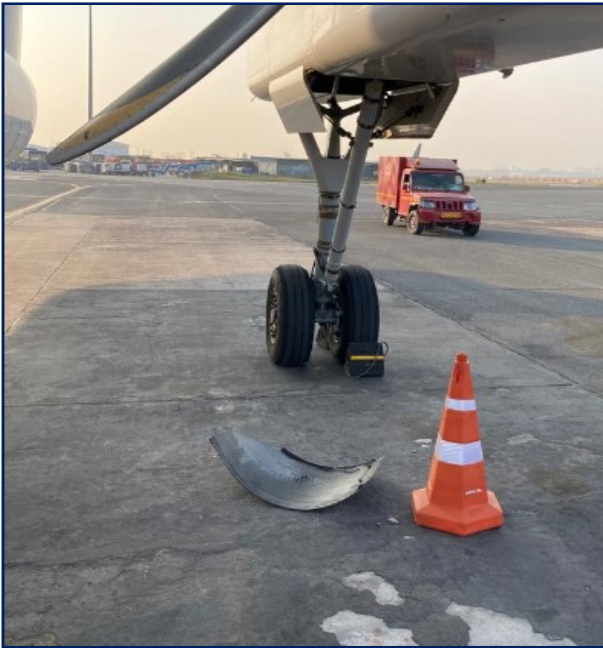
Fig 14: Wreckage part under LH engine

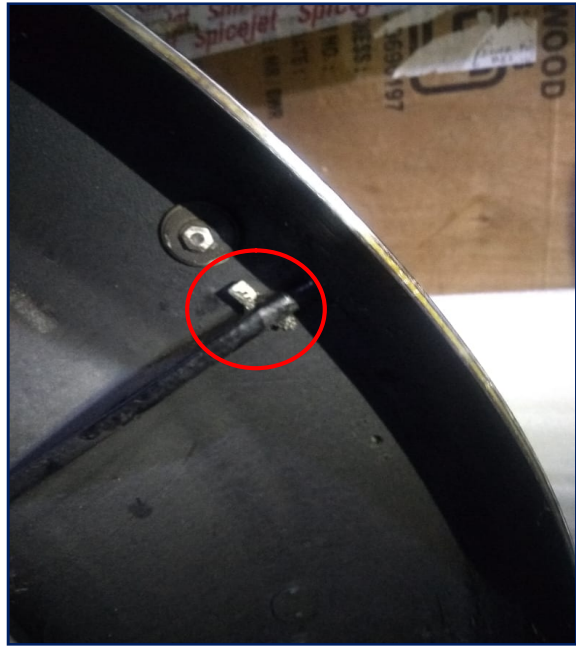
Fig 15: Small UFC pieces pieced into Hub Rib

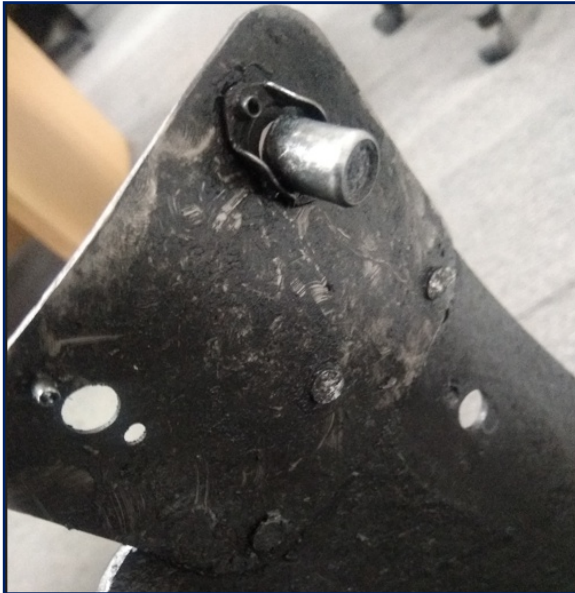
Fig 16: Bottom metal strap view from inside

- h) On bottom metal strap, one receptacle was found missing and the other receptacle was found attached with shim. From tell tale signs found on the bottom metal strap, it appears that the fastener was missing for quite some time.

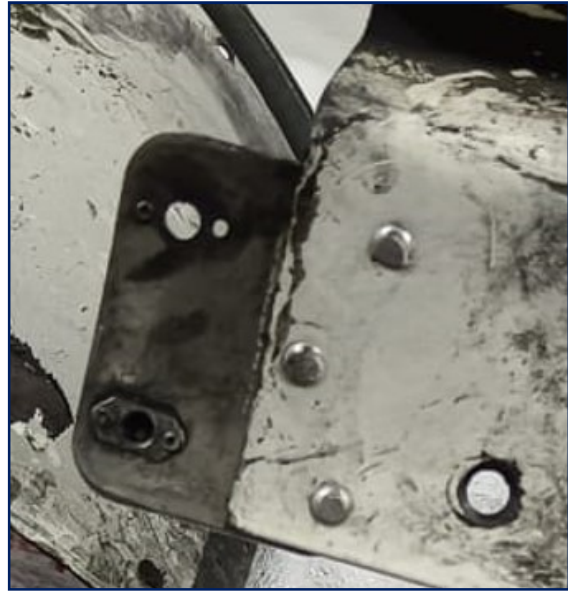
Fig 17: Outer view of bottom metal strap

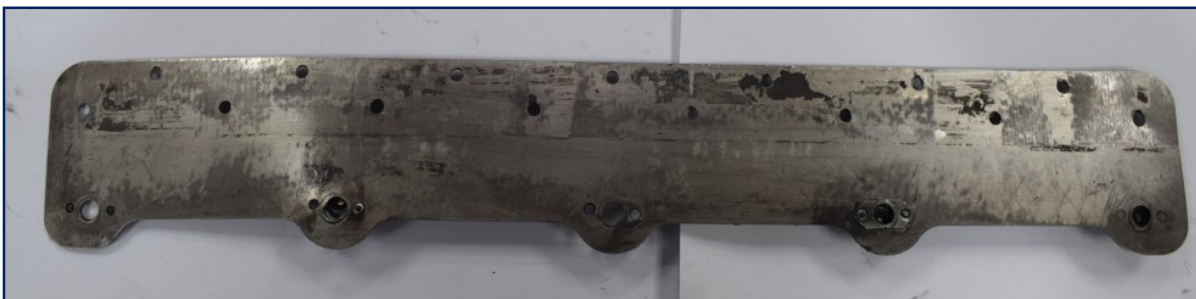
Fig 18: Top metal strap (Top view)

- a) All fifteen rivets, which join the top metal strap with the inboard UFC had failed. However, one sheared rivet was found attached with the composite inboard UFC.

- b) All fifteen rivet holes were found elongated.
- c) Top metal strap riveted to inboard UFC, was found attached with outboard UFC by three fasteners.

- d) Fasteners tell tale signs found on the top metal strap and cowling indicates that out of five Camloc fasteners two fasteners were already missing i.e., prior to this incident.

- e) Top metal strap was found with bend at both forward and rear end. The rear end bend was found more prominent than the forward end.
- f) On top metal strap, receptacle rivet holes were found elongated, especially where shim were found used.

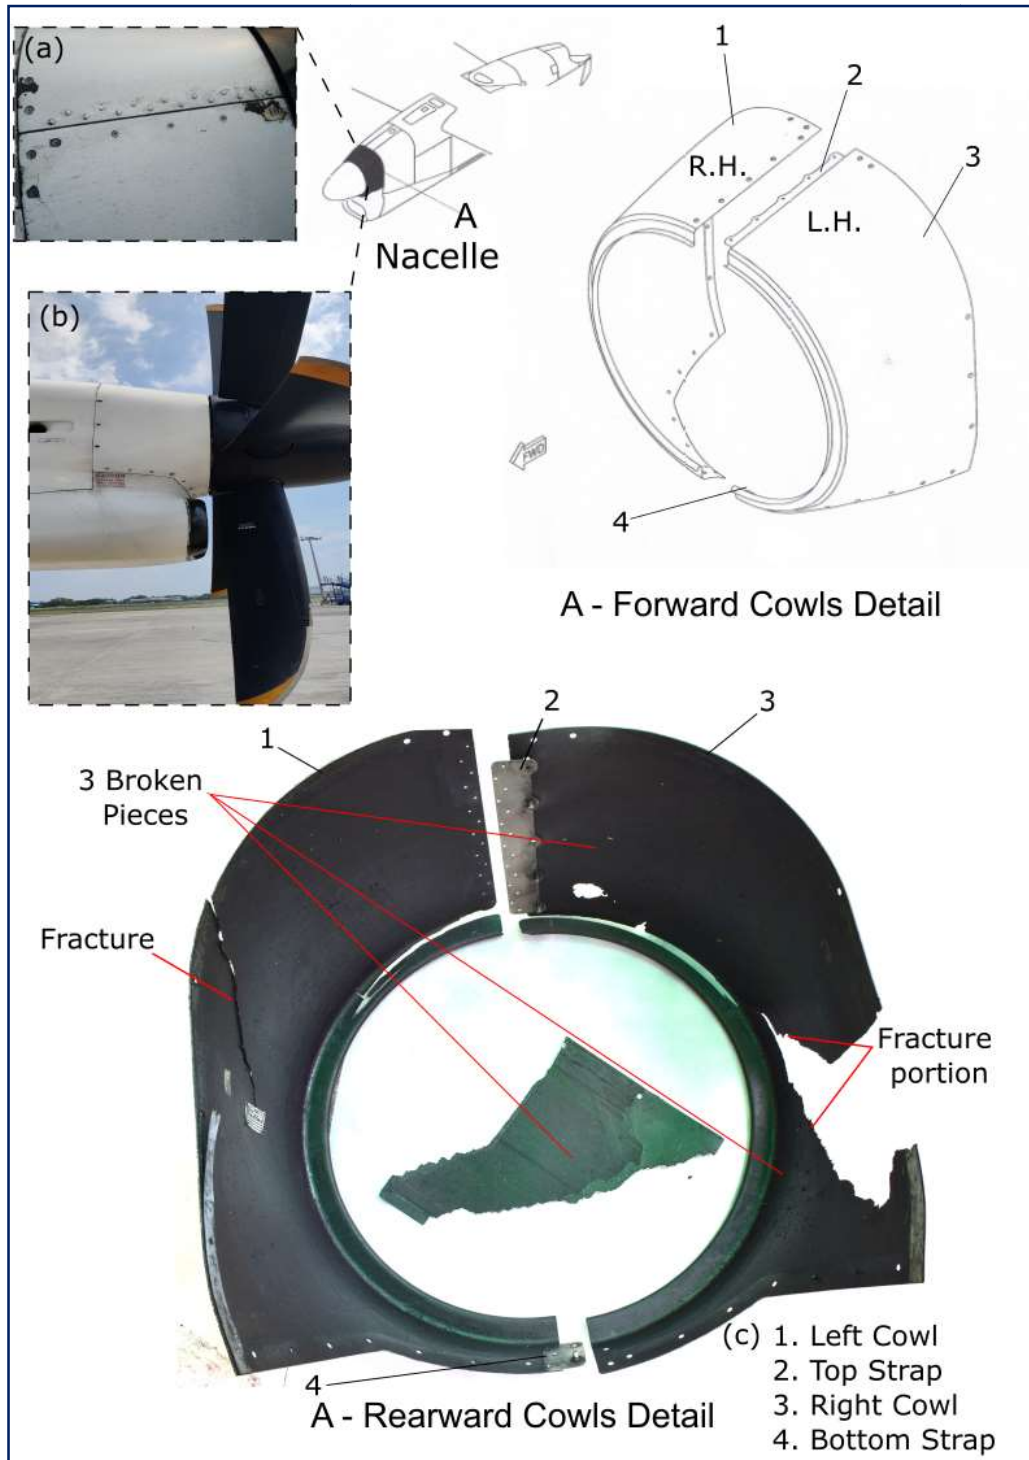
Fig 19: Schematic view, installation position and visual examination of upper forward cowling

- i. During the visual inspection, the left cowl (L.H.) and right cowl (R.H.) were found fractured, as shown in Fig. 19 (c).
- ii. The R.H. side UFC composite panel was found broken into 3 pieces at various locations, whereas L.H. side found with fracture on the composite panel, as shown in Fig. 19(c). The strike damages were also observed on R.H. and L.H. side UFC, as shown in Fig. 20 (c – 1, 2 & 3).
- iii. At the top fitting of the upper forward cowling, two fasteners (F_1 and F_3) and fourteen rivets (R_1 to R_{14}) were found missing, as shown in Fig. 20 (a).

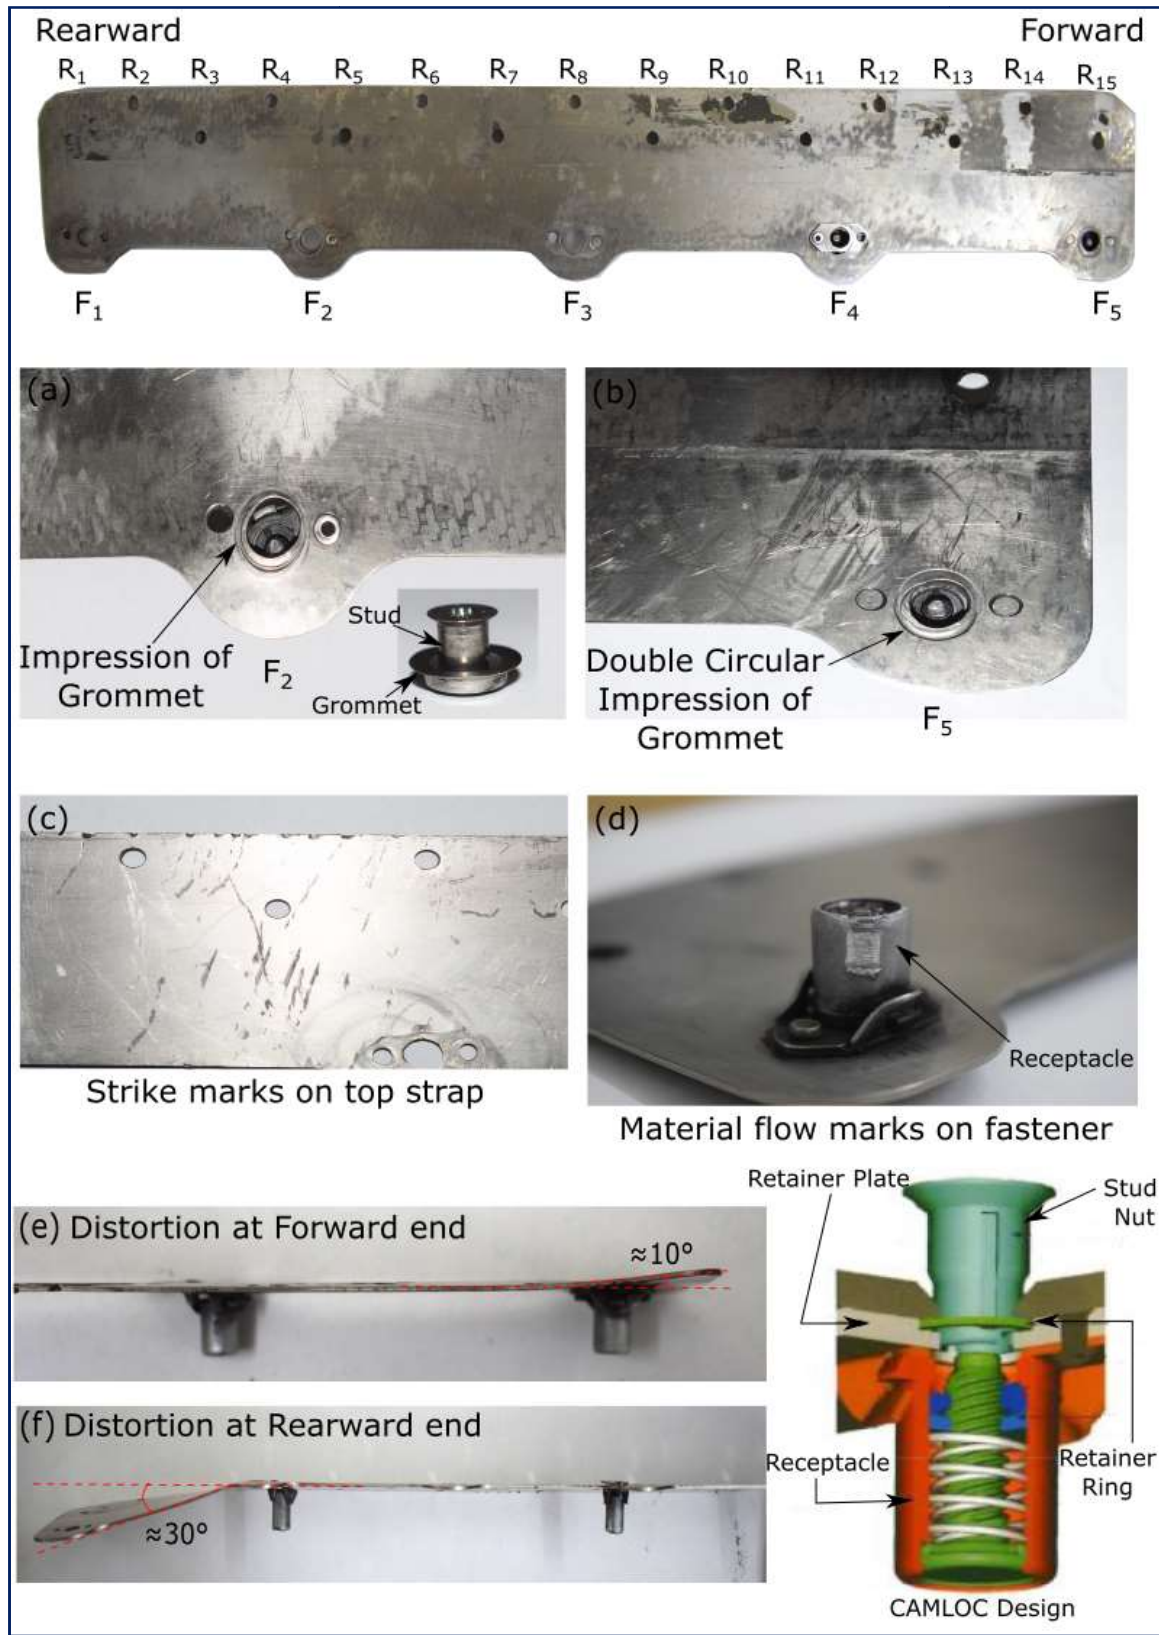
Fig. 21: Visual examination of top strap.

- ii. At all five fastener locations on the top strap plate multiple impressions of grommets were observed, as shown in Fig. 21 (a) & (b).
- iii. The strike marks were also observed on the top strap, as shown in Fig. 21 (c).

- iv. The top strap was also found to have distortion at the forward and rearward end, as shown in Fig 20 (c) and Fig. 21 (e) & (f). The forward end bent at approximately 10° angle and the rearward end at about 30° , as shown in Fig. 21 (e) & (f), respectively.

- a. The material flow was found on all receptacles of fasteners, as shown in Fig. 21 (d).
- b. One clamp washer was found at F_4 during the visual inspection, as shown in Fig. 22.

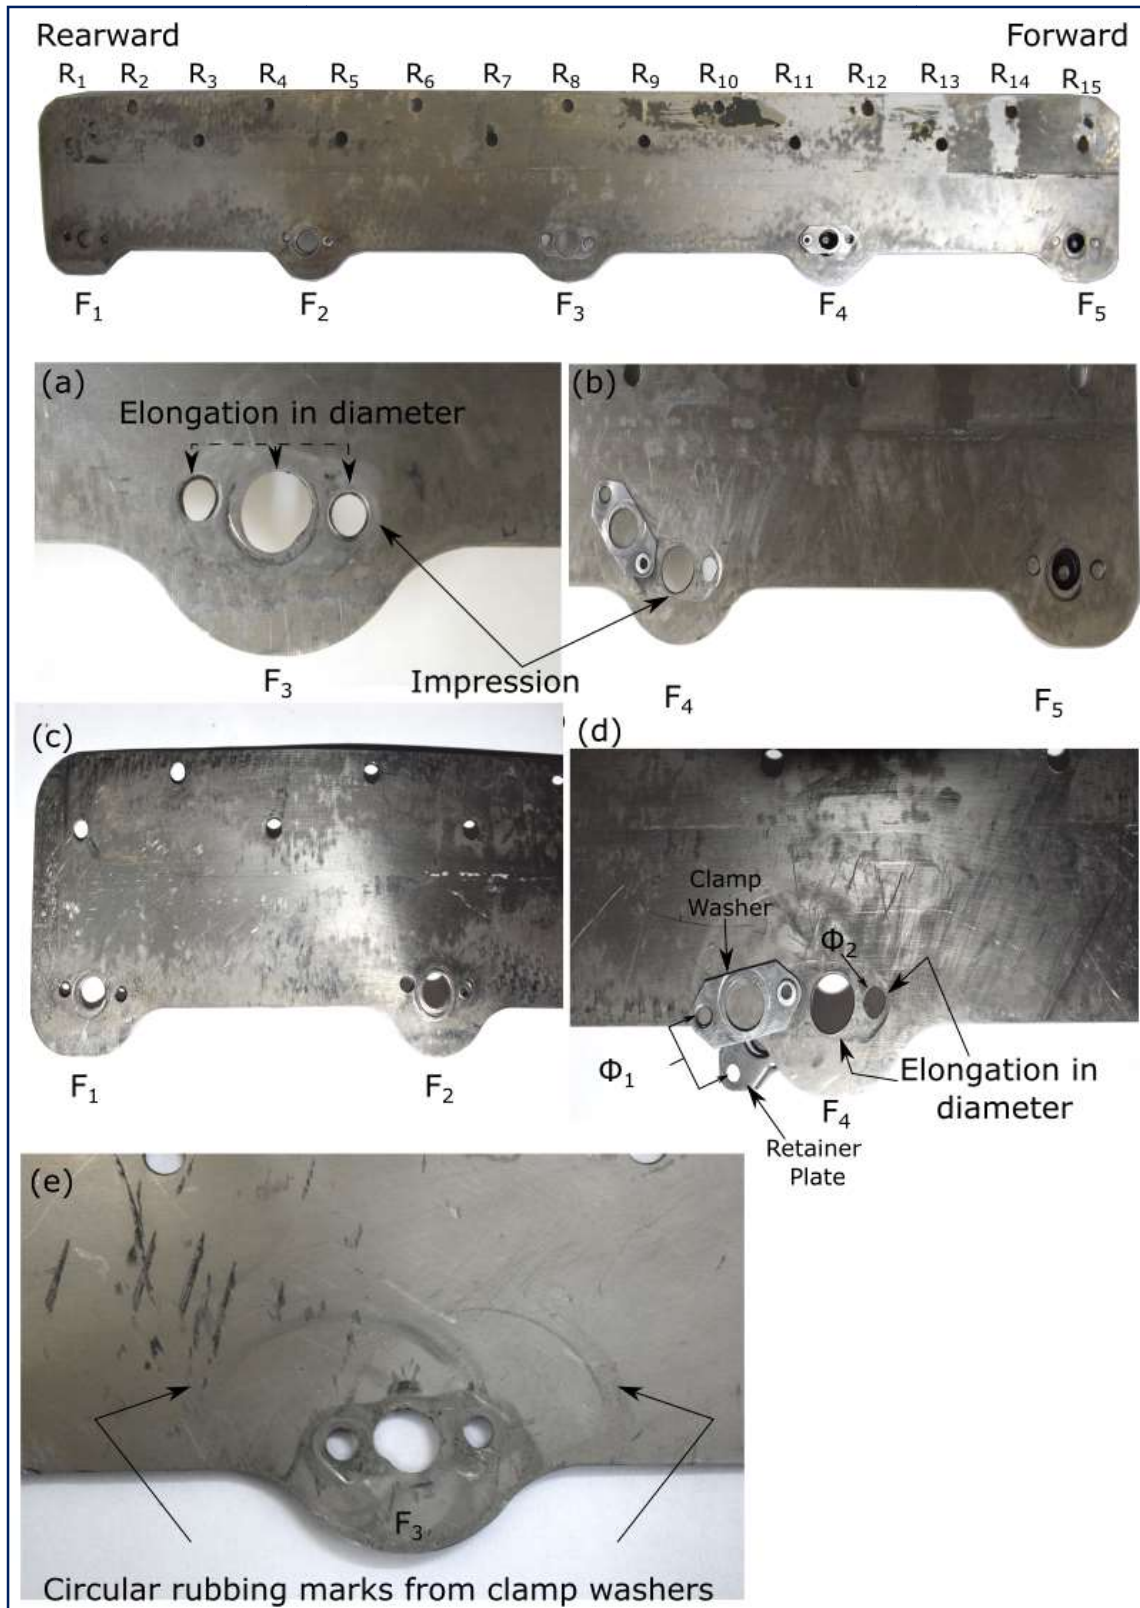
Fig. 22: Visual examination of top strap and drilled holes.

- v. The ovality was observed on all five fastener holes (F_1 to F_5 , oval) and on all fifteen rivet holes of top strap, as shown in Fig. 22.
- vi. The two circular arcs of rubbing marks about the two rivet axes were found at F_3 , as shown in Fig. 22 (e).

- c. The impression of clamp washers were also observed on F_3 and F_4 , as shown in Fig. 22 (a) & (b), and there was no significant presence of clamp washers impression on F_1 , F_2 , and F_5 , as shown in Fig. 22 (b) & (c).

- d. The Camloc receptacle rivet hole at F_4 on top strap was found over-sized ($\Phi_2 > \Phi_1$) compared to corresponding drilled holes on the clamp washer and retainer plate, as shown in Fig. 22 (d).

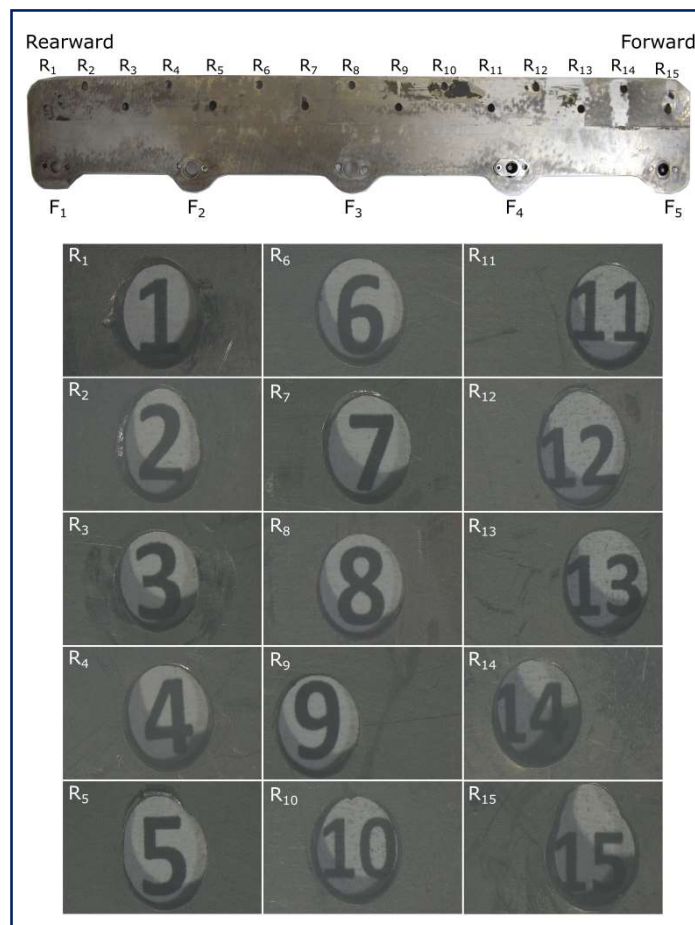
Fig 23: Stereoscopic examination of faying surfaces of rivet holes on top strap.

- e. The faying surfaces and drilled holes (R_1 to R_{15}) on the top strap were examined under the stereo-microscope and all drilled holes (R_1 to R_{15}) were found oval in shape with damages at their circumferences, as shown in Fig. 23.

The fasteners and rivet joints failed due to overload.

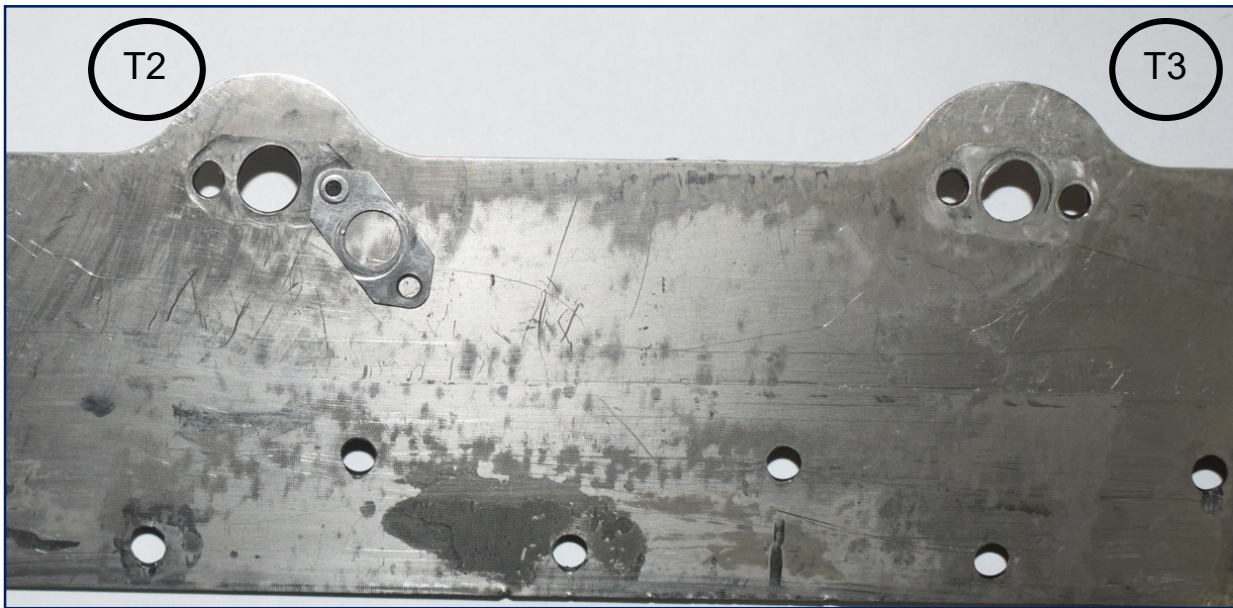
a) During investigation, the rivet holes diameter (on T2 & T3 location as per organization's engineering circular) found on the metal strap was quite larger than the rivet holes diameter of receptacle unit. (Refer fig 24 & 25). **This is a tell tale sign, which confirms that the elongation found on the rivet hole of the metal strap are pre existing to this incident.** The same is confirmed in the DGCA laboratory report.

Fig 24 : Metal strap viewed from top

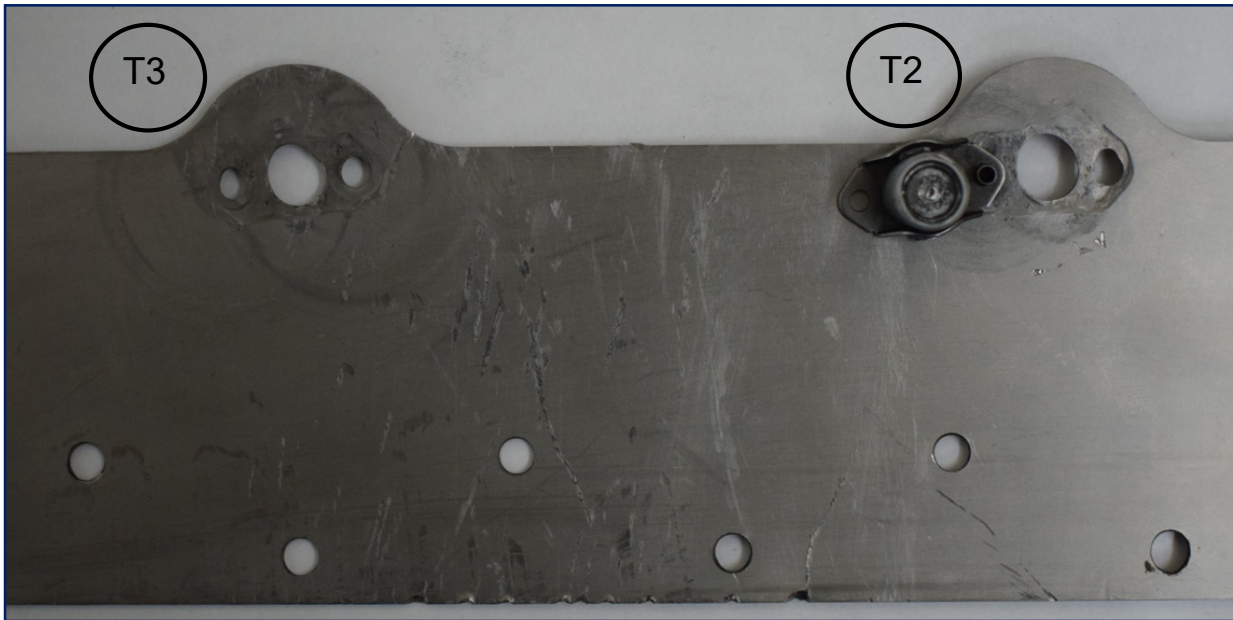
Fig 25 : Metal strap viewed from beneath

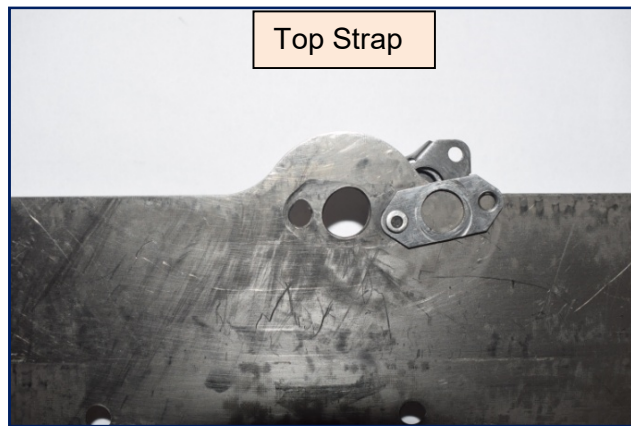
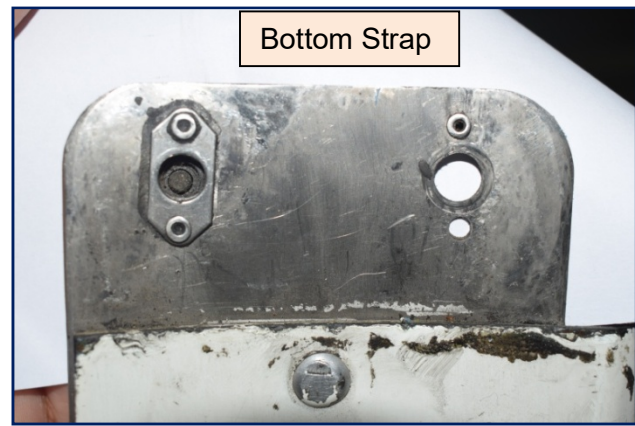
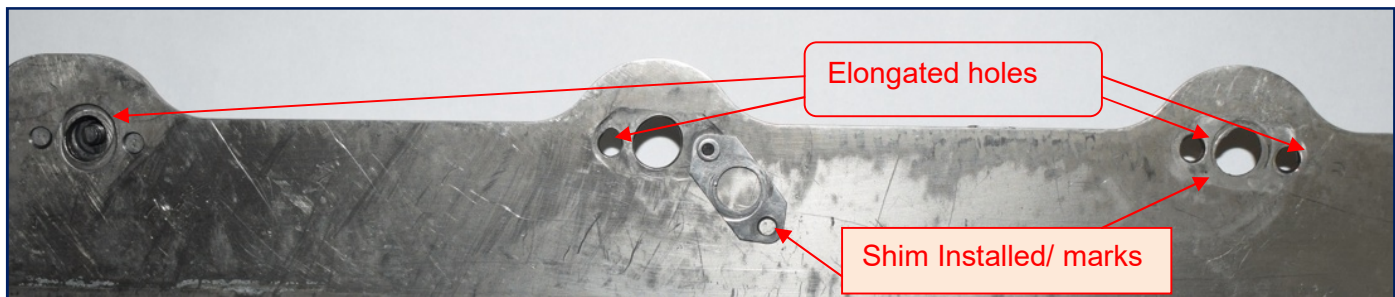
b) Shims were found installed inappropriately over the metal strap instead of using between the metal strap and the receptacle unit/ housing as given in OEM maintenance data. Maintenance personnel were found not capturing the observation/ rectification action as required by the organization's engineering circular. This will hamper the follow up action and lead to lack of traceability of the work carried out. Therefore, the exact reason and date/place of maintenance/installation of the shim on the metal strap could not be traced from the maintenance records. In the installation shown in the photograph, the shim is installed over the metal strap. As per OEM data the shim is an optional component to ensure proper grip length of the chosen rivets i.e., to accommodate different type of rivets lengths.

Fig 26: Shims installed over elongated rivet holes.

c) During investigation, Shim marks found on the metal strap indicates that the shims were used at multiple locations against the OEM design requirements for shim. The shims were used as back plates in order to rivet the receptacle with elongated metal strap rivets holes, **which is a non adherence to the maintenance procedures/data as given in SRM**. Same is confirmed in the DGCA laboratory report. This infers that instead of discarding the metal strap with elongated rivet holes as required by the SRM, organization has installed shims as back plates to fix the receptacles with elongated holes. This inappropriate installation would interfere with mating part creating a gapping condition and will interfere with the normal operation of the Camloc fasteners installed on the UFC.

As a result of inappropriate Shim installation, the Stud nut will not be able to engage completely with the receptacle. Consequently the Camloc fasteners installed with shims will not be able to carry the designed loads and this will redistribute and increases the stress concentration on the remaining fasteners and rivets. With this configuration, when UFC was subjected to the vibrations caused due to rotating propeller blades and the vibration created by the other rotating components of the engine in addition to the severe conditions of exposure to aerodynamic buffeting due to propeller wash eddies may accelerates the failures of Camloc fasteners and rivets.

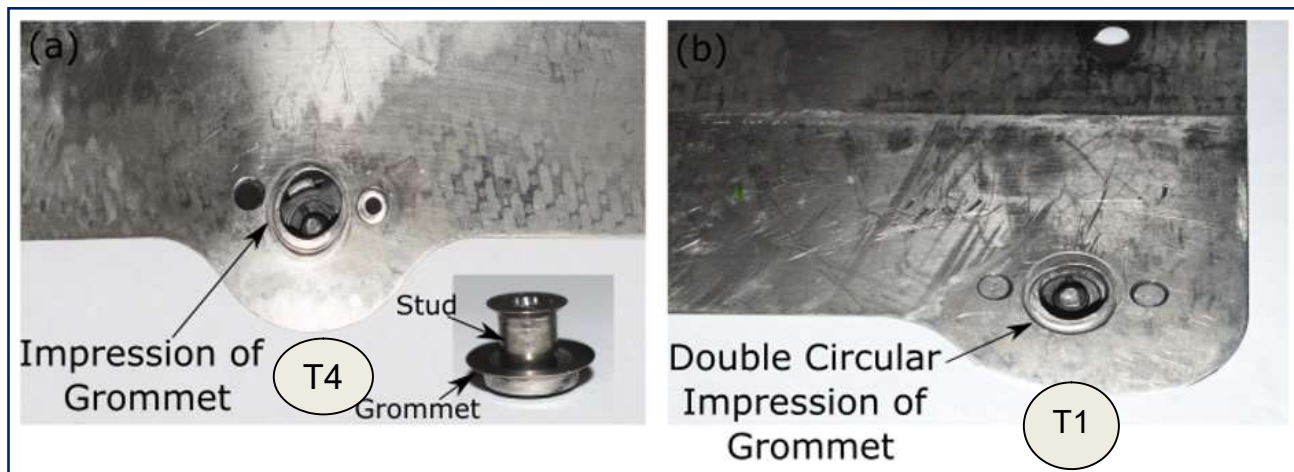
d) Impression of grommets were observed on the top metal strap at multiple Camloc fastener locations i.e., Grommet was found damaging the metal strap. Grommet impression on the metal strap indicates improper installation (tooling/techniques).

Fig 27: Grommet Impression on metal strap

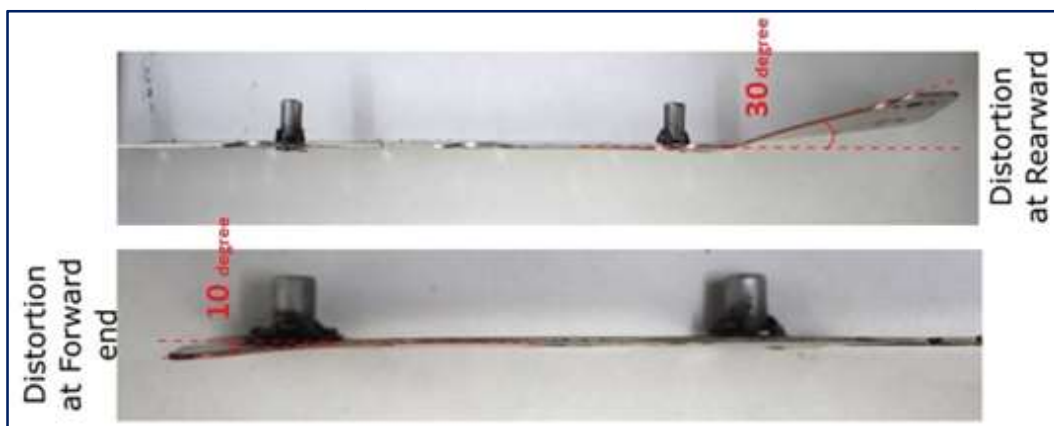
During the investigation, there were tell tale signs which indicates that 02 (T3 and T5) out of 05 fasteners installed on the top metal strap were missing prior to this incident. Therefore the metal strap fasteners were under increased stress/load. Which can explains the bend found on the top metal strap, which is more pronounced in the rear side than the bend found on the forward side of the top metal strap. **Therefore, it is concluded that the RH UFC failure started from the rear end of metal strap.**

Fig 28: Top metal strap bend
