**FINAL INVESTIGATION REPORT ON ACCIDENT TO**  
**M/S FALCON AVIATION ACADEMY, CESSNA 152 AIRCRAFT VT-PTC**  
**AT SULTANPUR, U.P. ON 16 MARCH 2022**

**K. Ramachandran**  
**Investigator -In- charge**

<b>Aircraft and Accident details of Cessna 152 Aircraft VT-PTC on 16 March 2022</b>			
<b>1.</b>	<b>Aircraft</b>	<b>Type</b>	<b>Cessna 152</b>
		<b>Nationality</b>	<b>Indian</b>
		<b>Registration</b>	<b>VT-PTC</b>
<b>2.</b>	<b>Owner</b>	<b>M/s Falcon Aviation Academy</b>	
<b>3.</b>	<b>Operator</b>	<b>M/s Falcon Aviation Academy</b>	
<b>4.</b>	<b>Country of Manufacture</b>	<b>United States of America</b>	
<b>5.</b>	<b>Pilot</b>	<b>Student Pilot License (SPL) Holder</b>	
<b>6.</b>	<b>No. of Persons on board</b>	<b>01 (Trainee pilot)</b>	
<b>7.</b>	<b>Extent of Injuries</b>	<b>Nil</b>	
<b>8.</b>	<b>Date &amp; Time of Accident</b>	<b>16<sup>th</sup> March 2022/ 0745 UTC</b>	
<b>9.</b>	<b>Place of Accident</b>	<b>Sultanpur Airfield</b>	
<b>10.</b>	<b>Co-ordinates of Accident Site &amp; AMSL</b>	<b>26° 14' 15" N, 82° 02' 38" E &amp; 97 m.</b>	
<b>11.</b>	<b>Last point of Departure</b>	<b>Rewa Airfield</b>	
<b>12.</b>	<b>Intended landing place</b>	<b>Sultanpur Airfield</b>

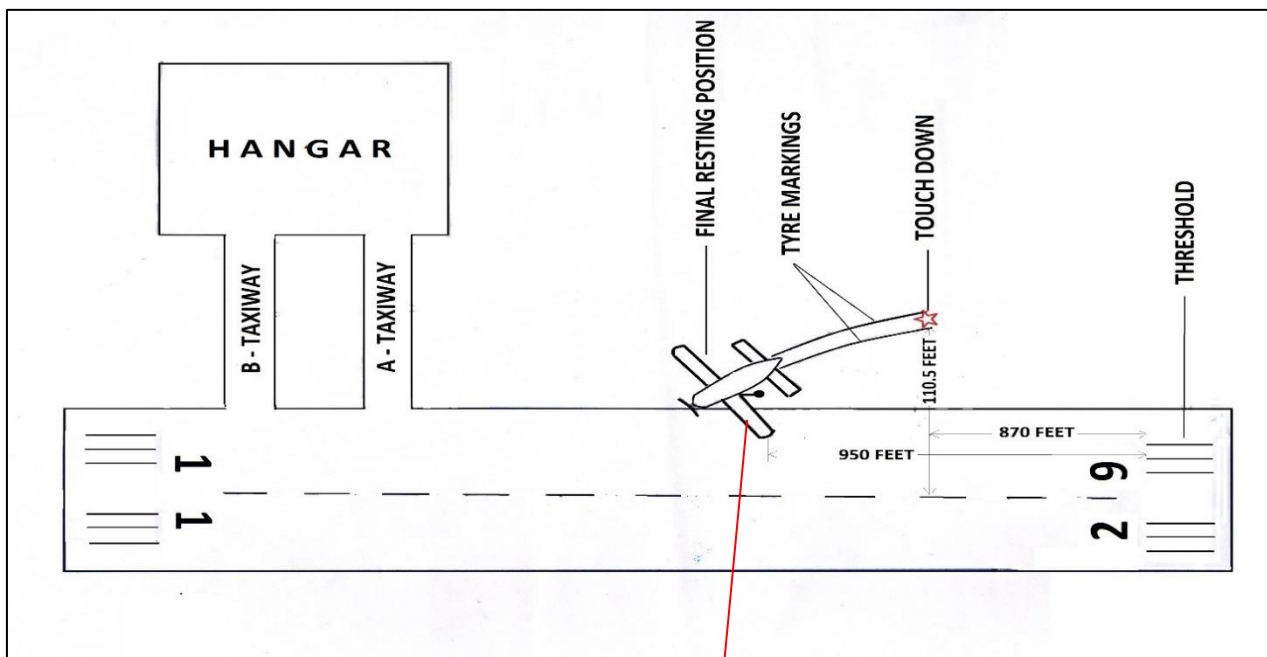
During landing the aircraft touched down on the right side of the runway on soft ground (Unpaved surface). The touchdown point was 110 feet right of runway centerline and approx. 870 feet from threshold of runway 29. The aircraft rolled for another 80 feet on soft ground before coming to the final rest position on the edge of the runway. During onsite investigation following was observed:

**Figure 2: Probable path followed by the aircraft after touchdown**

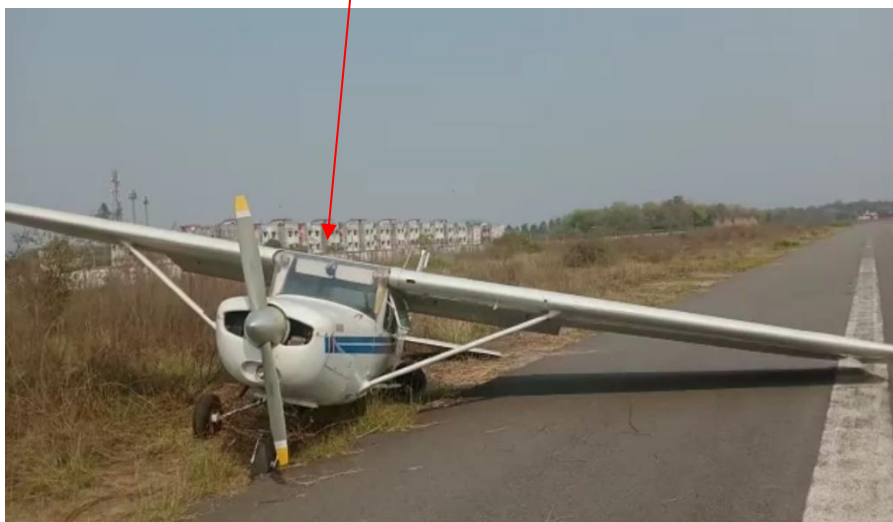
- In its final resting position, the aircraft was lying on left bank attitude with left wing tip touching runway (Refer Fig.3 below).
- There was white mark on the runway indicating rubbing of left wingtip on runway.
- With the fact that aircraft touched down off the runway at about 110 feet from runway centerline and came to final rest at the edge of the runway indicates that the trainee pilot tried to bring the aircraft back on runway. Further, this was evident from the tyre marks observed on the soft ground.
- During this process the left wheel got stuck at the runway edge and the left strut was broken.

**Figure 3: Final resting place of the aircraft**

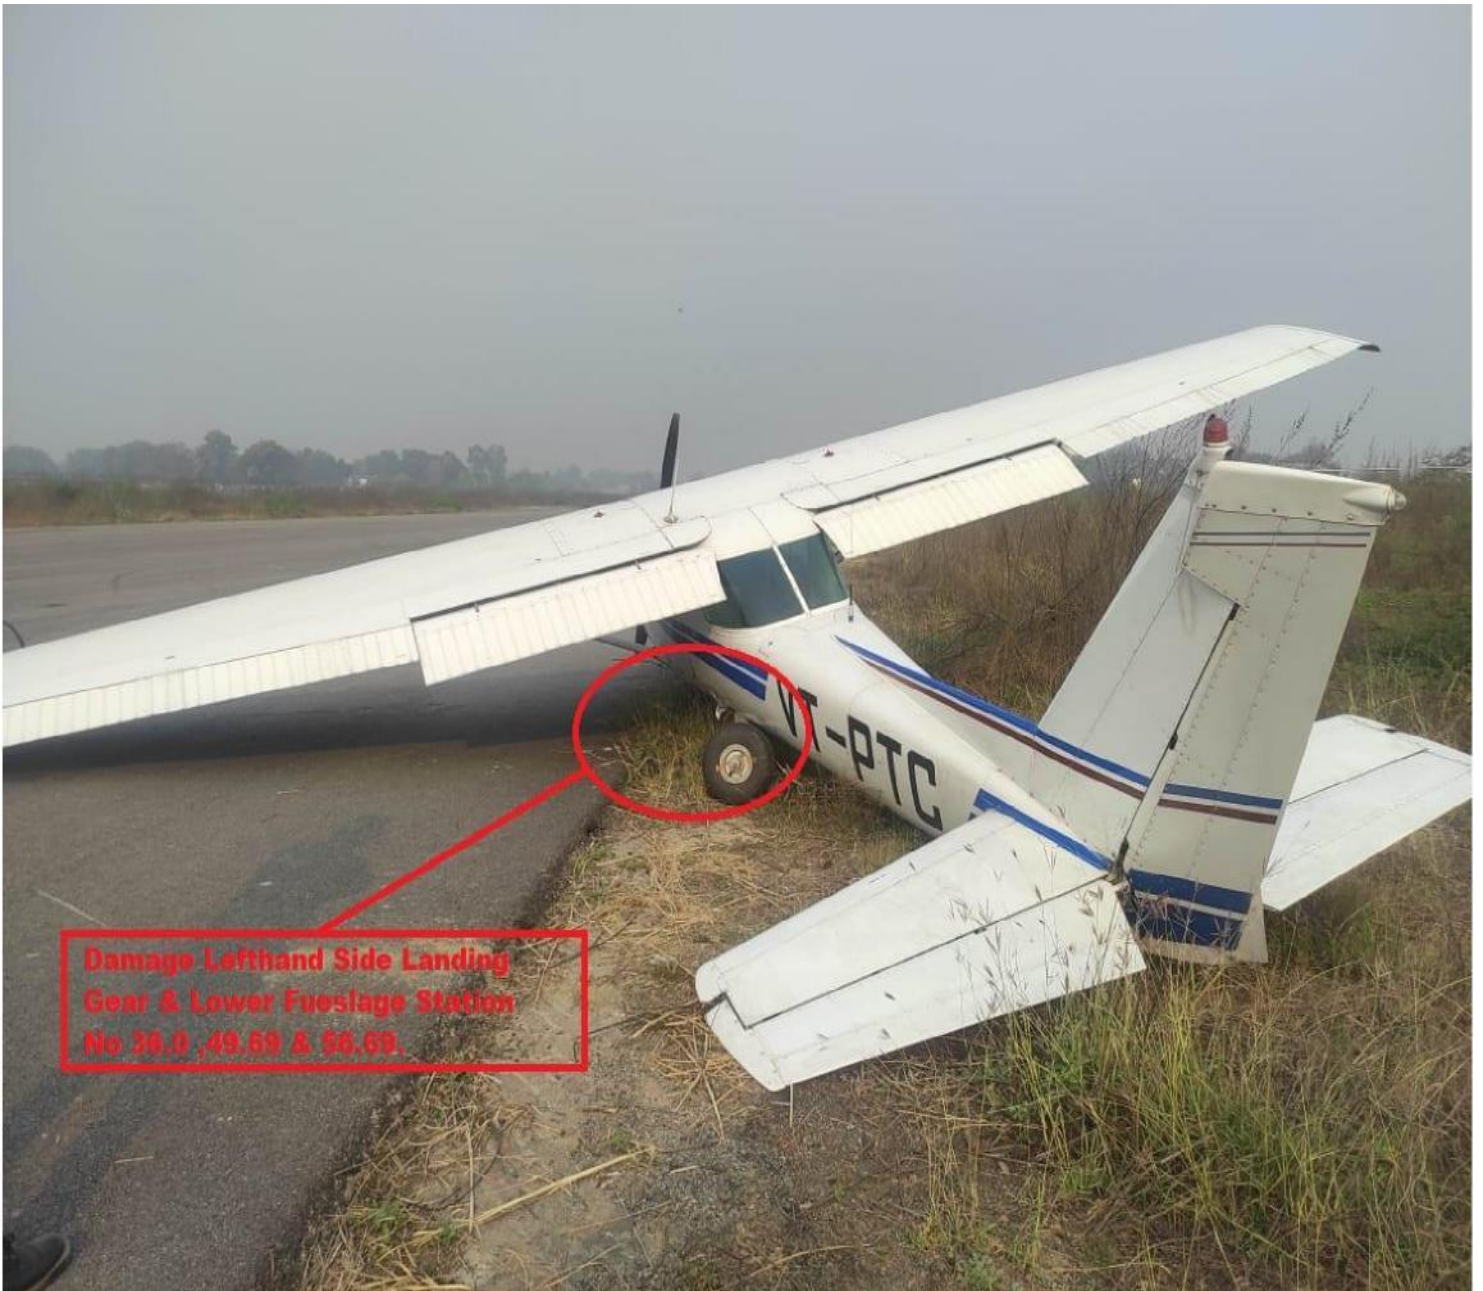
**1 – Cessna 152 VT-PTC aircraft on accident Site.**

**Damage Lefthand Side Landing  
Gear & Lower Fueslage Station  
No 36.0 ,49.69 & 96.69.**

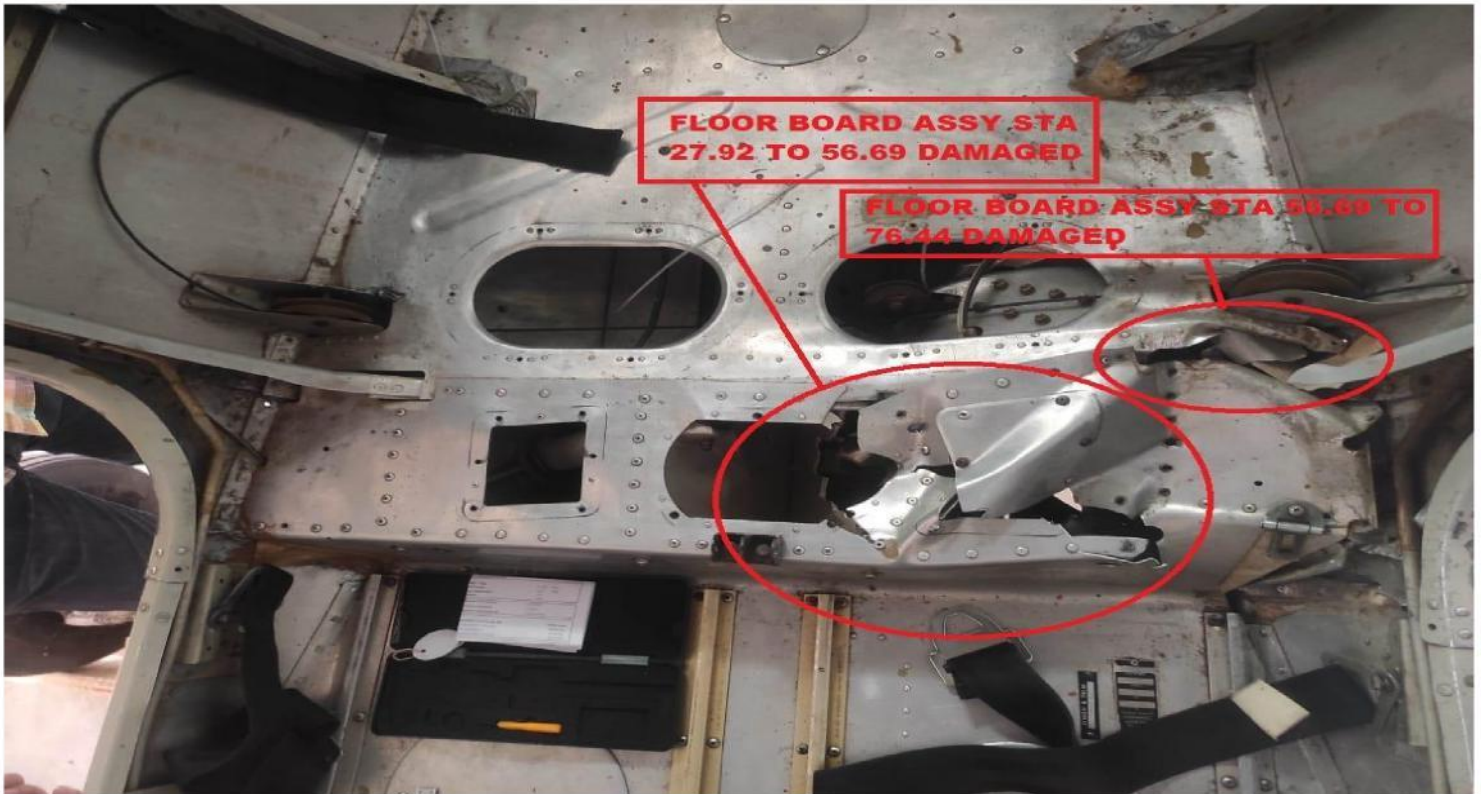
2- Floor board assy (0410238-1) STA 27.92 to 56.69 & Floor board Assy (0412030-5) STA 56.69 to 76.44 along with Angle (0412060-1), Angle (0412171-1) found damaged.

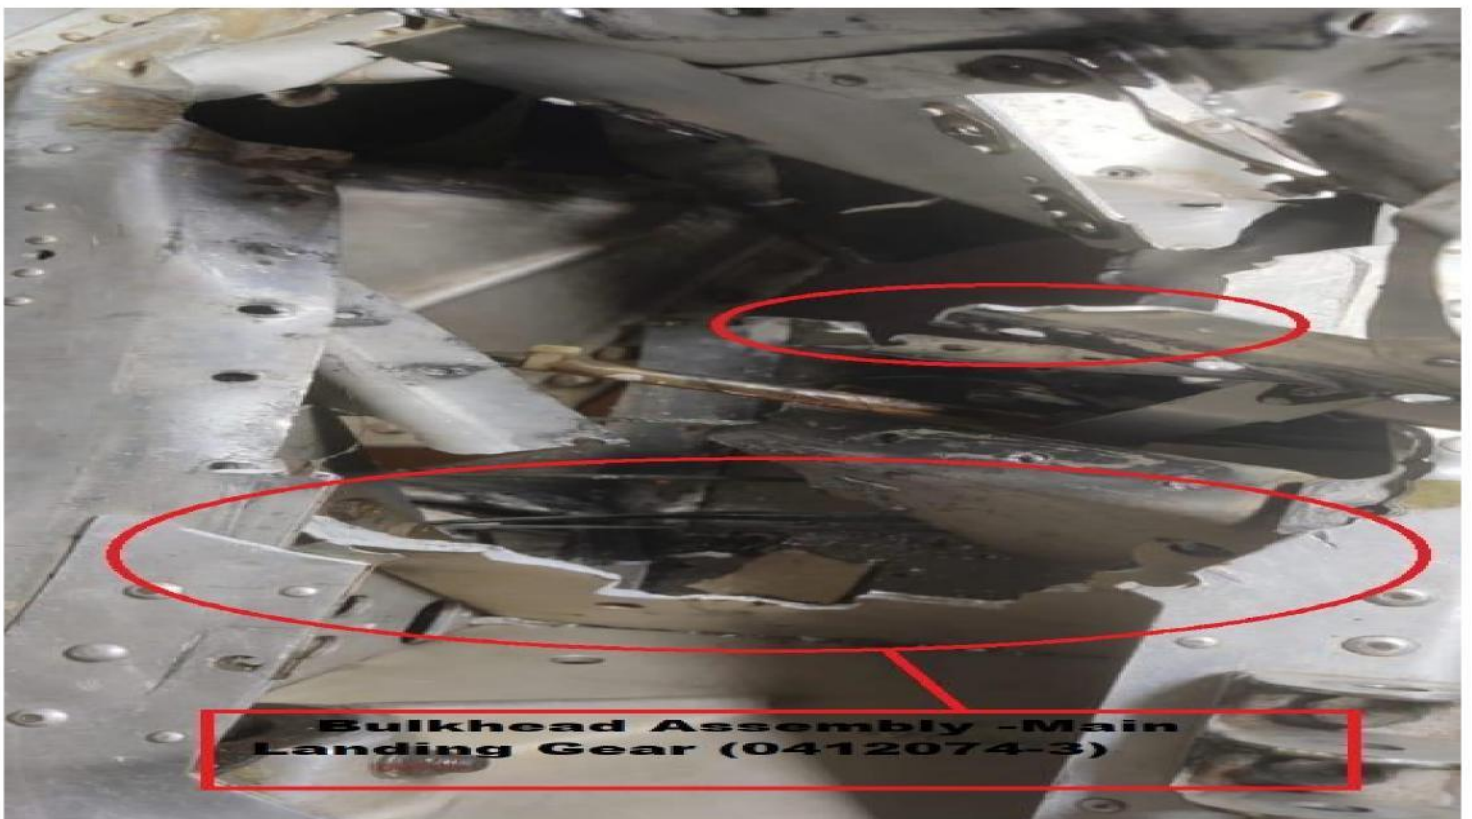
3- Bulkhead Assembly –Main Landing Gear (0412074-3) found damage with LH Bracket (0441204-7).

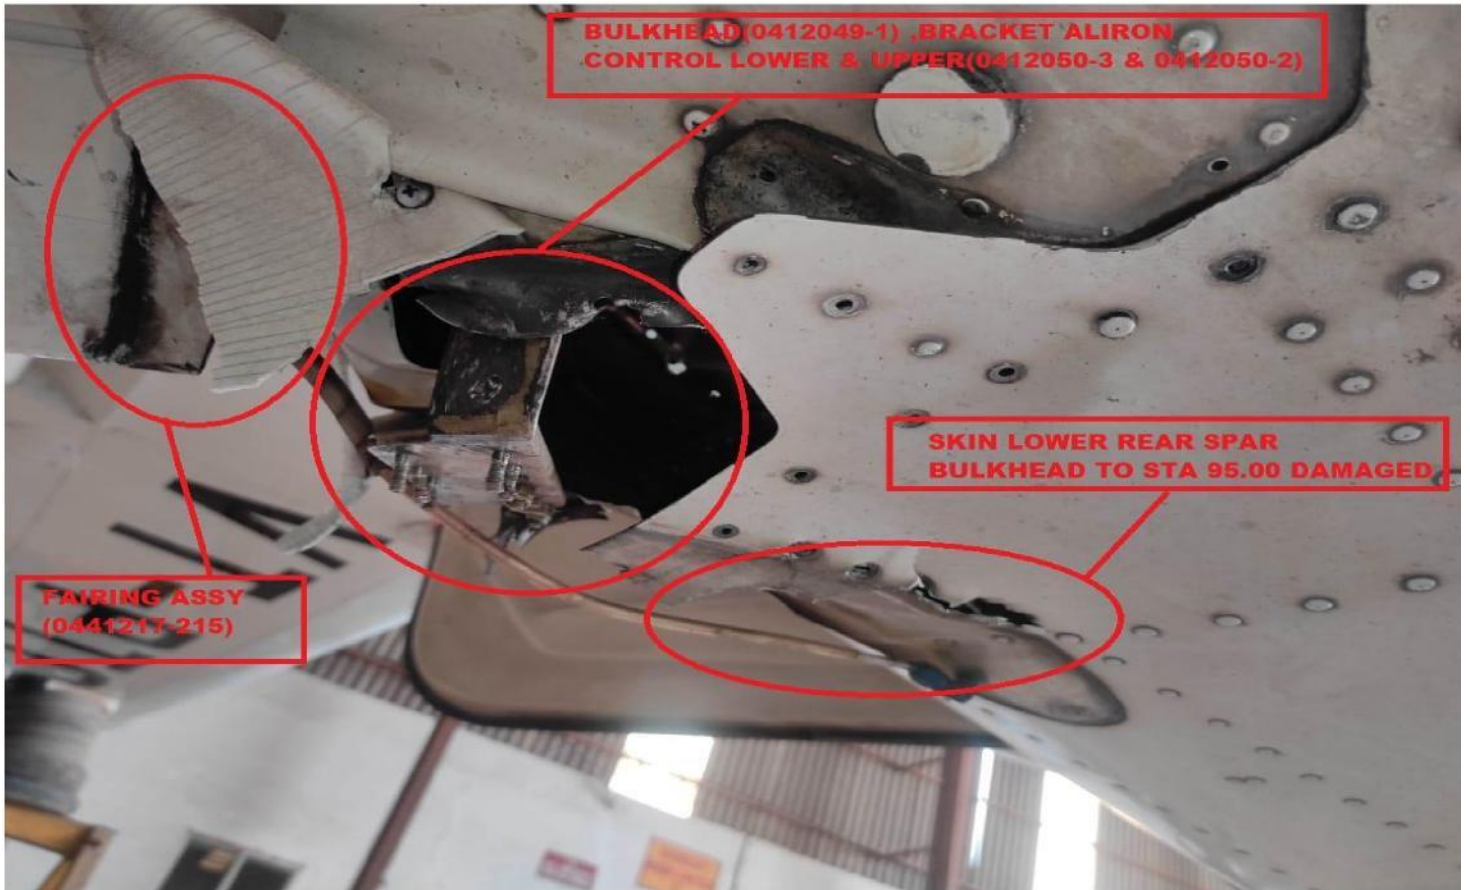
- 4- Bulkhead (0412049-1), Bracket Aileron Control Lower & Upper (0412050-3 & 0412050-2) damaged.
- 5- Skin Fuselage (0411126-5) STA 27.92 to 56.69 damaged.
- 6- Fairing Assembly (0441217-215) damaged.

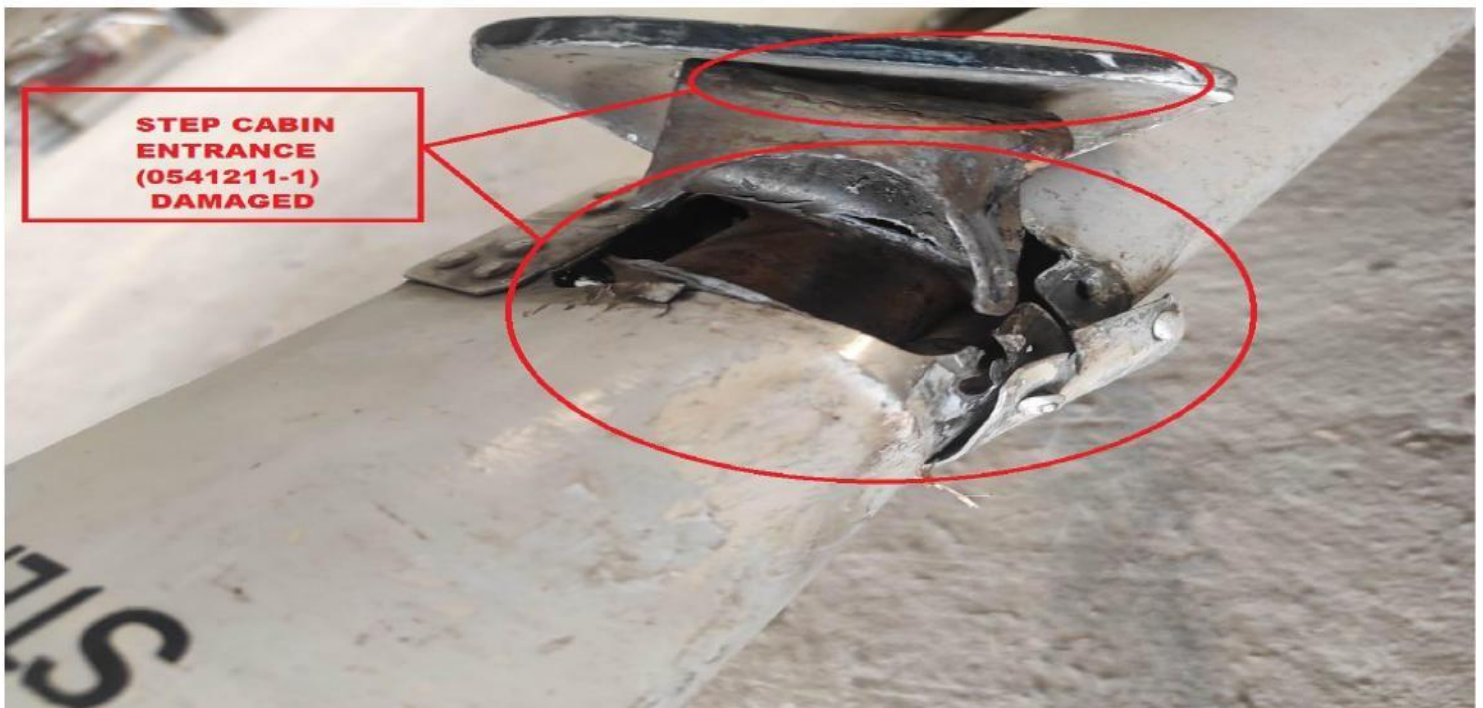
- 7- Step Cabin Entrance (0541211-1) of Left-hand side found damage.

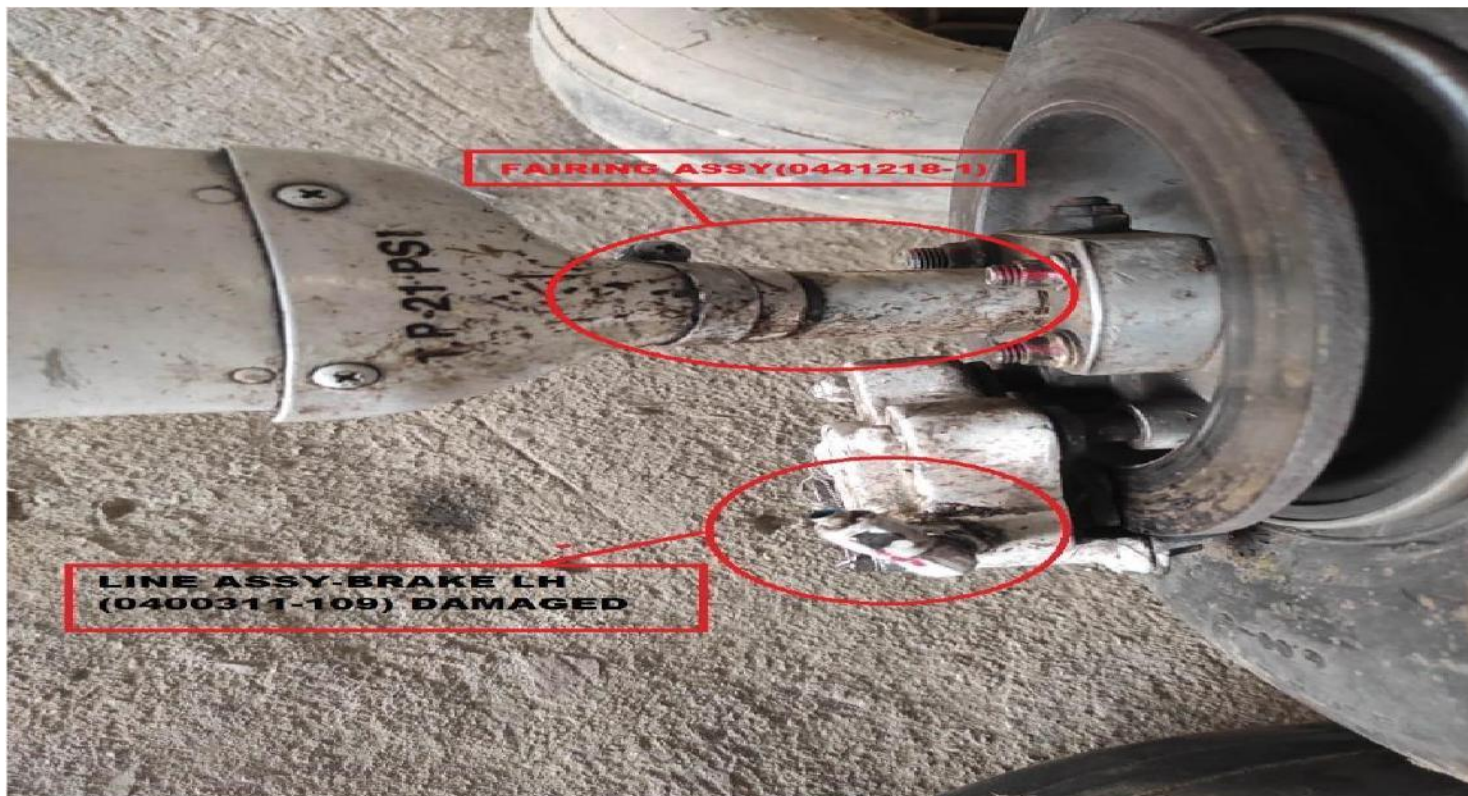
8- Line Assy Brake Left hand side (0400311-109) & Fairing Assy (0441218-1) found damaged.

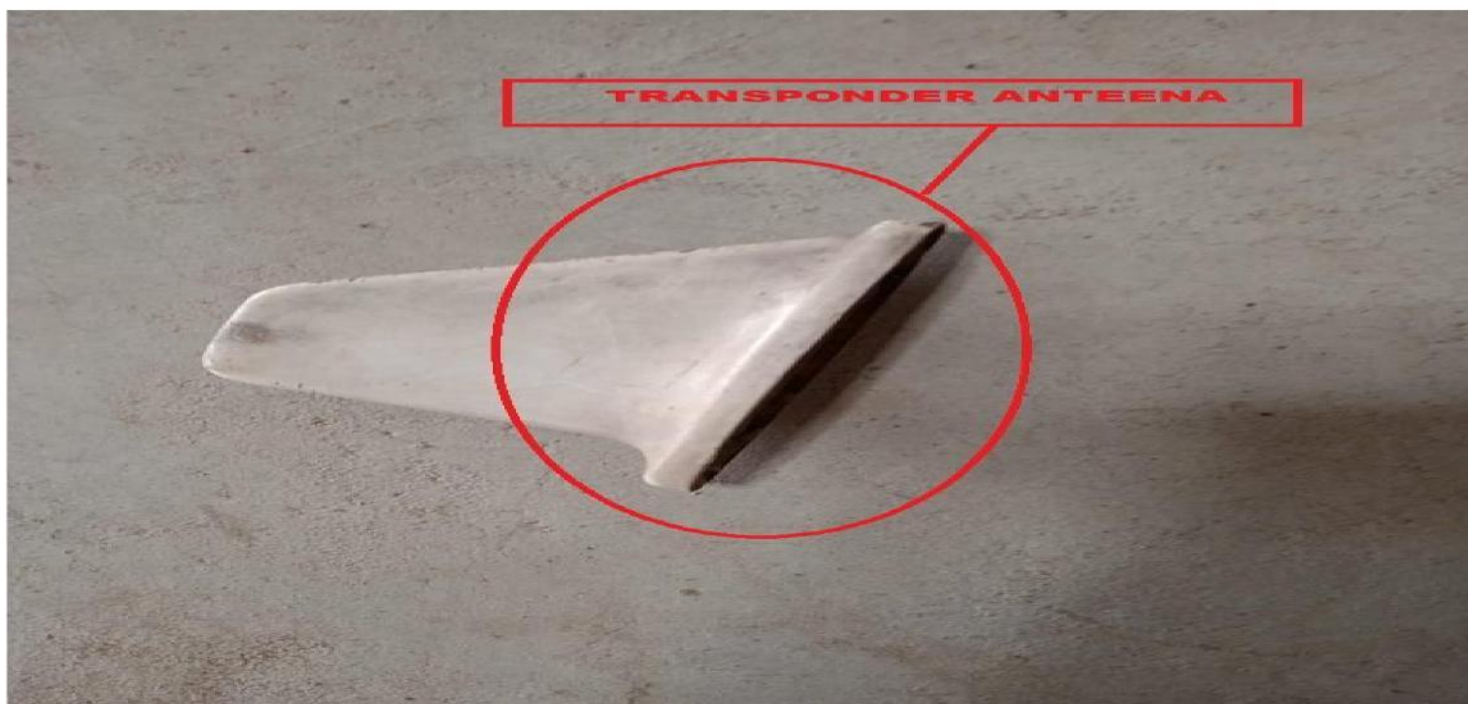
9 - Transponder Antenna found damaged.

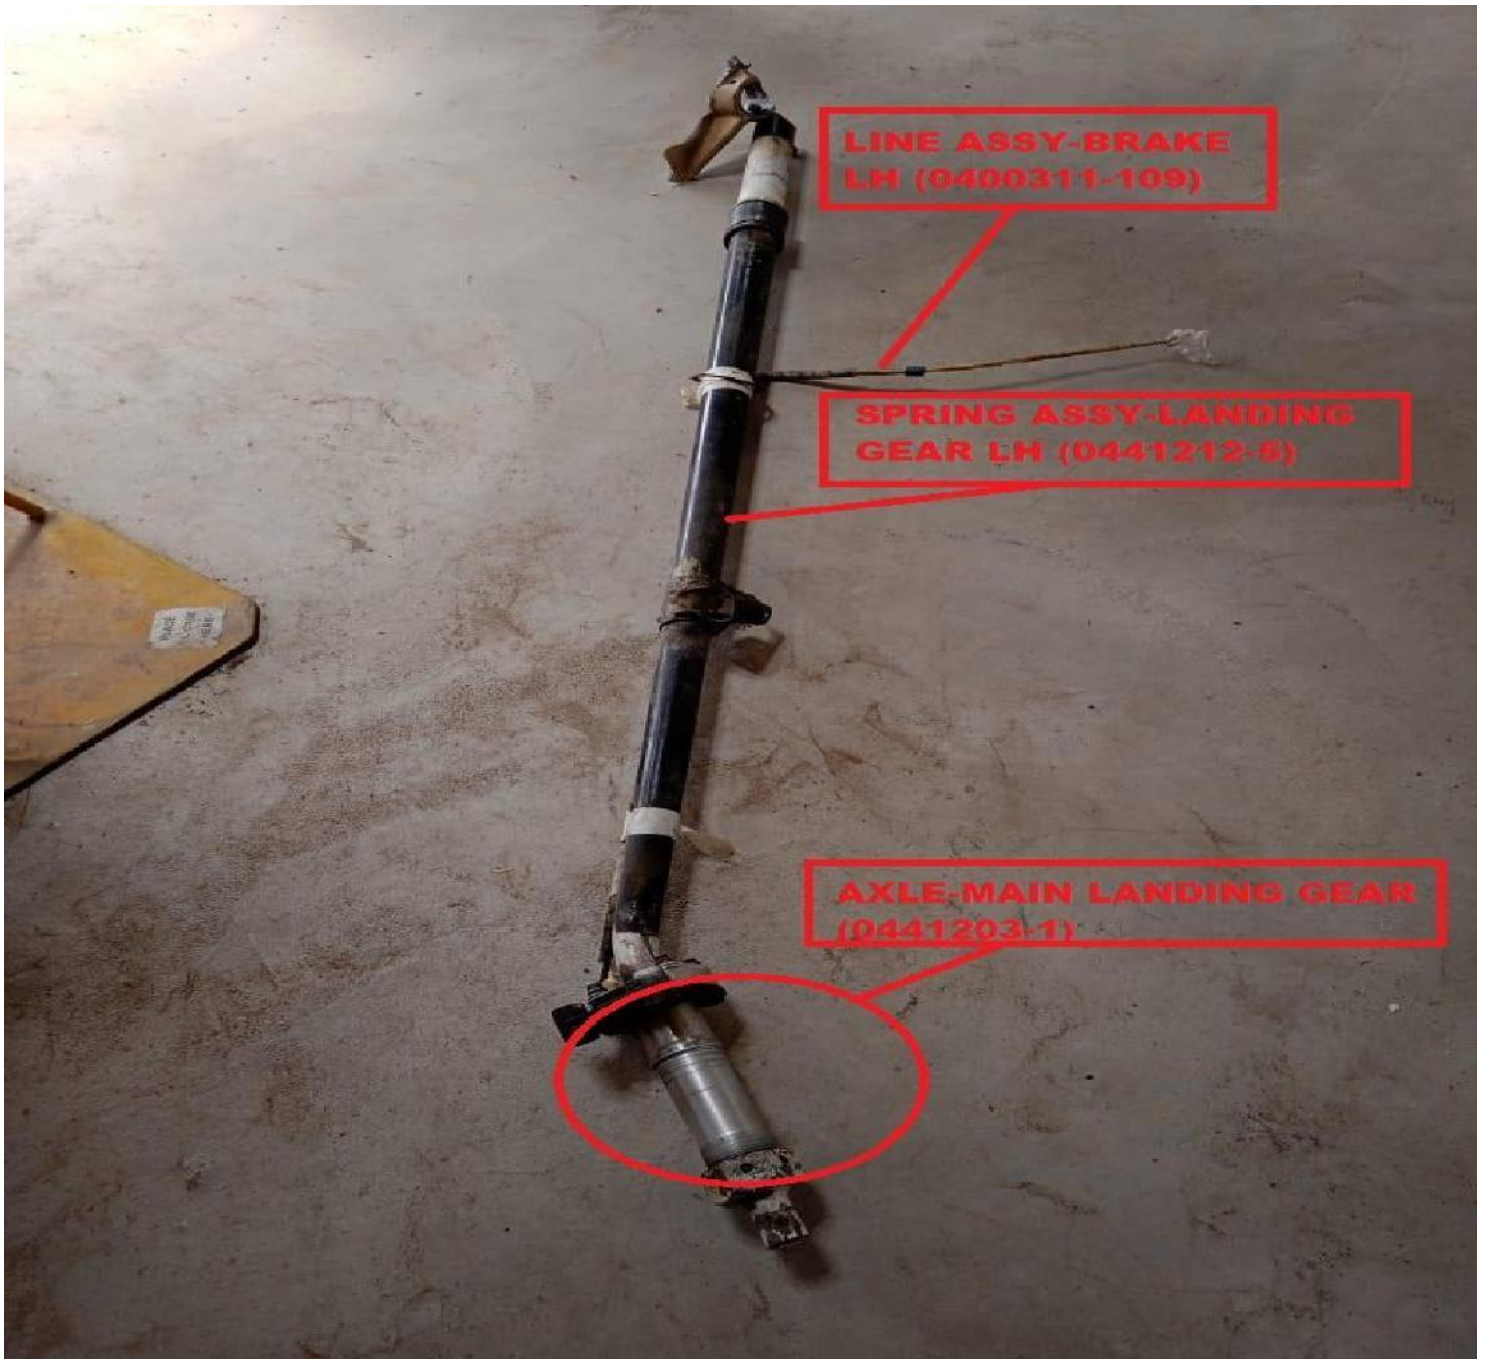
10- Spring Assy-Landing Gear LH (0441212-5), Axle-Main Landing Gear (0441203-1), Line Assy-Brake LH (0400311-109) was damaged.

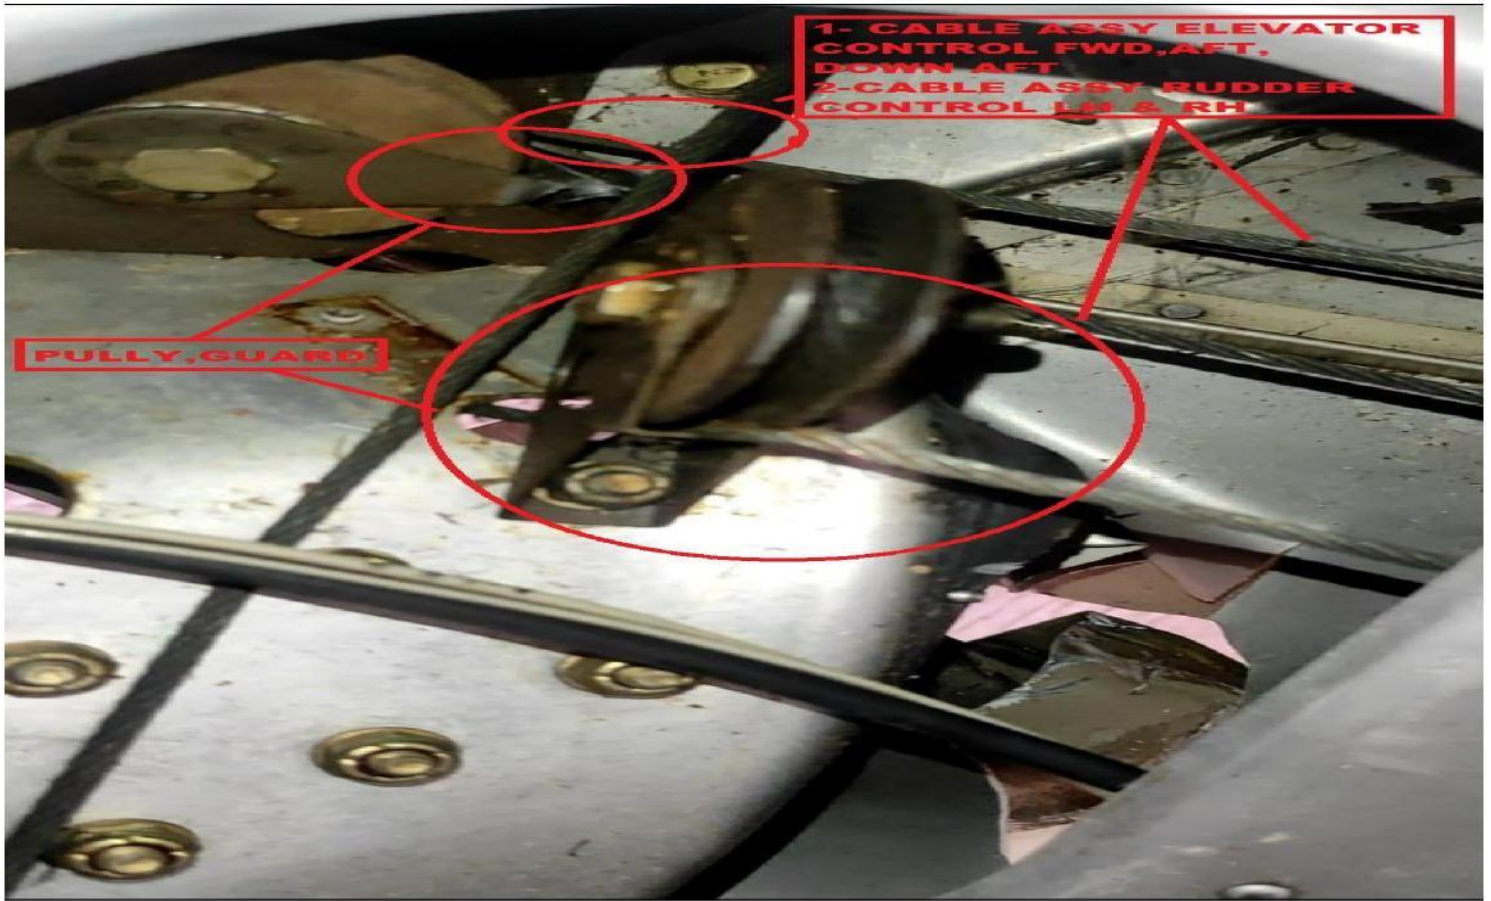
11- Cable Assy Elevator Control FWD, AFT, DOWN AFT (0400107-166, 0444107-163 & 0444107-164) found kinked & damaged.

12- Cable Assy Rudder Control LH & RH (0400107-149, 0400107-150) found kinked & damaged.

13- Some Pulley, Guard found damaged.

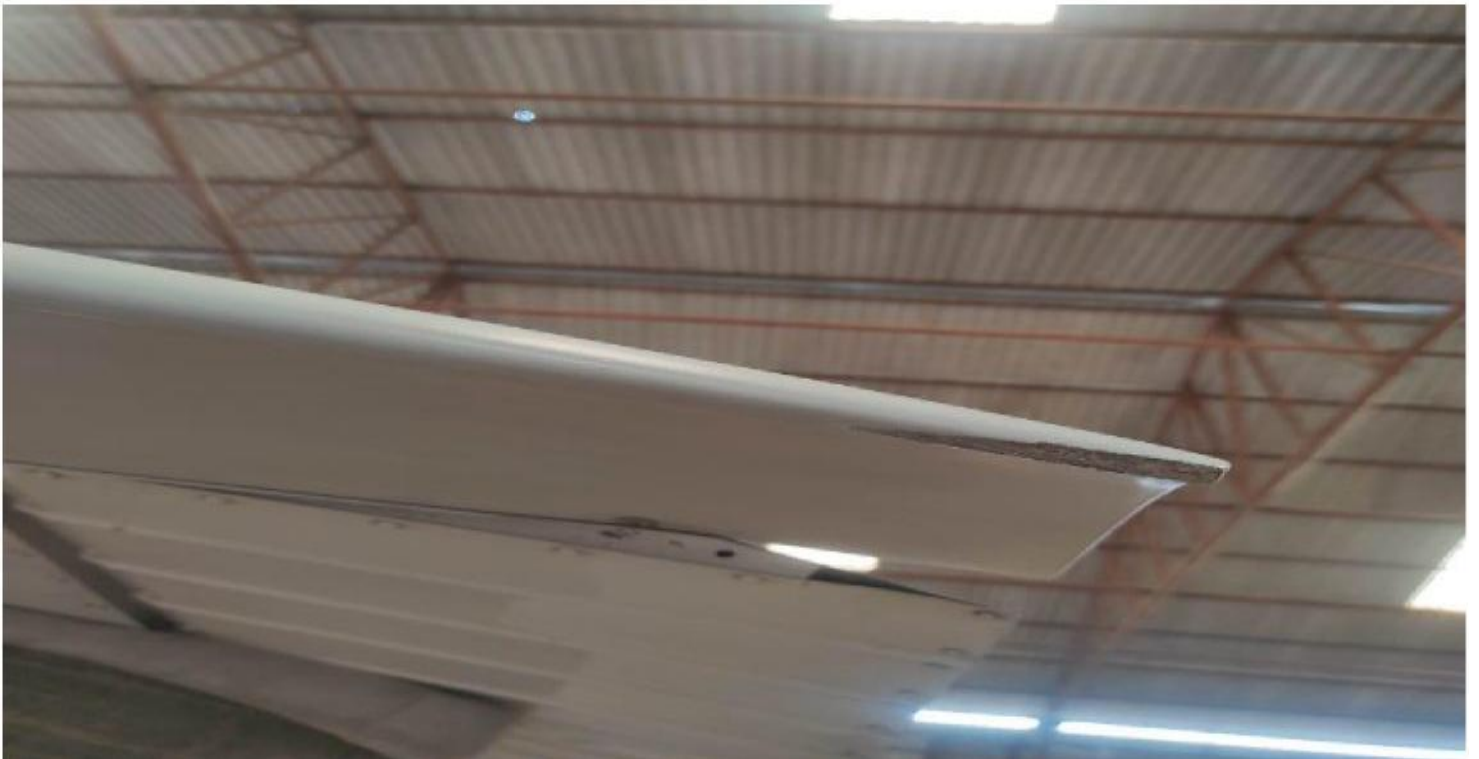
14- Tip Assy Wing LH (0523565-29) trailing edge corner found scratched.
