**Final Investigation Report on Accident involving Pawan Hans' S-76D helicopter
bearing registration VT-PWI at Mumbai Off-Shore on 28 June 2022**

**Aircraft Accident Investigation Bureau
Government of India
Ministry of Civil Aviation**

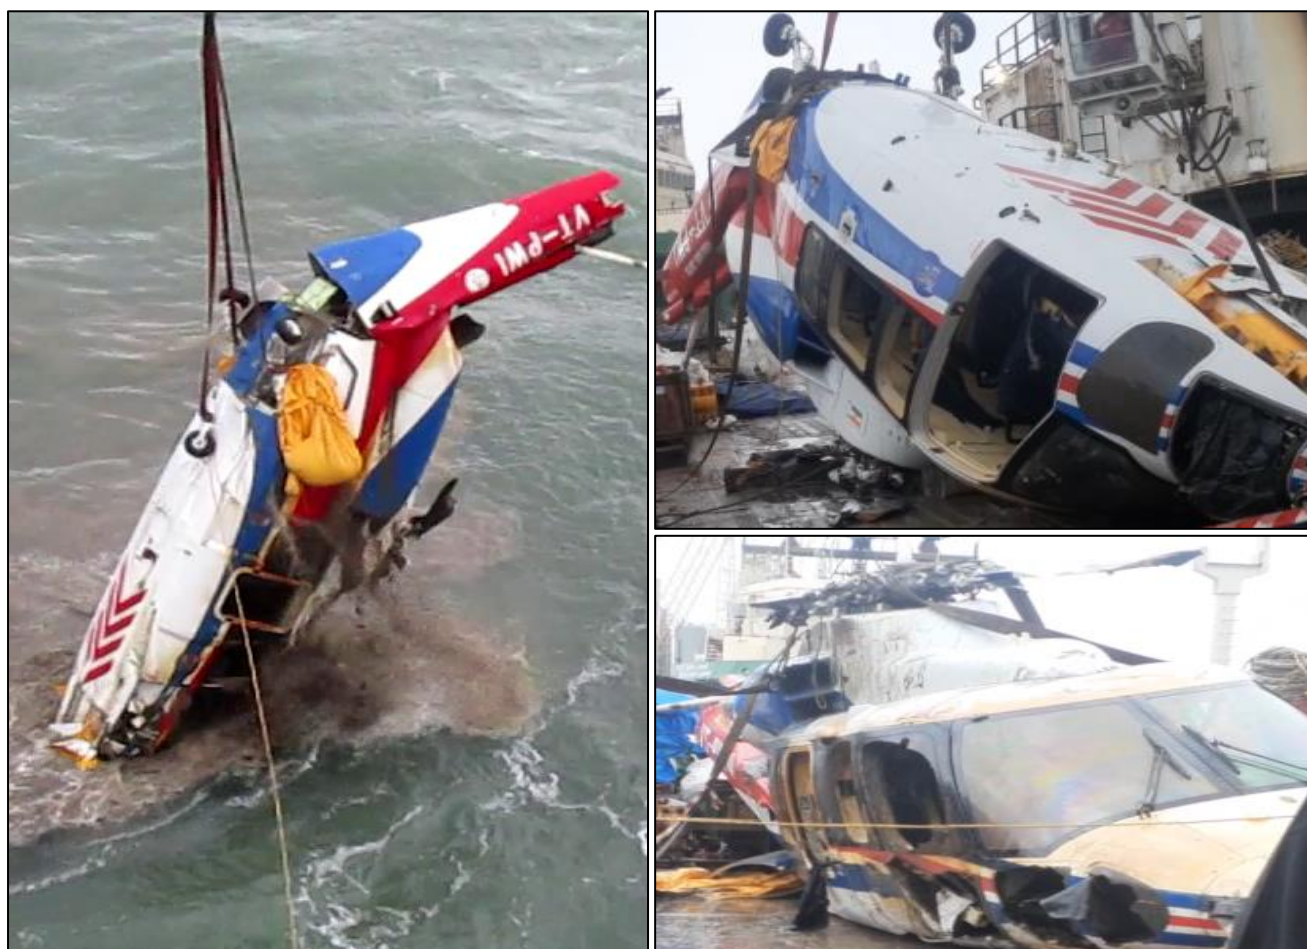
The helicopter was destroyed in the accident. The helicopter wreckage was lying on the sea bed in up-side down position and retrieved in same condition on 06 July 2022. The wreckage was positioned on the ship by crane and later set upright on the ship deck. The wreckage was brought ashore at Nhava port and transferred to a shipping container for transportation to Juhu by road.

Figure 1: Damage to helicopter

- There was no significant damage to Nose portion, Passenger cabin and Flight control deck.
- All pylon fairings, MGB fairing, Engine intake, Engine cowling and exhaust cowling were found intact on both sides.

- Right side pilot door was found damaged and middle row window was found jettisoned and missing.
- Left side pilot door was not available and Left side passenger windows were not available.
- Nose landing gear was found detached. There was impact damage on the belly below pilot's seat forward of Right side wheel well.
- Actuators and struts linkages of both main landing gears were found broken.
- MLG assemblies were found partially folded under the aircraft. NLG shock-strut and wheel and tire assembly were separated from the NLG cylinder and had protruded into the passenger cabin.

- Bottom side of tail boom was found ruptured from fuselage attachment.
- Tail cone assembly was found detached from forward of the tail stabilizer.
- Tail drive shaft fairing was found damaged and partially detached.
- Right side stabilizer was found damaged but attached.
- IGB casing was found damaged. TGB was found broken and separated.
- Tail rotor blades (03 in number) were found broken and missing. One blade was found damaged.
- Tail rotor retaining plates, pitch change horn were intact and pitch link was found broken.
- TGB casing was found damaged and TGB fairing was not available.

- Yellow, blue and red blades had fractured from very close to the root (attachment). The black blade got sheared off from the hub assembly on the main rotor head.
- The main rotor head bifilar assembly on the left side of the black blade was bent approximately 45° at a downward angle. The yellow blade pitch control link was missing. It had broken at the swash plate attachment point and was not attached to the main rotor head.
- Output side of the Section V tail rotor drive shaft was sheared at the point where the driveshaft goes into the intermittent gearbox fairing.
- The yellow tail rotor blade root end was intact. This blade sustained damage to the leading edge and was broken off at the blade root. The other three blades were not available and had separated at the blade root assembly with rotational damage.

- Both engines did not show any sign of damage, other than corrosion from the saltwater and element exposure. Visual inspection of both engines was conducted and no significant damage was noted. Boroscopic inspection did not reveal any abnormality in the core engine.

- Nose LH and RH floats had operated, but got damaged though they remained attached to the helicopter.
- LH and RH floats of main wheel were found attached to the helicopter in deflated condition.
- LH and RH Life rafts pods got sheared off from the hinges and had separated from the inflation system.

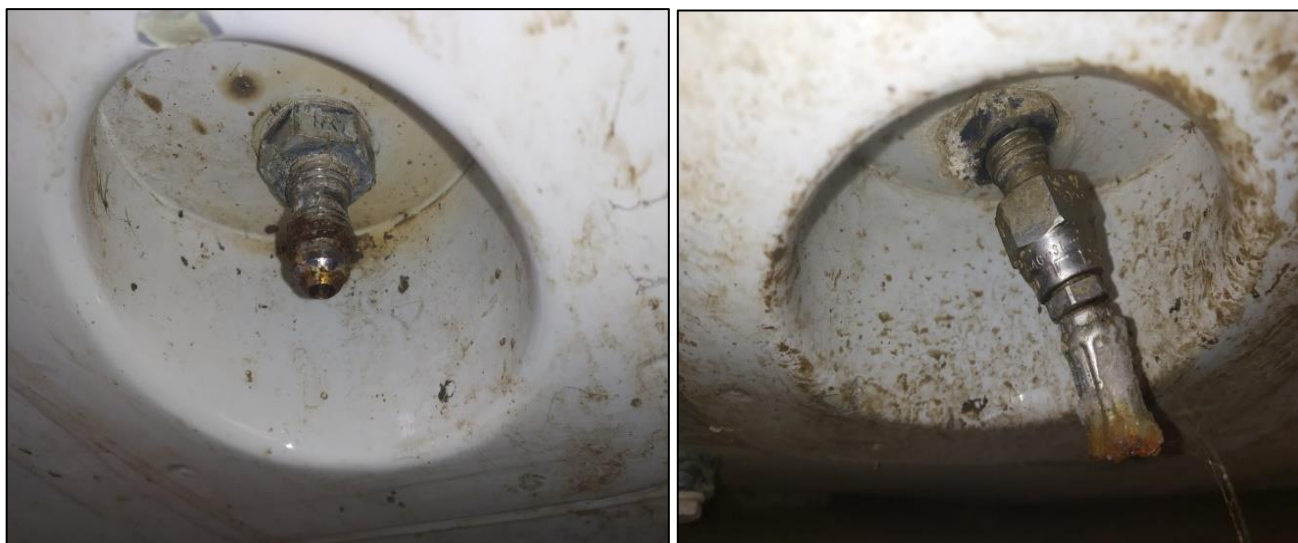
- Pneumatic pipe lines to RH Life Raft Pod broke off from the attachment points and the RH Raft was missing. LH Life Raft Pod was missing along with the pneumatic pipe lines connecting it to the Inflation System.

Figure 2: Aircraft side pneumatic connection to Life Raft Pods (left side and right side)

- External life raft release handle was found intact with protection cover intact. The above damages include impact damages and those unavoidable additional damages which were suffered during retrieval.

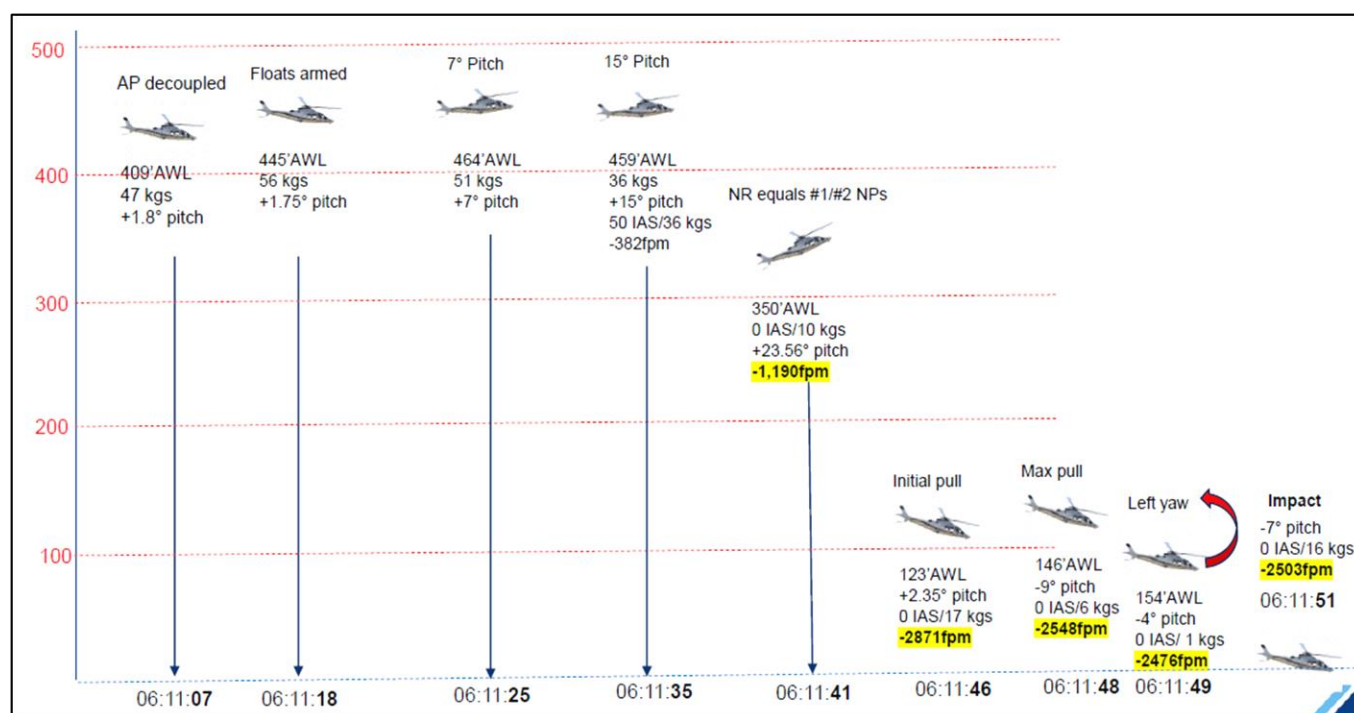
While the altitude was 750 ft, the helicopter began to decelerate. At about 06:11:31 the pitch was increased nose-up and the pilot continuously continued reducing the torque. The pitch angle increased to 7.1 Nose up and while Ground Speed and IAS were recorded as 46 Kt and 58 kt respectively. In another 3 seconds, while the Engine 1 and 2 torque setting was at 15% and altitude was 752 ft, Pitch angle increased to 12.1 Nose up. The ground speed and IAS were 39 kts and 54 kts respectively and rate of descent increased to 364 fpm.

Figure 19: Approach Profile

At 06:11:41 the maximum pitch up angle of about 23.5° was recorded and this more or less coincides with the groundspeed reducing to almost zero. By this time the aircraft had entered an energy deficient state, due to the low torque value and near zero speed. The rate of descent increased to 1136 fpm. High nose-up attitude combined with reducing air speed at low altitude made it practically difficult to recover the helicopter from impact with the water. The onset of uncontrolled flight occurred when the aircraft was pitched to approximately 23° nose up while simultaneously lowering the collective to the full down position.

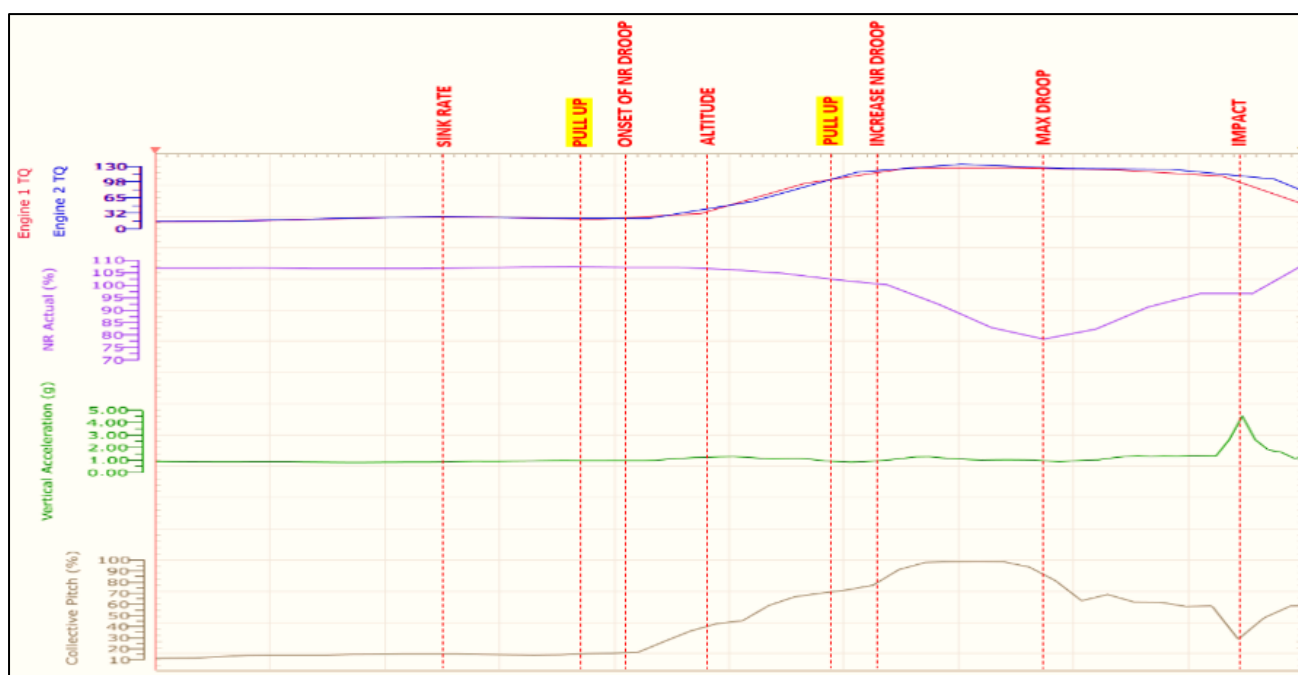
Figure 21: Graphical representation of flight data parameters with events identified in CVR recording

From the CVR data, the initiating event for the onset of the rotor speed droop appears to be in reaction to the first EGPWS alert to “PULL UP”. This is corroborated by the FDR data which shows that just following the alert there is a rapid Collective up movement and an accompanying rise in Engine Torque. Further, the increased rate of rotor speed droop appears to be in reaction to the second EGPWS alert to “PULL UP”. This is also corroborated by the FDR data which shows another rapid rise of the Collective and a demand in Engine Torque to greater than 125%.

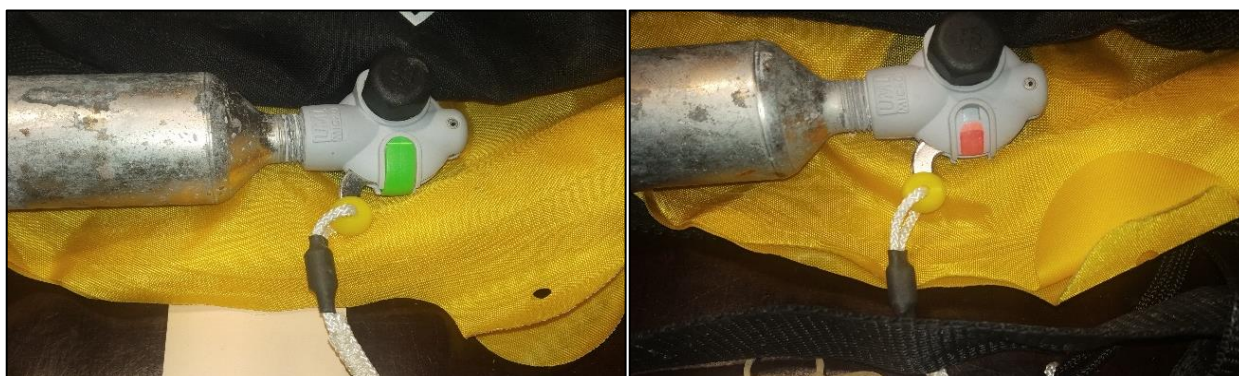
- The inflation toggle of only one lifejacket (Sr. 20045484) was pulled. This was indicated by absence of green clip on the Inflation mechanism (Figure 26). The Hammar MA1 toggle for this life jacket was intact, but automatic operation had taken place as indicated by the red indicator on Hammar MA1 system (Figure 27).

Figure 26: Inflation mechanism – Green Clip present (left); Green clip absent (right)

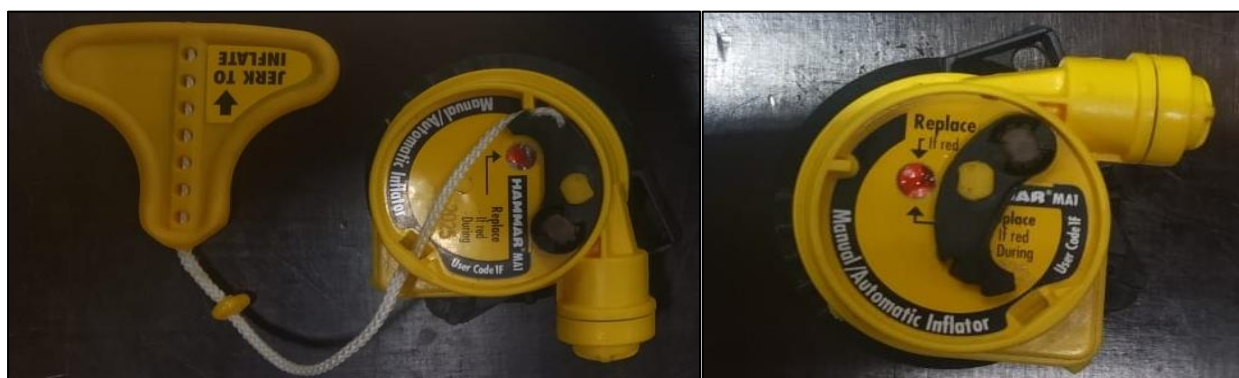
- The inflation toggles on the other three life jackets were not pulled. On two of these life jackets (Sr. 20045469, Sr. 20045536) the Hammar MA1 system toggle had been pulled and ripped off (Figure 27).

Figure 27: Hammar MA1 system with toggle intact (left) and toggle ripped off (right)

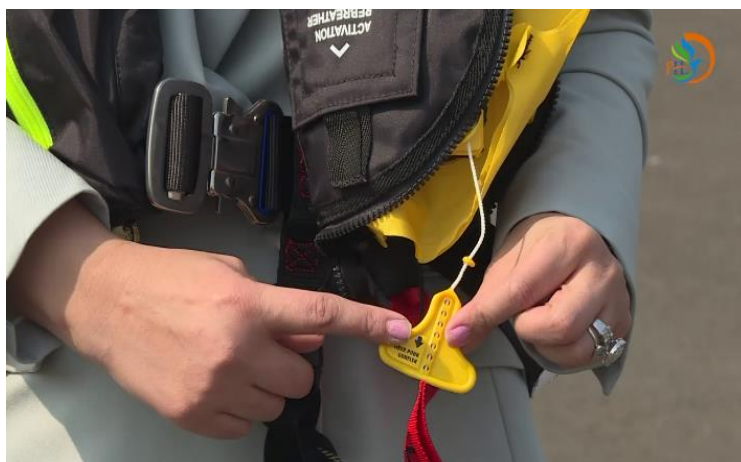
While audio narrative was "to inflate the life jacket pull the toggle sharply after jumping into water. This will inflate your lifejacket automatically", the video pointed at the Hammer Toggle (which is meant for ERBS) (Refer Figure 28). The Inflation toggle, which is meant to inflate the life jacket was nowhere identified in the Passenger Safety Briefing video.

Figure 28: Hammer Toggle meant for ERBS

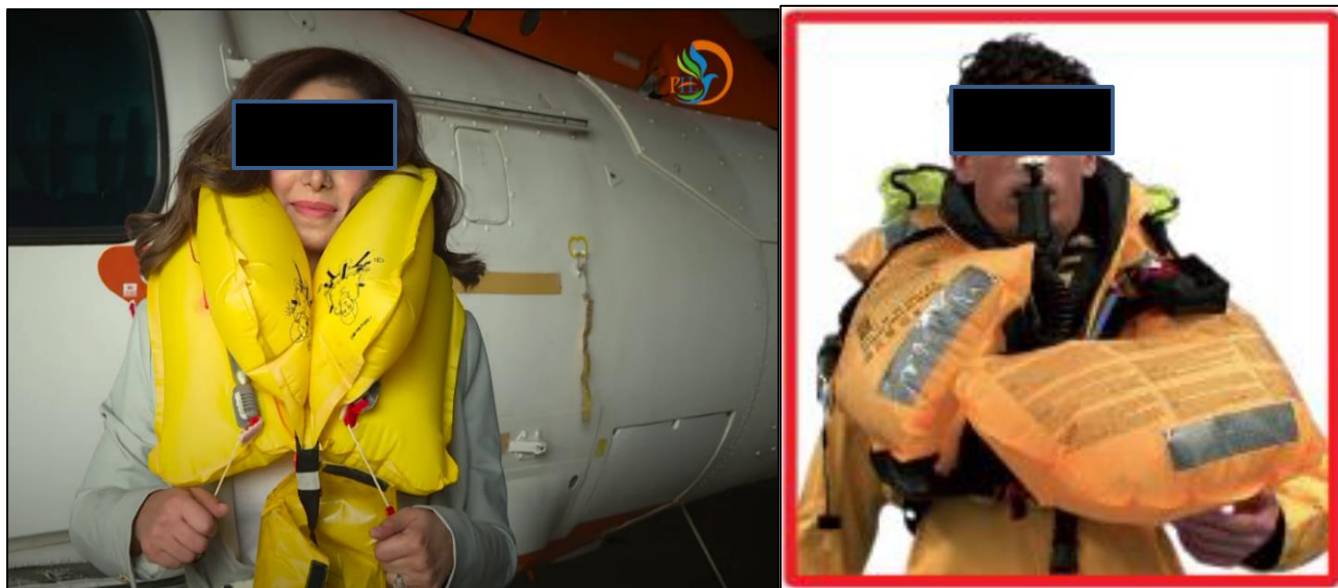
Investigation Team further noted that the inflated lifejacket shown in the video was also different from the LRS001 lifejacket which was actually available on the helicopter. The Figure 29 below shows the comparison of screenshot from Passenger Safety Briefing Video and actual image of inflated lifejacket from OEM's briefing card.

Figure 29: Comparison of Inflated Life Jacket shown in Passenger Safety Briefing Video (left) and actual image of inflated lifejacket from OEM's briefing card (right)

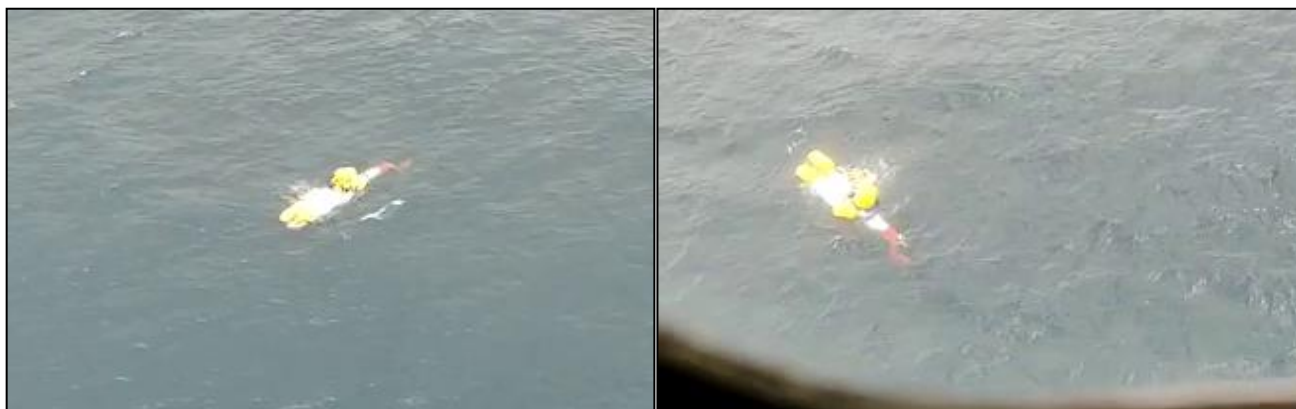
Figure 30: VT-PWI floating in the sea after impact

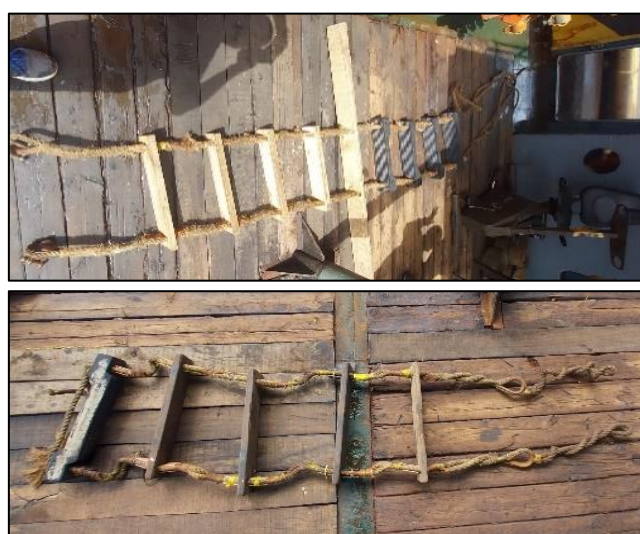
(c) Rope Ladders used for rescue – The ladders used for rescuing the 04 survivors were examined. The length of ladder on starboard side door was measured to be approx. 2 meters long and on the port side door it was approx. 3 meters long. These were found to be in good condition. As per the specification of Malviya-16, the total depth of main deck is 7 m. The depth from the base of the door where the ladders are attached to the sea upper surface was measured to be more than 5 meters. This indicates that although the ladders were in good condition, their length (2 m and 3 m) was not sufficient to touch the sea surface, so as to help rescuing people from sea. The survivors reported that they faced difficulty in getting hold of the ladder due to its length, which was way shorter than the height of the ship.

Figure 34: Rescue ladders
