Aircraft and Accident details of Cessna 172 S VT-AMU on 21st January 2022

SYNOPSIS

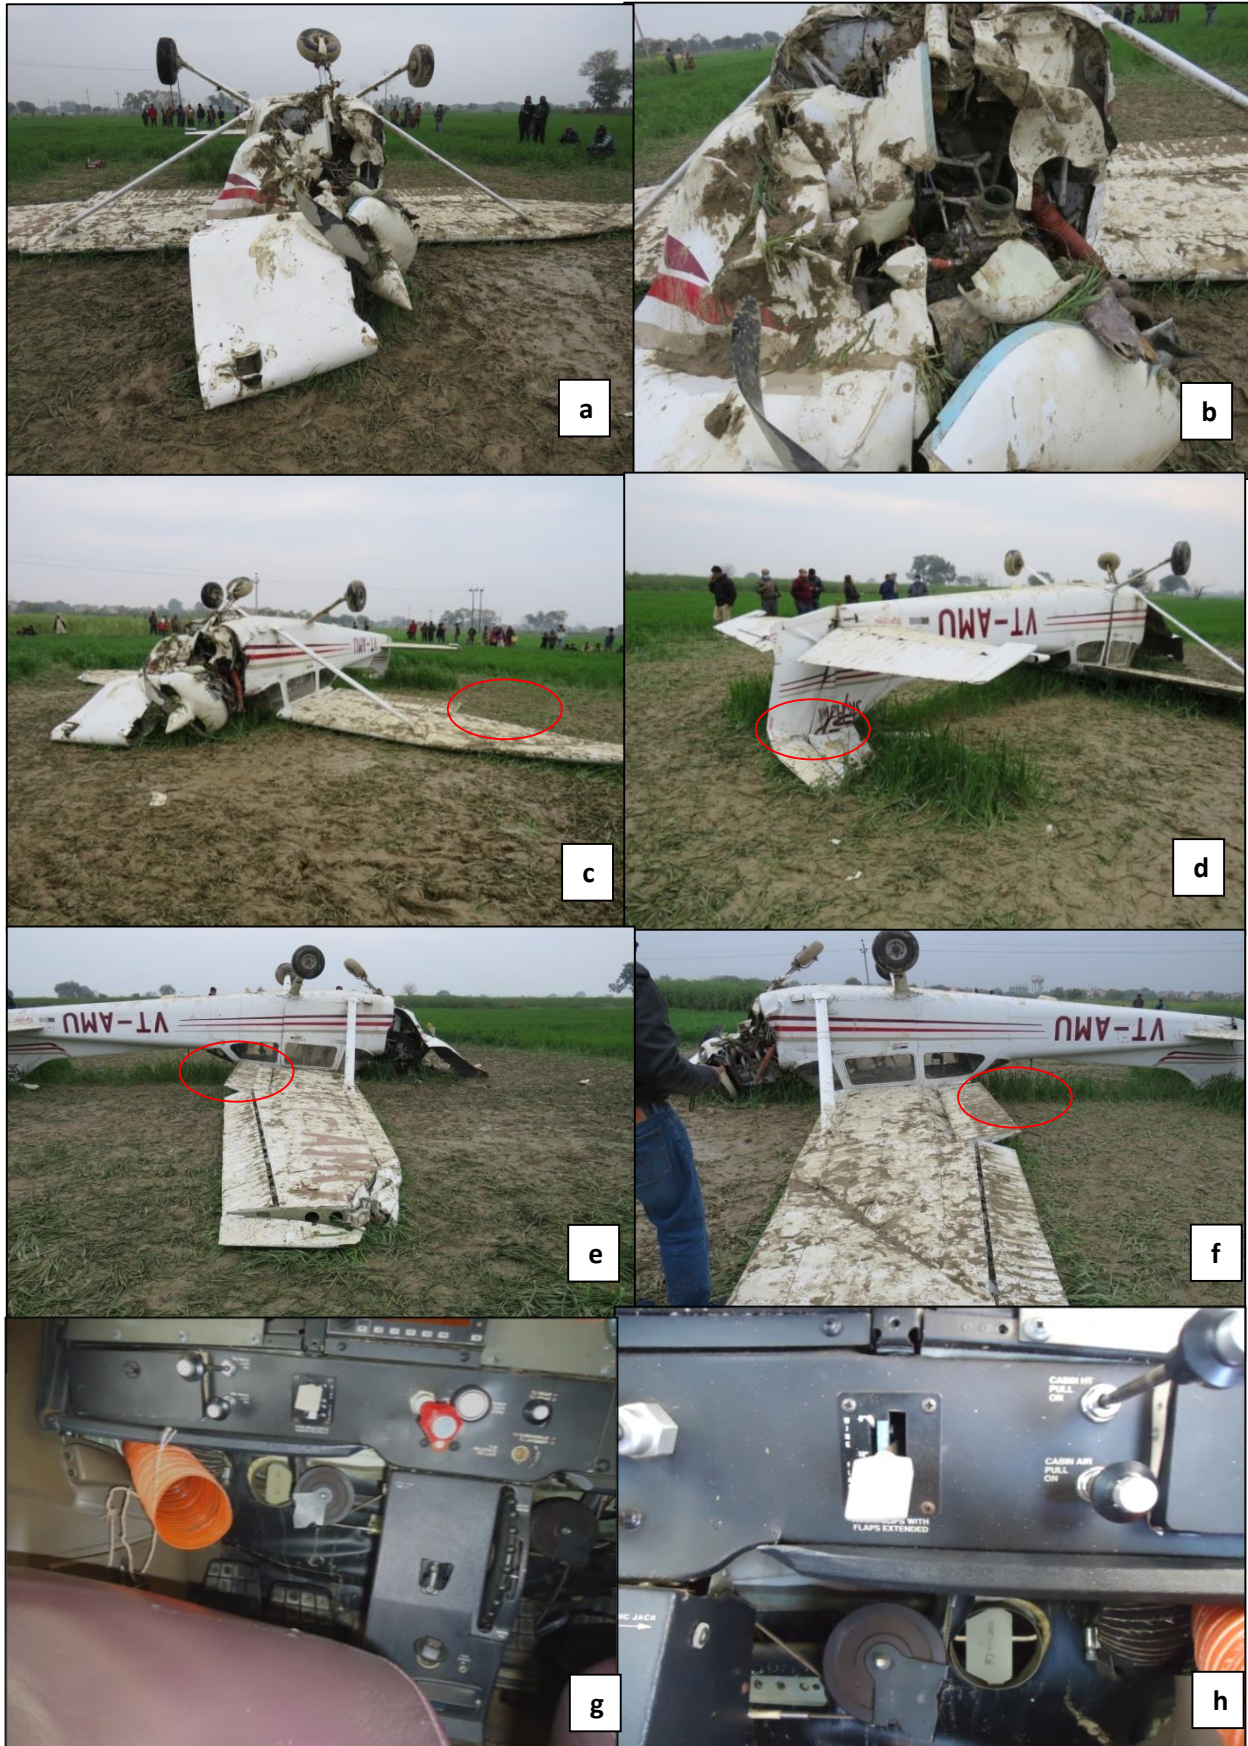
Figure 2 (left to right): a-Damaged Aircraft upside Down; b-Damaged Nose Portion; c-Bent Starboard wing; d-Bent Ventral Fin due to weight; e-Aircraft Left Flap extended position; f-Aircraft Right Flap extended position g-Flap Selector Switch in 100 Position; h-Throttle in Full Power Position

The aircraft was resting in upside down condition with the ventral fin taking the load during the somersault. The right wing took impact during the somersault resulting in slight bending inwards. The engine cowling was completely damaged and separated from the engine.

The nose undercarriage strut took the impact while passing over the wedge during the controlled descent and bent inwards before toppling of the aircraft. The flaps were in extended position on both the wings. The leading edge of the port wing housing, the anti-collision lights were found impacted and damaged. The starboard wing was found with an inward bent.

The Flap selector switch was in 100 position corresponding to the extended flap position. The throttle was fully in and in full power position corroborating with the PIC's statement that a "go-around" maneuver was attempted on impact with the ground.

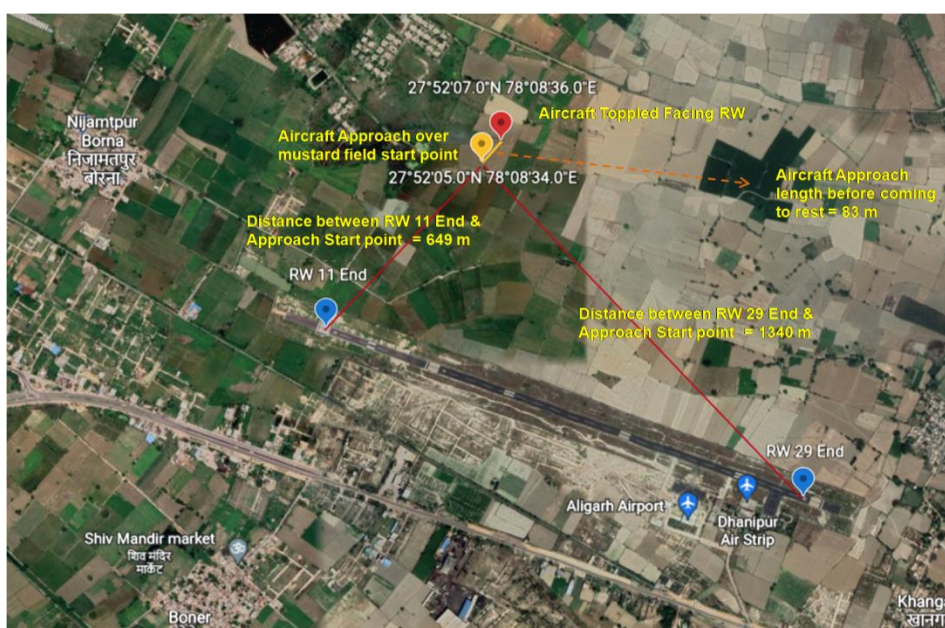
The aircraft crash landed at a distance of 649 meters away from Runway 11 end and 1340 meters away from Runway 29 end in a paddy field. The exact crash location of the aircraft was 27°52'07.0"N, 78°08'36.0"E. The aircraft was in toppled condition (Inverted position).

Figure 3: Aircraft Crash Site with distances marked (Pic Courtesy: Google Earth)

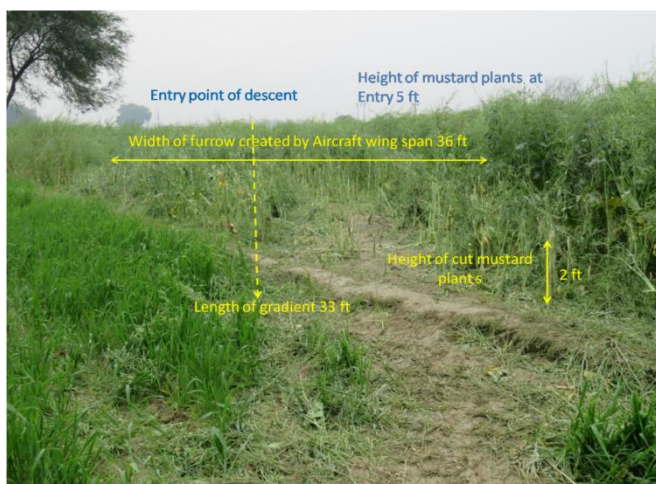
Figure 4: Aircraft Crash Site with distances marked

field, chopping of the plants with a gradient in a gradual manner. The width of the furrow created by the aircraft was 36 ft. which is akin to the wing span of the aircraft. The height of the mustard plants at the entry point of the field was 05 ft. approximately and the minimum height of the plants cut by the aircraft was 02 ft. The main wheels and the engine propeller created tracks on the field up to a distance of 160 feet. The tell-tale signs of chopping of the mustard plants of 05 ft. height to 02 ft. height over a distance of 33 ft. created by the aircraft indicates that the aircraft had descended in a shallow attitude, touched down on the field and rolled approximately 160 ft.

before coming to a halt after somersaulting as the nose wheel getting obstructed over a wedge on the ground. The whole wreckage was found in an inverted position at a distance of approximately 198 ft. from the point of entry into the mustard field.
