**Final investigation report on accident involving Cessna aircraft VT-FAO  
operated by M/s Flytech Aviation Academy  
on 26.02.2022 near village Thungathurthi, Nalgonda (Telangana)**

**Aircraft Accident Investigation Bureau  
Government of India  
Ministry of Civil Aviation**

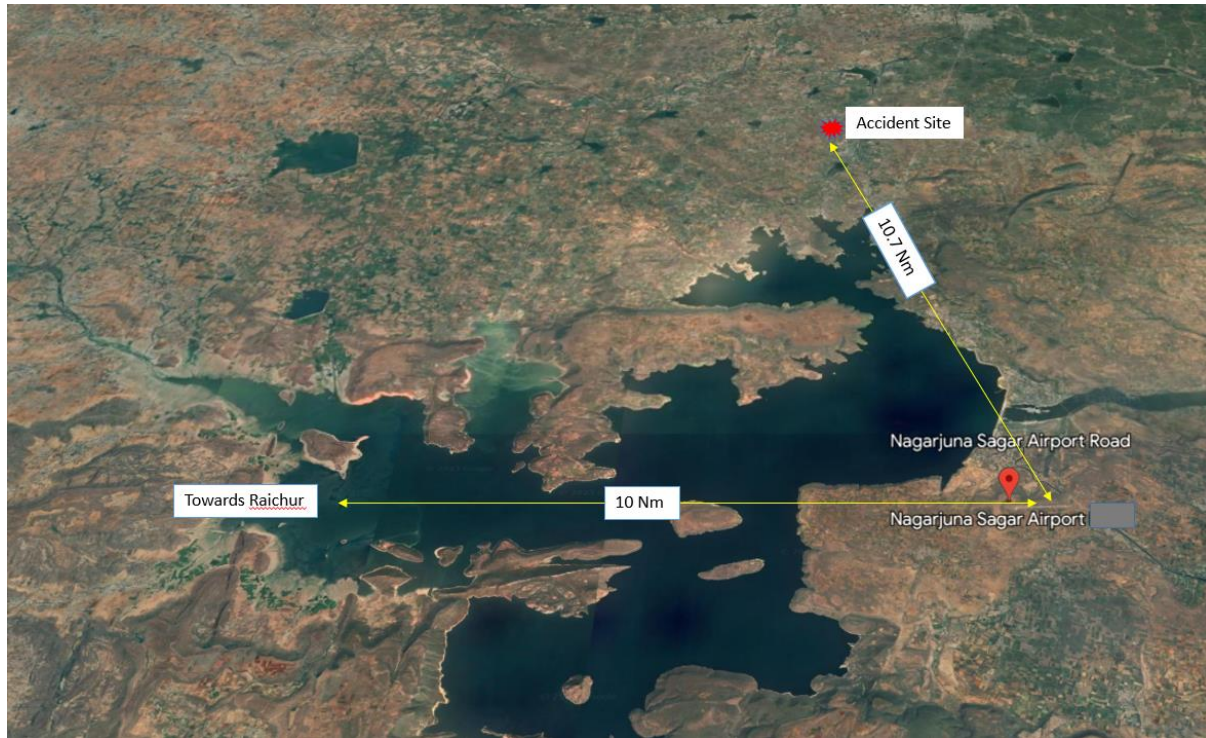
Aircraft came to rest in a nose-down attitude at the place of impact. The aircraft was severely deformed by impact forces. But, the search-and-rescue satellite system did not receive any signal from aircraft's emergency locator transmitter (ELT). The student pilot received fatal injuries in the accident.

**Figure 1: Accident Site**

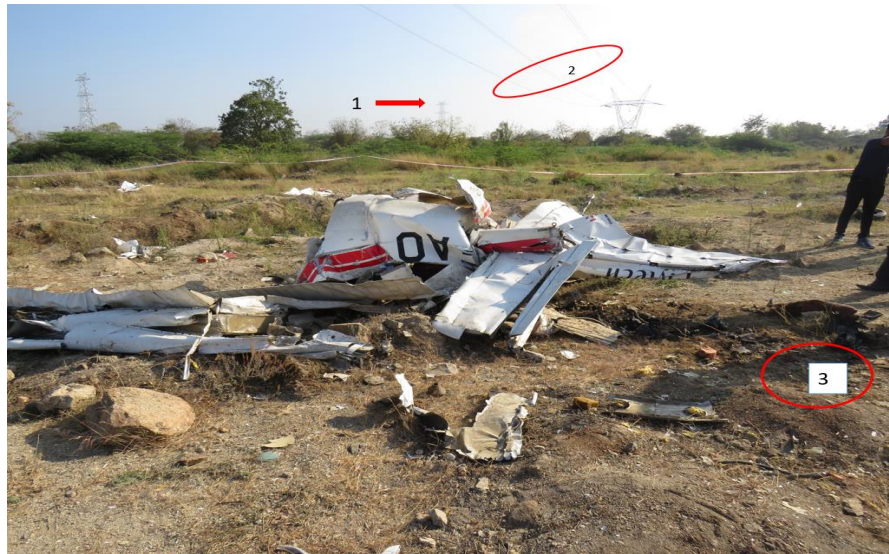
Although, the aircraft avoided contact with the electric wires, it was observed by the witness that the aircraft started moving in nose down attitude. Shortly, the aircraft collided with ground resulting in formation of a dust cloud at the crash site. The impact occurred at the location identified as No. 3 on Figure 10.

**Figure 10: Aircraft path after making 180° turn [1. Newly installed Tower, 2. Electric wires & 3. Point of Impact]**

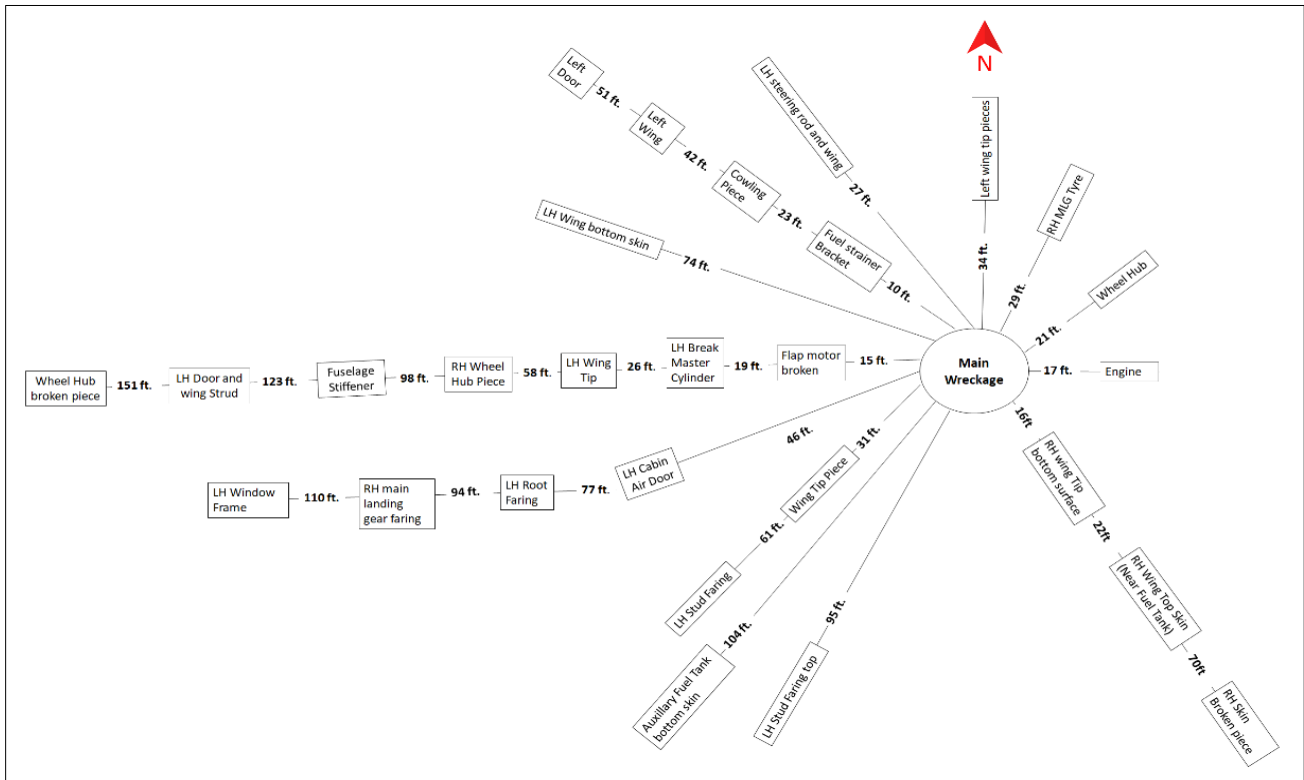
**Figure 12: Wreckage distribution diagram**

All the aircraft parts scattered in the area were identified. Based on their locations at the crash site, an aircraft wreckage diagram was plotted (Fig 12). It was found that aircraft parts were scattered up to 151 feet apart from the main wreckage, corroborating with the fact that it was a high-energy impact at the site.

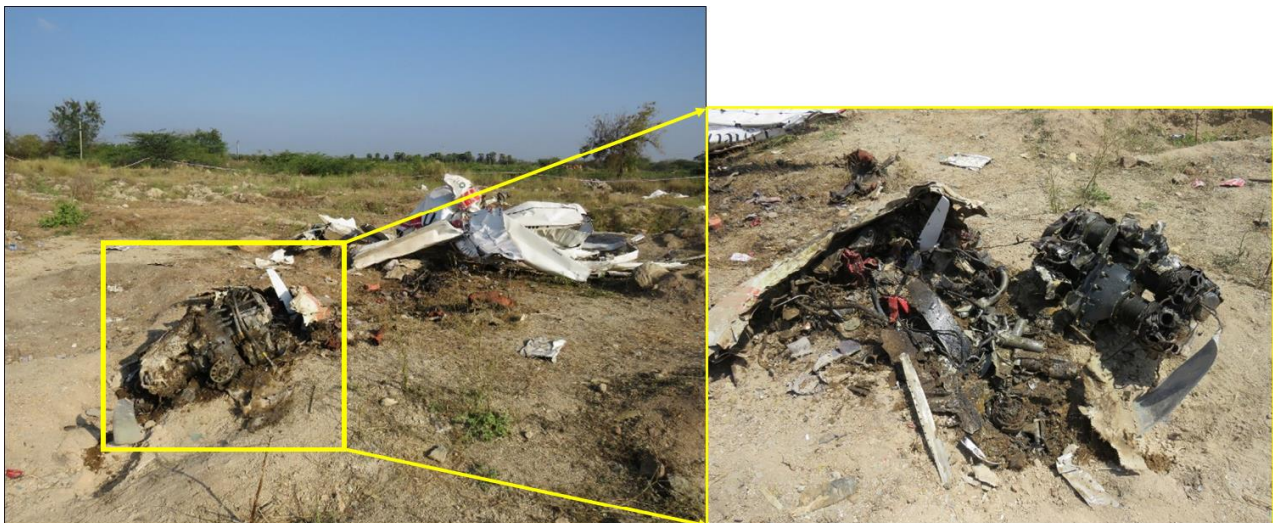
was found on a barren land. After examination of crash site, it has been observed that forward section along with the fuselage was severely deformed, consistent with a high-energy collision with the ground along the aircraft's longitudinal axis. The aircraft had come to rest in a nose-down attitude.

Both wings had ripped off from main fuselage after they struck the ground. The empennage had separated from the airframe and was found behind the aft section of the fuselage, indicating that the separation had occurred on impact with the ground. Pilot seat got separated and found beside the main wreckage.

The engine got separated from the firewall completely and found at a distance of approximately 17 feet from the main wreckage. Propeller hub of each blade was found stuck into the ground adjacent to damaged engine and were found broken from the center mount. RH main landing gear tyre was found detached from the assembly hub. Further, tyre grooves were found beyond the limits. Some of the wreckage photographs are provided at the Annexure D of the report.

**Figure 13: Aircraft Main Wreckage and Engine Wreckage**

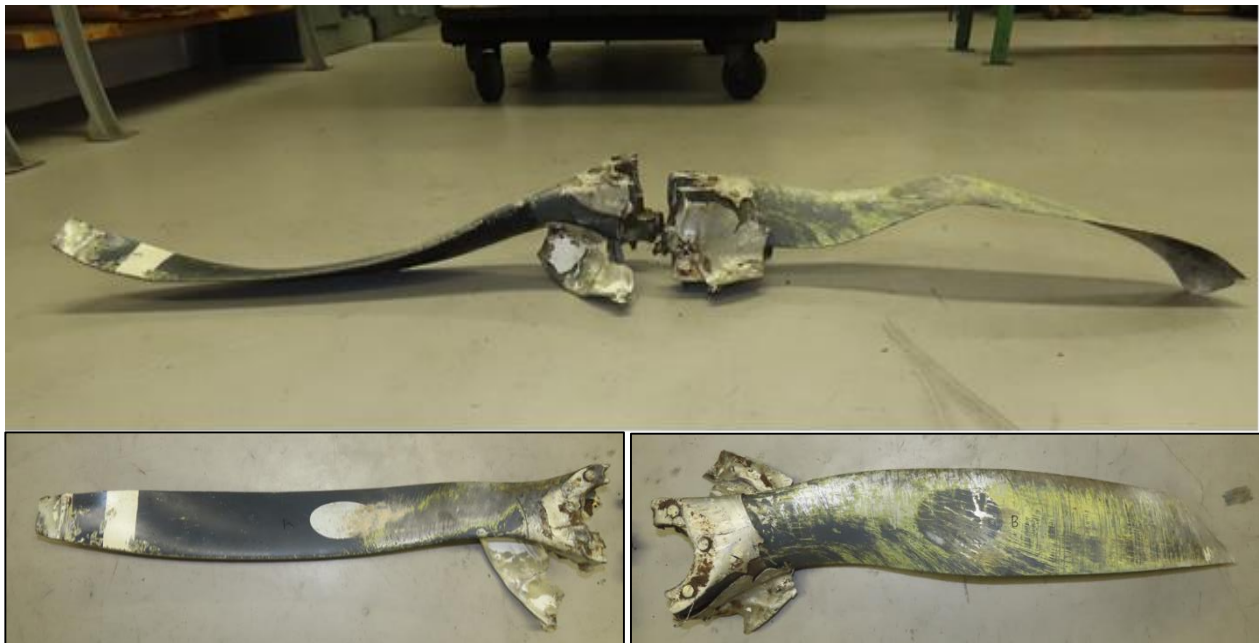
- The metal fixed pitch propeller was found fractured through the center of the propeller hub. Both blades exhibited damage in the form of chord wise scratching, leading edge damage and gouging, and S-bending to the overall propeller.
- Blade "A" exhibited bending, cordwise scratching on the first 16", along with tip damage in the form of bending and gouging.

**Figure 14: Blades labeled "A" and "B"**

- Blade "B" exhibited overall bending with cord wise scratching, leading edge polishing, and twisting of the blade towards the tip.
- Carburetor suffered a high amount of impact damage and could not be fully evaluated. The floats were of the plastic type and one float was impact separated from the unit.

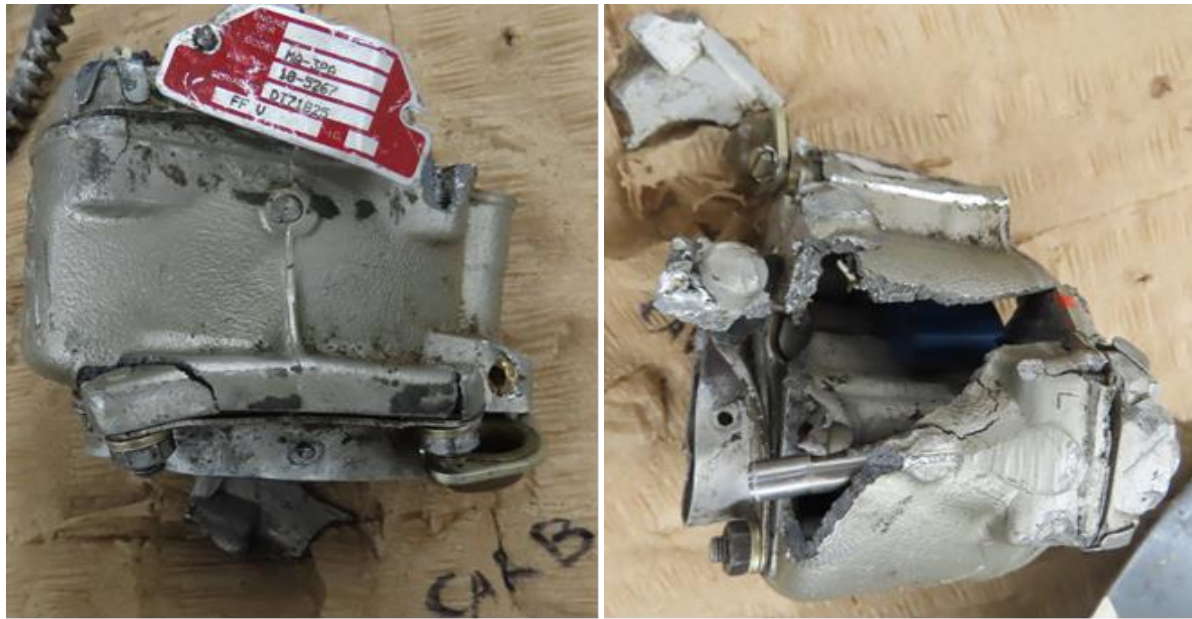
Figure 15: Carburetor

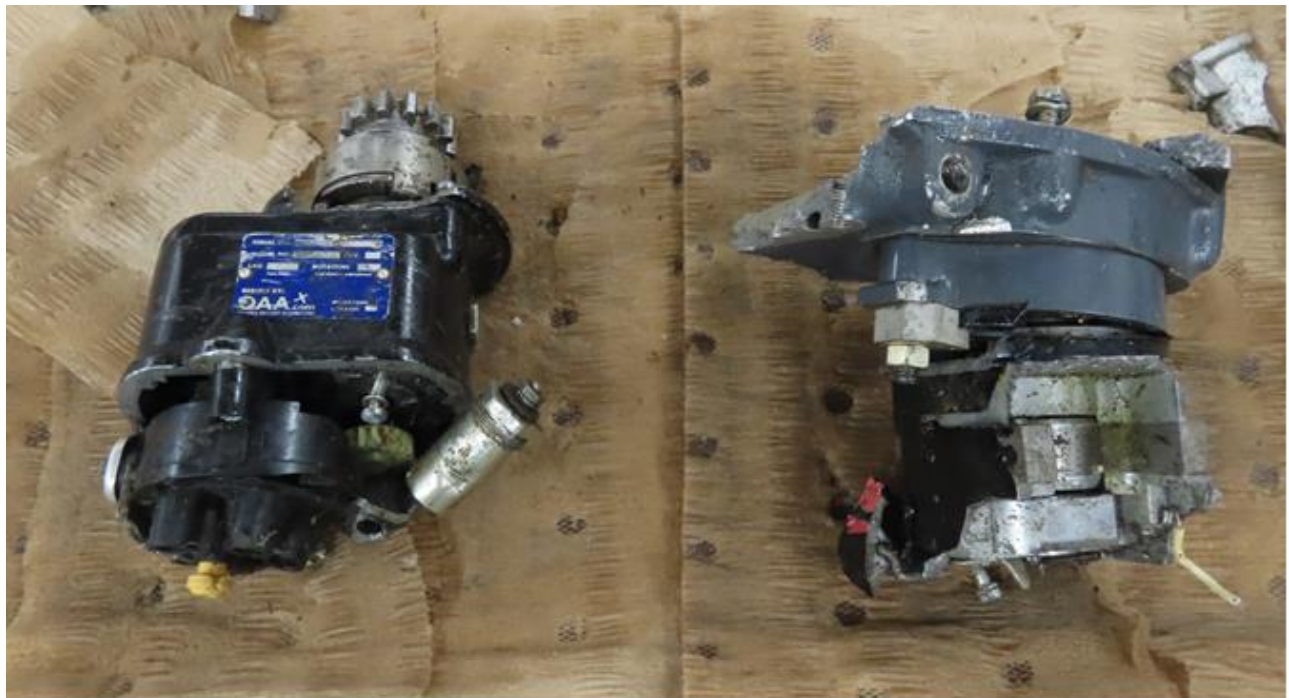
- Both magnetos suffered high amounts of impact damage and could not be tested for spark or operational condition.

Figure 16: Magneto

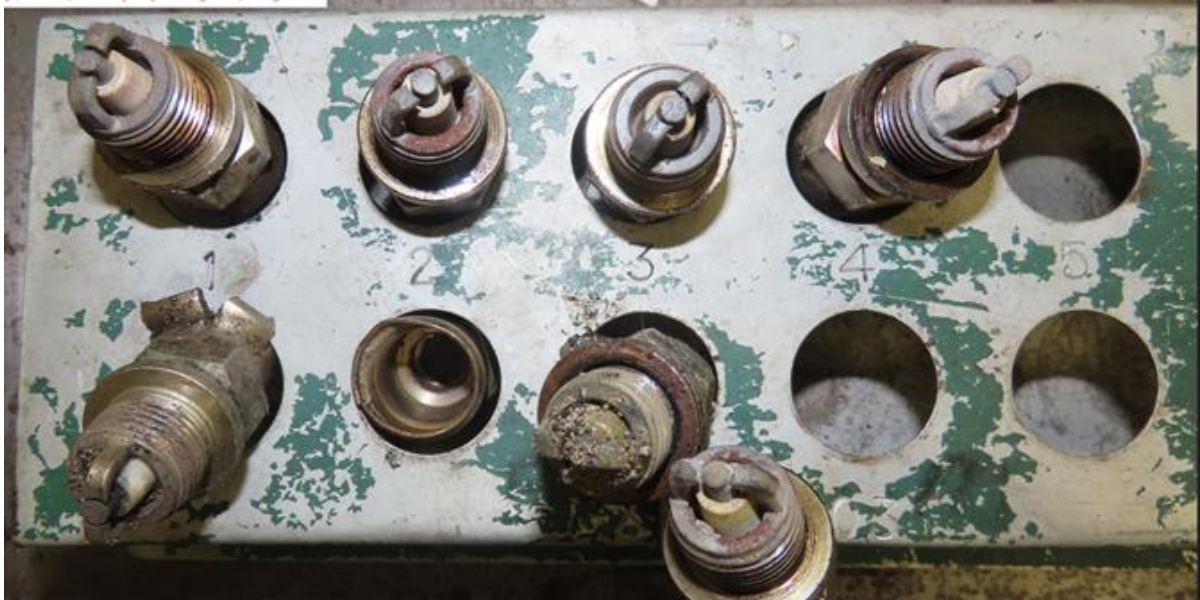
- Sparkplugs showed normal wear and coloration consistent with normal engine operation. Bottom plug on cylinder 2 was impact separated from the cylinder and could not be examined further. Plugs on cylinder 1 and 3 had debris from the impact and combustion deposits present.

**Figure 17: Spark Plug**

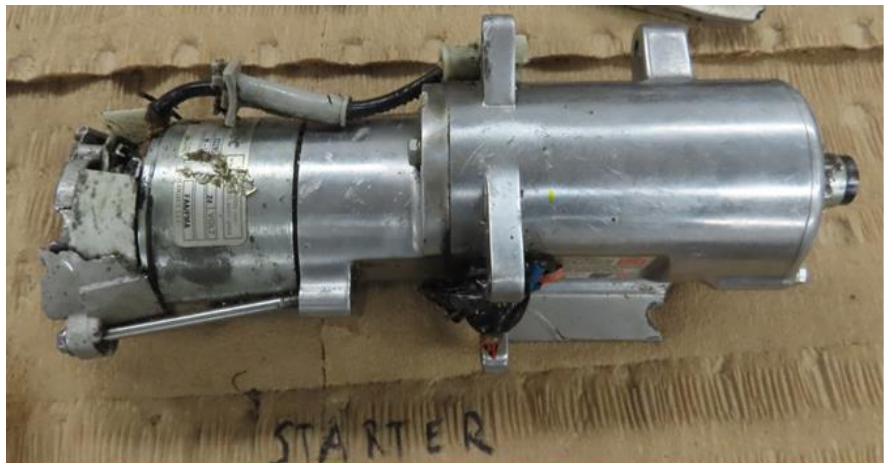
- Harness sustained a high amount of damage in the form of cuts and abrasion consistent with impact damage and could not be tested.
- Data plate was not legible on the starter housing. The rear of the unit was found fractured and damaged. The front of the housing showed signs of gouging and swiping of the surface consistent with contact of the starter ring gear during engine rotation.

**Figure 18: Starter**

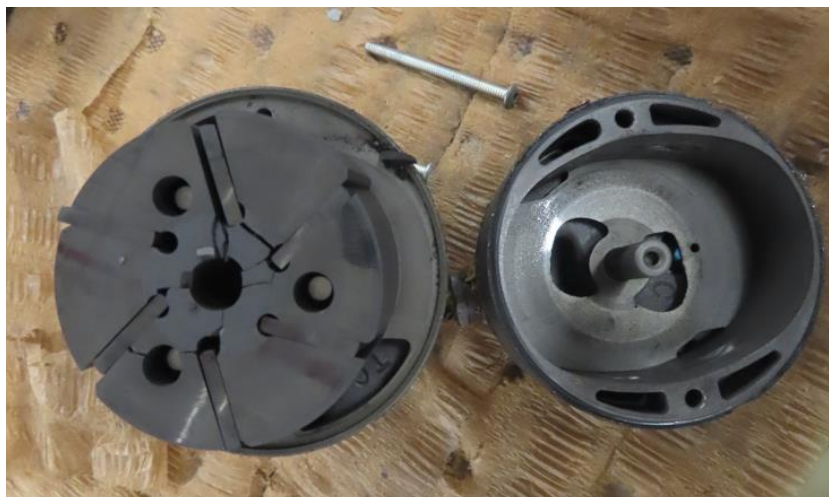
- Alternator was highly fragmented and could not be further evaluated. Vacuum pump disassembled and rotor showed cracks throughout.

**Figure 19: Vacuum pump**

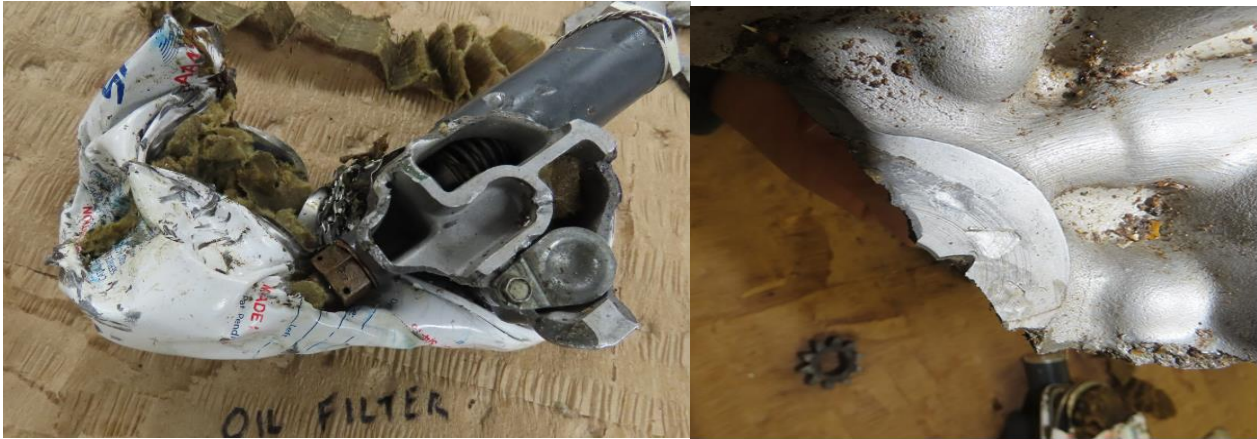
- Oil system could not be evaluated as the oil filter suffered high impact damage and a portion of filter element could not be gathered for evaluation. The oil suction screen was not present at the exam and could not be evaluated. No signs of a lack or loss of lubrication was observed throughout the engine exam on any of the bearings or rotating surfaces. A portion of the oil pump housing was present and one of the oil pump gears impacted the housing consistent with hard ground impact which left an imprint of the gear. This imprint showed swiping of

**Figure 20: Oil Filter & Oil Pump Housing**

the material consistent with rotation.

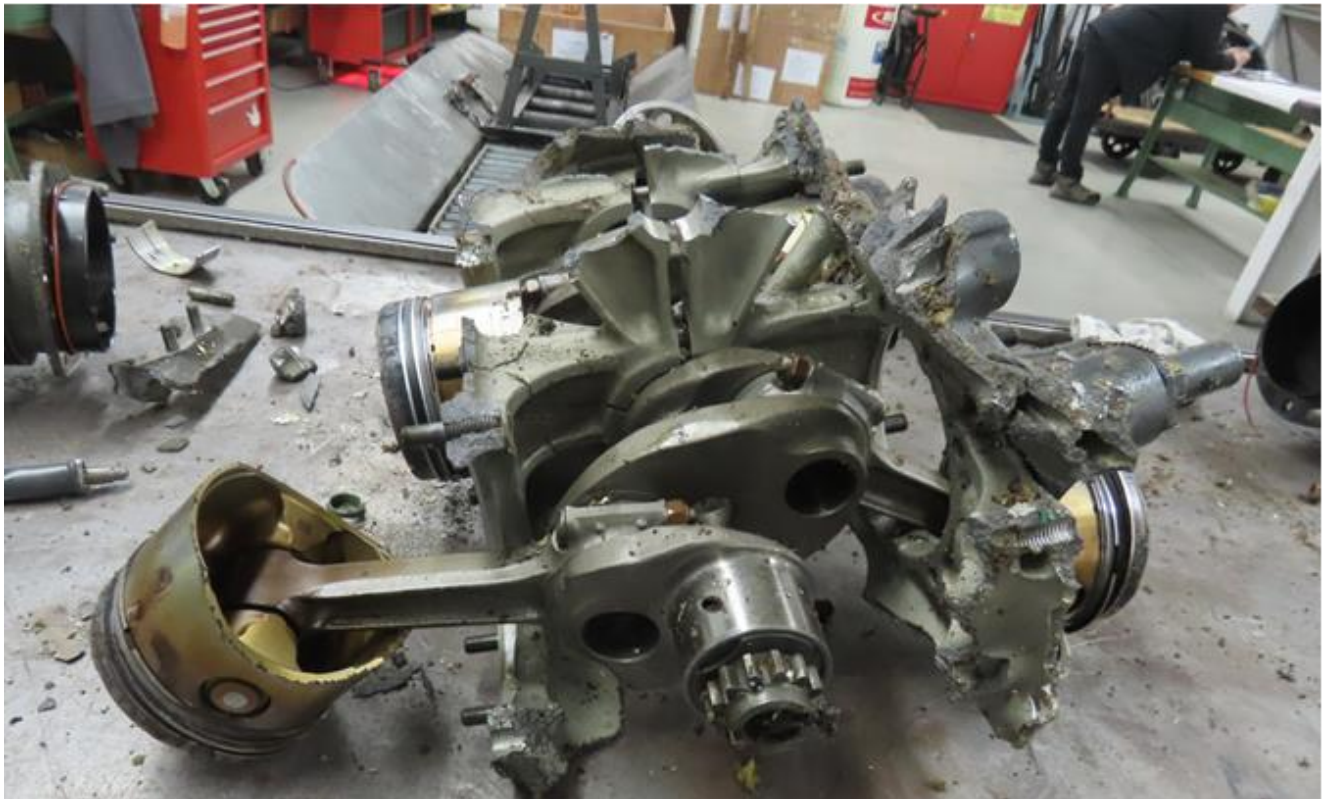
**Figure 21: Crankshaft**

- All connecting rods were removed from the crankshaft except for the number 1. The crankshaft suffered an approximate 8 degree bend which pinched the connecting rod onto the crankshaft journal. The connecting rods bearing were removed (7 out of 8) and examined. No lack or loss of lubrication conditions were observed, and the surface of the available bearings were found unremarkable.
- The crankshaft main bearings were examined and no lack or loss of lubrication conditions were observed. The surface of the available bearings were found unremarkable.

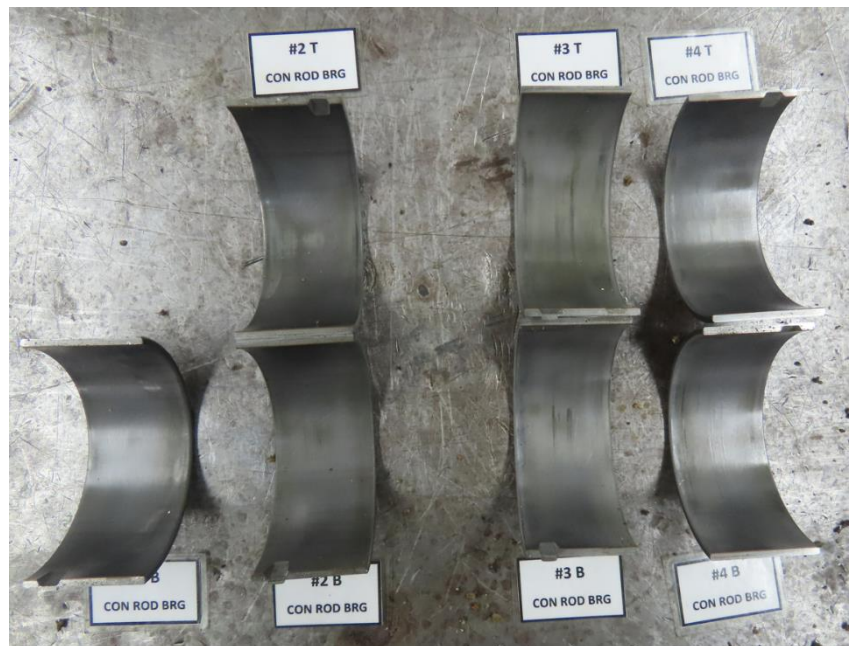
**Figure 23: Bearings**

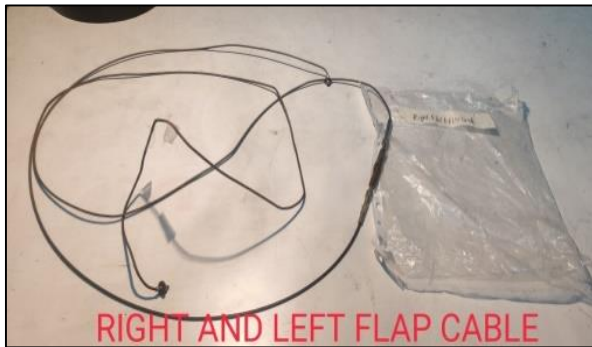
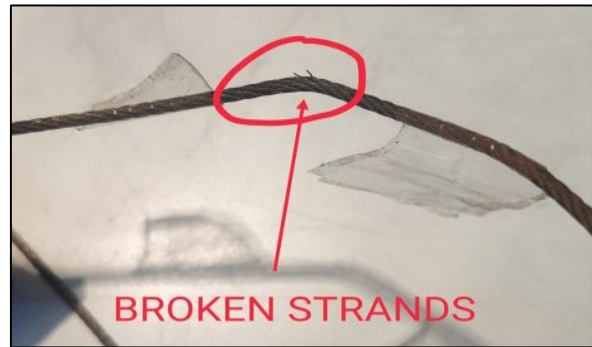
### 1. Right and left flap cable

1. Condition of cable brownish mark on some areas.
2. At one location 3 strands broken.

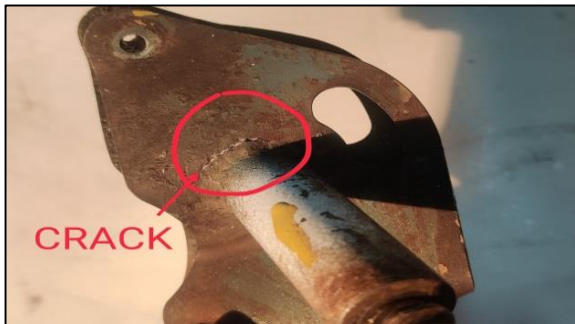
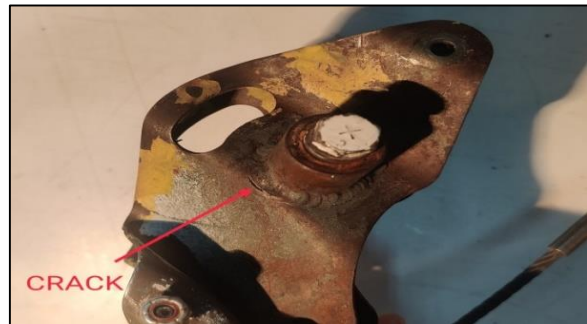
### 3. Right aileron

1. Cable locking not present, may be removed by engineer after crash.
2. Quadrant- welding crack found may be due to crash.

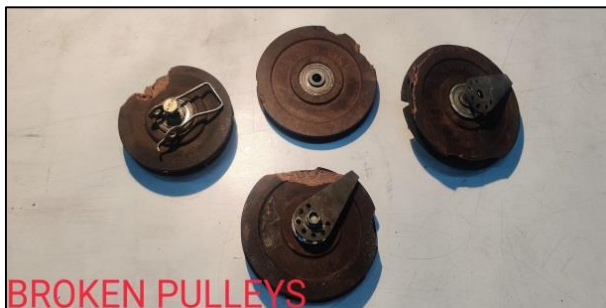
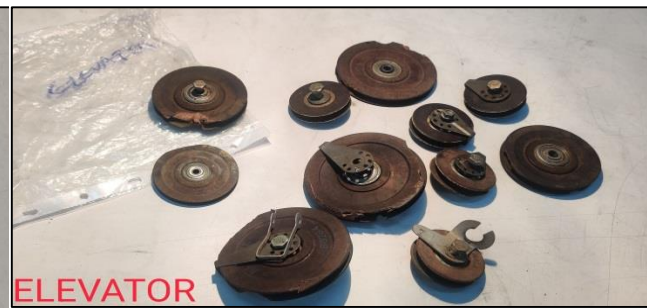
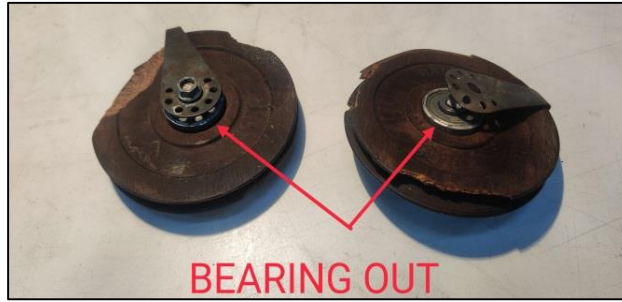
### 4. Elevator

1. On 2 pulleys (size- 3.5" dia)- bearing comes out from pulley bearing checked for free rotation found ok.
2. Many pulley broken may be at the time of accident.
3. On one pulley (size- 3.5" dia) cable guide found bend.

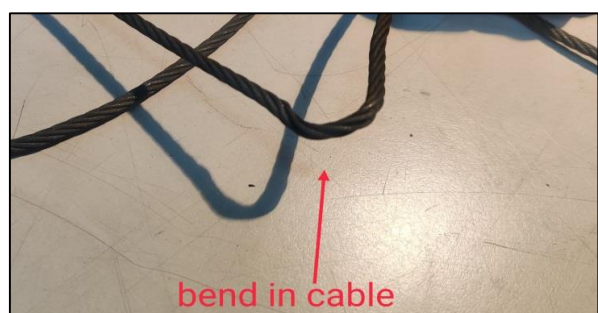
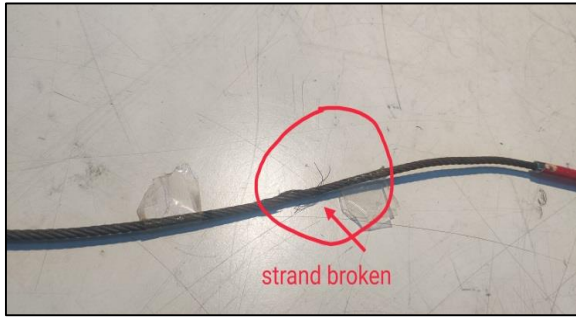
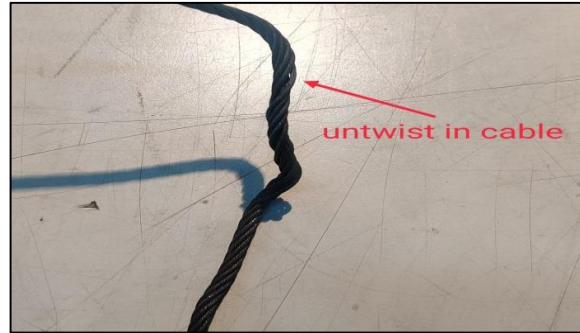
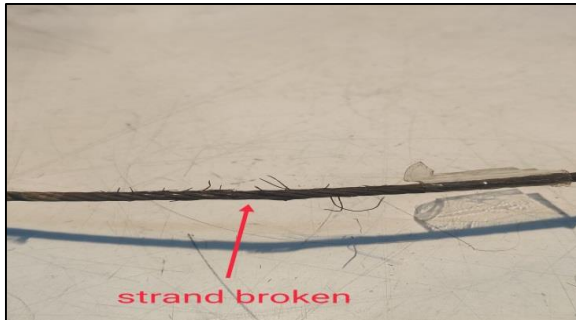
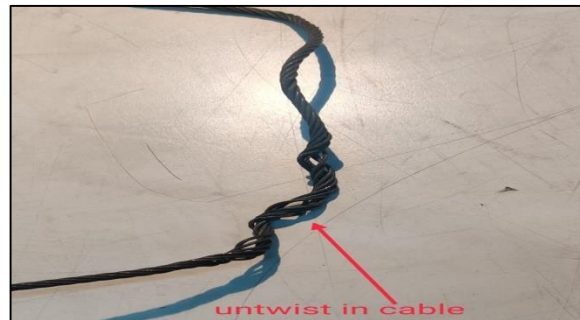
**6. Left rudder cable**

1. Cable found corroded at many places and many strands found broken 26 cm away from adjustable fork end.
2. No locking found on adjustable fork end.
3. Cable found bend at 38 cm from fixed fork end.
4. At one location , cable found untwisted ( 8 cm long) at 75 cm from fixed fork end and at 100 cm from the fixed fork end (untwisted length 3 cm).
5. corrosion observed on many places.

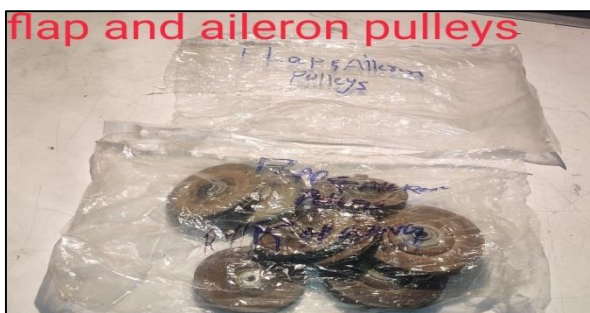
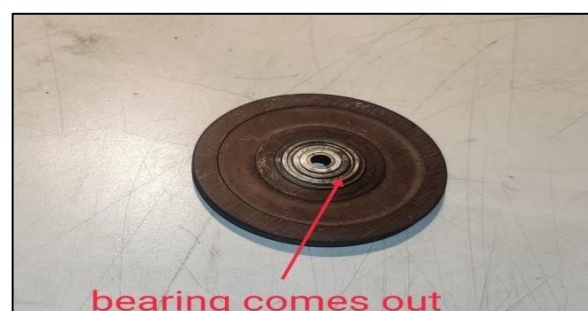
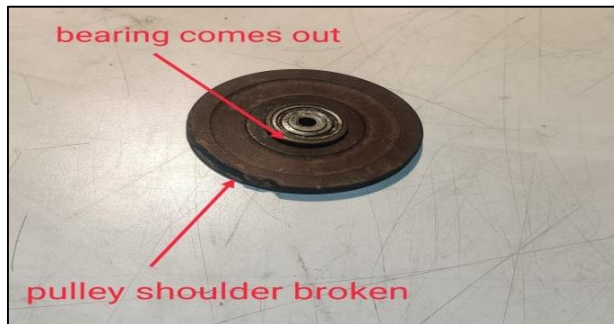
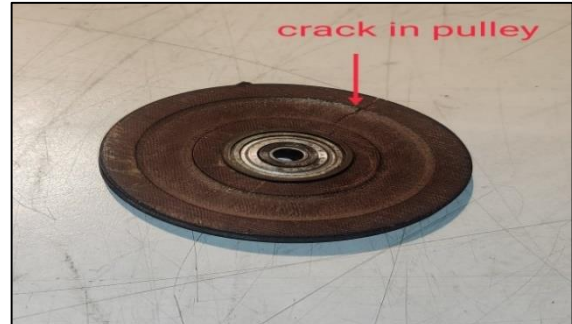
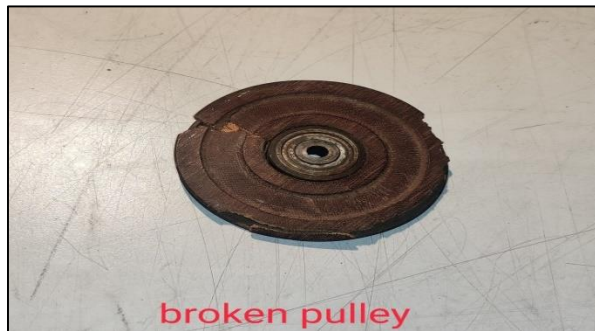
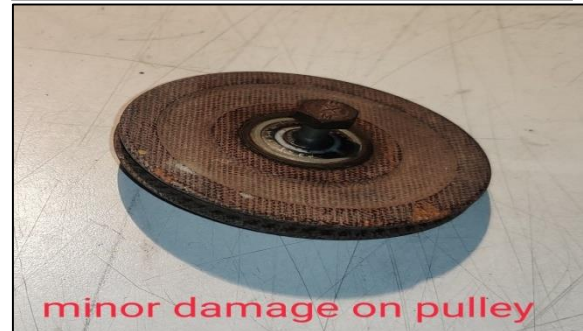
#### 9. Flap and ailerons pulleys

1. One pulley bearing comes out of the pulley.
2. On one pulley, bearing comes out of the pulley and pulley shoulder also found broken.
3. Crack found on pulleys on one of the pulley and bearing found jammed.
4. Another bearing found broken and binding observed in bearing.
5. On one pulley minor damage observed. However, bearing is free to rotate.
6. On two pulley ( **dia- 750 mm** ) pulley shoulder broken . Bearing is free to rotate.

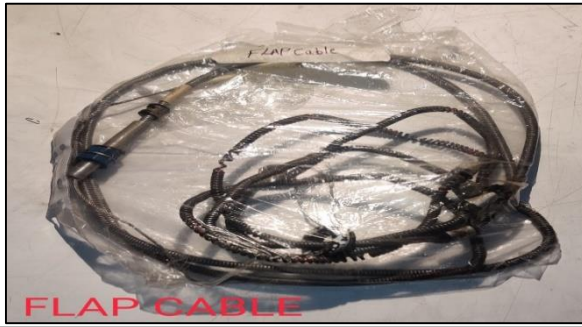
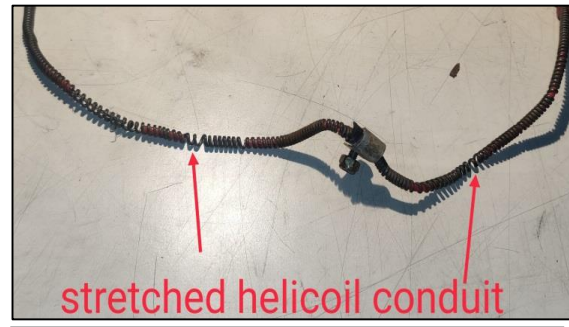
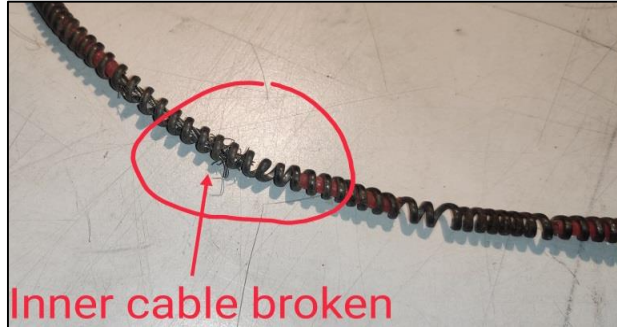
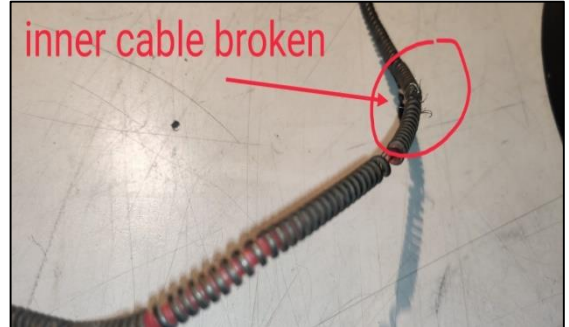
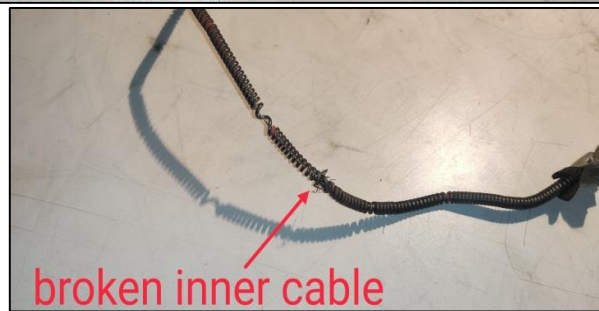
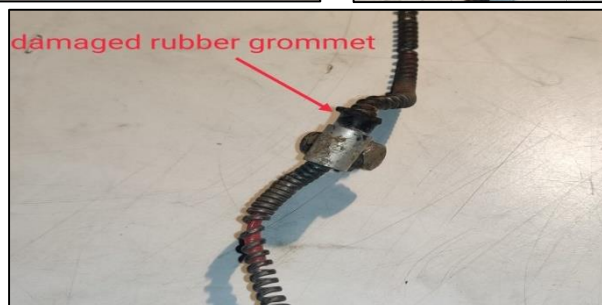
## 11. Flap cable

1. Outer flexible helicoil conduit found strached at many location.
2. Inner cable found broken at many places.
3. Clamp and rubber grommet found damaged.

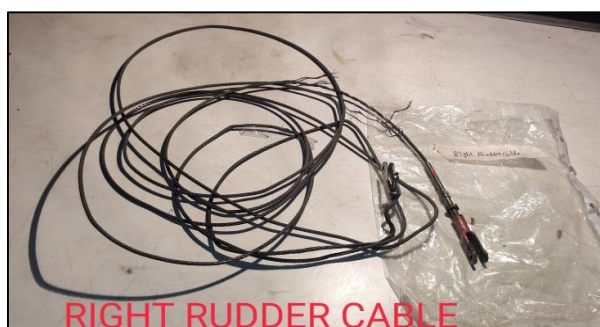
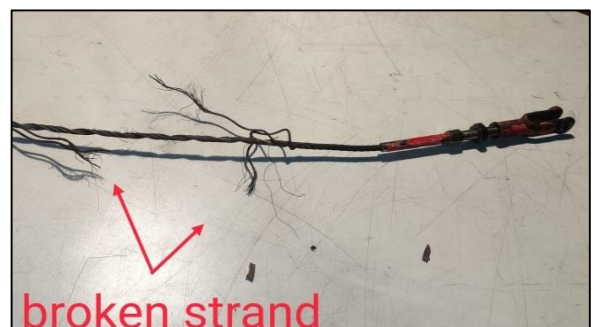
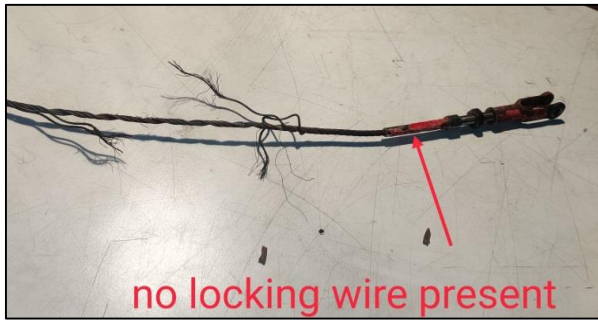
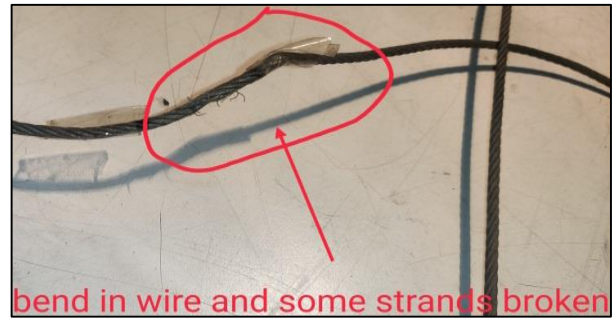
## 12. Right rudder cable

1. At 25 cm from the adjustable fork end, cable found corroded and 50 % of the strand found broken.
2. No locking wire found on the adjustable fork end.
3. Cable found untwisted (approx 10 cm) from the fixed fork end.
4. At approx ( 1 m) from the fixed fork end, cable found bend and some of the strands found broken.

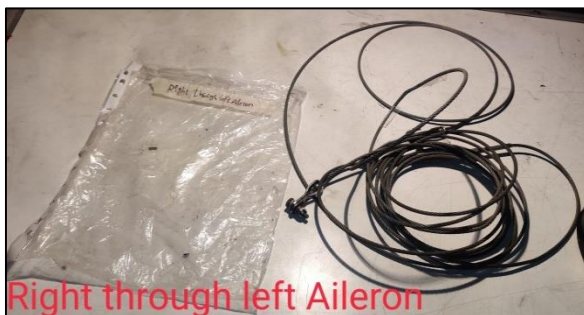
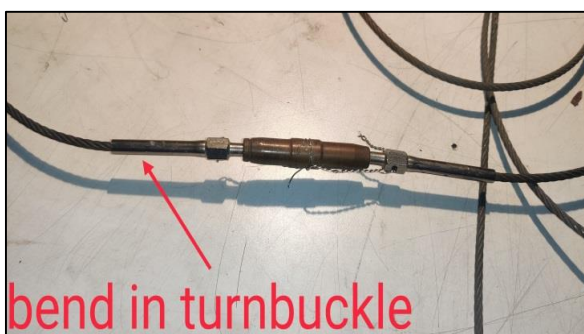
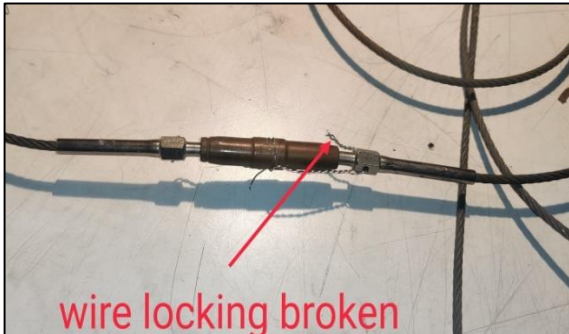
#### 13. Right through left aileron

1. At some places, brownish deposit found.
2. Trunbuckle found bend, locking wire found broken

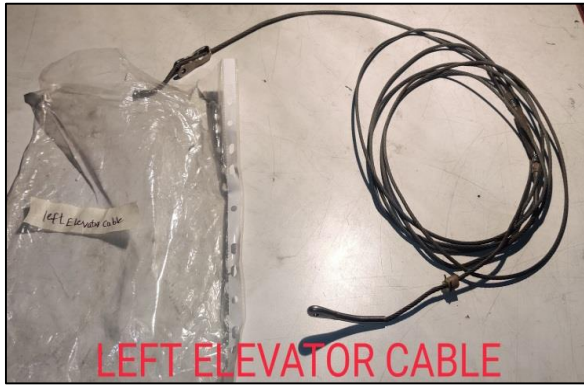
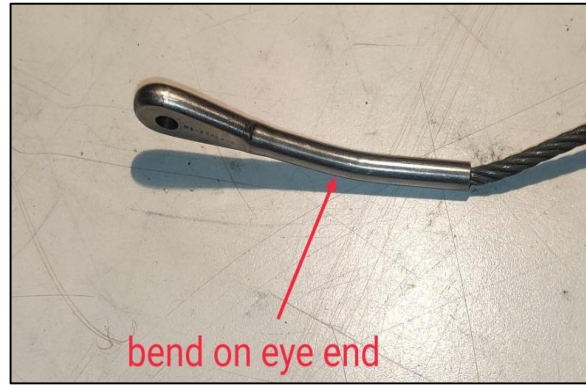
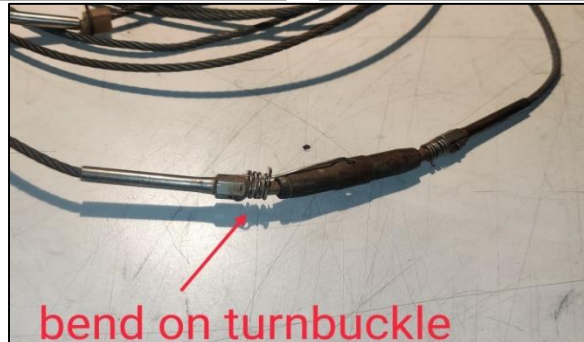
#### 14. Left elevator cable

1. Bend on eye end.
2. Turnbuckle found bend and wire locked.
3. Cable condition satisfactory.

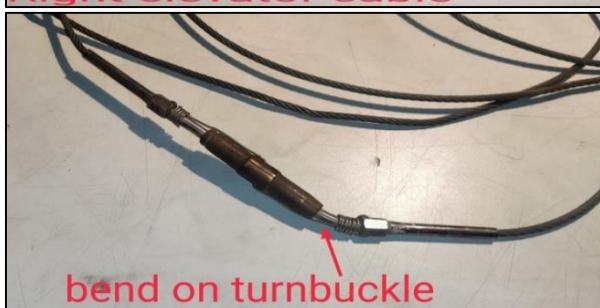
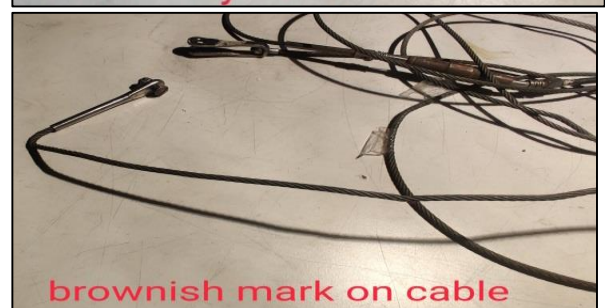
#### 15. Right elevator cable

1. Bend found on cable, 8 cm from eye end .
2. Bend found on trunbuckle.
3. Brown deposite found on cable (66 cm from fixed fork end).
4. At 66 cm from fixed fork end, strand found broken and wear marks (8 cm long) found on the cable.
5. 26 cm from the eye end , slight damage found on the cable.

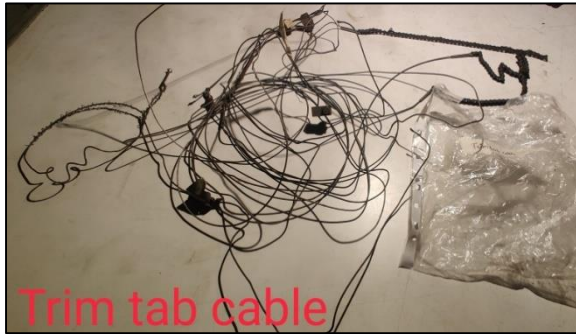
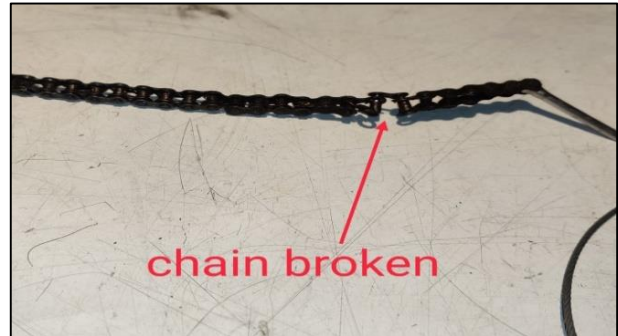
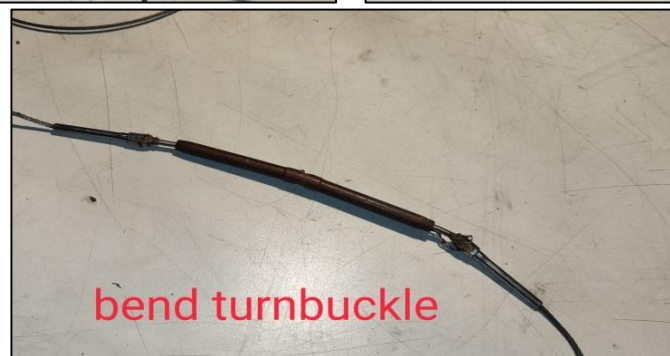
## 16. Trim tab cable

1. Chain found broken.
2. One eye end from chain found detached.
3. Another end (30 cm from eye end) found snapped.
4. From detached end, cable found unwinded and broken. At 60 cm from detached eye end, strand found broken.
5. At 30 cm from detached end cable found snapped.
6. Turnbuckle found bend and wire locked.
7. At many places wire is untwisted.

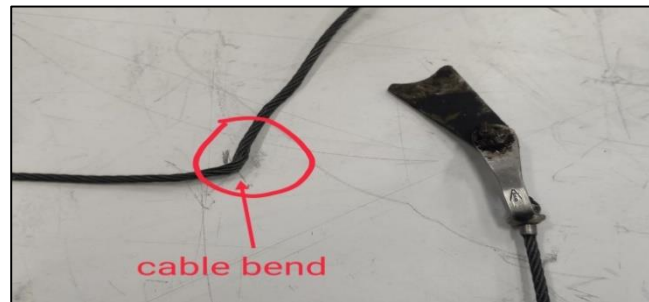
## 17. Right aileron

1. At one meter from fork end cable found bend.
2. Slight untwisted cable observed at many places.
3. 11 cm from the turnbuckle end, cable found partially snapped.
