**Final Investigation Report**  
**on**  
**Serious Incident of Airprox between**  
**M/s Indigo A320 aircraft VT-IAV (Flight IGO6261) and**  
**M/s Air Asia India Ltd. A320 aircraft VT-HYD (Flight IAD773) at**  
**Mumbai Airspace on 21 March 2022**

**K Ramachandran**  
**Investigator-in-charge**

# **RADAR SNAPSHOTS FROM 155140 UTC TO 155324 UTC**

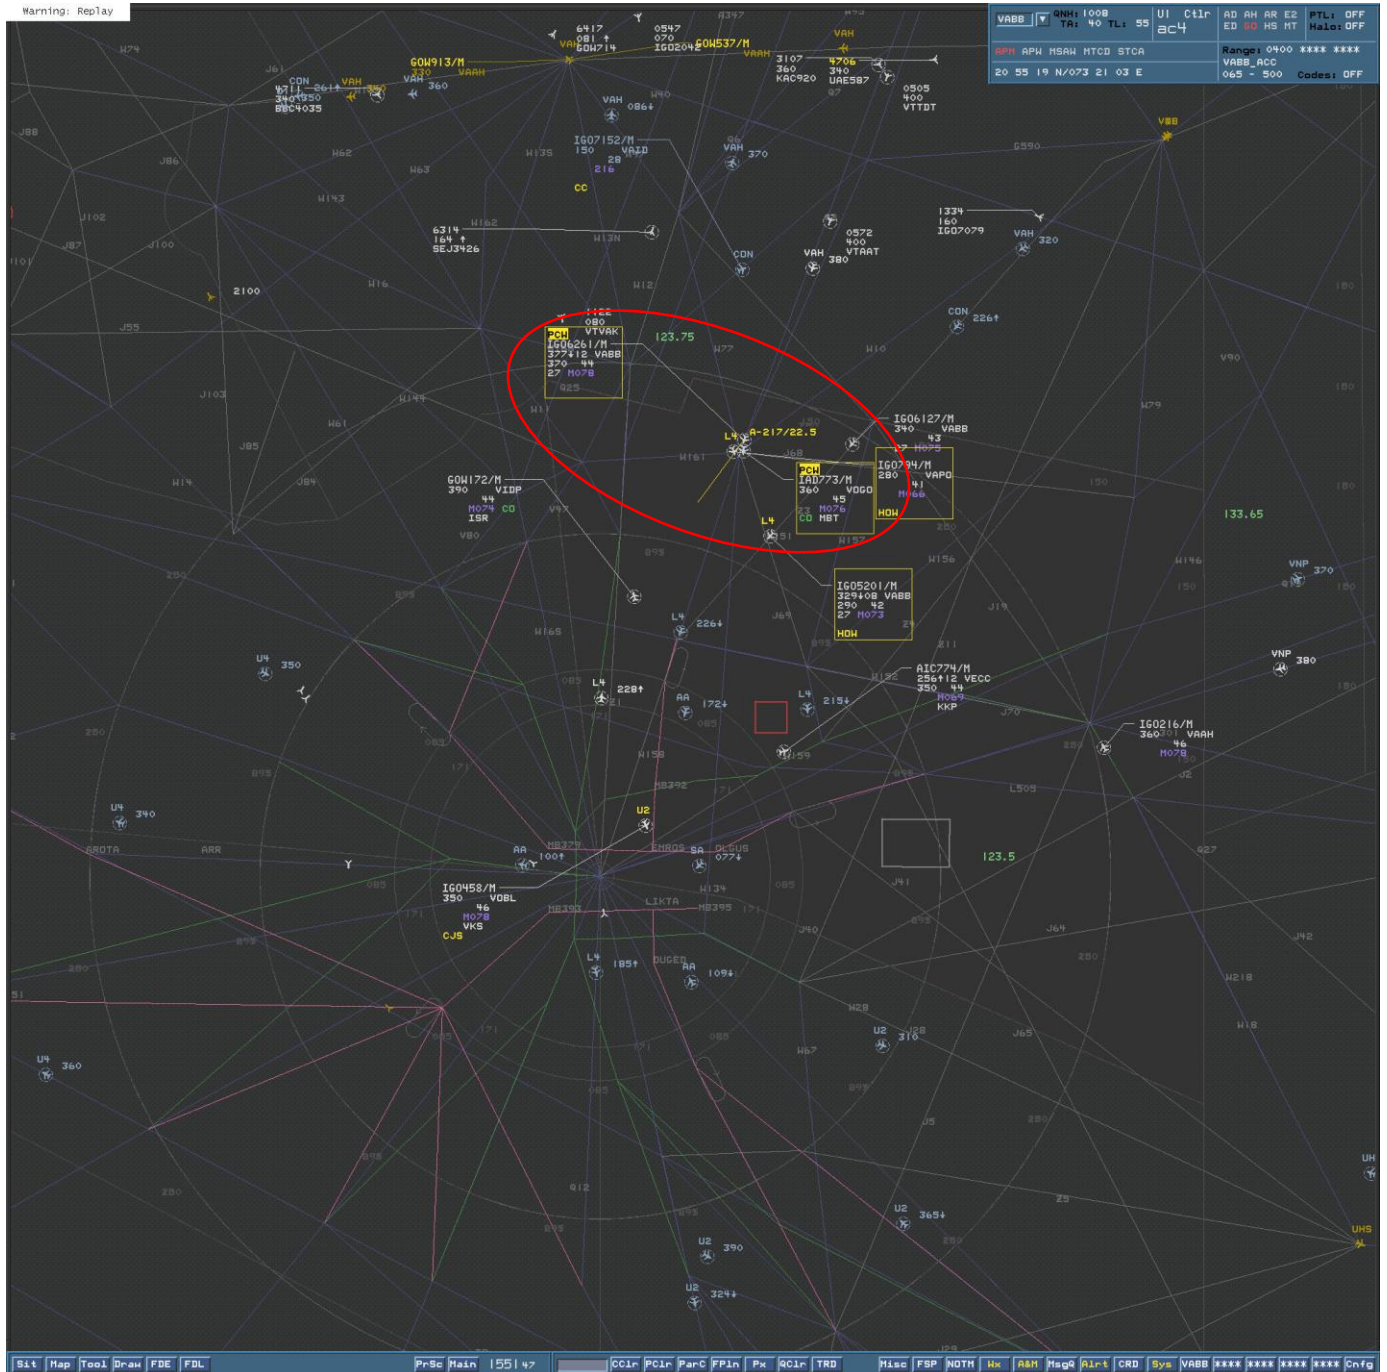
**PCW warning was generated at 155147 UTC**

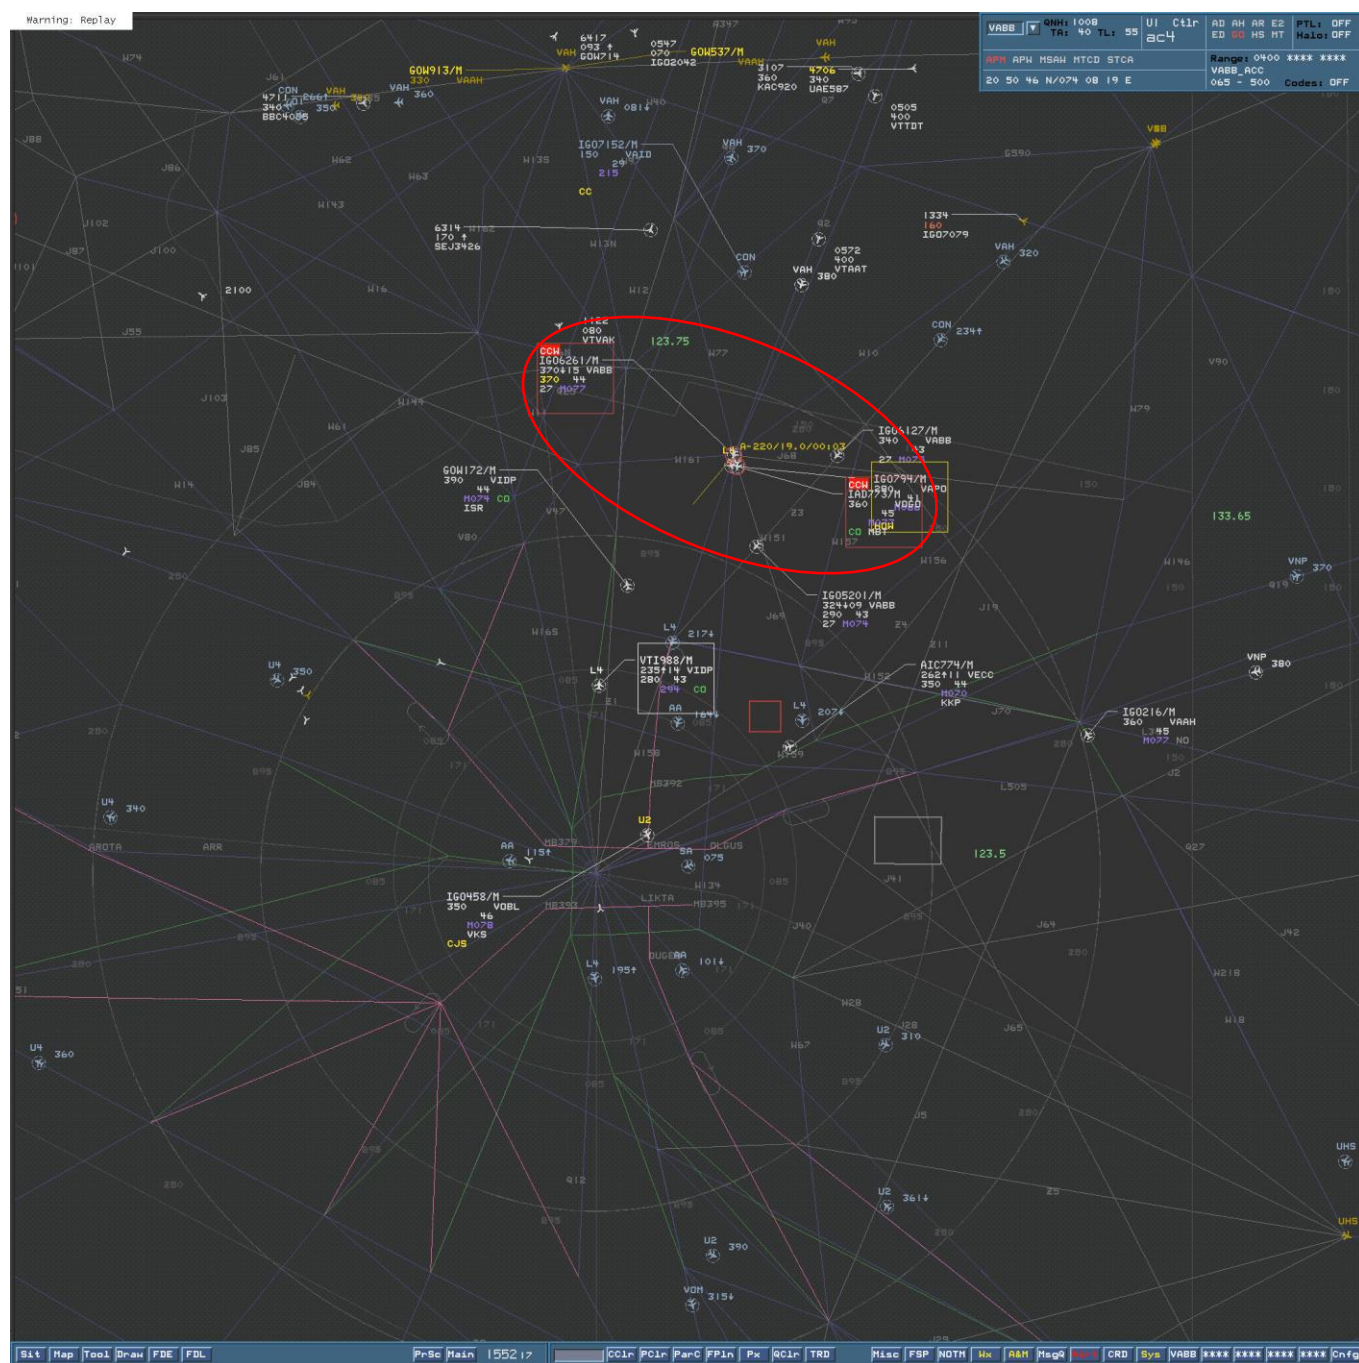
## CCW Warning was generated at 155217 UTC

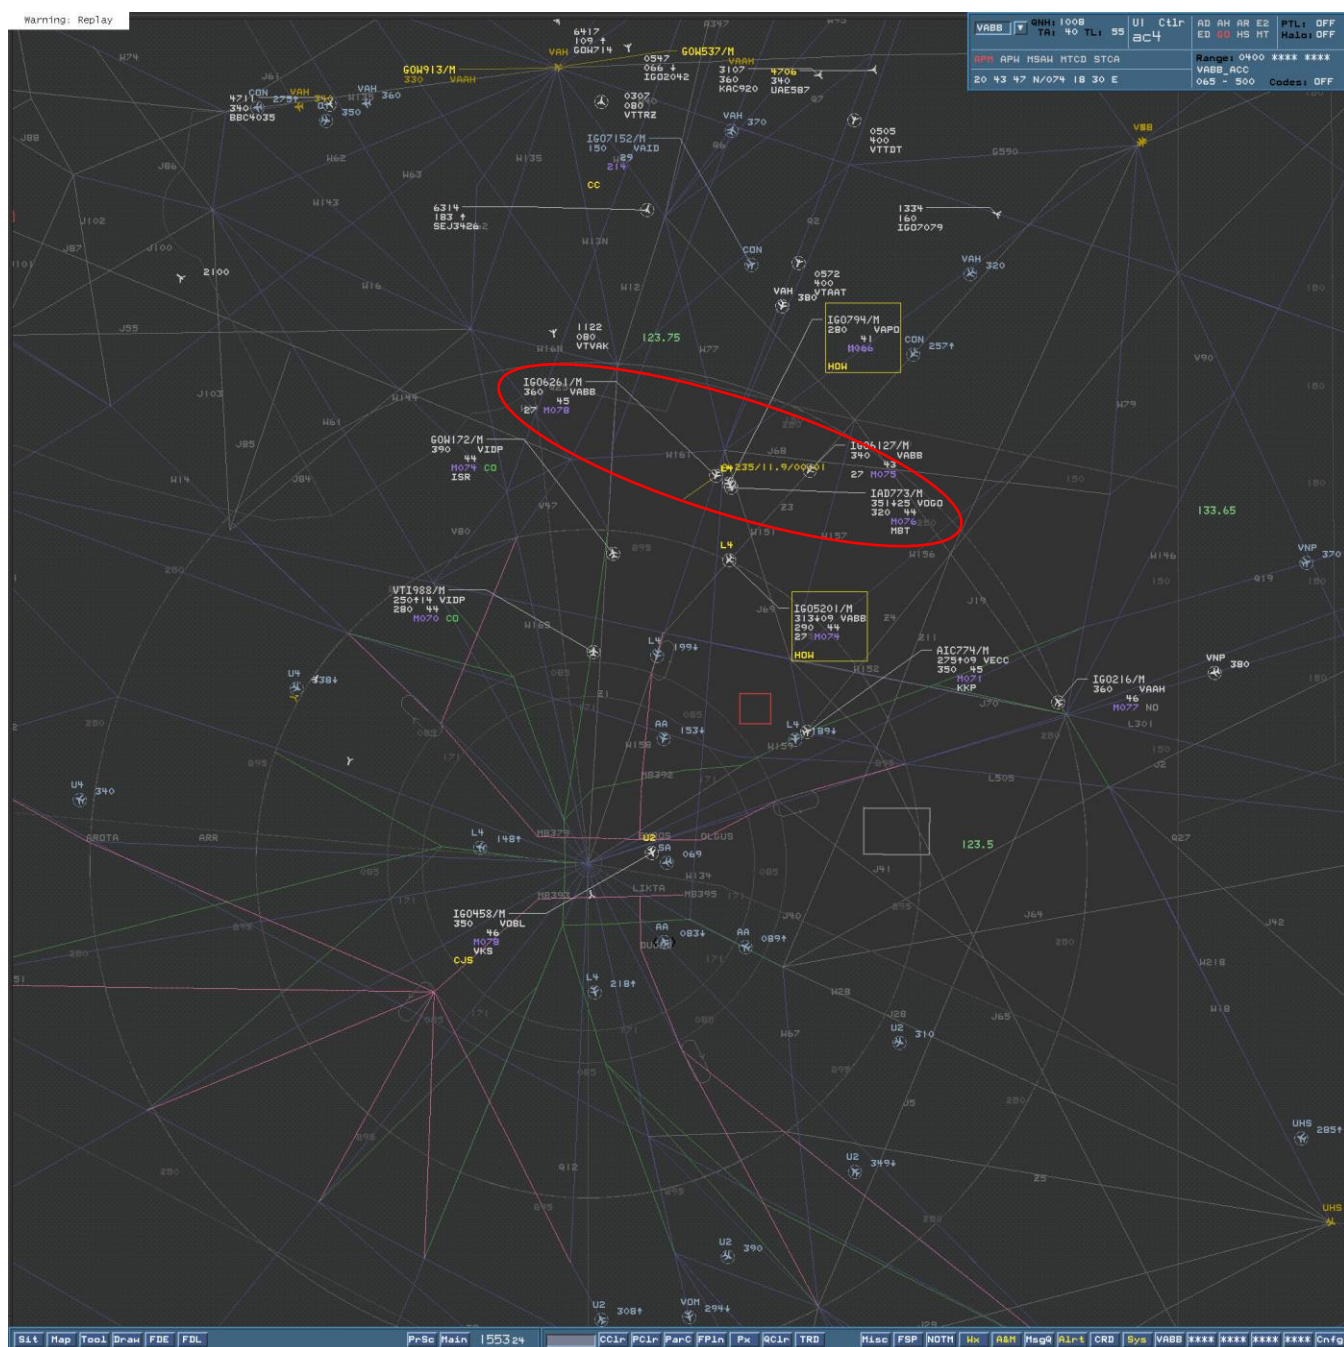
***The Breach of Separation was resolved at 15:53:24 UTC***
