Final Investigation Report
on Serious Incident involving Alliance Air's
ATR-72-212A aircraft bearing registration VT-AIW
at Jabalpur on 12 March 2022

Aircraft Accident Investigation Bureau
Government of India
Ministry of Civil Aviation

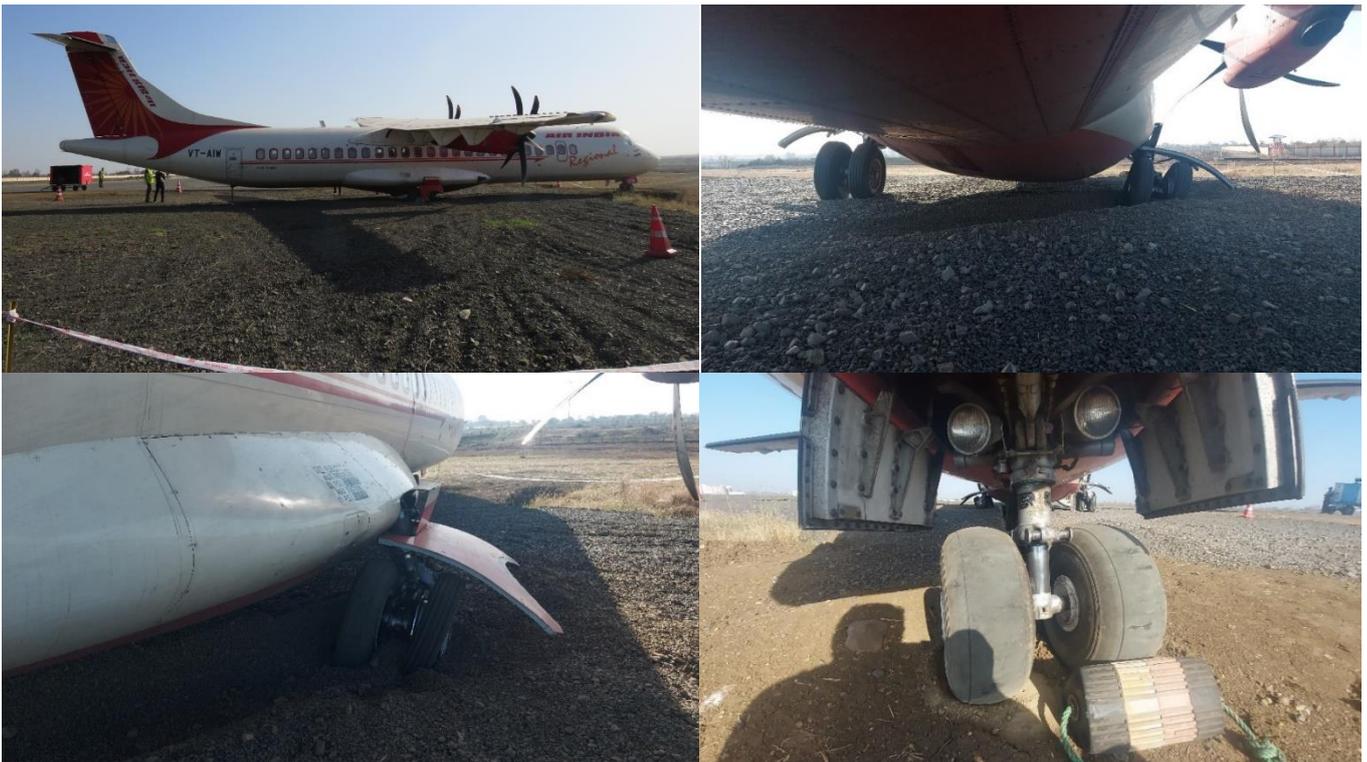
The aircraft suffered damage primarily to its #03 and #04 RH Main Landing Gear wheels. RH Main Landing Gear brake hydraulic pipes were damaged and LH Taxi Light Bracket on the Nose Landing Gear was damaged as can be seen in the Fig 1 below:

Figure 1: Damages on Landing Gear

There was no maintenance due on the aircraft as on date of incident. The aircraft was returned to service after maintenance and repair carried in consultation with the OEM and approved by DGCA. Aircraft serviceability was not a factor in this incident.

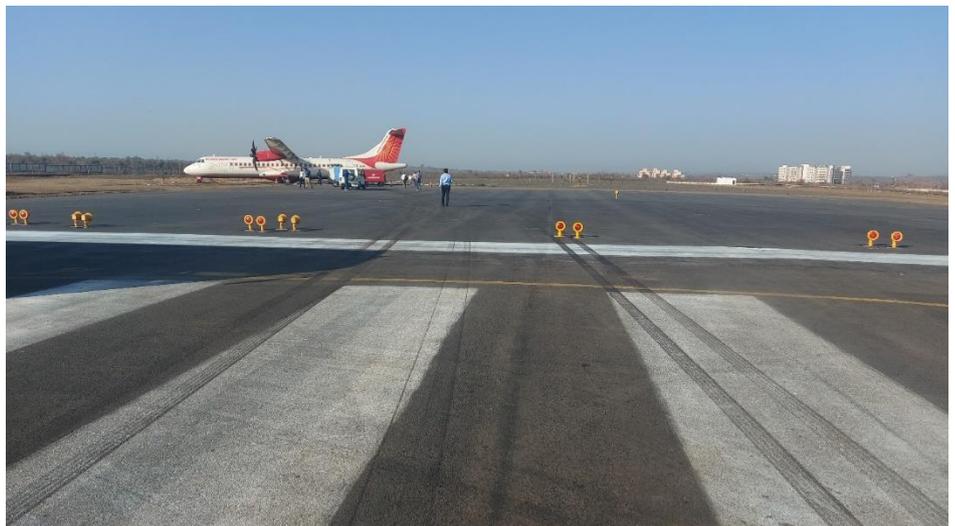
Two Runway End Lights were reported damaged as the aircraft exited the Runway. Figure 2 shows the aircraft wheel marks passing over Runway end lights.

Figure 2: Aircraft wheel marks on runway

The lights were repaired before the resumption of runway operations.

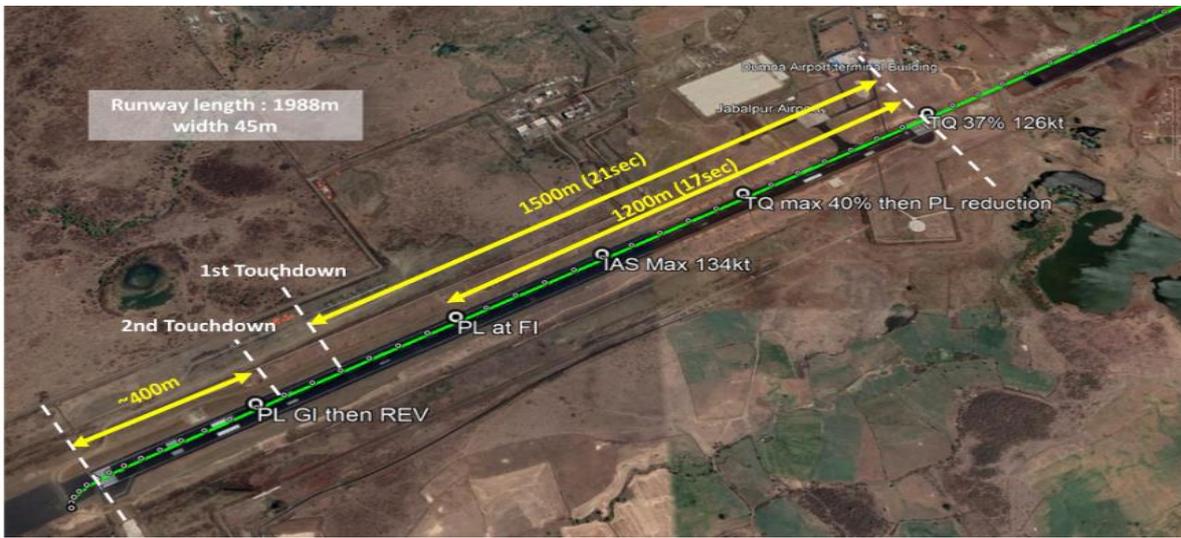
Based on GPS position, the Runway 24 threshold was crossed with a radio height of ~60 ft, IAS at 126 kt increasing toward 134 kt and torque at 37%. The pitch attitude was -2.8°. During the next about 17 seconds the torque increased reached peak of 40%. At RA 10 ft the aircraft was at 500 m from threshold and PLA1 & PLA2 were at 55.5° and 56.2°, and corresponding torque was at 39 % and 41.5 % on engine 1 & 2 respectively. Power Lever began to retard thereafter for next about 12 seconds till aircraft was 1600 m from threshold and torque decreased.

Figure 5: Distance to Flight Idle and Touchdown

IAS remained around 130 kt during the floating phase. As soon as PL were retarded at FI (35°), IAS began to decrease. Aircraft had floated for 1500 m before touching down at 07:43:52 UTC which was about 21 seconds after crossing threshold. During the 21 seconds after crossing threshold

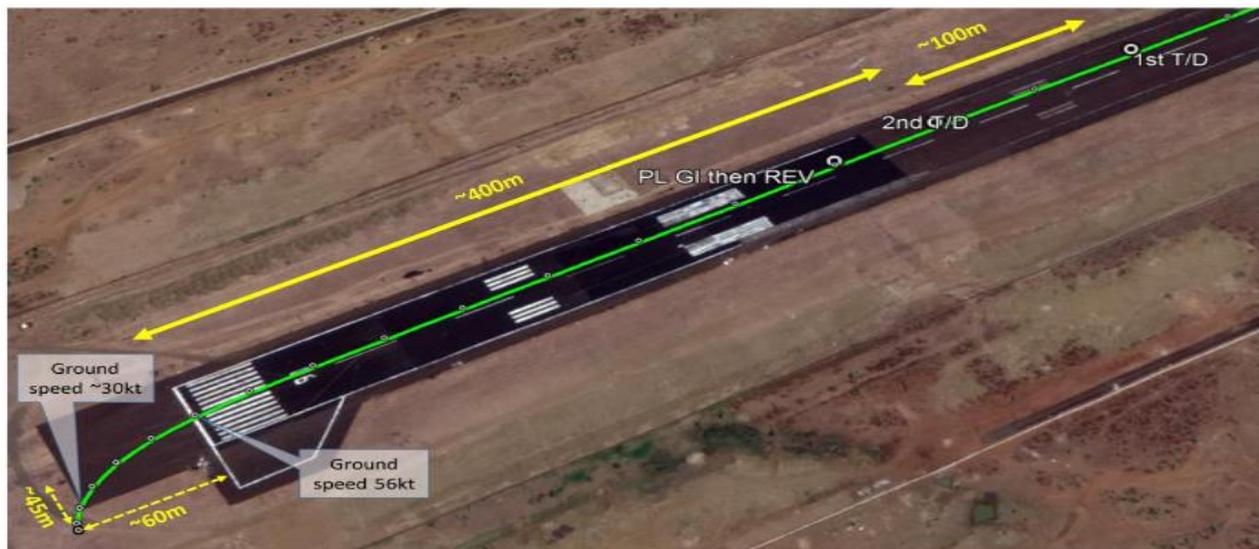
Hereafter, control inputs from the co-pilot were observed from the DFDR data. Aircraft then bounced and a right roll order was applied. A second touchdown occurred with

- +1.5 G of vertical load factor
- 115 kt of IAS
- -2.6° of pitch angle and

- -3.4° of left roll angle was recorded.

Figure 6: Touchdown and aircraft exit from runway

At first WOW signal, IAS was recorded as 104 kts compared to selected IAS (V_{app}) 107 Kts. Both touchdowns were done with negative pitch attitude. Around one second after the 2nd touchdown, Power levers were set from FI to REV during ~2 seconds then set at GI. Both crew member pressed brake pedals, brake pressure reached 3000 psi.

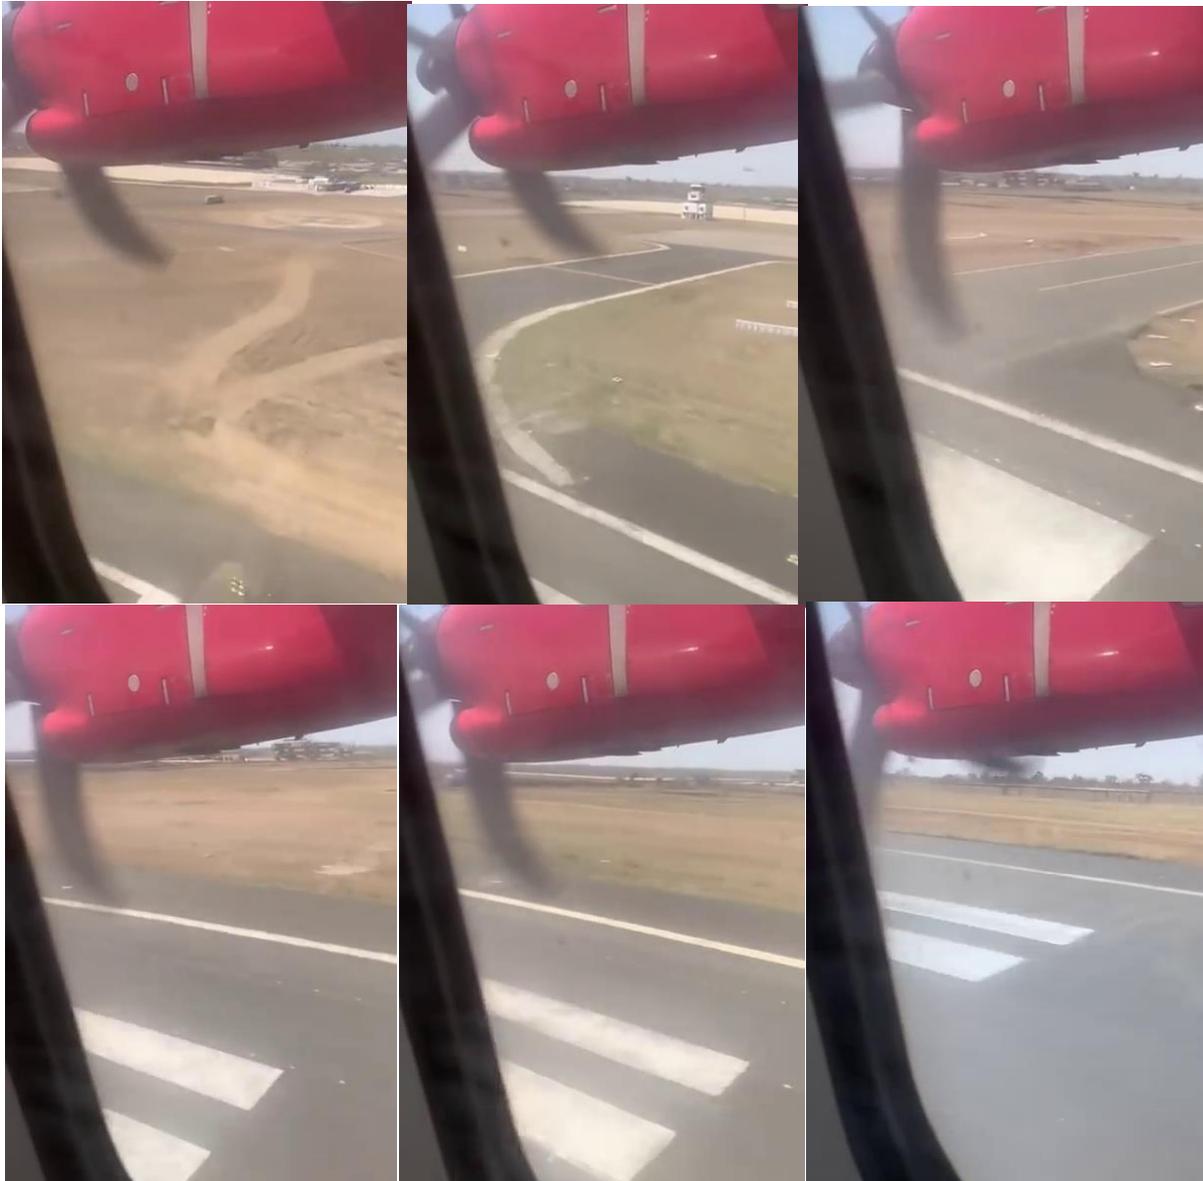
Figure 7 shows the aircraft crossing the Runway 24 threshold and crossing the touch down zone of Runway 24. Aircraft took about 07-08 seconds to cross the touch down zone of Rwy 24 and reached touch down zone of opposite runway (Runway 06) in another about 11 seconds.

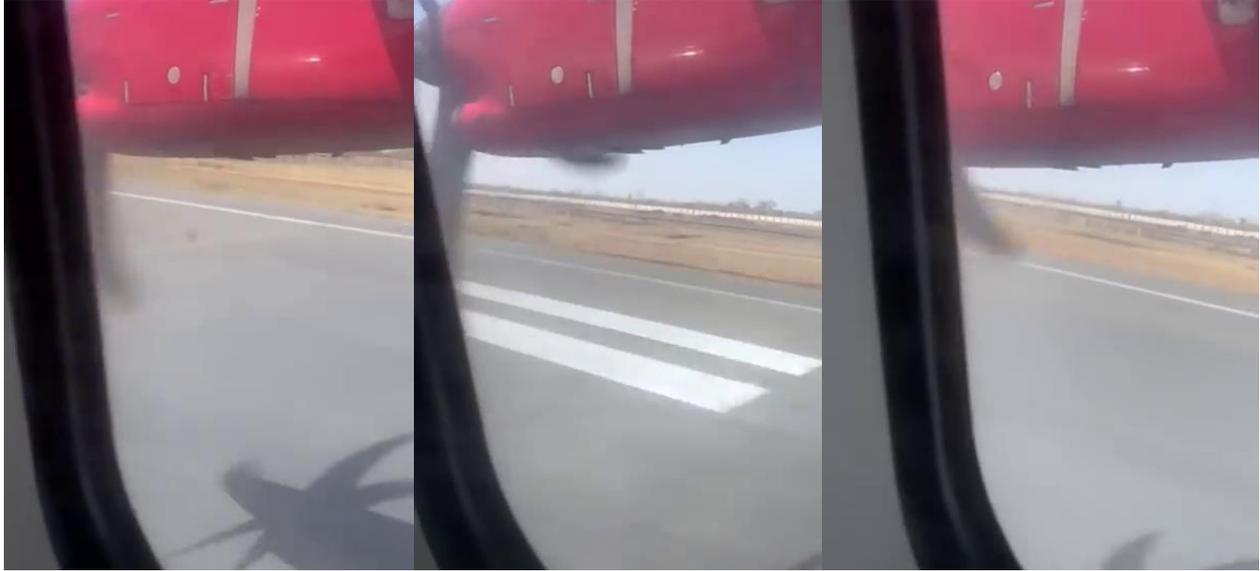
Figure 8 shows the frame where aircraft appears to have made first touchdown after crossing the 3rd set of Runway 06 TDZ marking and slightly bounced before touching down over 2nd set of Runway 06 TDZ marking.

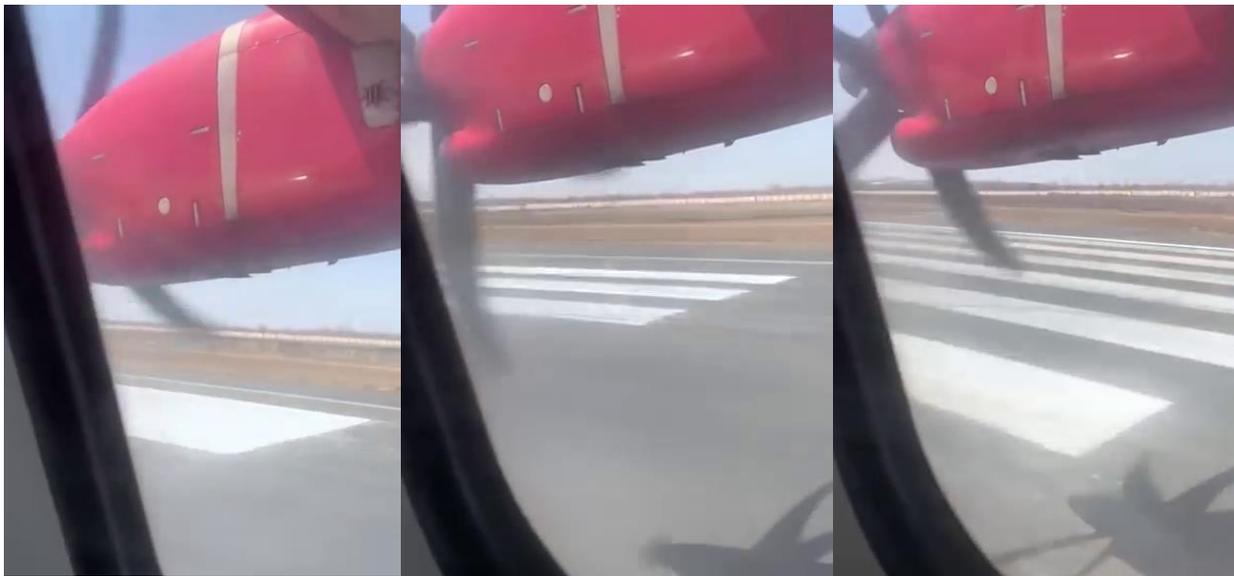
Figure 9 shows aircraft rolling after touchdown over aiming point of Runway 06, 1st set of Runway 06 TDZ markings and Runway 06 Threshold. The aircraft can be seen having deviated to the left before crossing the threshold of Runway 06. From the video it was observed that the aircraft took about 21 seconds to touch down after crossing Runway 24 threshold.

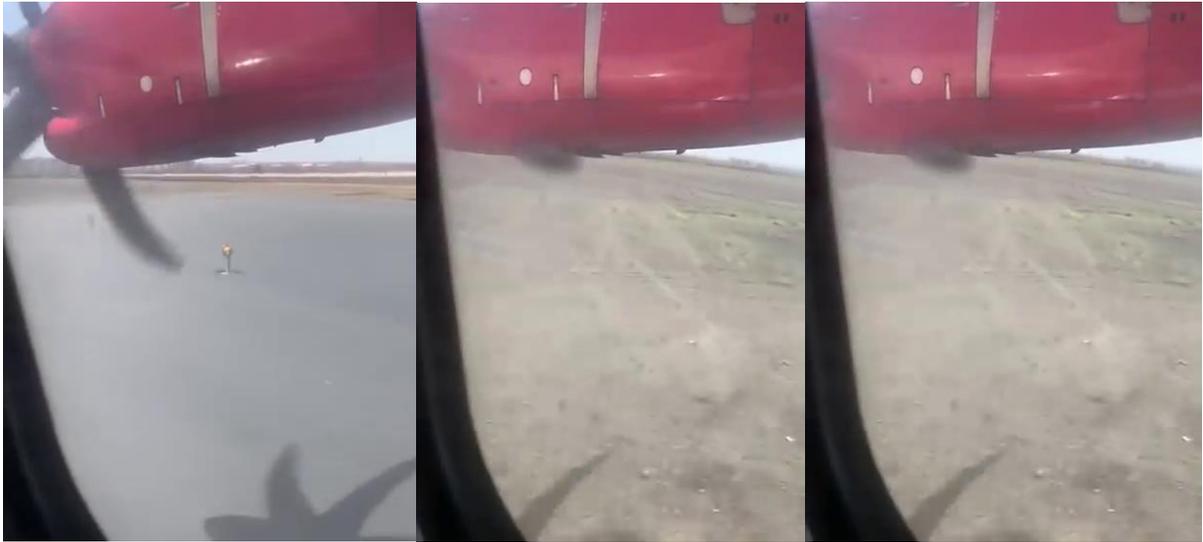
Figure 10 shows aircraft rolling in runway strip and entering the RESA. Aircraft rolled for about 12 seconds after first touchdown before it overran the Runway 06 threshold and in another 04 seconds it exited the paved area or Runway Strip.

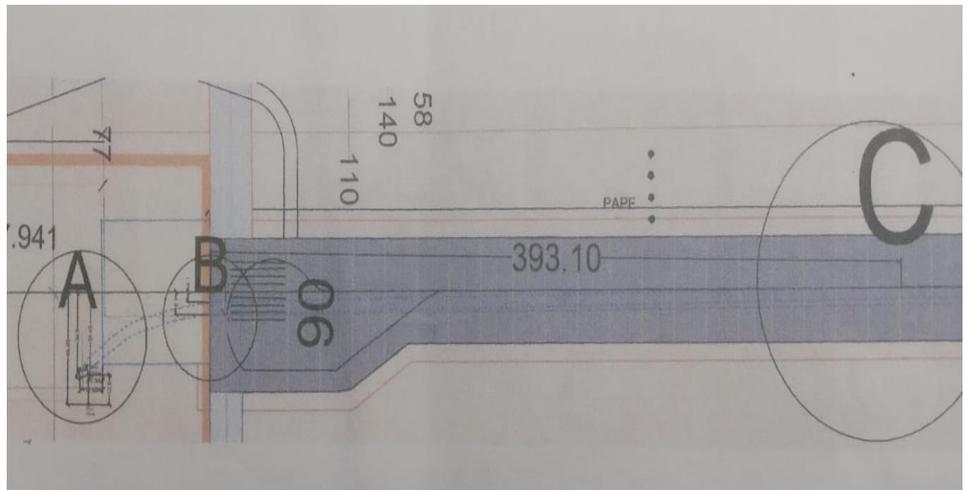
The investigation team from AAIB reached Jabalpur in the morning of 13 March 2022. The team surveyed the site and examined the aircraft. The wheels marks of the aircraft were visible. Location of wheels marks were plotted on the runway layout. **Figure 11** shows the runway 06 side

Figure 11: Location of wheel marks plotted on Runway 6

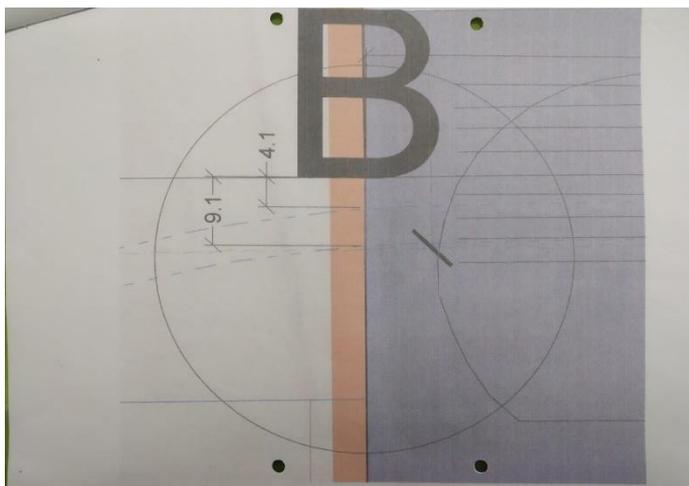
Figure 12

with the point C in the figure showing the location up to which the wheel marks could be traced. This point is approximately 393 m from the runway end.

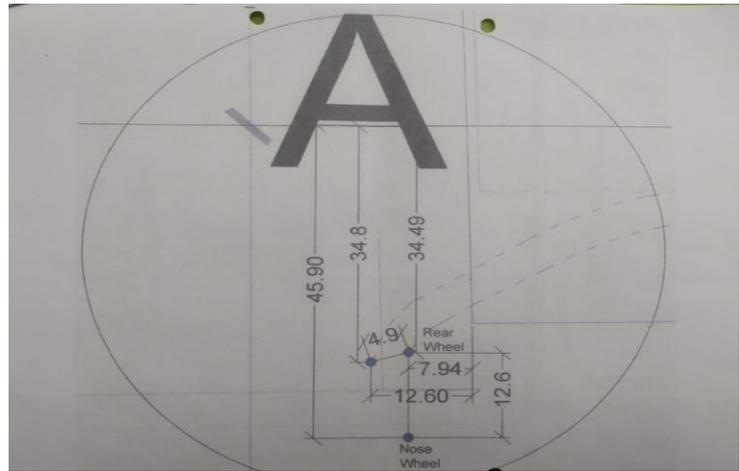
As the aircraft exited the runway the RH wheel and LH wheel were 4.1 m and 9.1 m left of Runway Centerline.

Figure 13 shows the exploded view of point A showing the distance of all three Landing Gears from runway center line and edge of paved surface. Aircraft nose wheel was approximately 45 m left of runway center line and about 8 m from paved surface of runway strip.
