Final Report
on
Serious Incident of Airprox
between two A320 aircraft
VT-ITD (IGO455) and VT-ISV (IGO246)
operated by M/s IndiGo
near Kempegowda International Airport, Bengaluru
on 7 January 2022

AIRCRAFT ACCIDENT INVESTIGATION BUREAU
MINISTRY OF CIVIL AVIATION
GOVERNMENT OF INDIA

Date & Time of Incident	7 January 2022 & 032552 UTC	
Place of Incident	Near Kempegowda International Airport, Bengaluru	
ATS Units	Aerodrome Control and Approach Control Surveillance Units	
Type of Occurrence	Airprox	
Classification of airspace	Class D	
Applicable ATC separation	Surveillance based horizontal separation of 3 NM and vertical separation of 1000 feet	
Recorded Minimum separation	Approx 0.9 NM horizontal (lateral) and 100 feet vertical	
Light conditions	Daylight	
	Aircraft 1 (IGO455)	Aircraft 2 (IGO246)
Type of aircraft	A320- 271N ICAO Type Designator A20N	A320- 251N ICAO Type Designator A20N
Wake turbulence category	Medium	Medium
Nationality	Indian	Indian
Registration	VT-ITD	VT-ISV
Last point of departure and ATD	Kempegowda International Airport, Bengaluru (VOBL) 0325 UTC	Kempegowda International Airport, Bengaluru (VOBL) 0325 UTC
Pont of intended Landing	Netaji Subash Chandra Bose Internat

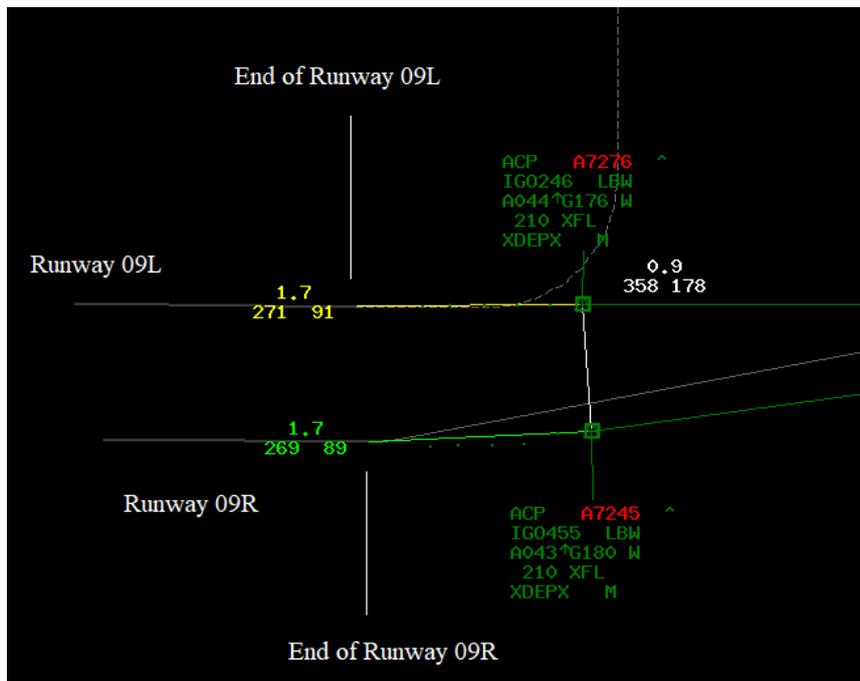
Figure 4: Location of incident

Approximately 1.7 NM East of physical ends of runways 09L and 09R at Bengaluru Airport.

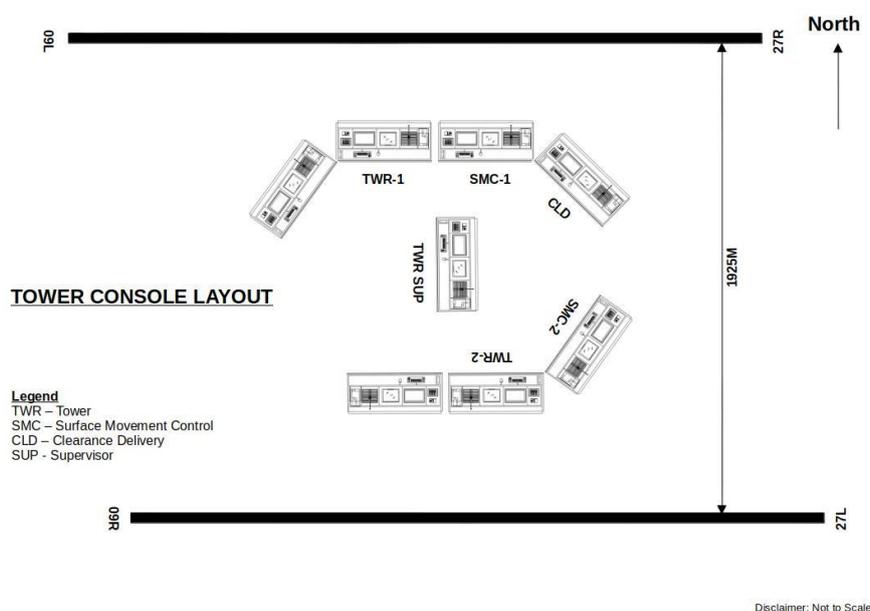
Figure: 5: Control Tower work positions layout

The Aerodrome Control Tower had two working positions for Aerodrome Controllers. TWR-1 controller facing north runway 09L/27R and TWR-2 controller facing south runway 09R/27L. SMC-1 and SMC-2 controllers sit in close proximity of TWR-1 and TWR-2 controllers. (Ref: figure 5).

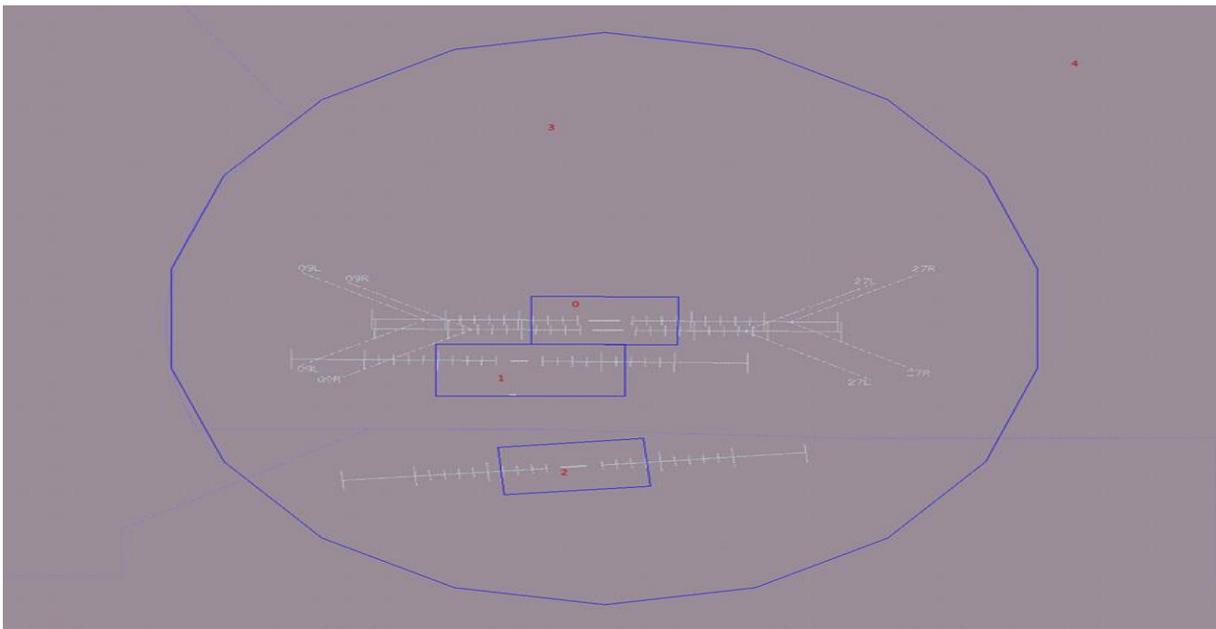
Figure 6: STCA inhibited airspace

Short Term Conflict Alert warns controllers about possible infringement of prescribed separation between two tracks. Look Ahead Time defined in the system is 120s. Several volumes of airspace are defined as per the applicable separation. In case of conflict detection, STCA alert is displayed, involved tracks are joined by a line in yellow colour initially (giving time for controllers to react) turning to red subsequently. Alarm window pops up simultaneously highlighting the targets involved and remains in the display until acknowledged and cancelled by the controller. STCA in areas in zone 0 to 2 are inhibited.

The area 0 is inhibited from level 0 to 5000 feet. It extended up to about 4NM from Runway 09L and 09R ends. STCA inhibited area was created to avoid nuisance STCA between aircrafts landing and taking off from VOBL considering the aircrafts operating in the Yelahanka (VOYK) traffic circuit and aircraft carrying out IAL procedure at Yelahanka (VOYK).

- 3) It is recommended that AAI should review the airspace in which STCA have been inhibited and take appropriate action.
- 4) It is recommended that AAI should review the coordination procedures between aerodrome controllers/ground controllers/ approach controllers for safe and efficient management of segregated operations on parallel runways and prepare a comprehensive coordination procedure without any ambiguity.

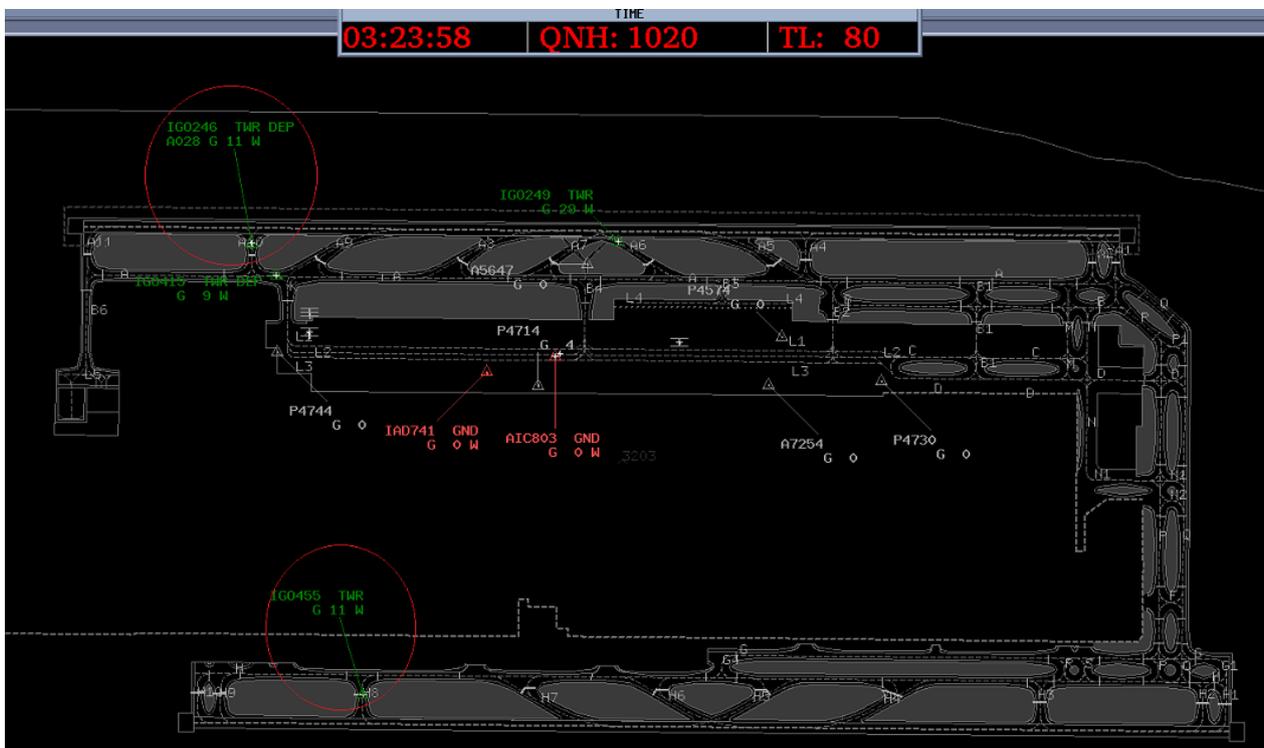
IGO 246 started pushback/start-up about 7 minutes later as compared to pushback/start-up time of IGO455, yet both the aircraft were approaching holding positions runway 09L and 09R respectively almost at about same time 0324 UTC because of the shorter taxi route of IGO246 to the holding position of runway 09L as compared to taxi route of IGO455 to the holding position of runway 09R. (Ref Figure 9 below)

SMC-1 advised IGO246 to monitor TWR-1 frequency about three and half minutes earlier than release of IGO455 to TWR-2 by SMC-2 Controller. The confusion started at this point. TWR-1 controller assumed that SMC-1 had released IGO246 for RWY 09L after ensuring last departure from runway 09R. Had SMC-

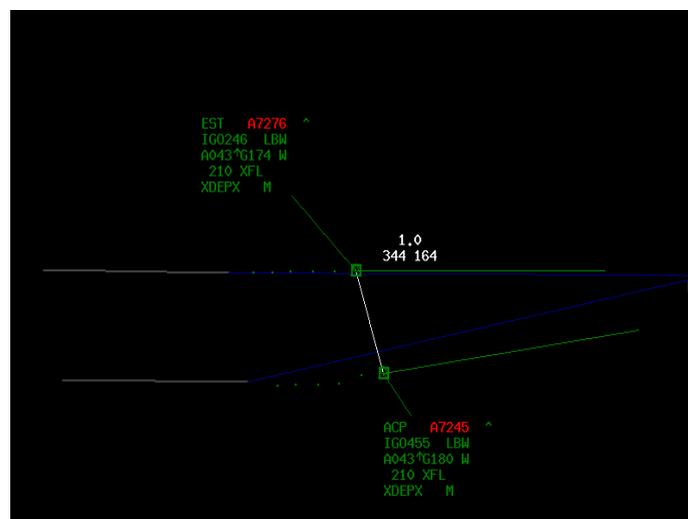
Figure 10

Both the aircraft IGO246 and IGO455 were airborne at same time 0325 UTC from runway 09L and 09R respectively. Both aircraft were required to follow assigned RNAV-1 SIDs. These SIDs were merging at a waypoint BL401 which was about 6 NM from runway 09R end.

As per requirement given in AIP India, all departures were required to contact Bengaluru Approach 127.75 MHZ after passing 3800 feet, unless instructed otherwise by the tower. Realizing the potential conflict between two simultaneous departures from runway 09R and 09L, the approach departure controller who had just taken over watch, instructed to IGO455 to turn right heading 180 immediately due to traffic which was acknowledged by the flight crew of IGO455. Meanwhile IGO246, passing IGO246 also contacted Approach Departure and reported passing 4200 feet. The Approach Departure controller immediately instructed to turn left heading 360 immediately and stop climb 5000 feet which was acknowledged by the flight crew of IGO246. Earlier IGO455, after departure from runway 09R, has initiated left turn to waypoint BL401 (Refer Fig 10 below).

However, the time IGO455 executed the ATC instruction to turn right, the minimum separation between these two aircraft IGO455 and IGO246 reduced to 0.9 NM and vertical separation reduced to 100 feet (Ref Figure 1). Subsequently, the required separation was re-established and both flights continued their destinations as per ATC clearances.

- 2) It is recommended that AAI should review the design of SIDs for different runways at KIA Bengaluru and design SIDs which may be suitable for independent instrument departures on parallel instrument runways.

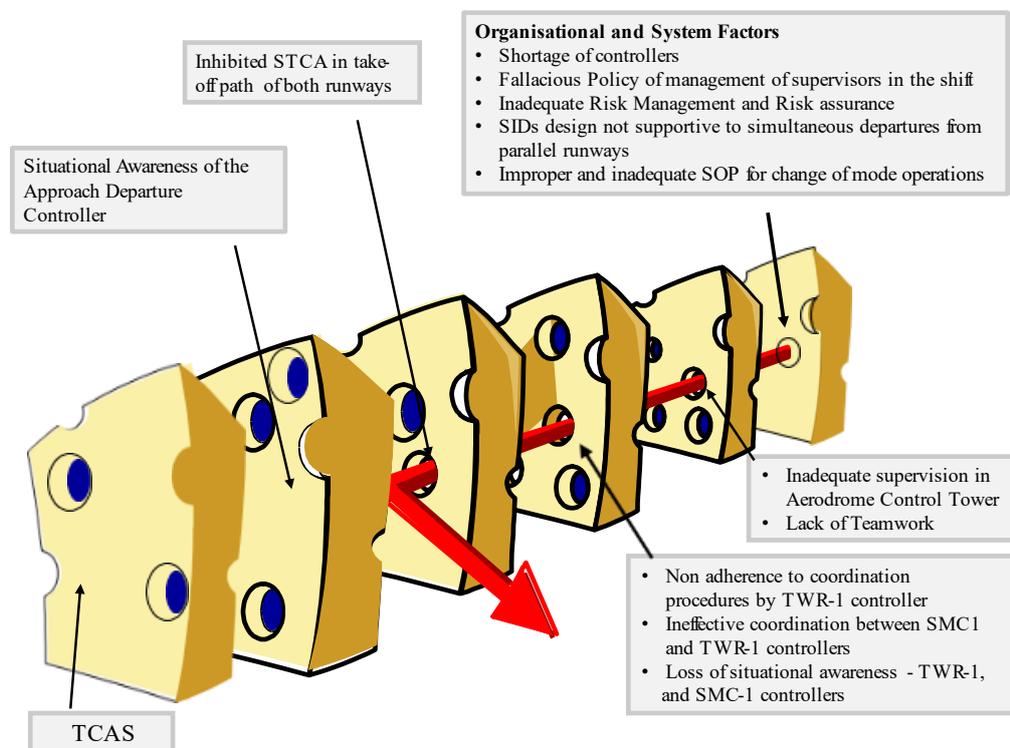
Figure 11

Multiple defensive layers were built into the ATC system to protect against variations in human performance or decisions at all levels of the organization. But there were many layers of weaknesses which were aligned leading to an airprox incident. Using The Swiss-Cheese Model, following figure (Figure 11) depicts how latent conditions were present within the system which manifested through local trigger factors leading to the airprox incident but there were also some defences/barriers which prevented it from resulting into a catastrophic outcome
