**Final Investigation Report on accident involving Aryan Aviation Private Limited's
Bell 407 helicopter bearing registration VT-RPN
near Kedarnath Helipad on 18 Oct 2022.**

**Aircraft Accident Investigation Bureau
Government of India
Ministry of Civil Aviation**

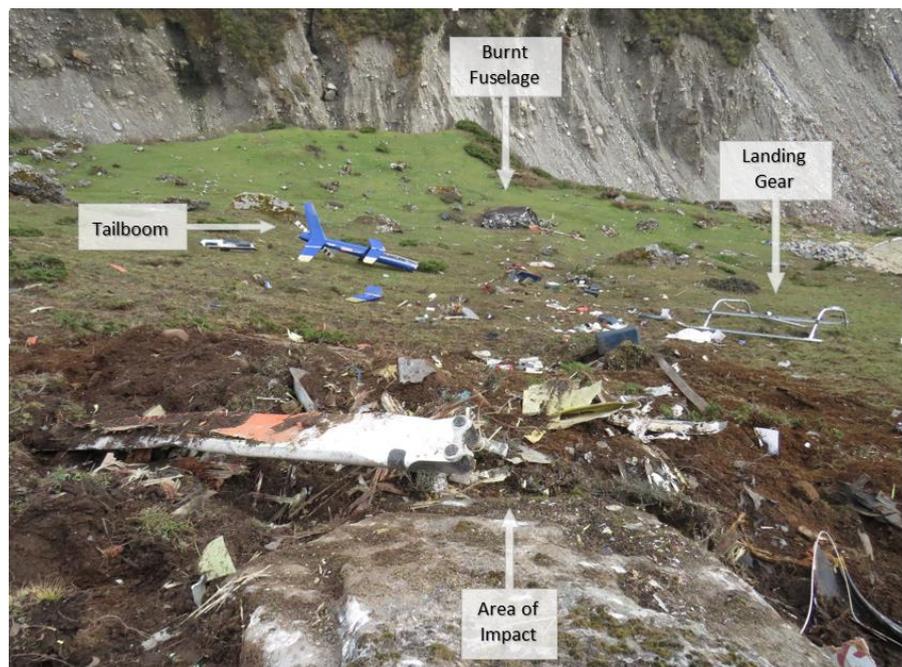
Figure 4: Crash site

The helicopter had hit the ridge and rolled down the slope. The impact shattered the structure and helicopter broke into multiple fragments. The wreckage was scattered all over the slope with main fuselage having rolled down the furthest. The picture taken from top, close to the point of impact showing the wreckage scattered on the slope is shown in Figure 4. The wreckage spread was concentrated within an area

of about 40m X 50m on a slope. Initial wreckage examination was carried out at the site and the wreckage was then gathered and transported to a storage facility near Delhi where detailed examination of wreckage was carried out in association with representatives from Bell Textron Inc. and Rolls Royce Engines. The observations and findings of examination are as follows: -

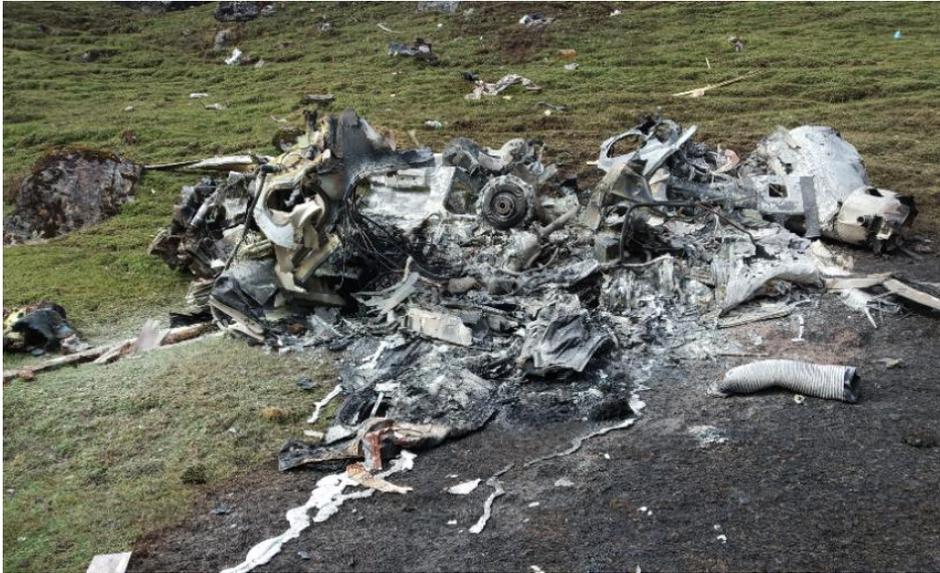
Figure 5: Burnt fuselage

As the fuel tanks are contained in centre section, most of the the center and aft main fuselage sections were consumed by post-crash fire. The cockpit and nose sections were not as badly fire damaged but exhibited fragmentation and crushing consistent with impact forces. The roof section was mostly consumed by fire. The doors and cowlings on the

right side exhibited more damage and had fractured into several pieces, whereas, the left side doors were almost intact. Most of the doors and cowlings had separated from the helicopter during impact and hence did not suffer from fire damage.

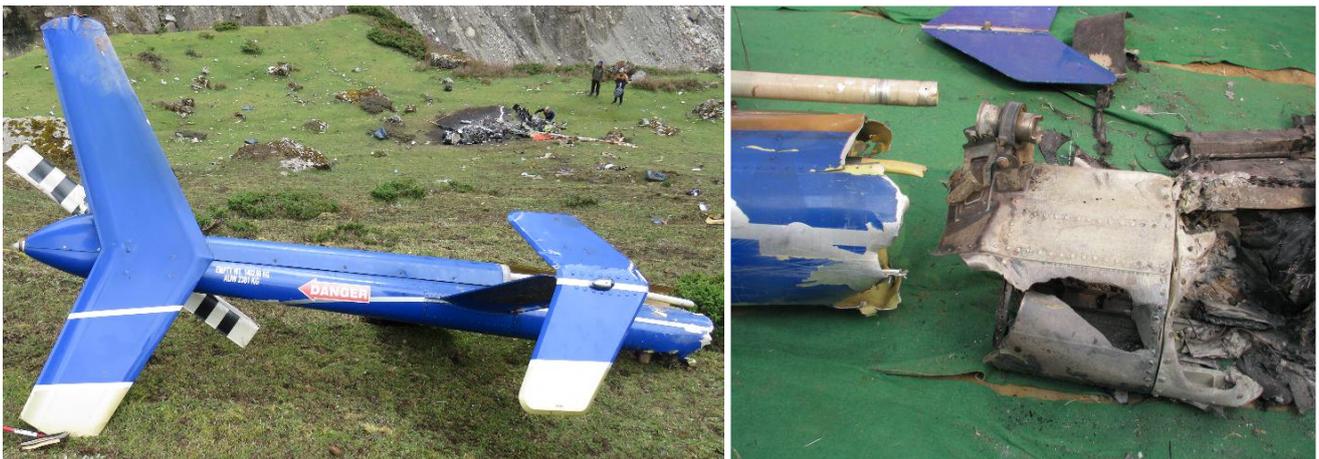
Figure 6: Tailboom fractured aft of intercostal support

The tail boom was largely undamaged, but had separated from the fuselage just behind the intercostal support at the front of the tailboom (Figure 6-L). The tail boom was found near the initial point of ground impact, and remained some distance from the fuselage's final location on left side of wreckage trail. The forward section of tailboom was fire damaged but remained solidly attached to the aft fuselage through the four attach bolts (Figure 6-R). The tailboom fracture was consistent with overload impact forces.

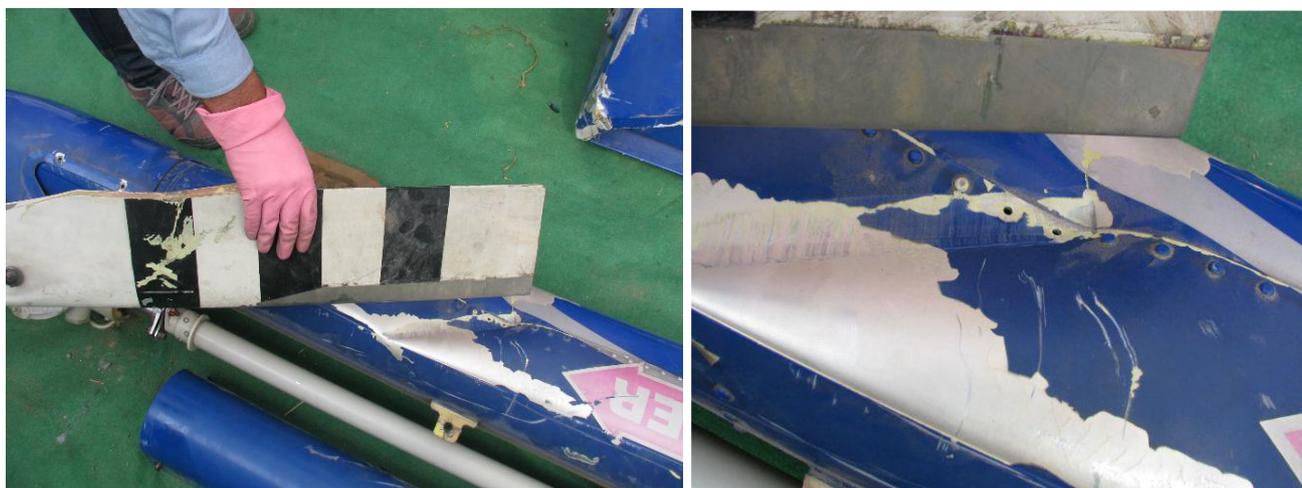
Figure 7: Tail Rotor contact marks on left side of tailboom

Tail boom did not have any main rotor strike marks. The horizontal stabilizer was relatively intact with the top of the right end plate bent inboard towards the tailboom during impact. The left side of the aft tailboom exhibited an impact crease caused by hard non-rotating contact with a tail rotor blade during the impact sequence (Fig 7).

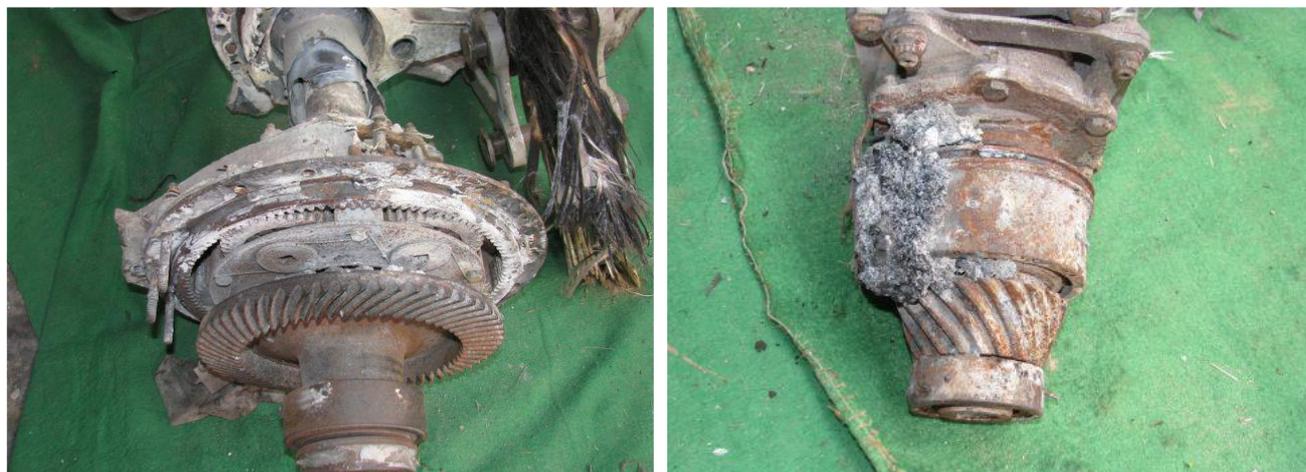
**Figure 8: Burnt Main Transmission casing, Intact Planetary Gears and Spiral Bevel Gear (L)
Input Quill Gear (R)**

No pre-accident impediments to main drive continuity were observed. The main drive system exhibited impact and post-crash fire damage. The main transmission case exhibited melting by the post-crash fire and the transmission internal gearing was exposed (Fig 8 - L). All internal transmission gears and bearings exhibited substantial fire damage and melted aluminum and melted magnesium case material was observed on gear and bearing surfaces. The main input quill was mechanically intact but was fire damaged (Fig 8 - R) and remained connected to the forward end of the KaFlex main driveshaft with intact, but fire damaged, quill bearings (Fig 9). The mating spiral bevel gear exhibited intact teeth (Fig 8 - L). The planetary gears would not rotate by hand due to extensive bearing fire damage. The mast was bent at the top of the transmission near the mast

bearing's installed location in the top case, consistent with occurring during impact. The mast remained connected to the main rotor hub at its top with an intact mast nut. The four elastomeric corner mounts exhibited melted and consumed inner elastomer and aluminum outer housing, but the nut and cotter pin on each mount was intact. The aluminum "A-frame" mount legs were not found, but several large slugs of melted aluminum were observed at the accident site.

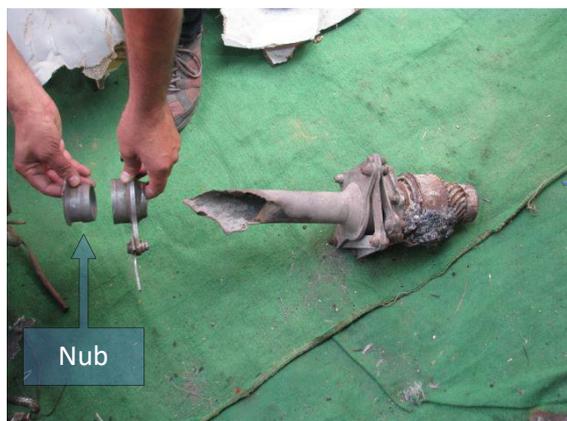
Figure 9: KaFlex main driveshaft and Nub

The helicopter was equipped with a KaFlex main driveshaft that does not require greasing at either the transmission or engine end couplings. The KaFlex driveshaft accommodates normal driveshaft misalignment through the flexing of steel flexures between the engine and main transmission during operation to accommodate continued drive continuity as the main transmission moves slightly within its elastomeric mounts during changes in power and main rotor disk orientation. The forward transmission end of the KaFlex main driveshaft remained attached to the main input quill assembly (Fig 9). All of the steel flexures on the forward transmission end were intact. The driveshaft tube fractured near the engine end consistent with overload impact forces as the airframe fragmented after first impact. The engine end flexures exhibited numerous overload fractures, but all fractures were in the body of the flexures and not at bolted joints. The outer diameter of the fail-safe inner "nub" that is attached to the engine end attachment fitting at the engine gearbox did not show evidence of contacting the driveshaft tube inner diameter, which it fits into concentrically with limited tolerance (Fig 9).

This lack of operational contact between the nub and the engine end driveshaft tube is evidence that the engine end flexures did not fracture in-flight, but their fractures occurred as result of impact forces. Therefore, the main driveshaft was connected to both the forward transmission end and to the rear engine end during operation, providing drive to the main transmission from the engine. All observed flexure bolts and nuts exhibited intact connections.

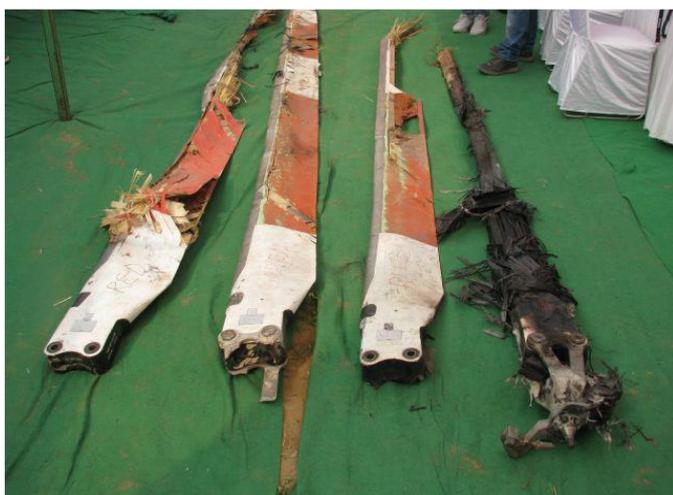
Figure 10: Main Rotor Blades

No pre-impact anomalies were observed in the main rotor blades. All fractures were consistent with occurring at impact. Each blade exhibited evidence of significant impact damage (Fig 10). Damage on Blade after body was noted on all four blades. Additionally, leading edge impacts were observed consistent with striking rocks. The Green main rotor blade was found right side up and away from the main wreckage near the location of first helicopter impact and a large boulder. The Green blade had impact damage, but the fiberglass spar was intact, and the outboard

half of the blade was stuck in mud. The Green blade grip was fractured through the four attachment arms consistent with overload forces and remained attached to the blade through both blade bolt holes. The other three blades were found with the main wreckage. The Red blade exhibited an intact spar to the blade tip. The Blue and Orange blades exhibited outboard spar fractures consistent with impact forces and were missing significant afterbody (blade skins and Nomex honeycomb) material from impact forces. The Orange blade was heavily fire damaged.

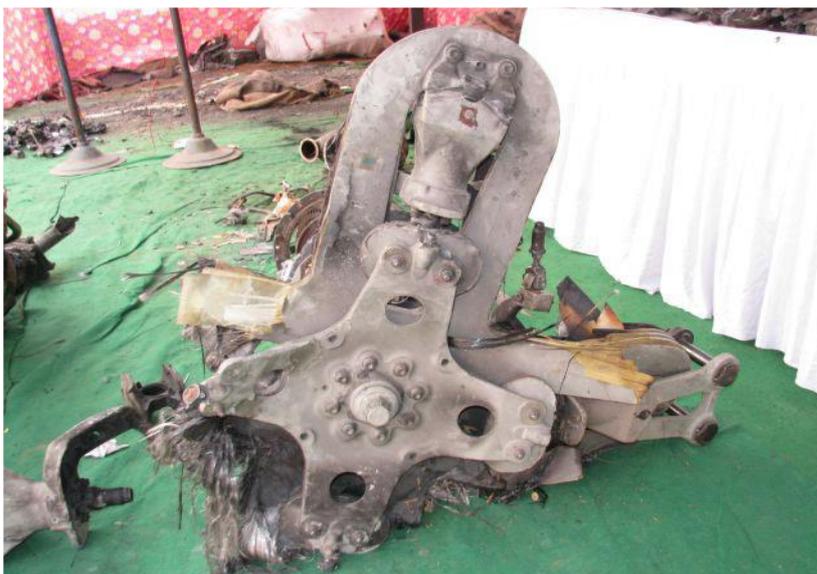
Figure 11: Main Rotor Hub

No pre-impact anomalies were observed in the main rotor hub. The main rotor hub was extensively damaged due to impact and fire but remained attached to the mast. The Red and Orange composite fiberglass yoke flexure arms were both fractured at about mid-span consistent with overload impact forces. The Green and Blue yoke arms exhibited significant delaminations and some fractured portions. The elastomeric bearings on all yoke arms were damaged.

The main rotor pitch change horns were attached to all the respective blade grips on each blade except the Green blade. All four aluminum main rotor pitch change links exhibited overload fracture evidence in the top of each aluminum pitch link tube near the steel insert that mates the attachment clevis to the pitch horn. All upper pitch link clevises remained attached to their respective pitch horns through the universal bearing joints.

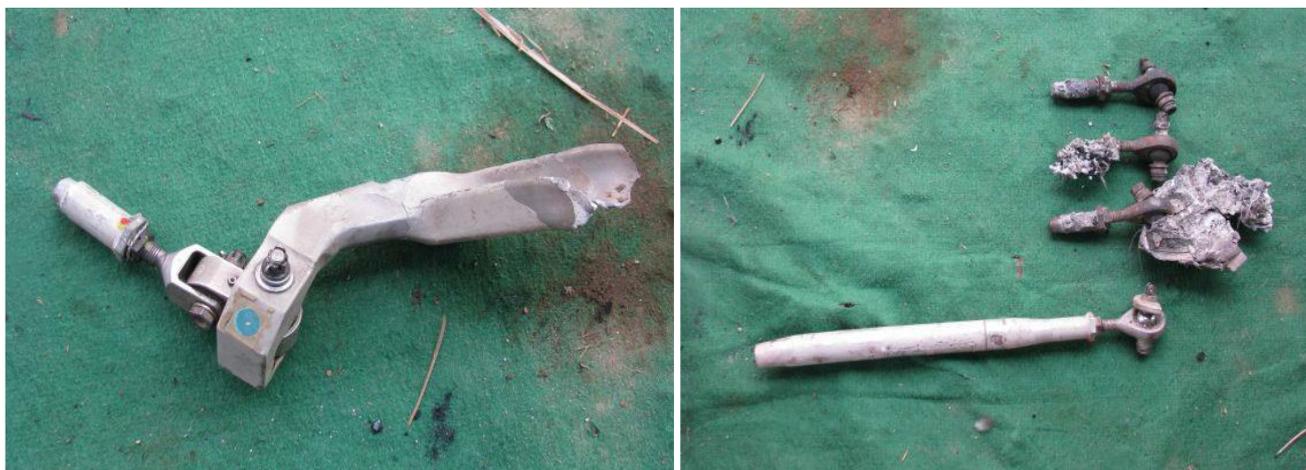
Figure 12: Green main rotor pitch horn and upper pitch link (L) and Melted and Fractured Pitch Links (R)

Three of the pitch change link aluminum tubes (Blue, Orange, and Red) were melted by fire and the upper clevises and lower rod ends for these were damaged by fire. The Green pitch change link (minus the fractured upper clevis) was not fire damaged and the lower rod end remained attached. All bolts and nuts to the upper clevises and lower rod ends remained joined with intact cotter pins also.

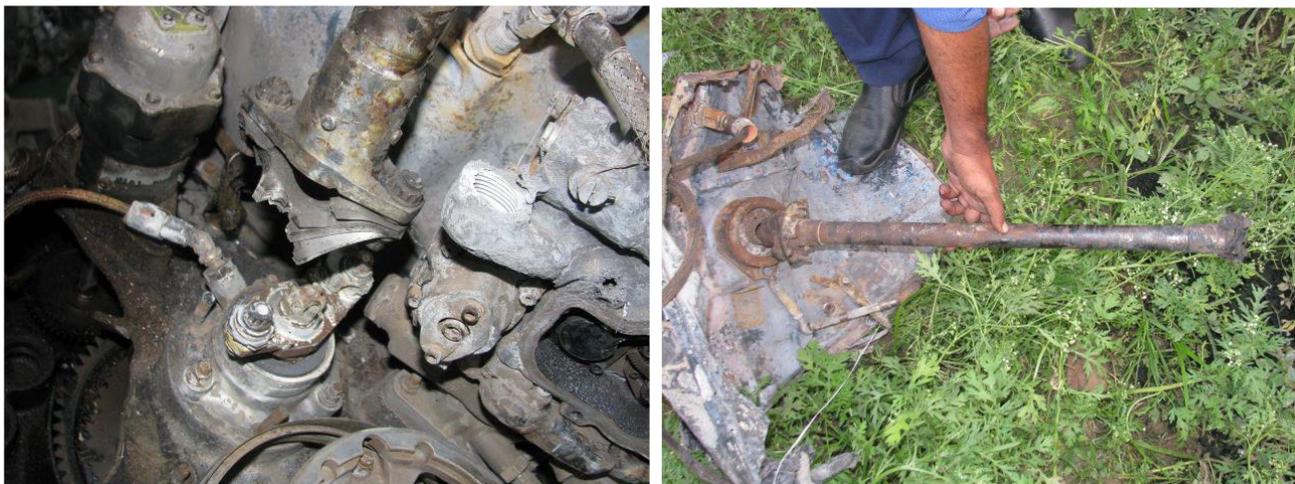
Figure 13: Fractured flexible Thomas Coupling (L) and aft end of fire damaged steel tail rotor drive shaft (R)

The tail rotor drive system and tail rotor assembly did not exhibit any pre-impact anomalies. Drive continuity was established in the tail rotor drive system. The tail rotor drive system exhibited fire damage to the steel drive shafts and hanger bearings in the aft fuselage and the forward fractured section of the tailboom. The steel shaft under the engine exhibited an overload impact fracture separation of the flexible steel plates (i.e., “Thomas” coupling) at the interface with the engine gearbox at the forward end of the shaft (Fig 13-L). The splined coupling at the aft end of the steel shaft had separated from the forward end of the steel oil cooler driveshaft consistent with disconnecting during the impact sequence and the driveshaft female splines were intact (Fig 13-R) The steel oil cooler shaft was fire damaged but the male splines on both forward and aft ends were intact. The steel oil cooler shaft would not rotate by hand because of the fire damage to its bearings.

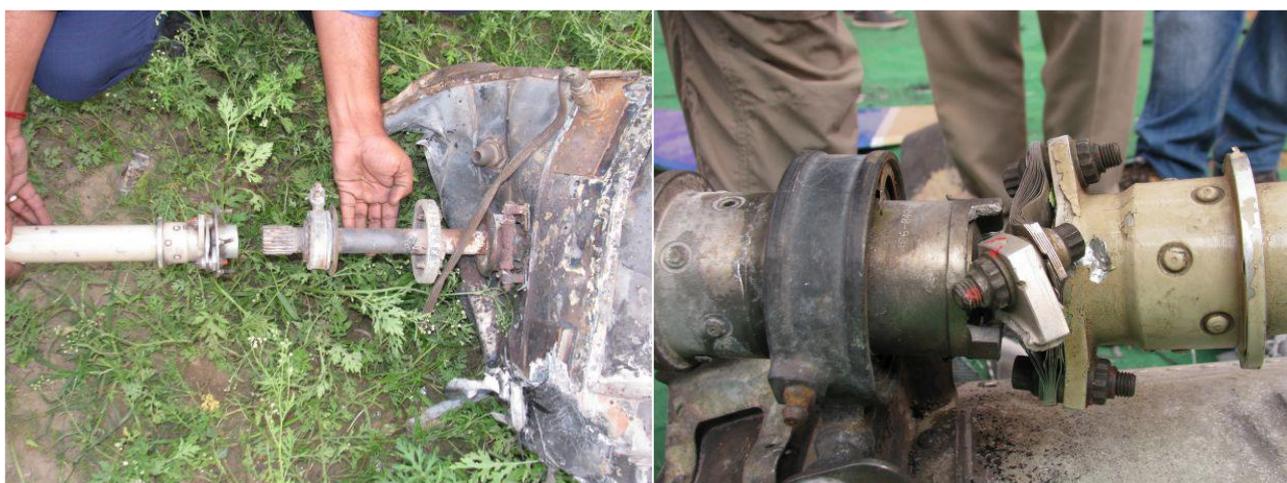
Figure 14: Aft Aluminium driveshaft (L) and Overload Fractured coupling ears (R)

The aluminum shaft between the oil cooler (forward end of shaft) and the hanger bearing (aft end of shaft) at the front end of the tailboom was not fire damaged. The aluminum shaft on the aft fuselage exhibited intact female splines that were disconnected from the oil cooler aft male splines (Fig 14-L).

The shaft's aft end also exhibited overload fractured adapter ears to the Thomas coupling at the tailboom attach hanger bearing (Fig 14-R) consistent with fracturing when the tailboom fractured nearby at the intercostal support during the impact sequence. The most forward tail rotor driveshaft on the tailboom exhibited a disconnect from its coupling adaptor to the tailboom attach hanger bearing as result of sheared rivets when the tailboom fractured (Fig 15-L).

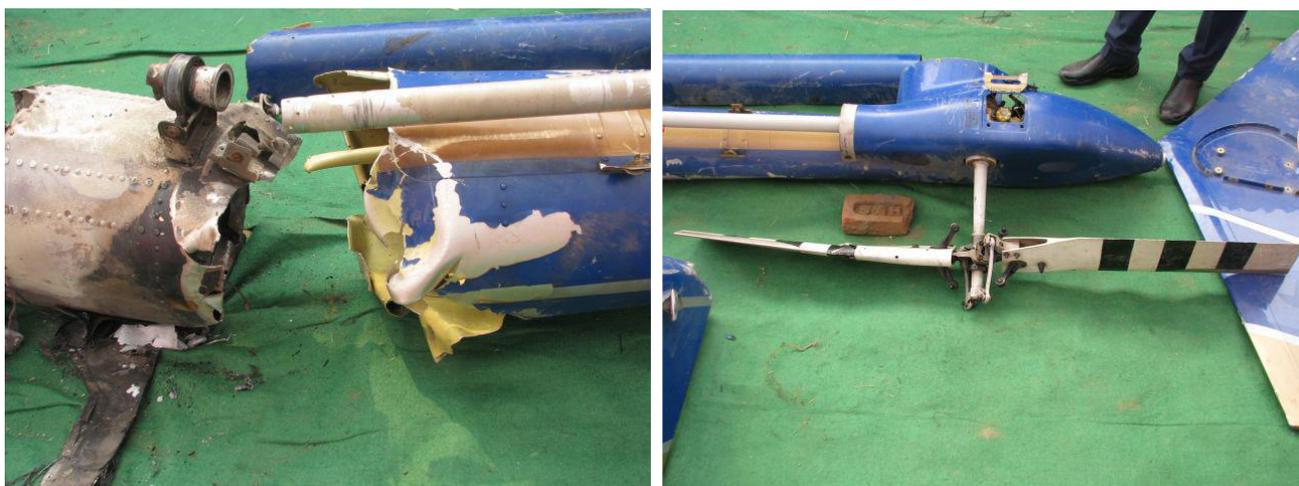
Figure 15: Forward coupling and driveshaft tube with sheared rivets (L) and Tail Rotor (R)

The remainder of the tail rotor driveshafts on the tailboom were intact and rotated freely in their hanger bearings with hand manipulation. The tail rotor gearbox and tail rotor assembly also rotated freely when the tailboom tail rotor driveshafts were manipulated by hand. No chips or debris were located on the tail rotor gearbox chip detector. The tail rotor hub was intact and remained solidly connected to the tail rotor output shaft splines.

Free pitch change in the tail rotor hub was demonstrated through hand manipulation of the tail rotor blades. One tail rotor blade was intact. The other tail rotor blade exhibited a chordwise bend towards the tailboom and delamination damage at an approximate 1/3 span location. The blade tip section and approximately 8 inches of the outboard leading edge made hard contact and creased the tailboom on its left side. The contact crease mark on the tailboom from the tail rotor blade is consistent with little to no tail rotor rotation at the time of tail rotor blade to tailboom contact. The tail rotor blades are not able to make contact with the tailboom during a normal flight regime and the contact crease mark is consistent with occurring during the impact sequence.

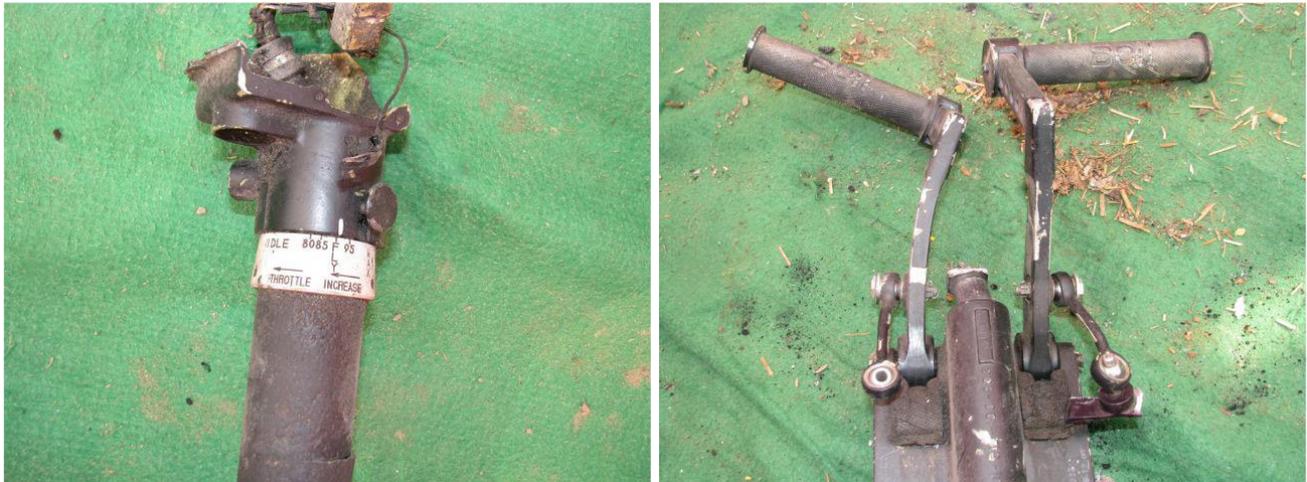
Figure 16: Throttle Position at FLY position (L) and Tail rotor pedals (R)

No pre-impact anomalies or flight control discontinuities were observed in the flight controls or hydraulic servos. The helicopter had single controls at the pilot right seat station. A copilot seat (left side) had a pedal lockout kit. The flight controls were badly damaged with impact fractures and melted control tubes. All observed flight control fractures were consistent with impact overload fractures. Flight control continuity could not be established because of melted control tubes from the post-crash fire, but all observed clevises and rod ends exhibited intact bolts, nuts, and cotter pins even when the control tubes or linkages were melted from the post-crash fire. The aluminum cyclic stick fractured at its base consistent with overload impact forces. The steel collective stick was bent and disconnected from its jackshaft from impact forces. The throttle position on the collective was found stuck in the "FLY" position (Fig 16-L).

The throttle did not rotate because of the bent collective. The tail rotor pedals were damaged from impact forces (Fig 16-R). Free movement of the tail rotor control system in the tailboom was shown by manipulating the tail rotor blades in the pitch direction and observing movement of the fractured

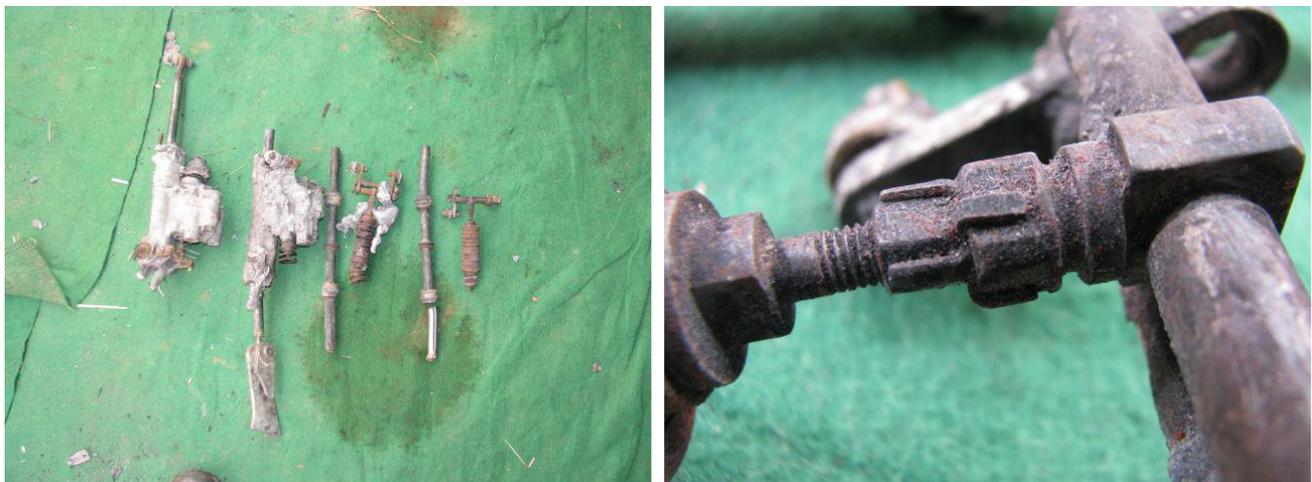
Figure 17: Fire damaged hydraulic servos (L) and wiredrive locking tabs and nuts on a servo (R)

tail rotor control tube at the forward end of the fractured tailboom. The main rotor and tail rotor hydraulic servos exhibited fire and impact damage, melting most of the aluminum servo valve bodies, leaving the steel piston rods and servo valves (Fig 17-L).

The nuts and locking tabs between the three main rotor servo lever input arms and the servo input wiredrive rods were intact (Fig 17-R) and no pre-impact rotational movement was observed at the threaded joints.

Intact locking tabs and nuts at servo wiredrive assemblies indicate that no incorrect control movements could be input to the servo through mismatched spool port holes. The tail rotor servo had fire and impact damage with nuts and locking tabs intact.

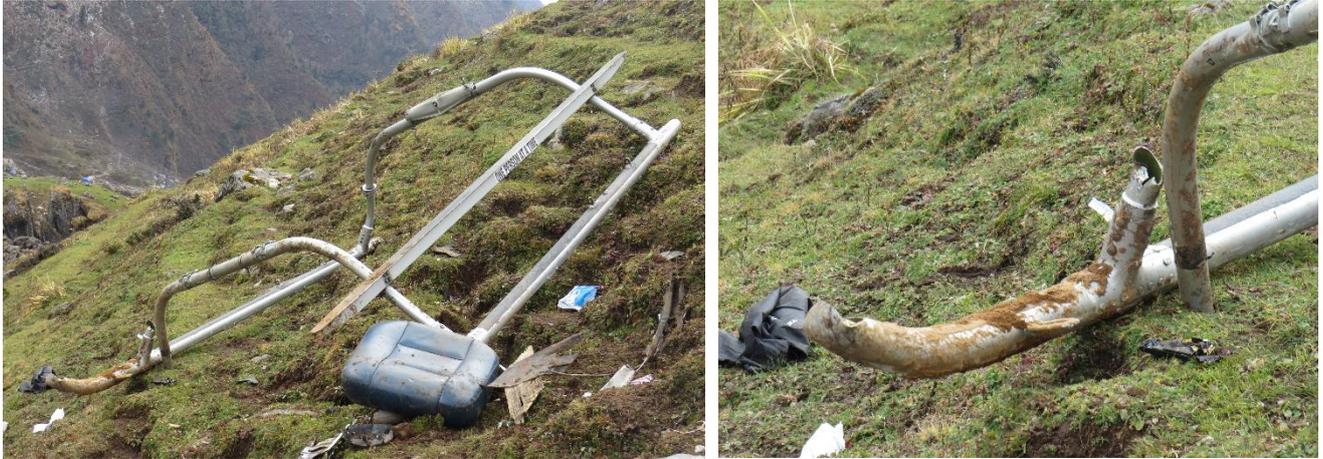
Figure 18: Landing Gear

No pre-impact anomalies were observed in the landing gear and all damage and fractures were consistent with occurring during impact. The right side of the landing gear exhibited fractures and damage, but the left side was essentially intact. The right skid toe exhibited a twisting crack from the tip to approximately 18 inches aft, consistent with getting stuck in the ground while the helicopter

was yawing or twisting during ground impact. The right forward crosstube fractured just above the saddle connection to the forward right skid. The right aft crosstube bent forward in the same location above the right aft saddle but was not fractured. The flight step attached to both right side

crosstubes fractured at its attach points to the crosstubes and separated from the crosstubes. The rear crosstube airframe attach pivot assembly remained connected to the rear crosstube. The forward crosstube fuselage attach fittings had separated from the crosstube from impact forces and remained connected to airframe belly structure that had ripped away during impact.

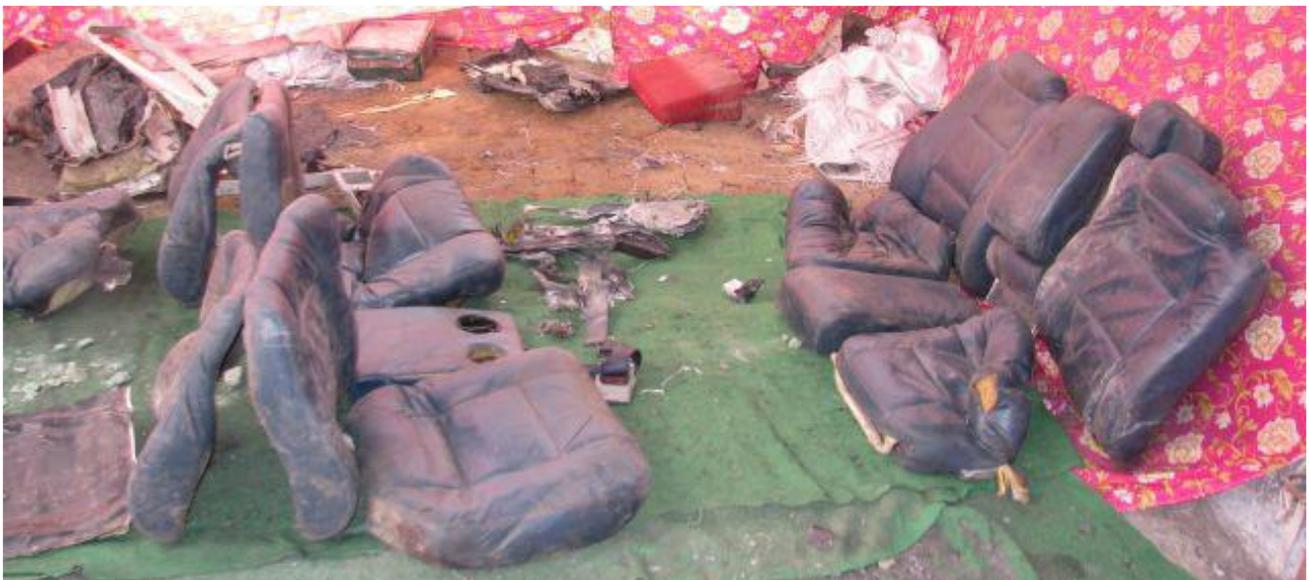
Figure 19: Crew and Pax Seats laid as per aircraft configuration

No pre-impact failures were observed in the seats or restraints. Passenger bodies were reportedly not found near their seats at the main wreckage site. The pilot was reportedly found near the main wreckage. All but one of the seat cushions was observed and one of the cockpit seat pans was missing. The missing seat cushion and seat pan were from either the pilot or copilot position. The seats were laid out during reconstruction in their approximate positions (Fig 19), but it was unclear at each seat position (cockpit, aft facing cabin, forward facing cabin) which was the left or right seat. Some seat bottom cushions and frames exhibited significant bending damage from impact forces. The fuselage exhibited fractures in the area of the seats structure. In the rear seats, all five steel

male latches were found, and they were not connected to aluminum female latches. Disconnected rear seat restraints found during the wreckage examination are consistent with the seat restraints not being connected during the short flight resulting in the passenger bodies dispersed in the wreckage trail. The pilot seat belt and two shoulder harness straps for the 4-point system were found connected together. The pilot shoulder harness straps were found separated and fractured from the inertial reel with evidence of melting at the ends of the fractured straps. The right side male latch belt remained attached to fuselage structure through the hinge attachment. The copilot shoulder harnesses were not connected, and the seat belt male latch was found disconnected.

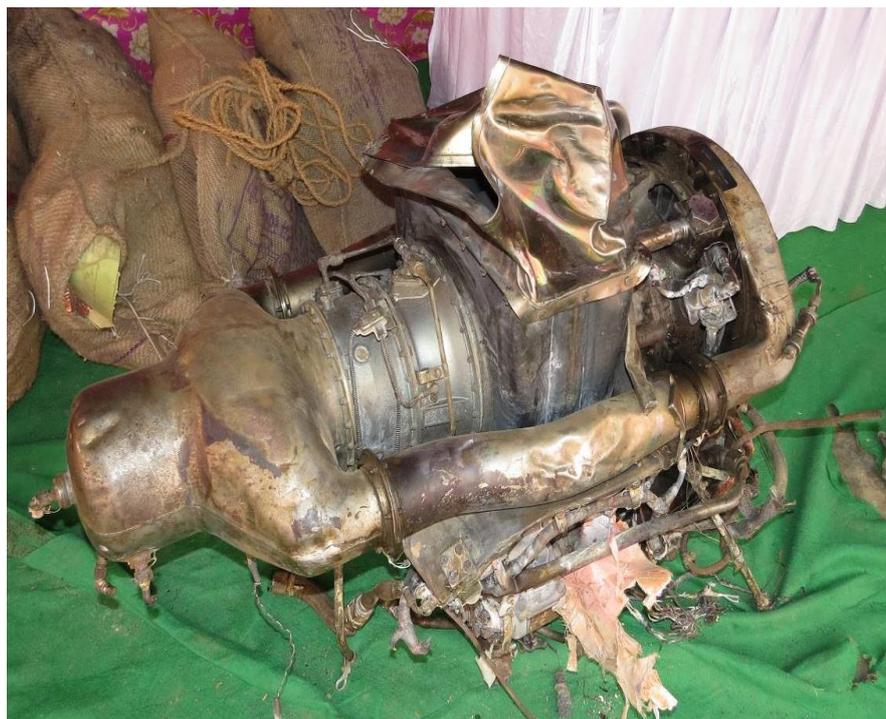
Figure 20: Engine wreckage

During the accident sequence, the engine had remained with the fuselage as it tumbled down the steep terrain, and was exposed to intense post-crash fire. The engine exhibited extensive impact damage. The accessory gearbox housing was fractured, exposing the N1 and N2 gear trains. The exhaust duct was crushed against the turbine exhaust outlet. All engine mounts were fractured in overload. Examination of the compressor revealed all compressor blades with leading edge impact damage

and evidence of foreign object ingestion during operation (FOD). Fine metallic powder, consistent with compressor shroud aluminized lining material, was found within the compressor bleed discharge duct. The compressor rotated manually with considerable resistance, which was attributed to impact, fire and FOD damage. Rotation of the compressor resulted in corresponding rotation of the N1 drive train, which was visible through the fractured accessory gearbox. There was no evidence of pre-impact failure of any of the compressor's rotating components.

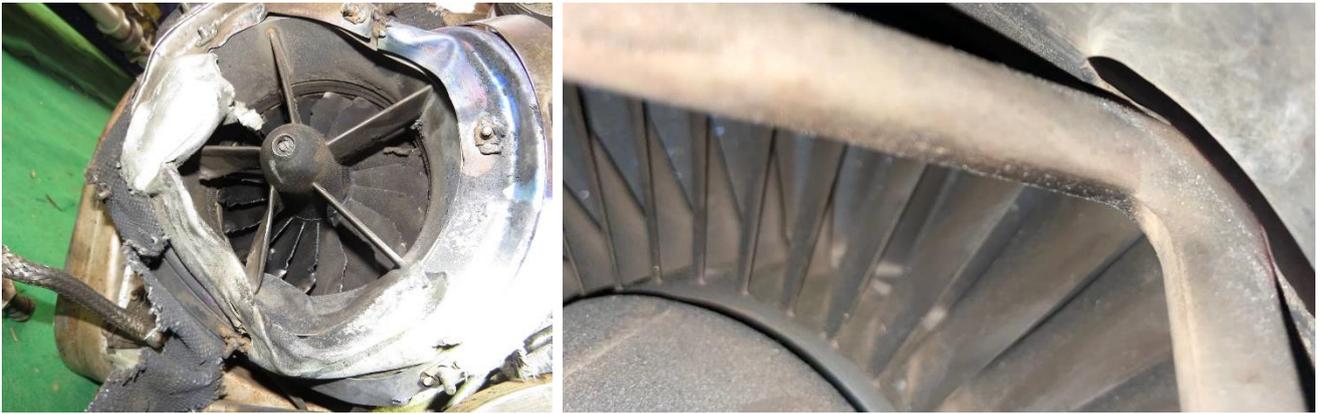
Figure 21: Engine inlet (LH) and 4th Stage Power Turbine Blades (RH)

The 4th stage (power) turbine could be accessed via the exhaust duct. Manual rotation of the power turbine resulted in corresponding rotation of the N2 drive train, including the main and tail rotor output shafts. Rotation was smooth and required minimal effort. The 4th stage turbine blades exhibited no evidence of operational failure or distress (Fig 21). The fuel spray nozzle was removed from the combustion chamber. The fuel spray nozzle exhibited corrosion on the spray face (typical of having been recently exposed to water), but did not exhibit any evidence of clogging or abnormal operation. The outer combustion cannister was removed from the turbine, exposing the inner combustion liner, 1st stage turbine nozzle, shield and turbine blades.

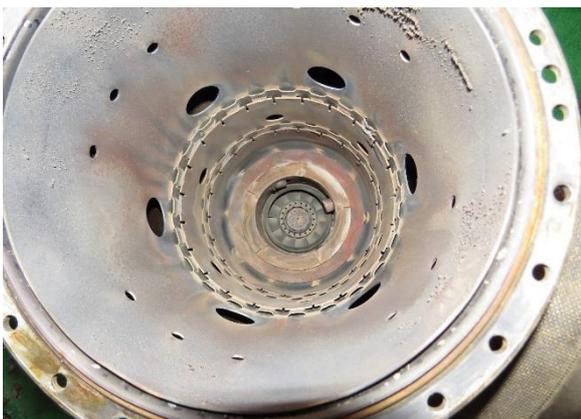
Figure 22: Combustion Chamber

The inner combustion liner was undamaged, exhibited no cracking, thermal damage or evidence of abnormal combustion, such as streaking (Fig 22). Metallic spatter was distributed around the forward end of the combustion liner.

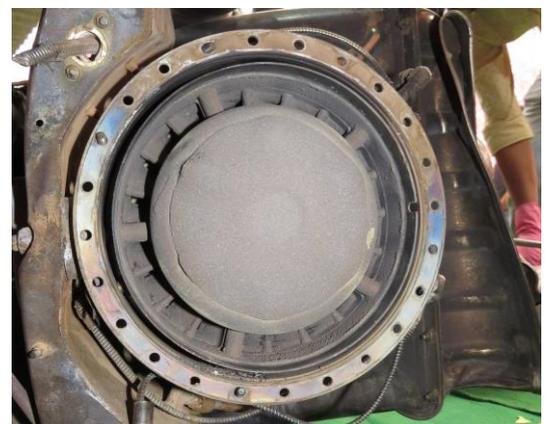
Figure 23: 1st Stage Turbine Blades

The 1st stage turbine nozzle, shield and turbine blades were all coated with a significant layer of metallic spray and soil. There was also minor FOD damage to the leading edges of the 1st stage turbine blades (Fig 23). There was no evidence of thermal

distress or erosion of the blades. There was no evidence of pre-impact damage or failure of the turbine module. The findings within the turbine are all consistent with the compressor ingesting debris during the impact sequence: FOD liberates aluminized compressor lining within the compressor, which is transported along the gas-path, liquified by heat within the combustion chamber and then deposited on the turbine nozzle, shield and turbine blades. Additionally, soil and hard debris ingested by the compressor is carried along the gas-path, resulting in subsequent FOD damage to the turbine blades.

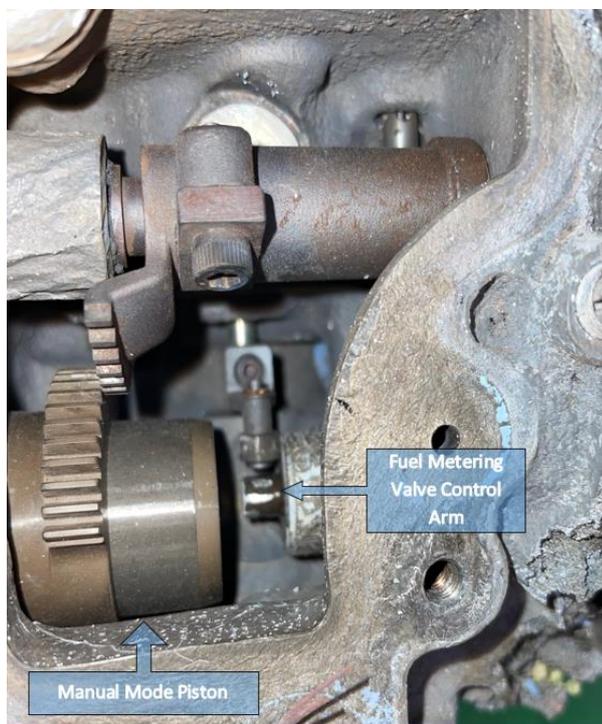
Figure 24: HMU

The Hydro-Mechanical Unit (HMU) remained in place on the engine's accessory gearbox. The HMU had been exposed to intense heat, but remained intact. Inspection covers were removed from the HMU, exposing the internal components of the HMU. Within the HMU, the manual-mode piston was found partially deployed. The piston had extended roughly 2/3 of the way necessary to fully capture the fuel metering valve (Fig 24).

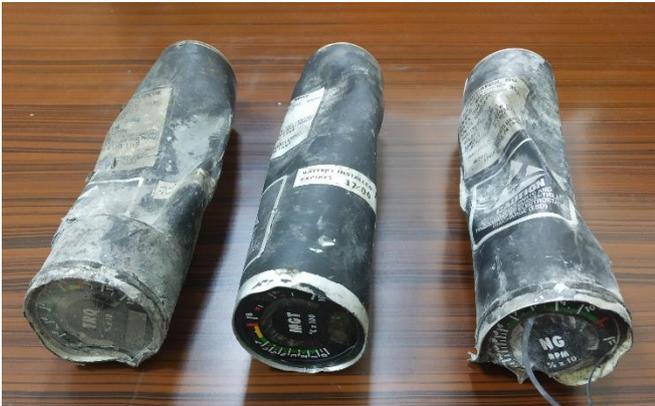
Figure 25: Ng Gauge, MGT Gauge and Torque

Three engine indicators i.e Ng Gauge, MGT Gauge and Torque Gauge were recovered from the wreckage site (Fig 25). The units contain non-volatile memory capable of recording any exceedance in parameters. Hence, assistance of the Transportation Safety Board of Canada (TSB) was sought to extract any data relevant to the occurrence.

The units had significant damage due to impact and fire and were not in position to be powered on. The units were dis-assembled and necessary repair on components and circuit boards was carried out so as to enable download of data. After requisite repairs, the circuit boards were sent to manufacturer's facility to perform data download. Data could be successfully downloaded from MGT Gauge and Torque Gauge using normal download setup, however, no data could be retrieved from the Ng Gauge. The Ng Gauge was returned to TSB facility and memory chip was removed from the circuit board. The raw data from the chip was then read out using a chip reader and examined. The data from all three gauges did not indicate any exceedance that would have been recorded in case of any malfunction.
