**Final Investigation Report on accident involving M/s Kestral Aviation's
Agusta AW119 MK-II Helicopter VT-RNK at Kedarnath helipad on 23 April 2023**

**Government of India
Ministry of Civil Aviation
Aircraft Accident Investigation Bureau**

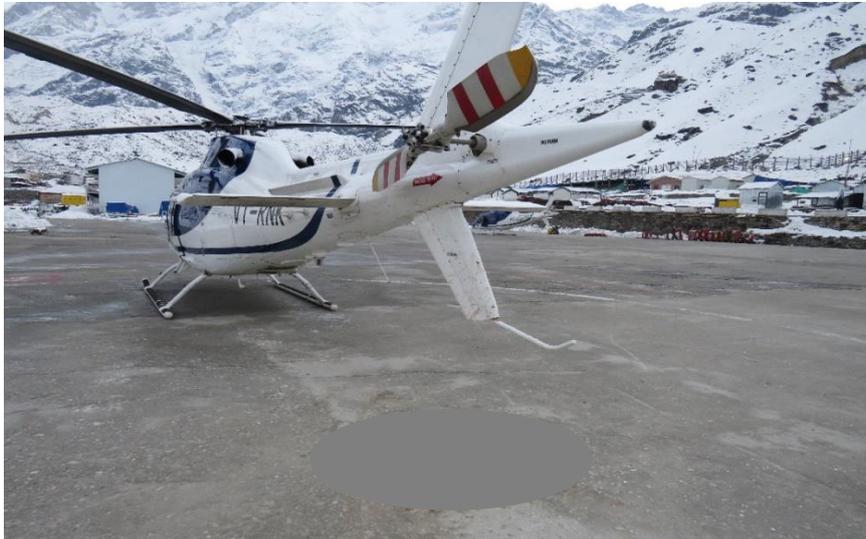
Figure 1: Accident Site

As per the statement of the eyewitnesses, the UCADA officials were escorted by their own personnel. They approached the helicopter from the front right side. Once the pilot asked them to hold, they stopped and were waiting for the signal from crew to board the helicopter. The aircraft was not switched off. The pilot was then busy scanning the cockpit, when he suddenly heard a thud noise, and on looking around he saw the other passengers staring at the rear of the helicopter with their hands on their head. The ground staff who was on board that time was on the left side of the helicopter and was closing the left side door after offloading the items from that side. One of the passengers (UCADA official) who were waiting to get onboard ran towards the rear of the helicopter and was hit by the tail rotor. On realizing something has happened, the pilot immediately switched off the aircraft with normal procedures. The passenger who came in contact of the tail rotor received fatal injuries and died on spot. The local authorities were informed about the accident and they cordoned off the accident area.

The accident occurred as the passenger while approaching for boarding from front right side suddenly moved towards the rear of the helicopter and came in contact with running tail rotors.

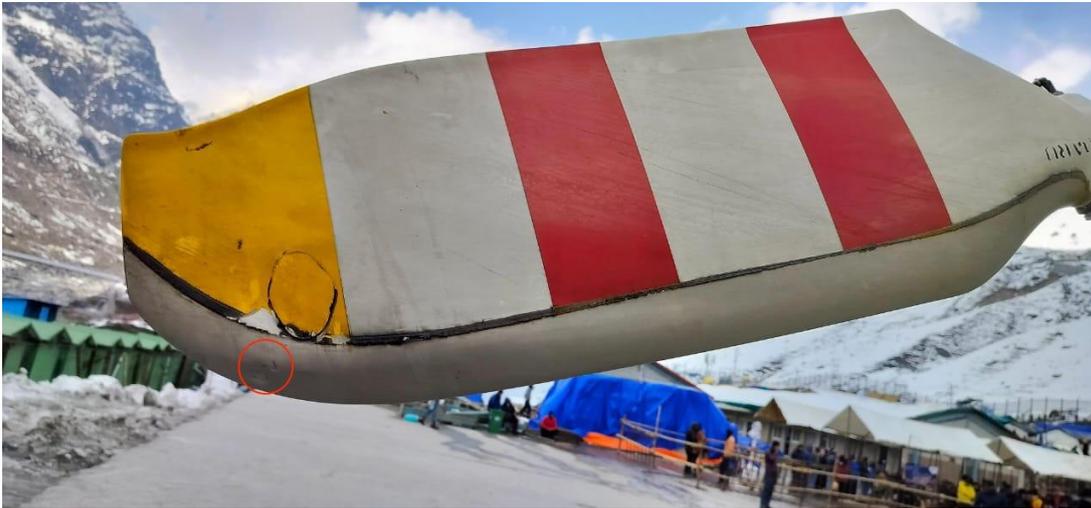
The helicopter received minor damage. There was a small dent on one of the tail rotor blades.

Figure 2: Small dent on tail rotor blade

Not relevant as the helicopter did not sustain any damages apart from small dent on the tail rotor blade.

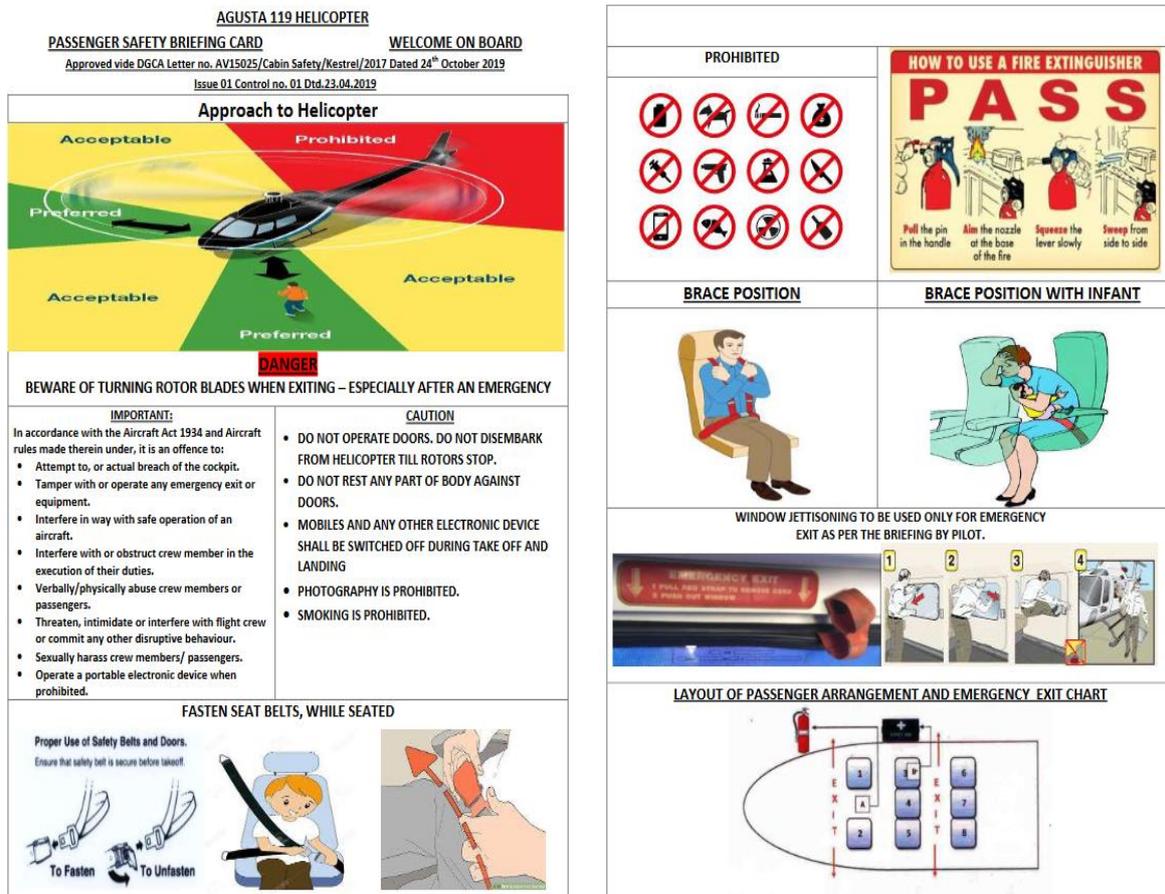
The passenger briefing was not carried out properly prior to boarding of the UCADA officials at Sahastradhara helipad and also at TBA helipad, Guptkashi before operating flight to Kedarnath. In general, the passenger briefing is carried out prior to boarding at Terminal building of Sahastradhara Helipad, however, both the passengers were escorted directly to the helicopter for boarding. The officials responsible for briefing the passengers could not do so as the flight was already getting late and they thought that the passengers being UCADA officials would be well versed with the procedures. However, the passenger briefing cards were available in the helicopter (Refer Fig 5). After the accident, it was informed by one of the UCADA officials that the flight from Sahastradhara to Guptkashi on 23 April 2023 i.e., the day of accident was the first time the deceased passenger flew in helicopter.

Figure 5: Passenger Briefing Card Available in Helicopter

helicopter with running rotors and the consequences associated with it. Also, the passenger may not have seen the passenger briefing cards available in the helicopter.

- 4.1** DGCA should issue directions to all Helicopter operators to strictly adhere to the SOPs regarding safety briefing provided to the passengers prior to boarding. Further, they may ensure that all passengers irrespective of their post/background are briefed about the safety aspects at a designated place (briefing area) prior to commencement of flight from every helipad. The compliance of these SOPs by each operator may be ensured by DGCA during their Surveillance/Audit/Inspection.
