Government of India
Aircraft Accident Investigation Bureau
Ministry of Civil Aviation

Preliminary Report: Accident involving M/s Global Vectra Helicorp Limited's AW139 helicopter bearing registration VT-GVI at Village Paud, near Pune on 24 Aug 2024

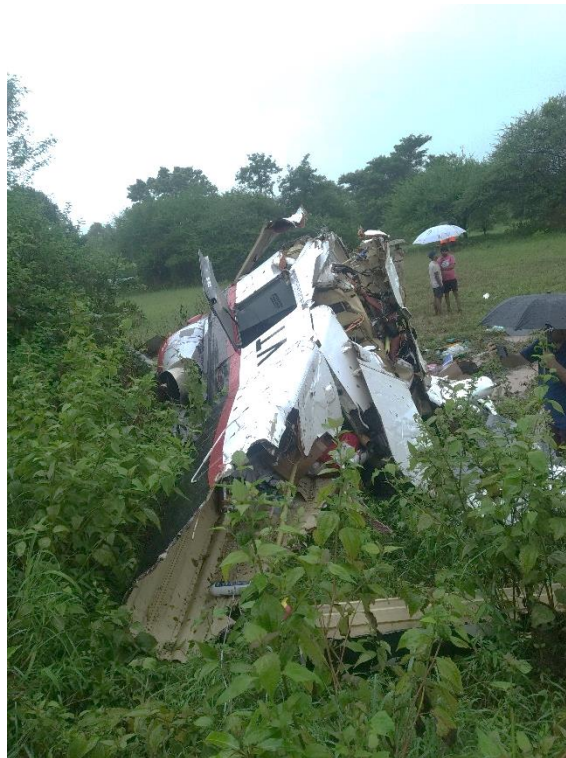
The coordinates of the accident site are 18° 31'37.3" N, 073° 35'39.3" E. The helicopter was destroyed in the accident.
