**FINAL INVESTIGATION REPORT ON ACCIDENT TO
M/S FALCON AVIATION ACADEMY,
CESSNA 152 AIRCRAFT, VT-PTE ON 05.01.2023
AT UMARI VILLAGE NEAR REWA, M.P**

AIRCRAFT ACCIDENT INVESTIGATION BUREAU

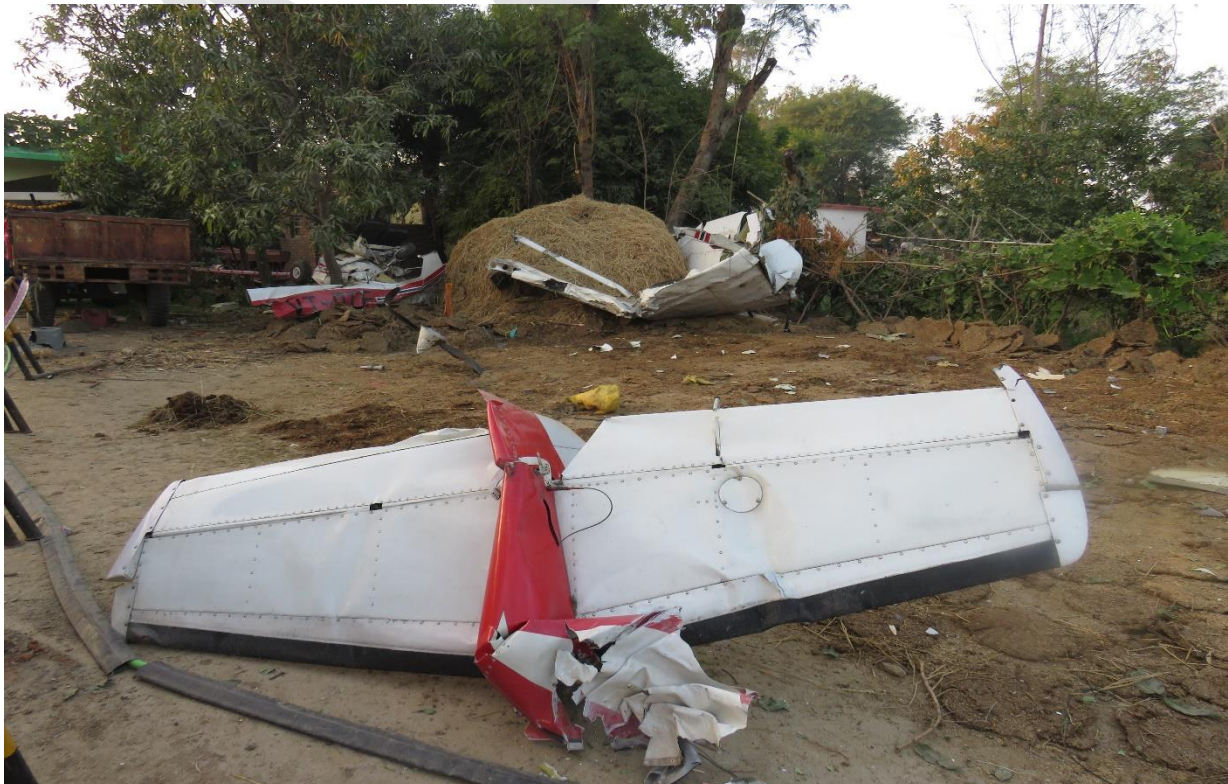
FIG 1: ACCIDENT SITE

The aircraft hit concrete terrace wall of a house and trees before impacting with concrete tower of a temple. Due to high impact, the temple tower was damaged and separated from top. The concrete terrace wall of house was also found damaged.

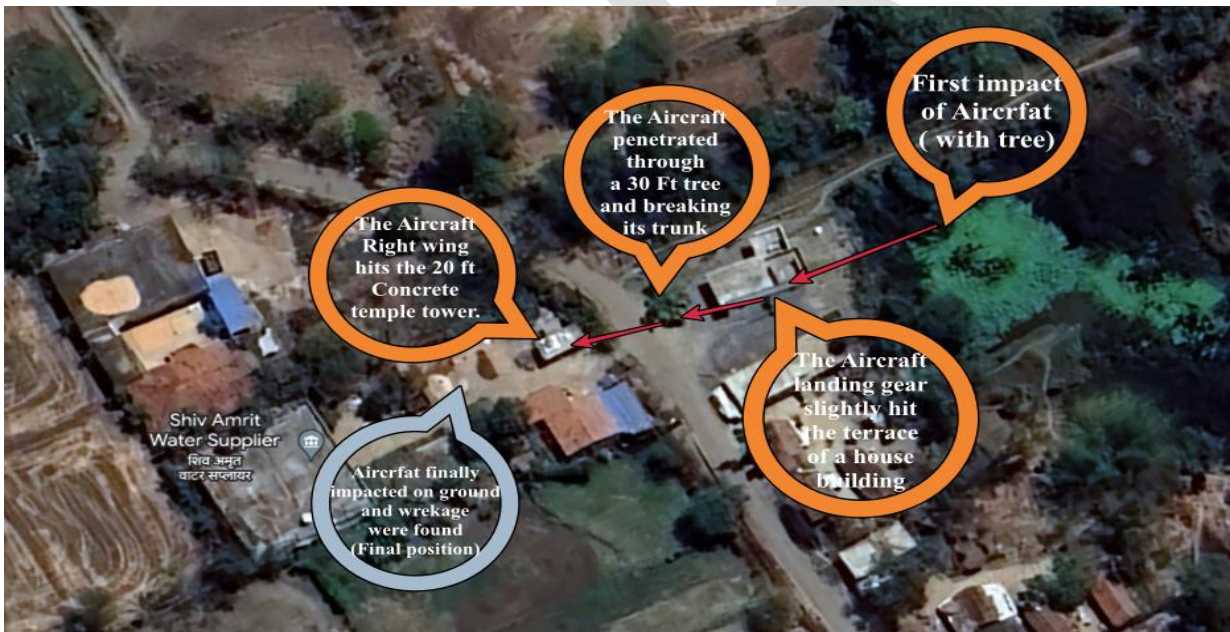
The crew were not able to find any visual cues from ground and in search of the same the crew kept on descending the aircraft. During this process the aircraft hit one of the trees before its landing gear hit the terrace of a house, which was about 15 feet above the ground as evident from the rubbing marks of landing gear tyre on the wall and damages at the same position on the concrete structure. Simultaneously, the left wing hit one of the trees adjacent to the house where there were signs of fuel spillage. Thereafter, the aircraft penetrated through another tree in front of the house, breaking its trunk. The right-side wing of the aircraft then struck a concrete temple tower. Due to the heavy impact the top portion of the temple tower broke and got separated from the structure. The right wing was also found separated from the aircraft structure. Subsequently, the aircraft impacted the ground before coming to the final rest position just in front of a house. The location of the aircraft where it crashed was at a distance of approximately 0.86 Nm from end of runway 25.

FIG 4: PICTORIAL REPRESENTATION OF VT-PTE FINAL PATH, IMPACT AND FINAL POSITION.

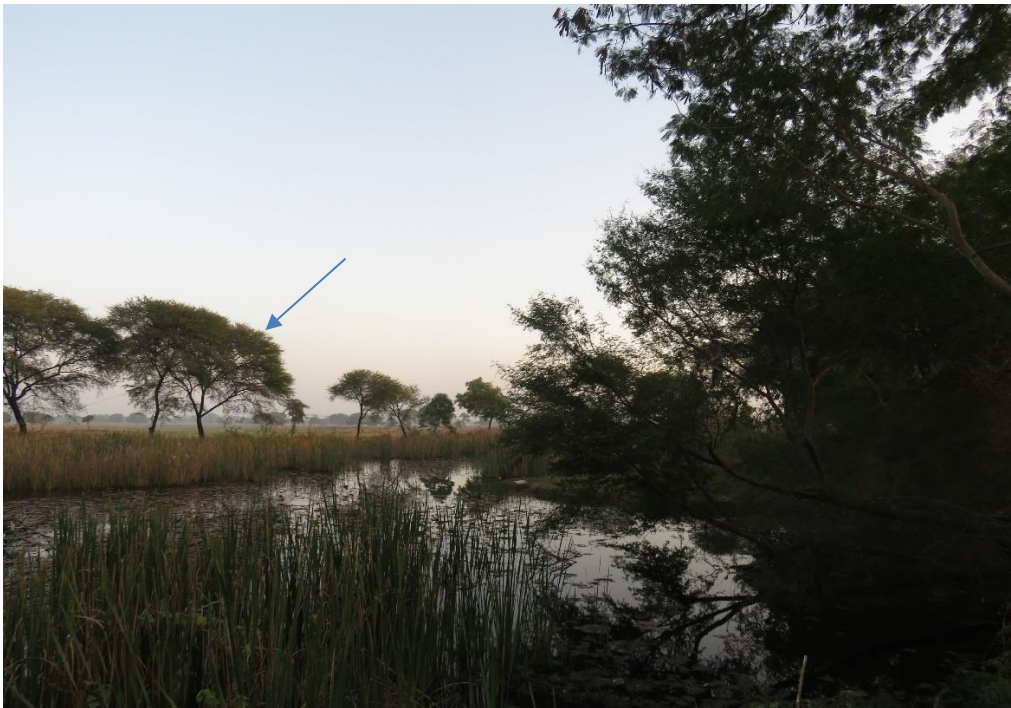
Fig 1: First Impact with tree

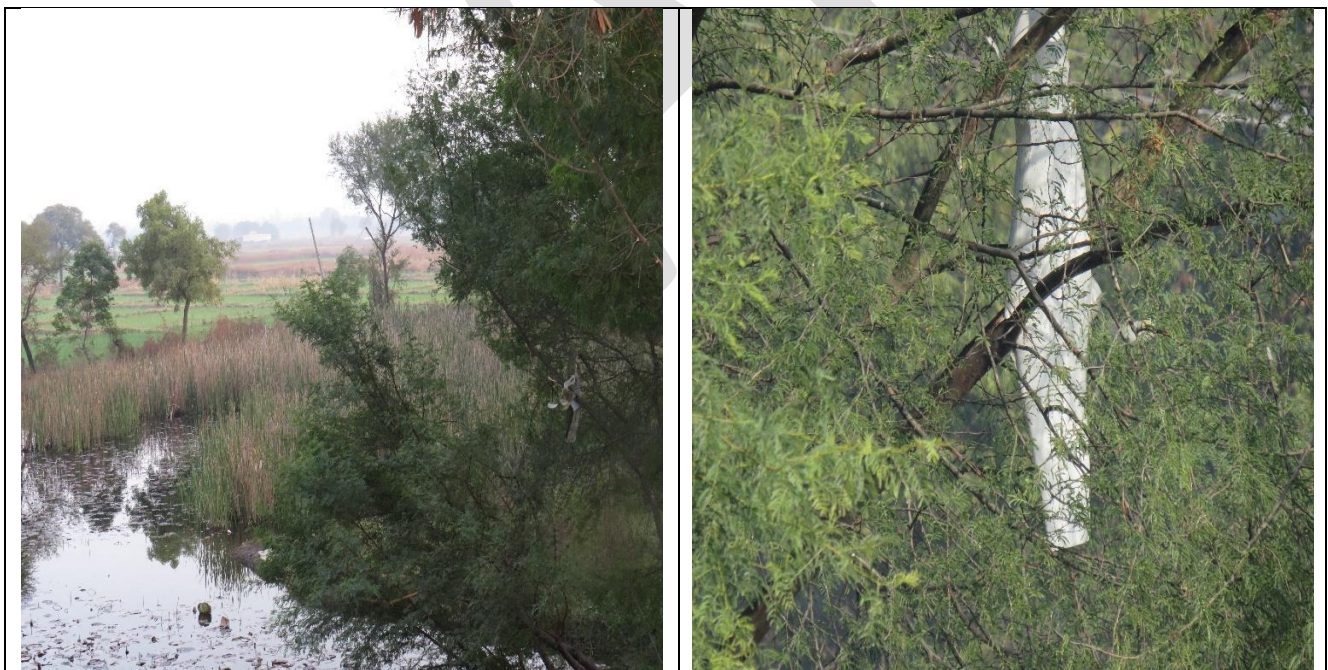
Fig 2: Second Impact with a tree and aircraft part lying on tree

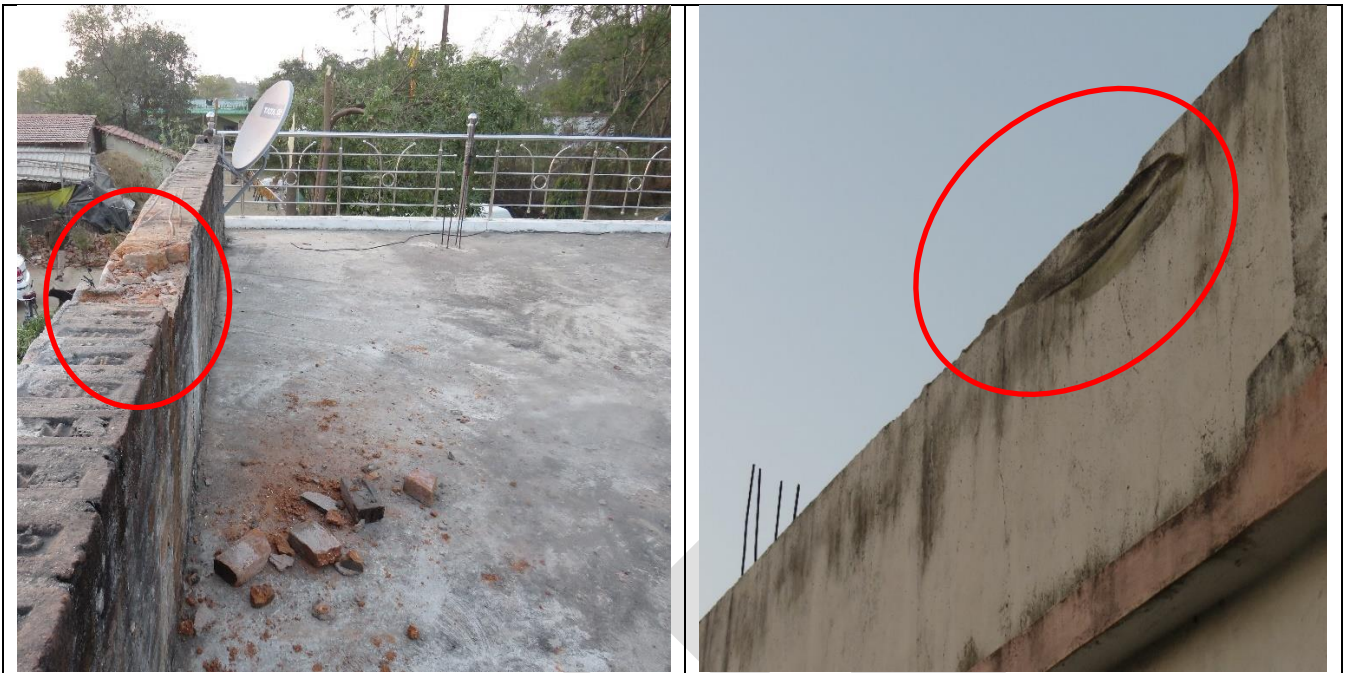
Fig 3 & 4: Third Impact with concrete terrace of a building and landing gear impact marks

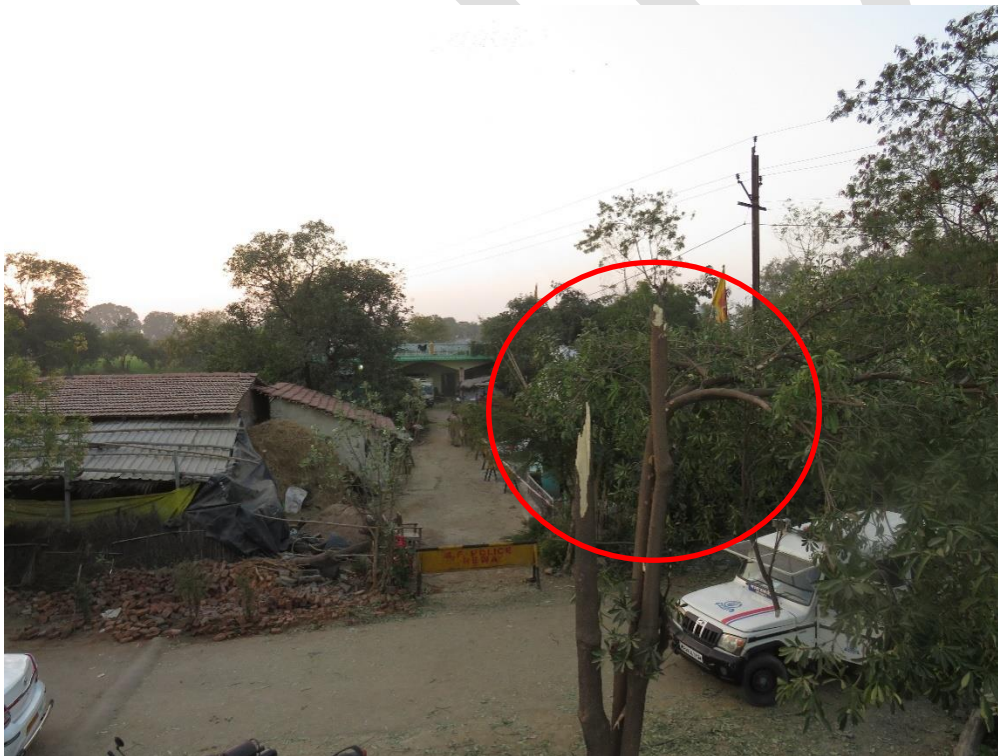
Fig 5: Fourth Impact with a tree

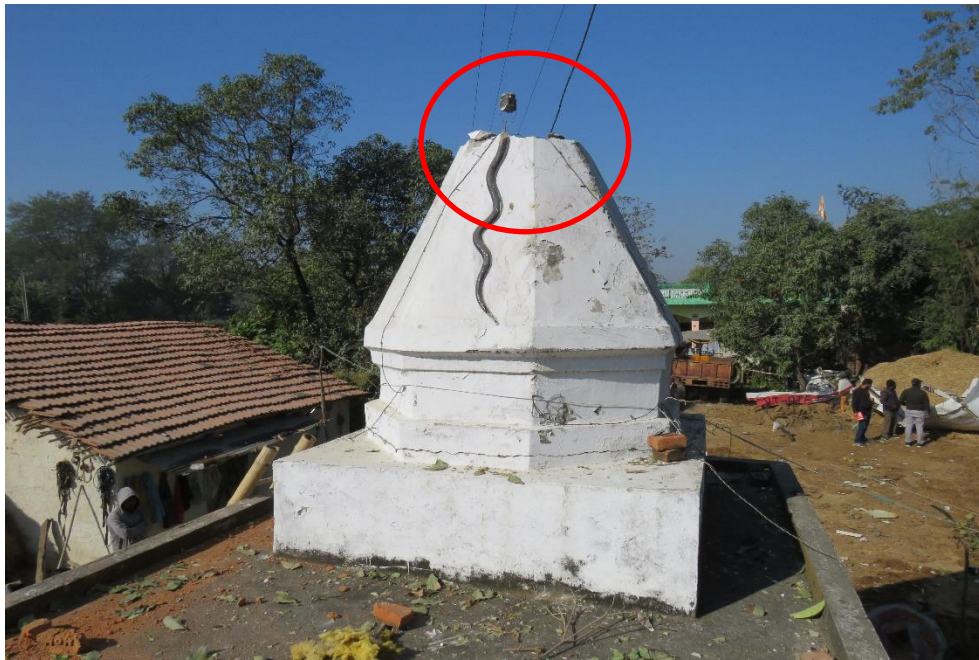
Fig 6: Fifth Impact with temple tower

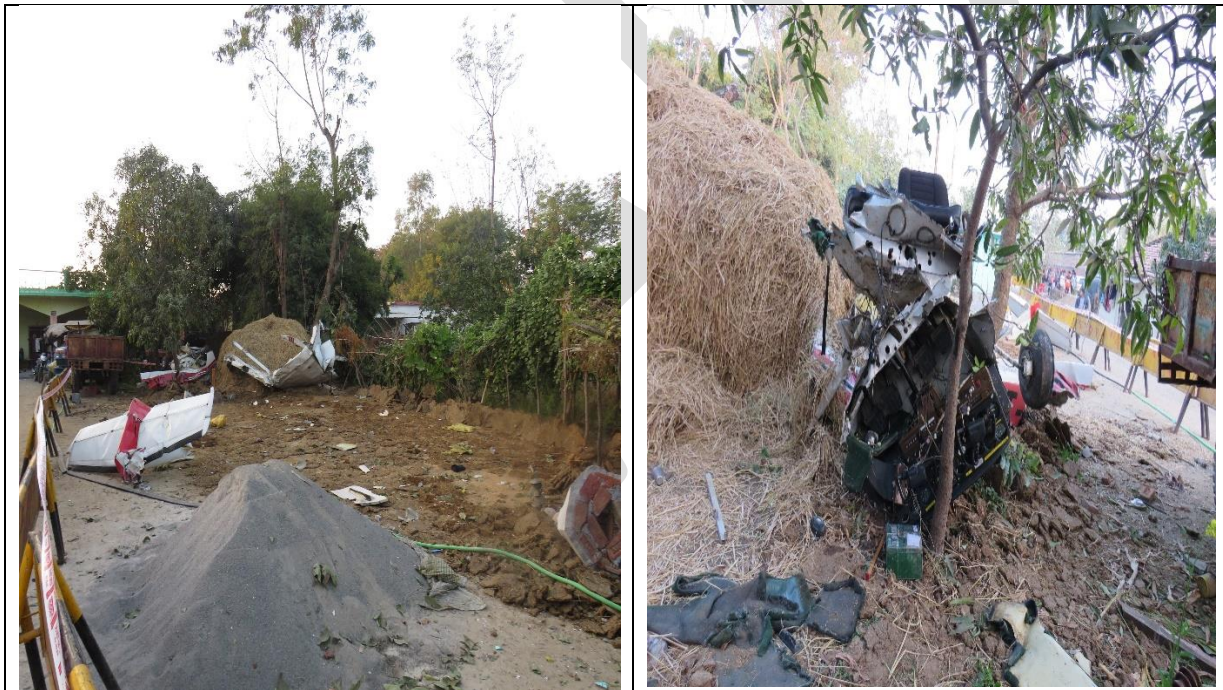
The aircraft was subjected to extensive compression damage to the forward fuselage, after heavy impact with trees, concrete structure, and ground. Some of the major damages sustained by the aircraft are appended below: -

- Both wings were found fully detached from the aircraft structure.
- The aircraft empennage was found separated from the Aircraft.
- The left horizontal stabilizer was observed with the banner tow cables and some tree remains wrapped around the edges of the wing.
- Flight control cables were found broken.
- Examination of the cockpit revealed the instrument panel was damaged due to impact.
- Visual examination of engine revealed following: -
 - The engine was found attached to the structure.

- The propeller was found detached from engine and stuck on ground with one blade penetrated 8-12 inch deep into the ground. The blades were found bent from the tip.
- The propeller spinner was not fragmented.
- In the cockpit, the throttle control knob and mixture control knob were in aft position. The carburetor heat control knob was in forward position.

Fig 7: Final wreckage position after Impact with ground
