**Government of India**  
**Ministry of Civil Aviation**  
**Aircraft Accident Investigation Bureau**

**Interim Report:** Accident involving M/s Aryan Aviation Pvt. Ltd.'s BELL 407 helicopter, bearing registration VT-BKA near Gaurikund, Uttarakhand, India on 15 June 2025.

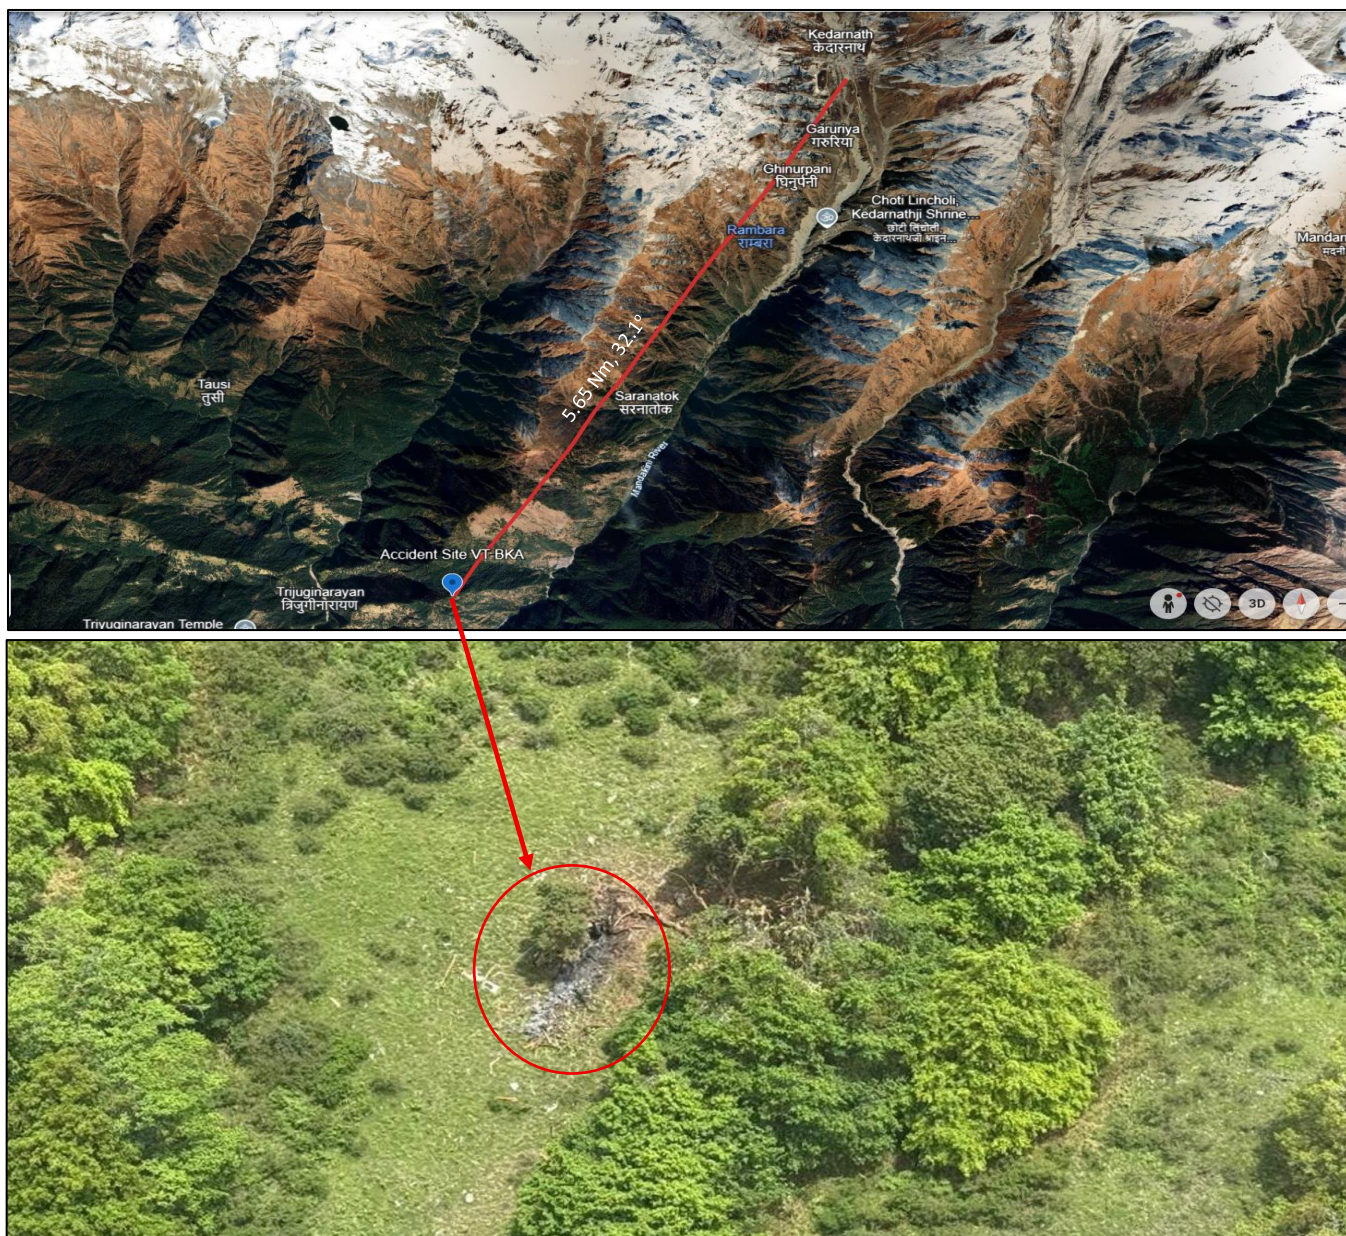
The helicopter was maintaining an altitude of approximately 9000 feet altitude (as required by the SOP) and crashed into the mountain on the right side of its flight path near the Kedarnath valley exit point. The accident site was at an ariel distance of about 5.65 Nm from the Kedarnath helipad on radial 32.1°. The co-ordinates of the accident site were 30° 38' 59.0" N, 79° 00' 35.0" E with elevation of 9051 feet. The helicopter impacted the terrain and caught fire. The wreckage parts were found scattered but were confined to the main wreckage area.

**PIC 1: AERIAL VIEW OF THE ACCIDENT SITE AND ITS LOCATION IN RESPECT OF KEDARNATH HELIPAD.**

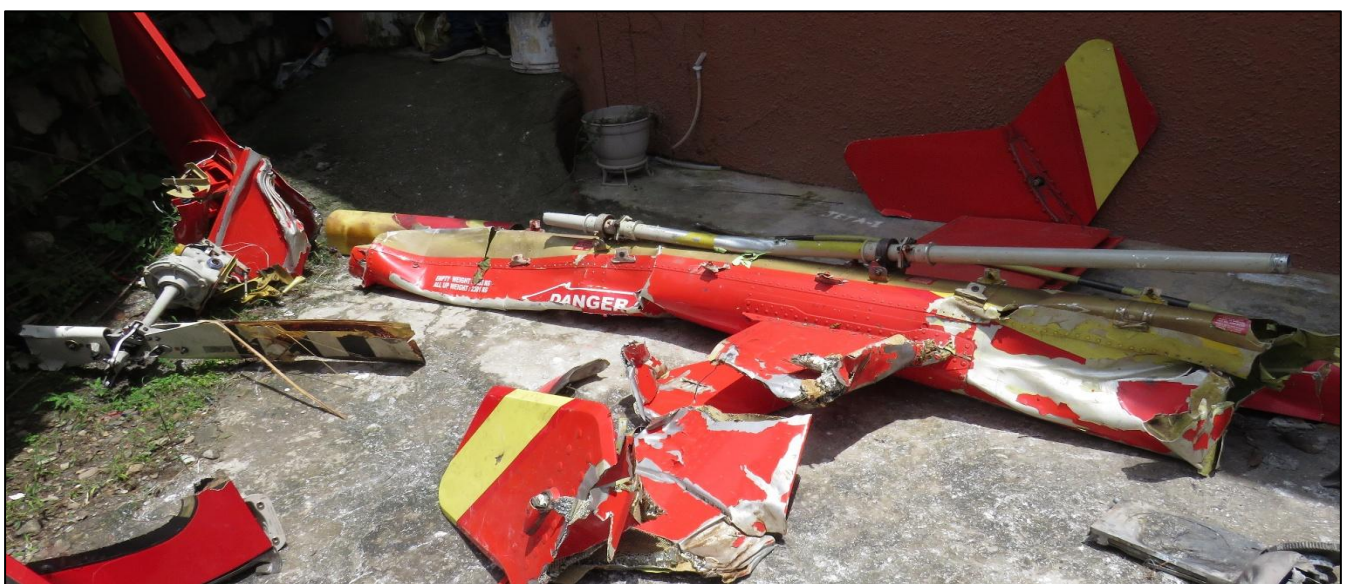
- The cockpit doors and cabin doors recovered from the site were found fractured in multiple locations.
- The tail boom was the major part recovered and suffered major impact damages on its right side.
- The tail boom was found fractured at mid-point aft of the tail boom attachment and the horizontal stabilizer.
- The tail rotor gearbox support casting fractured at the tail boom joint attachment.
- The tail boom had an impact damage to the right side behind the horizontal stabilizers.
- The left stabilizer and the finlets were found intact.

- The right stabilizer had a large impact damage on its leading edge. The finlet fractured horizontally about mid-point from the bottom and was twisted/delaminated.
- The vertical fin had a large impact damage on its lower leading edge with deformation of the shape towards the right.
- The stinger was intact and no damage was found.

- The tail boom tail rotor driveshaft was mostly present with its driveshaft cover. The mid driveshaft had some impact marks and was deformed.
- The hanger bearings were rotating so was the tail rotor gearbox.
- The tail rotor gearbox chip detector didn't reveal any presence of metal and was clean.
- The oil color was normal.
- The tail rotor gearbox separated at the disc attachment (input quill) and at the gearbox support casting due to impact forces.
- The aft fuselage driveshaft separated at the oil cooler blower and was fractured on its aft end. No pre-impact anomalies were found with the portion that was assessed.

**PIC 2: TAIL SECTION RECOVERED FROM THE ACCIDENT SITE**

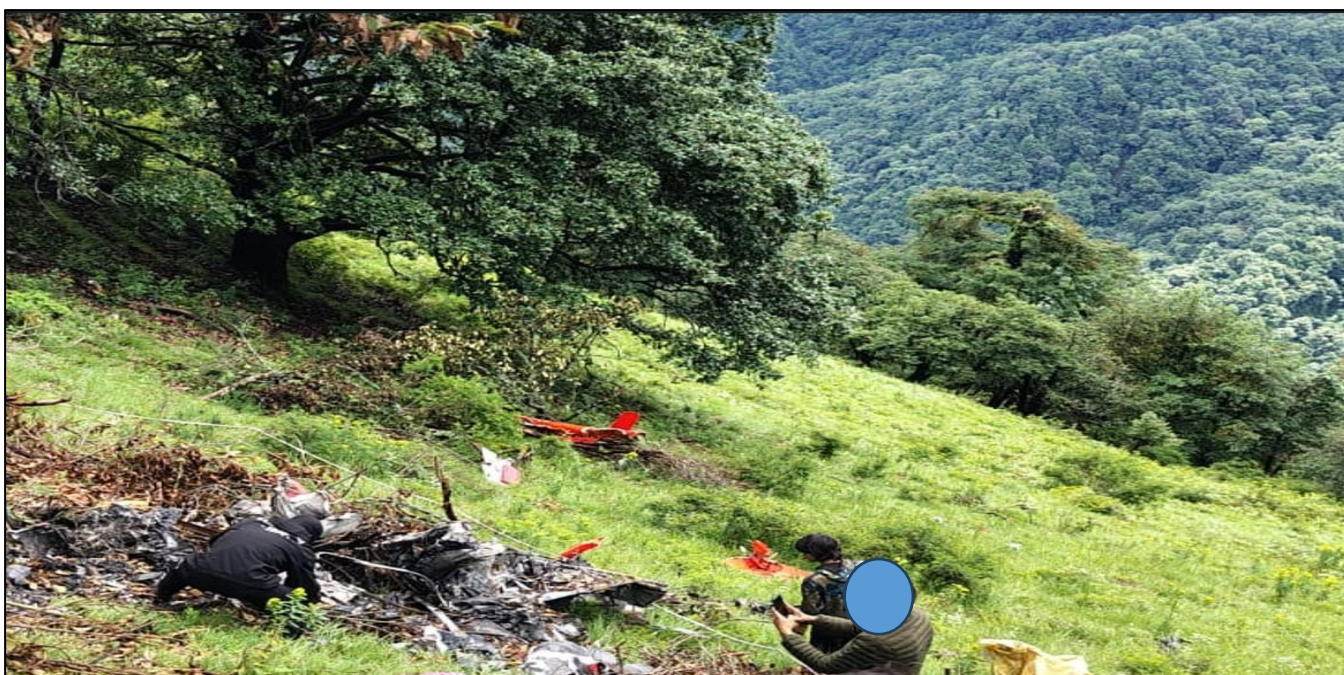
On analysing the footage of the CCTV camera facing the valley entry/exit point, during the time of accident, it was observed that the valley exit point was covered with clouds and were moving down into the valley. The other two helicopters which were behind the accident helicopter VT-BKA were observed to have exited the valley at a lower altitude by avoiding the clouds.

**PIC 4: ACCIDENT SITE**
