**Interim Report: Accident involving M/s Pinnacle Air Pvt Ltd. Helicopter, Type- AS350B2 bearing registration VT-KBS near Kedarnath ji Helipad, Uttarakhand, India on 17 May 2025.**

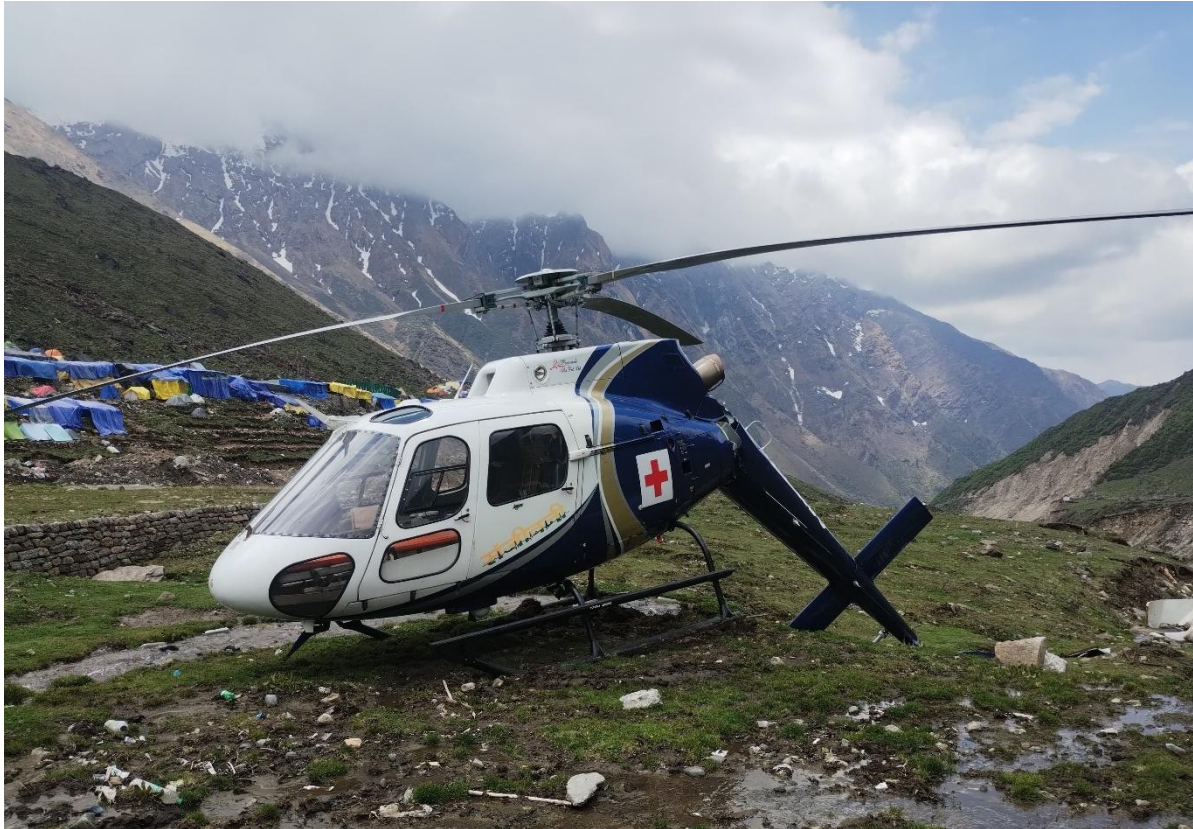
At 11:49 IST, when the Helicopter was on final approach, the helicopter suddenly started losing altitude and descended approximately 40 meters short of the designated landing pad at Kedarnath. During this descent, the aircraft yawed approximately 90 degrees to the left and made a hard landing on terrain in a damp unpaved area. The surface was in wet mud conditions that adversely affected landing.

Following the initial landing, the pilot tried to take-off again. During this second attempt, the left-hand side skid lifted off first, and the helicopter tilted towards right. Thereafter, once the right-hand side skid lifted off, the helicopter's lower vertical fin struck the ground, and made a counterclockwise spin while gaining some altitude before crash-landing at the same location. Upon second impact the tail boom broke from the junction and was severely damaged (Fig 01). After that the pilot made another unsuccessful attempt to take-off before switching off the

Fig 01: Final resting position of the helicopter with broken tail boom.
