**Government of India**  
**Ministry of Civil Aviation**  
**Aircraft Accident Investigation Bureau**

**Preliminary Report:** Accident involving M/s Aerotrans Services Pvt Ltd.'s BELL 407 helicopter, bearing registration VT-OXF in Gangnani, District-Uttarkashi, India on 08 May 2025.

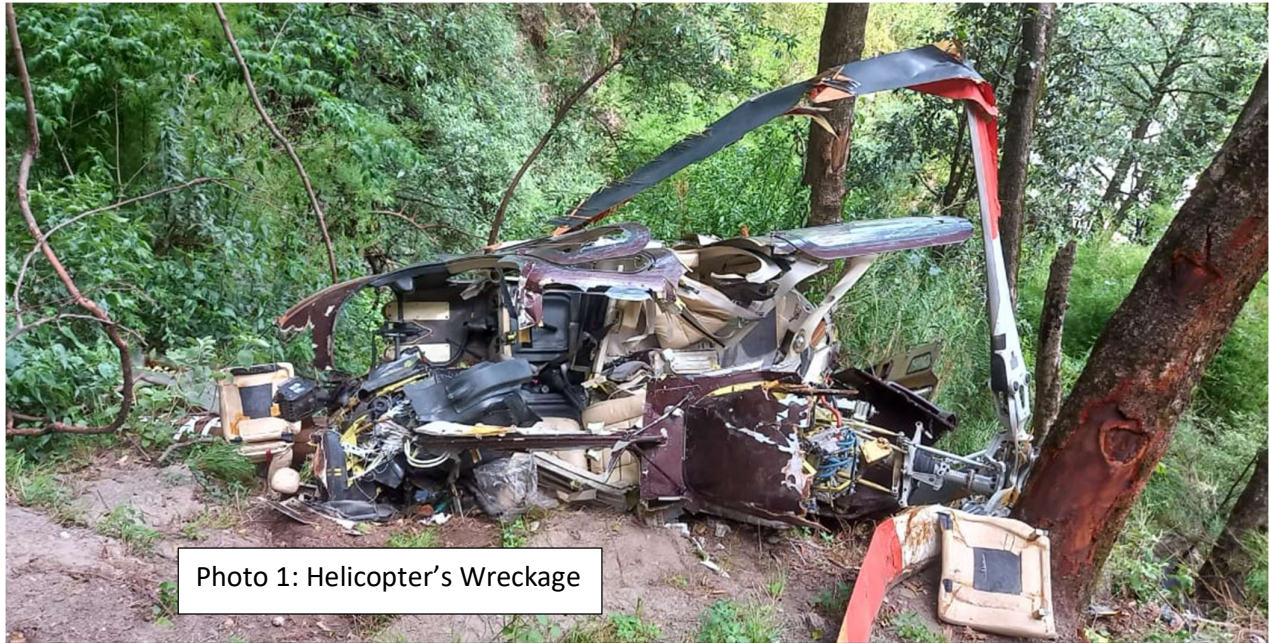
The accident took place in a mountainous region. After impacting a roadside overhead fibre cable and then hit the roadside metallic barricades. Subsequently, the helicopter tumbled down the hill. The helicopter finally came to rest against a tree, approximately 250 feet deep into a gorge. The helicopter wreckage was found resting on a surface with a slope of approximately 60°. The helicopter was destroyed in the accident. The coordinates of the accident site are Latitude: 30° 54' 47.6" N, & Longitudes 78° 40' 52.0" E.
