**Government of India**  
**Ministry of Civil Aviation**  
**Aircraft Accident Investigation Bureau**

**Preliminary Report:** Accident involving M/s Blue Ray Aviation Pvt Ltd.'s Cessna 152 aircraft, VT-PBA near Mehsana Airport on 31 March 2025

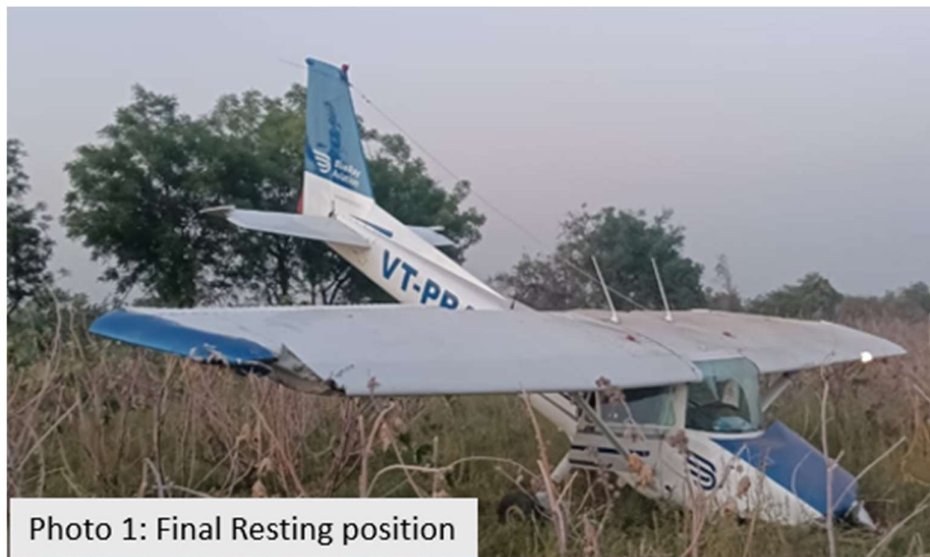
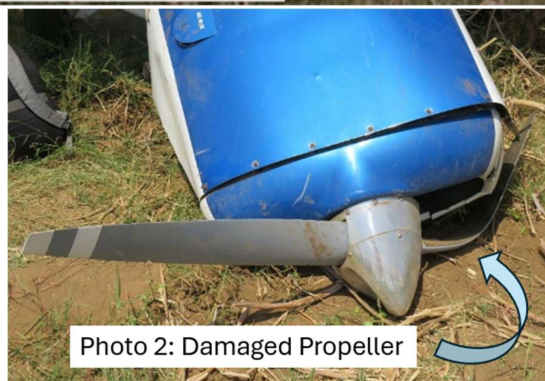
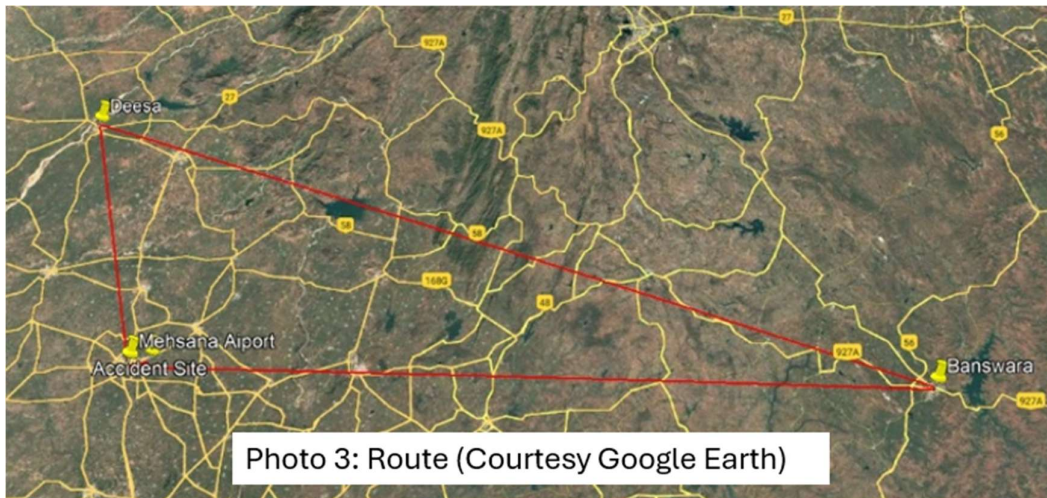
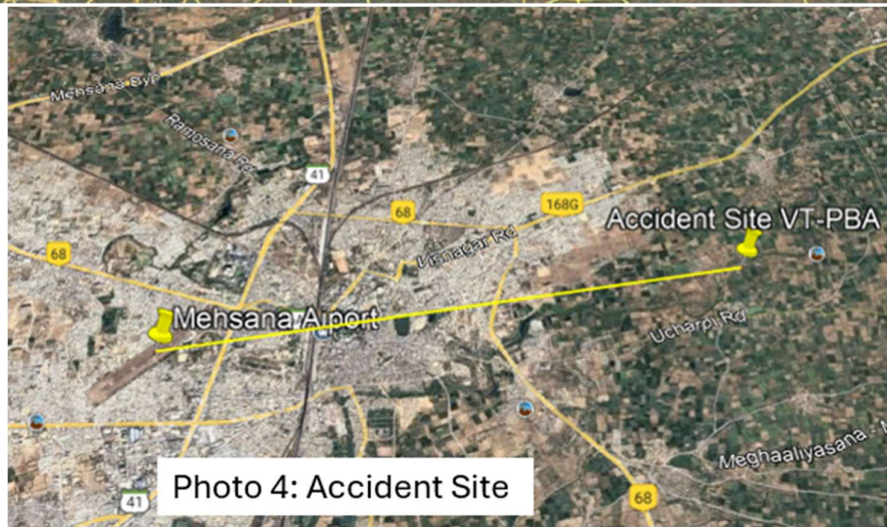
On receipt of ELT activation information from INMCC, the organization passed on the same to the two aircraft who were flying to locate the aircraft VT-PBA. Thereafter, both aircraft landed back. Organization activated the emergency rescue plan. The aircraft sustained substantial damages.
