**FINAL INVESTIGATION REPORT ON ACCIDENT INVOLVING**  
**GOVERNMENT OF CHHATTISGARH AGUSTA A109E HELICOPTER**  
**VT-CHG AT RAIPUR AIRPORT**  
**ON 12 MAY 2022.**

**GOVERNMENT OF INDIA**  
**MINISTRY OF CIVIL AVIATION**  
**AIRCRAFT ACCIDENT INVESTIGATION BUREAU**

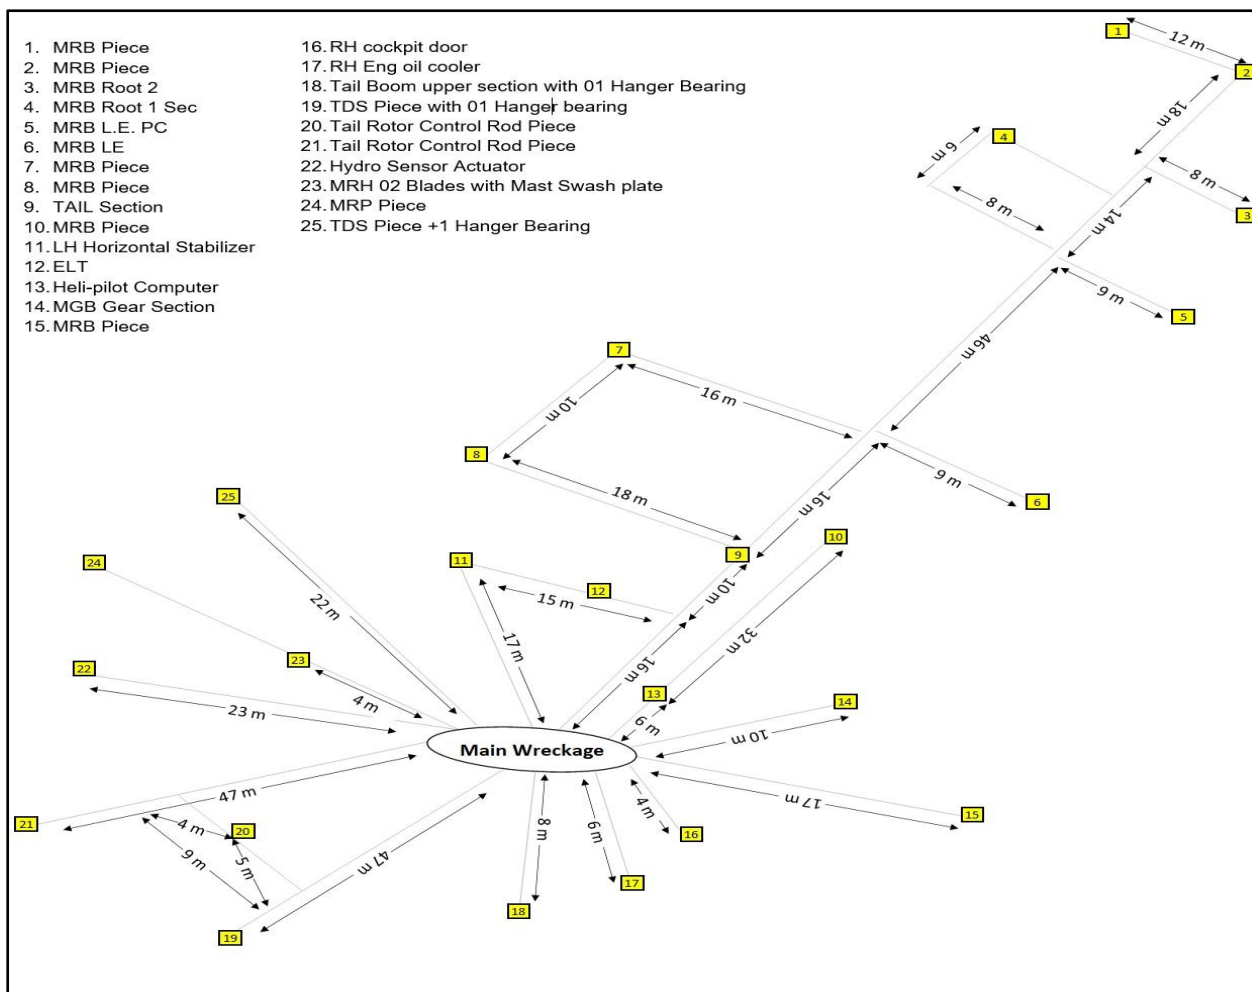
Parts of the main rotor blade, tail section and other structural parts were found scattered around the main wreckage. One of the parts was found as far as 500 m from the main wreckage. This part was probably hit by one of the rotor blades after it came off from its mounting during ground impact. The wreckage distribution plot has been made taking main wreckage as the reference (Refer fig 12. below).

**Fig 12: Helicopter Wreckage Plot**

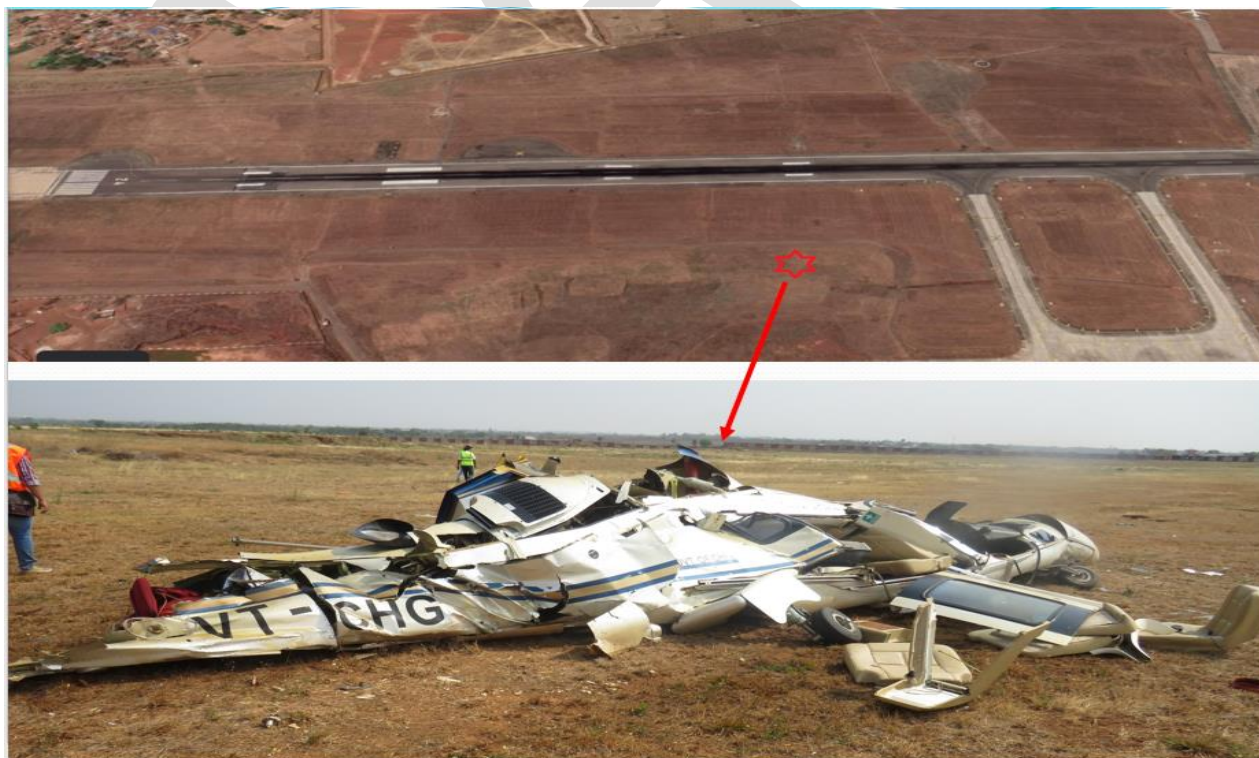
**Fig 13: Final resting position of the helicopter (Main wreckage)**

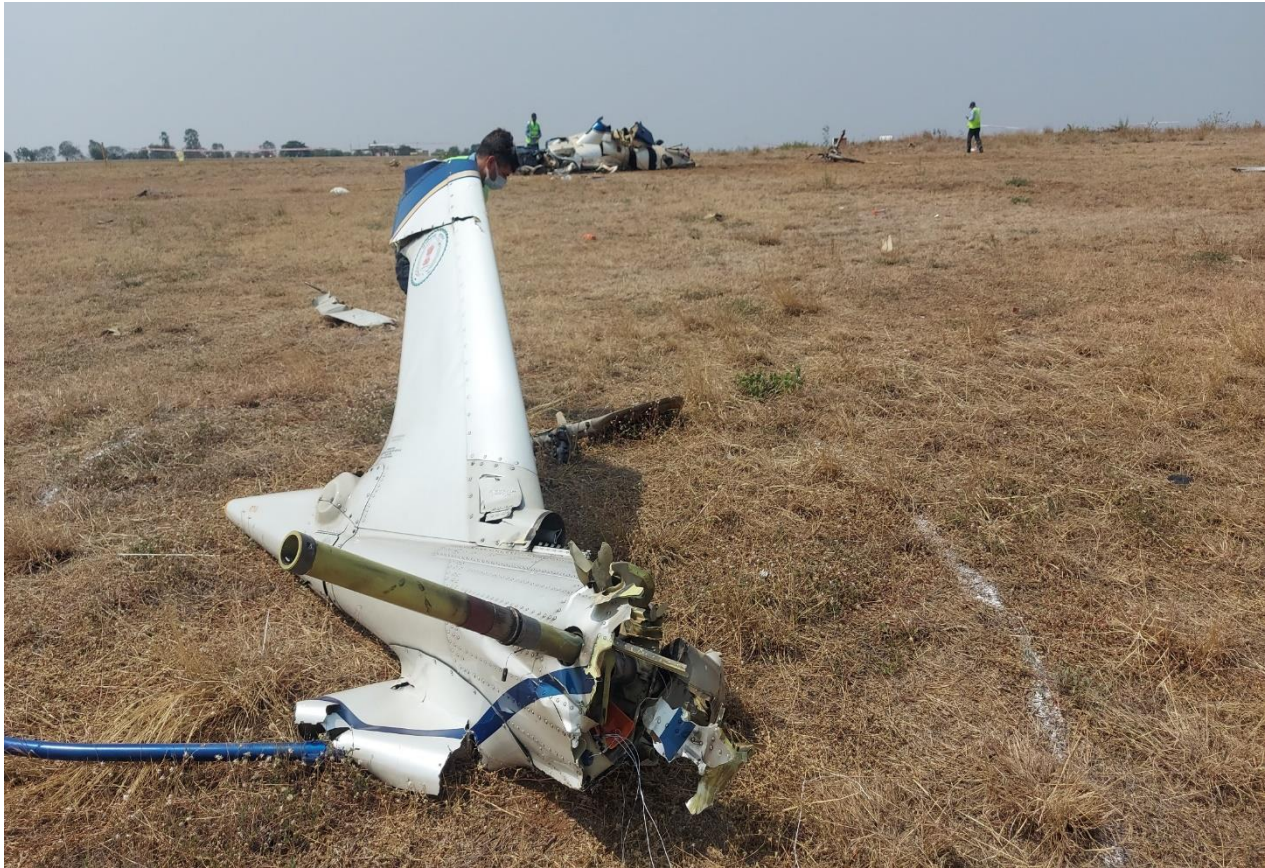
**Tail Boom:** The tail boom got cut by the main rotor blades near the horizontal stabilizer mounting position and thrown to the left side of the helicopter main wreckage. Tail rotor hub and blade assembly was disintegrated with broken Tail Gearbox drive shaft.

***Fig 15: Separated Tail rotor section found 26 m away from main wreckage.***

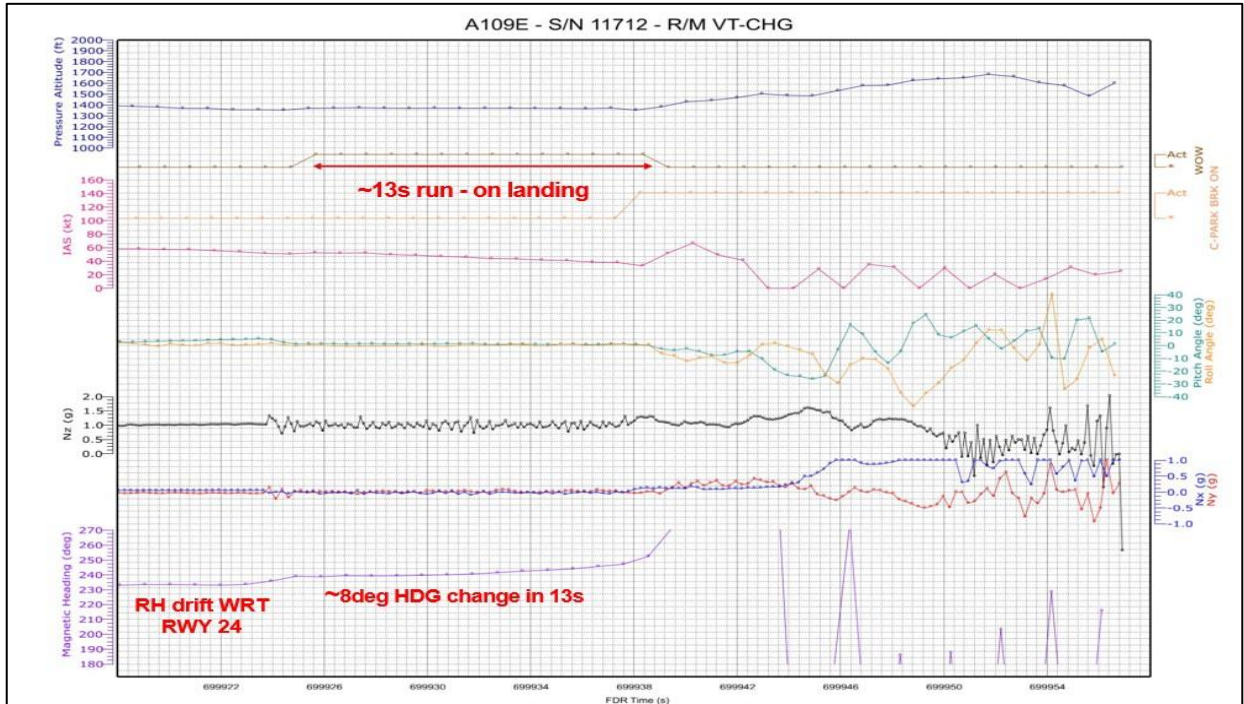
- From this point in time onwards the Flight Path data shows a behaviour consistent with a complete lack of control of the helicopter, with at least 7-8 full 360° RH rotations with a yaw rate reaching above 360deg/s. The helicopter climbed up to 1680ft AMSL before descending again while spinning CW. This is also consistent with the CVR, where sounds of helicopter rotating with various alarms like “rolling...rolling” was heard inside the cockpit and the helicopter subsequently impacted the ground.

Fig 17: Graphical representation of parameters vs FDR time during final phase (Part 1)

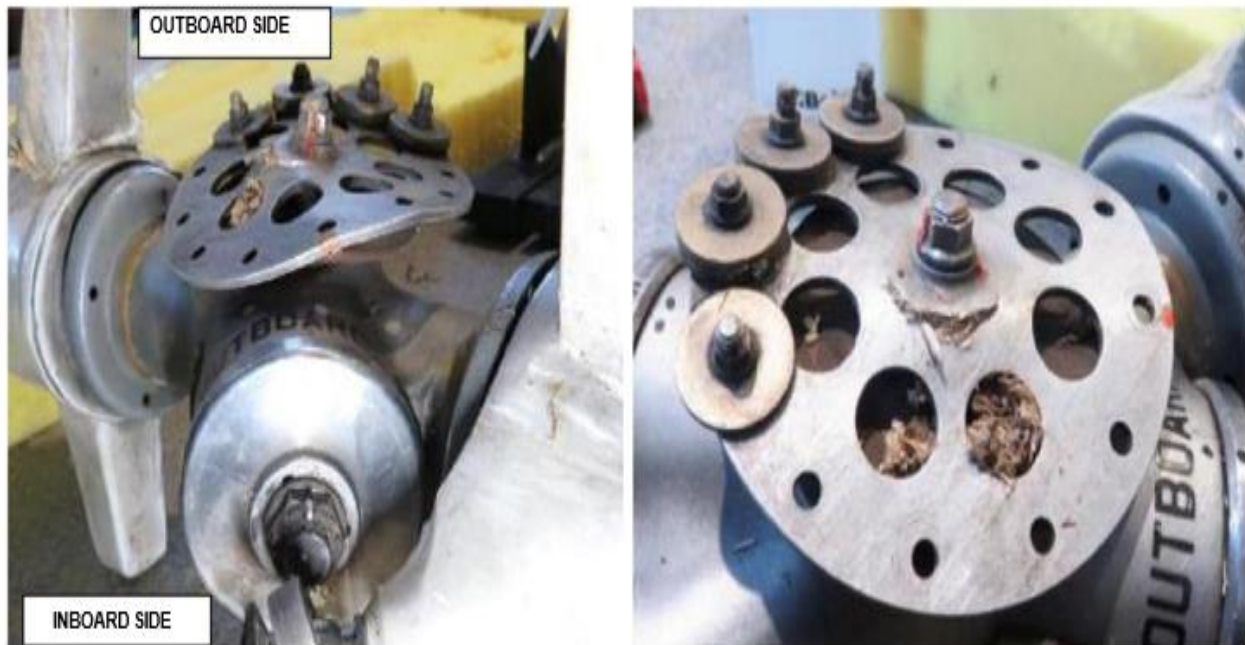
**Figure 2 – Details of the deformed balancing flange and the absence of the washer to be installed mating to it (Fig. 1).**

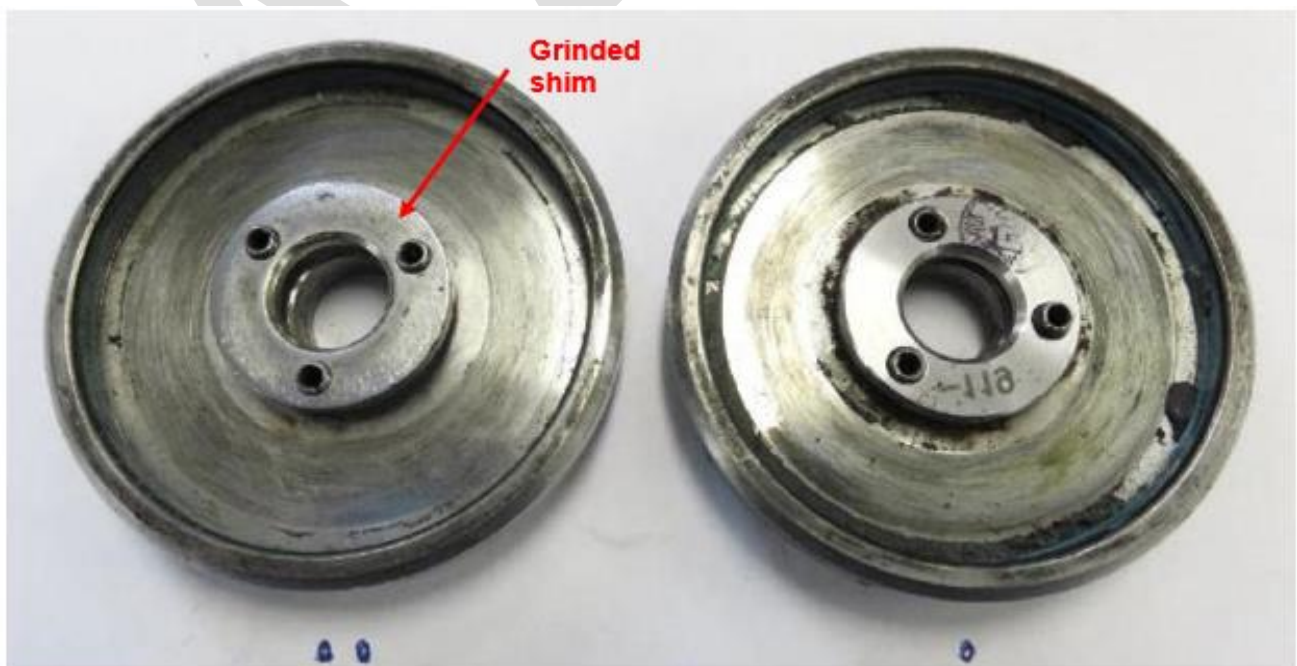
**Figure 7 – Details of the shims installed under the two hub flange assemblies (Fig. 6). The one under the hub flange with the washer foreseen in the maintenance manual is evidently grinded.**

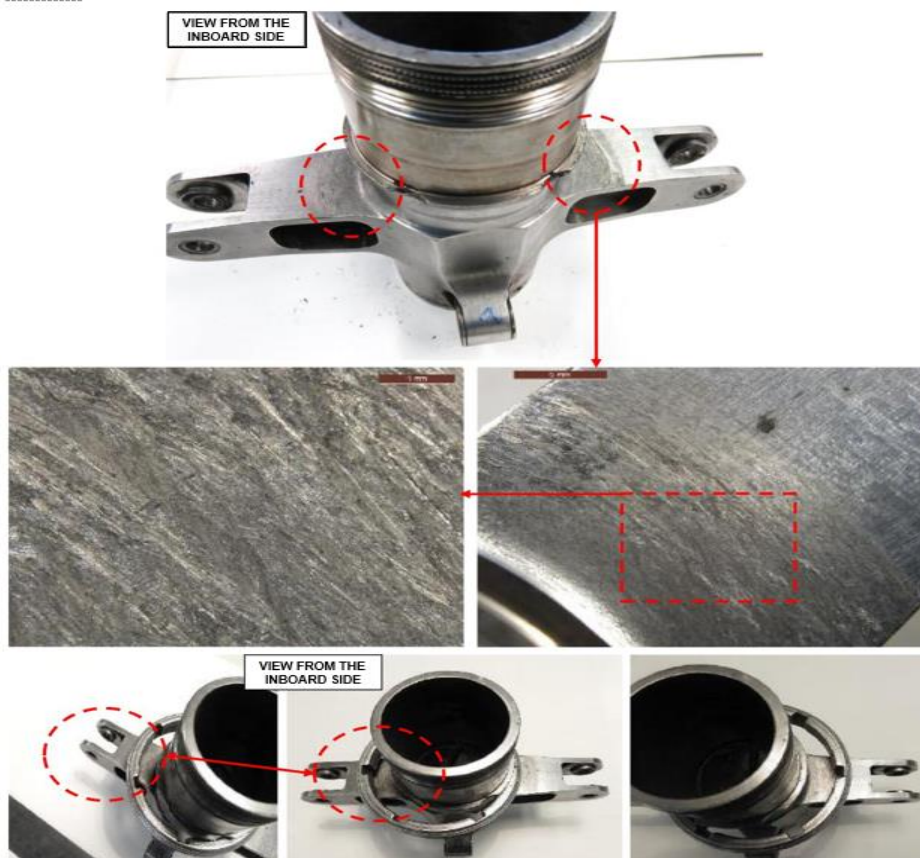
**Figure 11 – Details of the worn areas (red circles) with rubbing morphology, observed on the pitch link arms of the slider assembly. The borders of the worn areas correspond to the circumferential edge of the locking nut when in contact to the slider central body.**

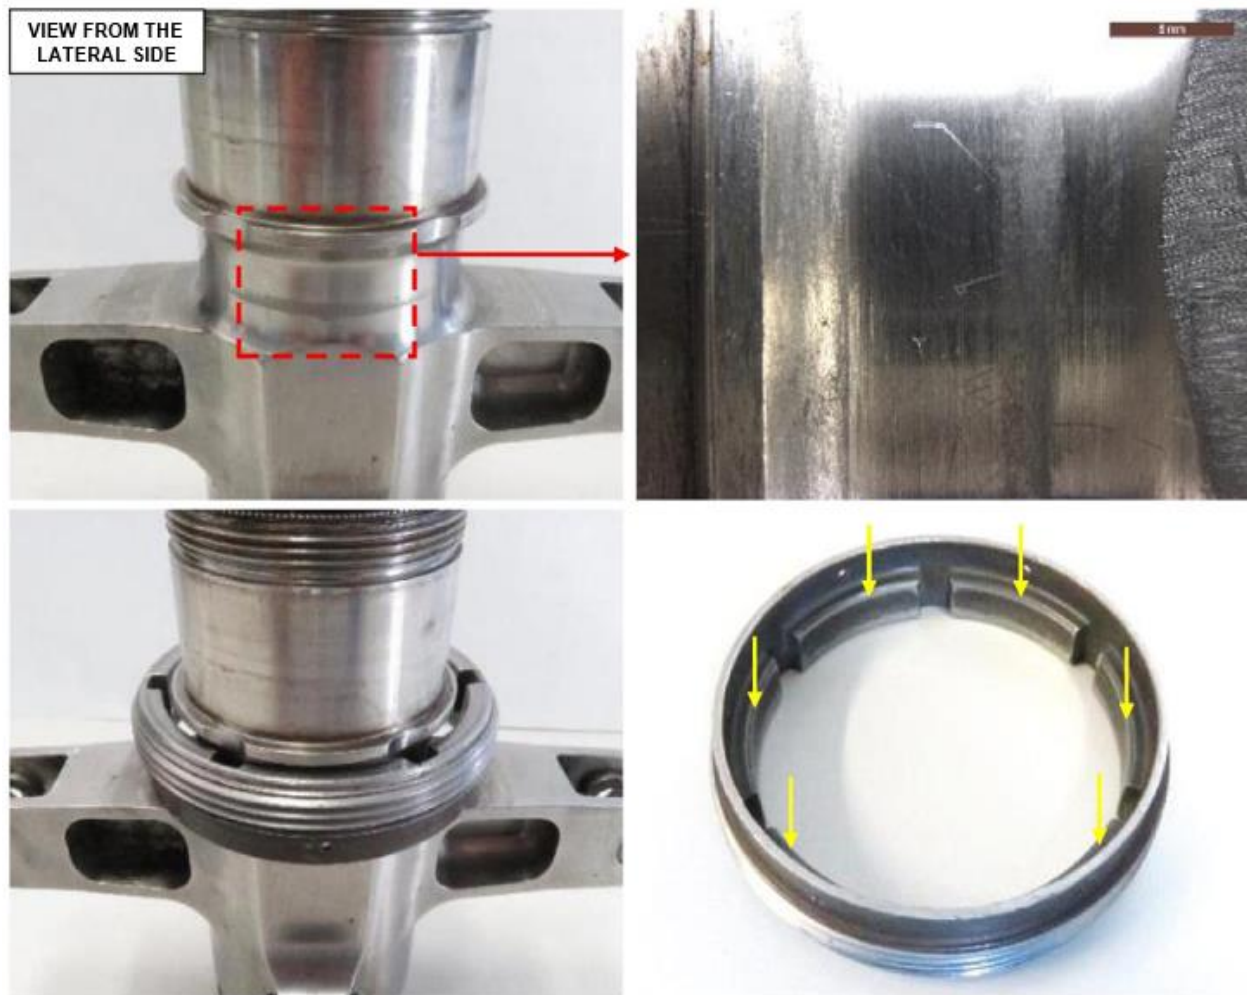
**Figure 13 – Details of the circumferential linear marks observed on the lateral surface of the central body of the slider assembly, compatible with the inner surface relief elements of the outboard locking nut (yellow arrows).**

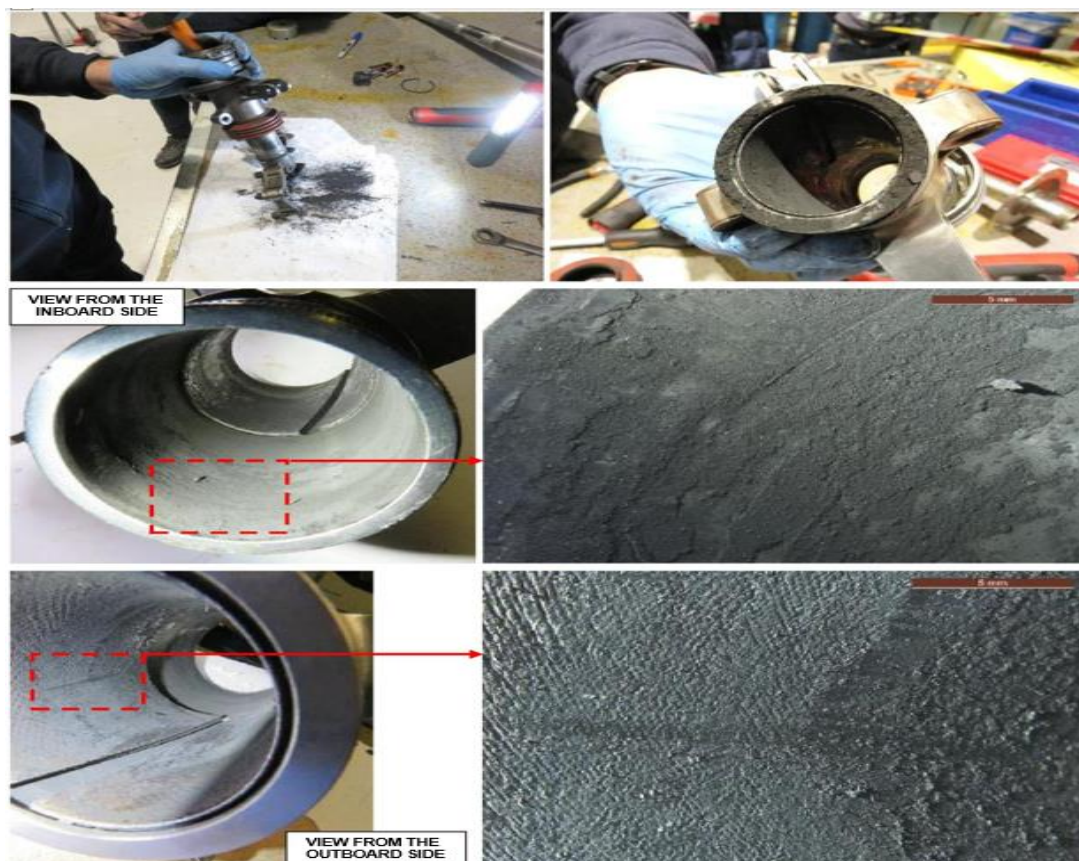
**Figure 14 – Details of the slider assembly during the disassembly from the tail rotor and before the cleaning. The inner surface is covered by dark powder from the heavily worn lining of the inner bushing.**

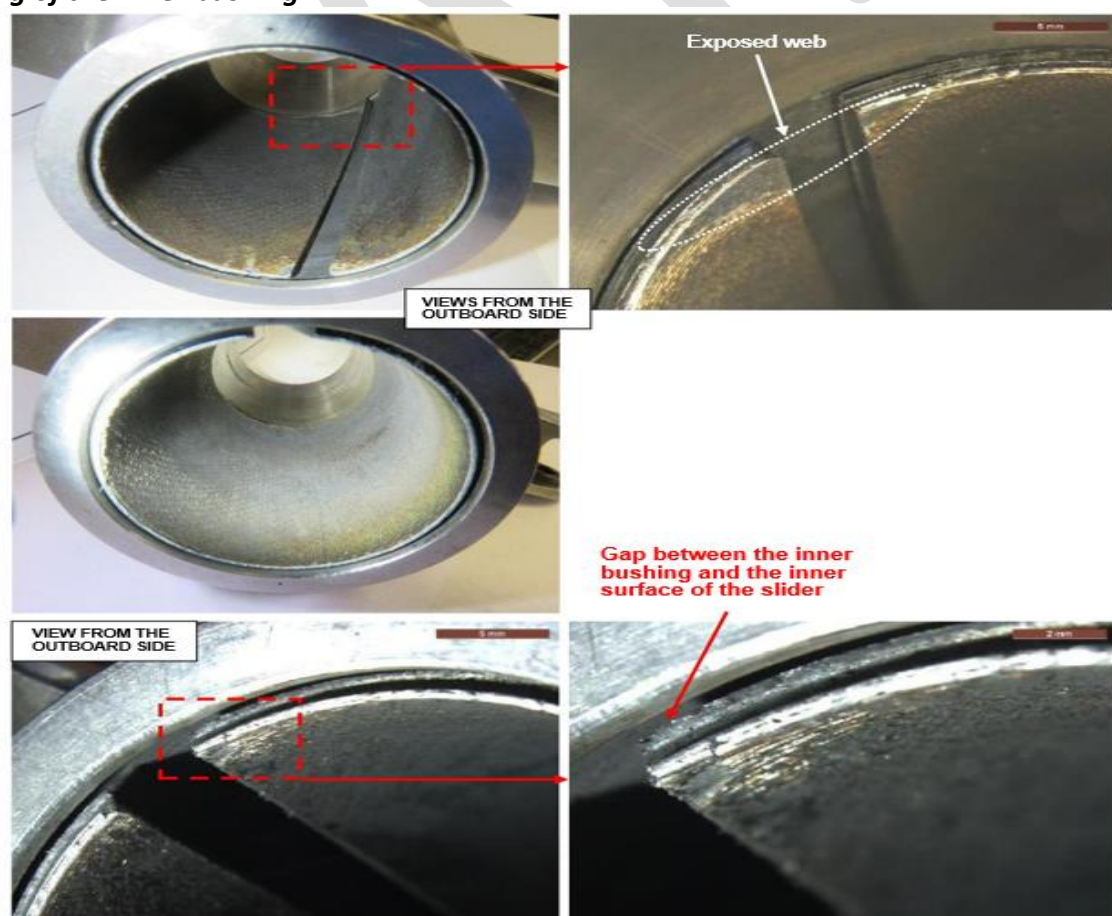
**Figure 15 – Details of the slider assembly after the cleaning. The inner bushing is worn and leaves a small portion of the underlying web exposed. Furthermore, the bushing is completely detached from the inner surface.**

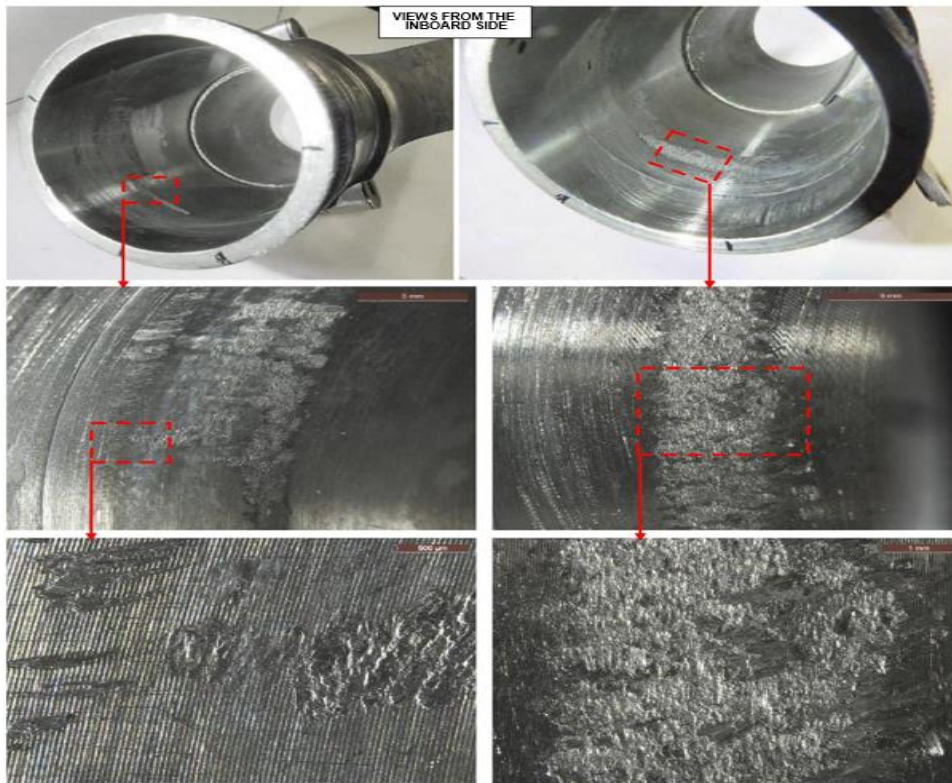
**Figure 16 – Details of the two nearby areas characterized by a multitude of short circumferential nicks, visible on the inner surface of the slider assembly after cleaning.**

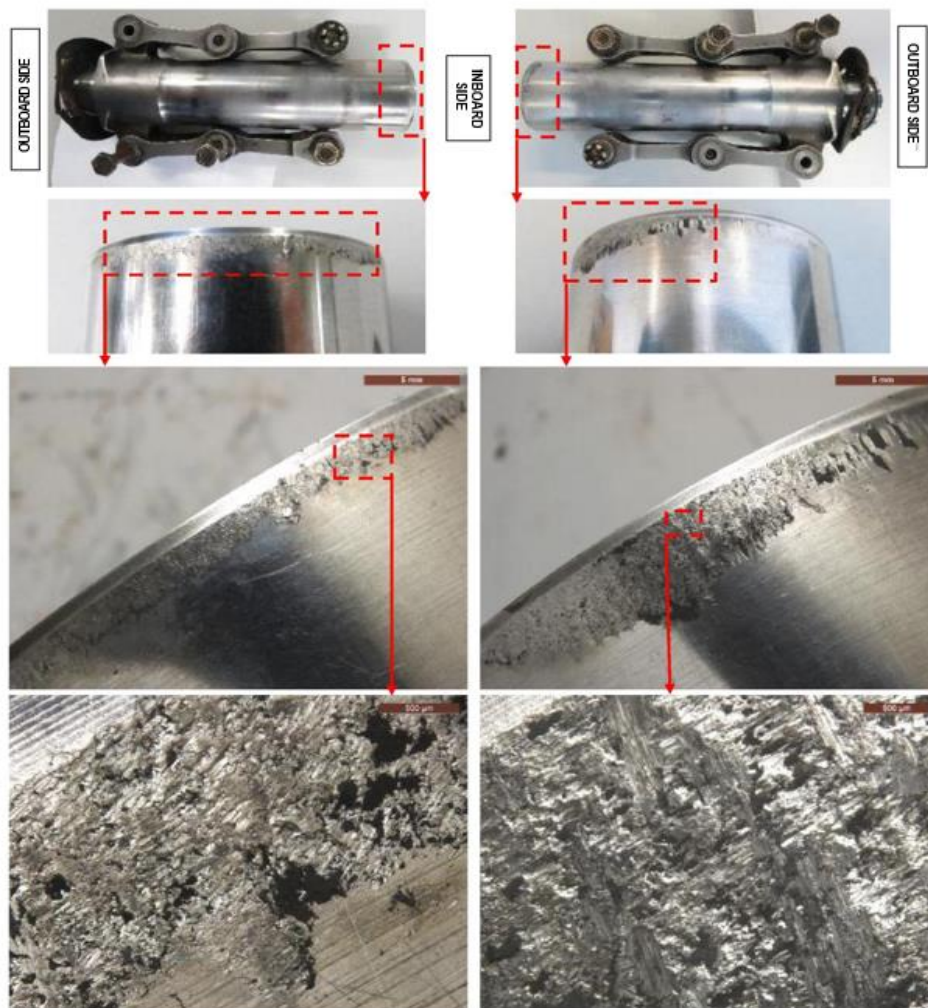
**Figure 17 – Details of the two areas characterized by a multitude of short circumferential nicks visible on the outer surface at the inboard side edge of the sleeve assembly in locations corresponding with those on the slider assembly (Fig. 17)**

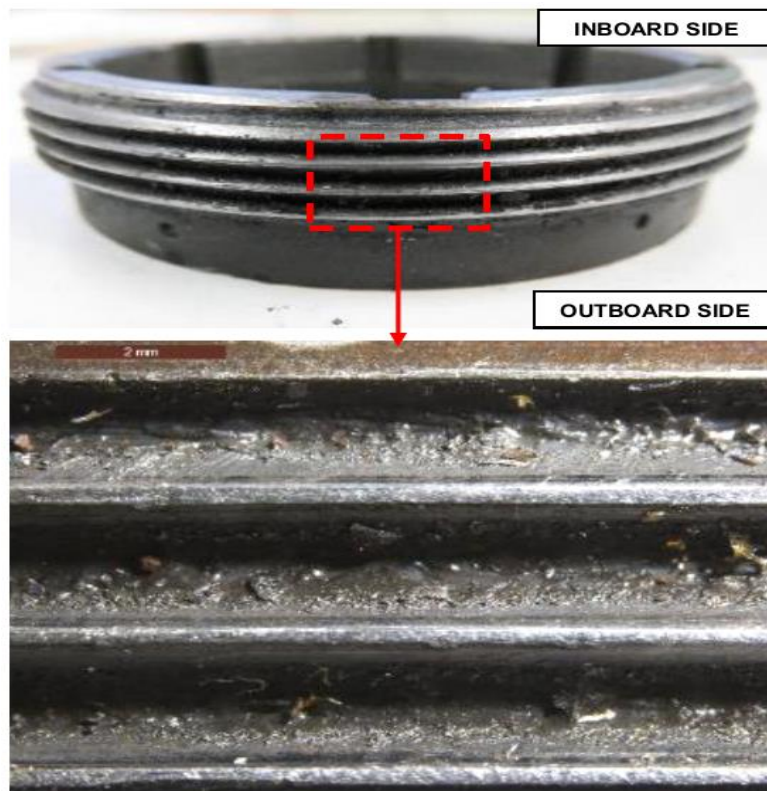
**Figure 18 – Details of the outboard locking nut covered by soil-rich duplex bearing grease and missing of the locking wires, as arrived in the laboratory.**

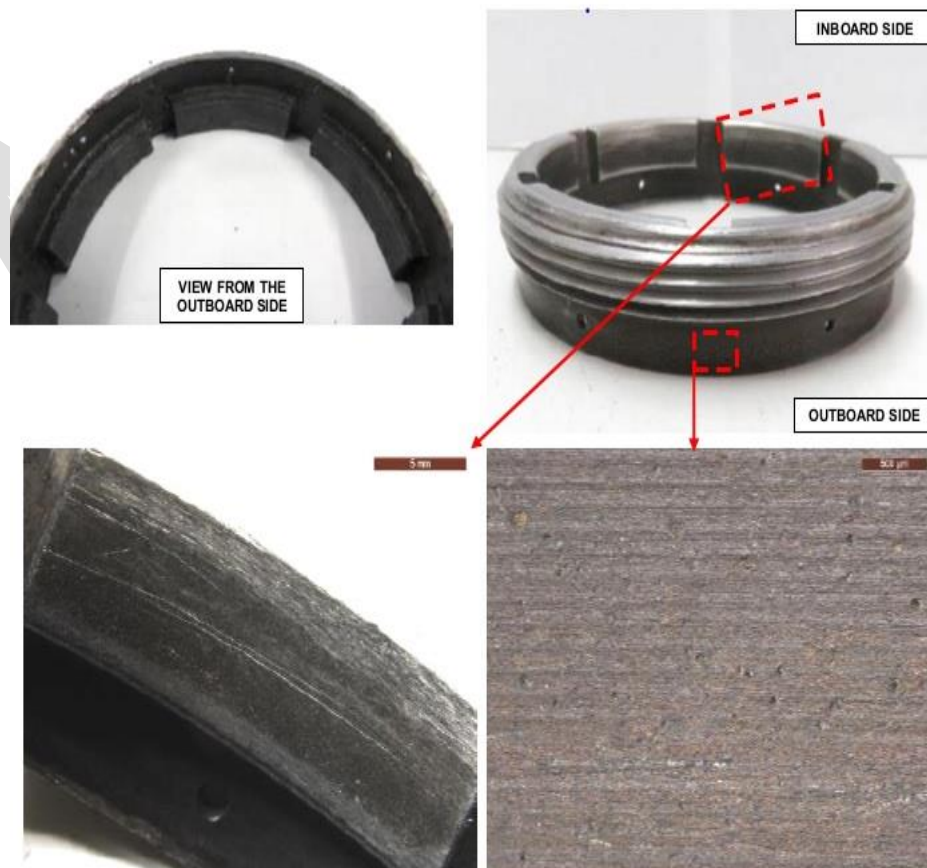
**Figure 19 – Details of the outboard locking nut surfaces after cleaning. The nut is almost completely brown in color due to generalized oxidation.**

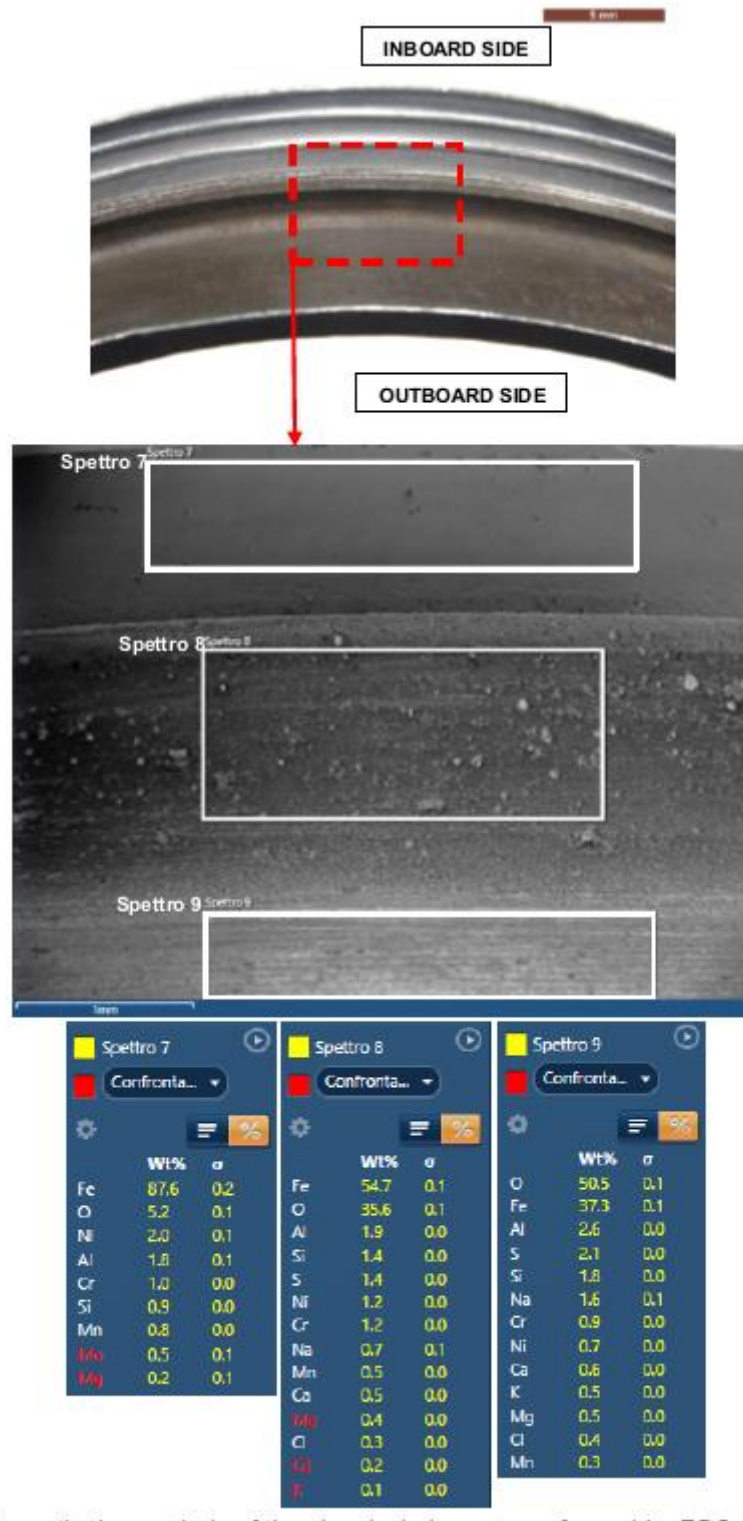
**Figure 20 – Semi-quantitative analysis of the chemical elements performed by EDS through the SEM on the outboard locking nut. Cd is almost completely absent in all scanned representative areas of the entire part. The brown areas are rich of O (Spettro 8 and Spettro 9) due to generalized oxidation, while the O amount is considerably lower in the scanned area of the thread (Spettro 7), which kept the color of the steel. All other detected elements belong to the nut steel alloy, the soil and the tail rotor parts with which the nut has come in contact in the event.**

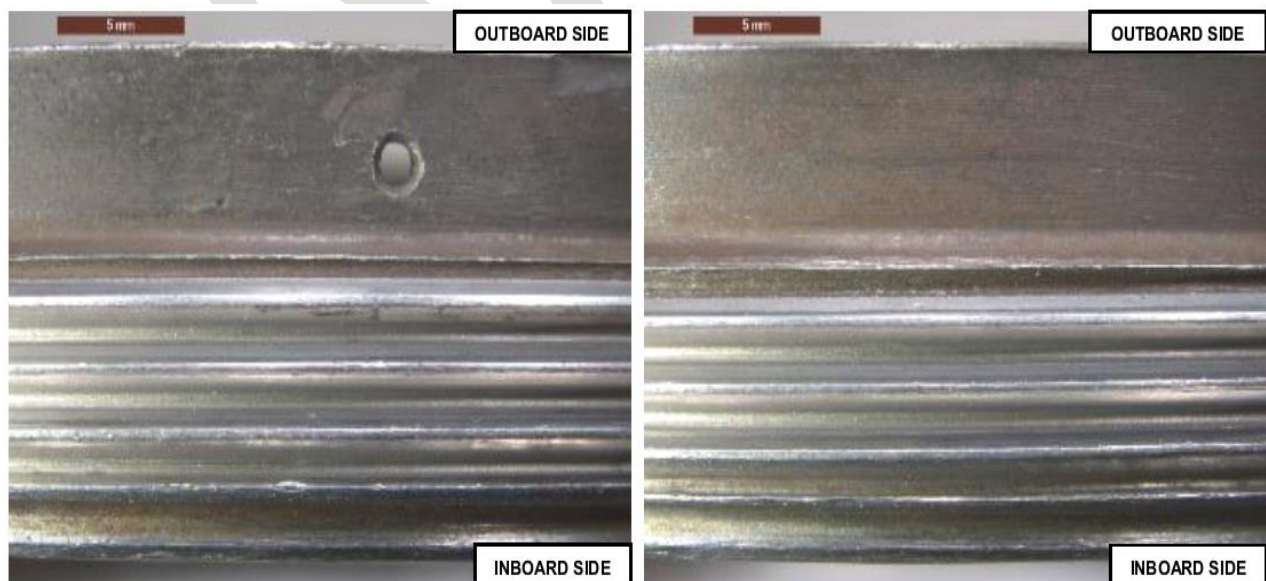
**Figure 22 – Details of the outboard locking nut thread free of thread locking adhesive (Loctite® 222)**

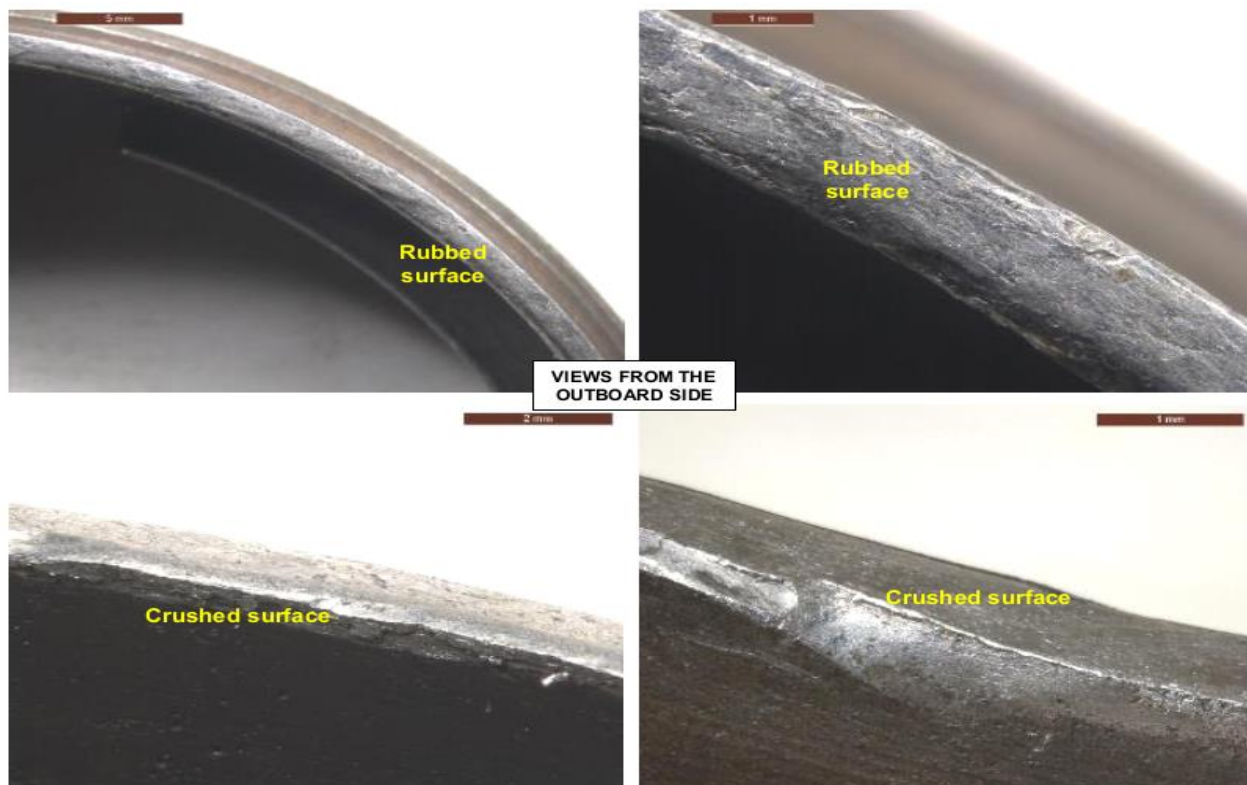
**Figure 23 – Details of the rubbed and crushed outboard circumferential surface of the outboard locking nut**

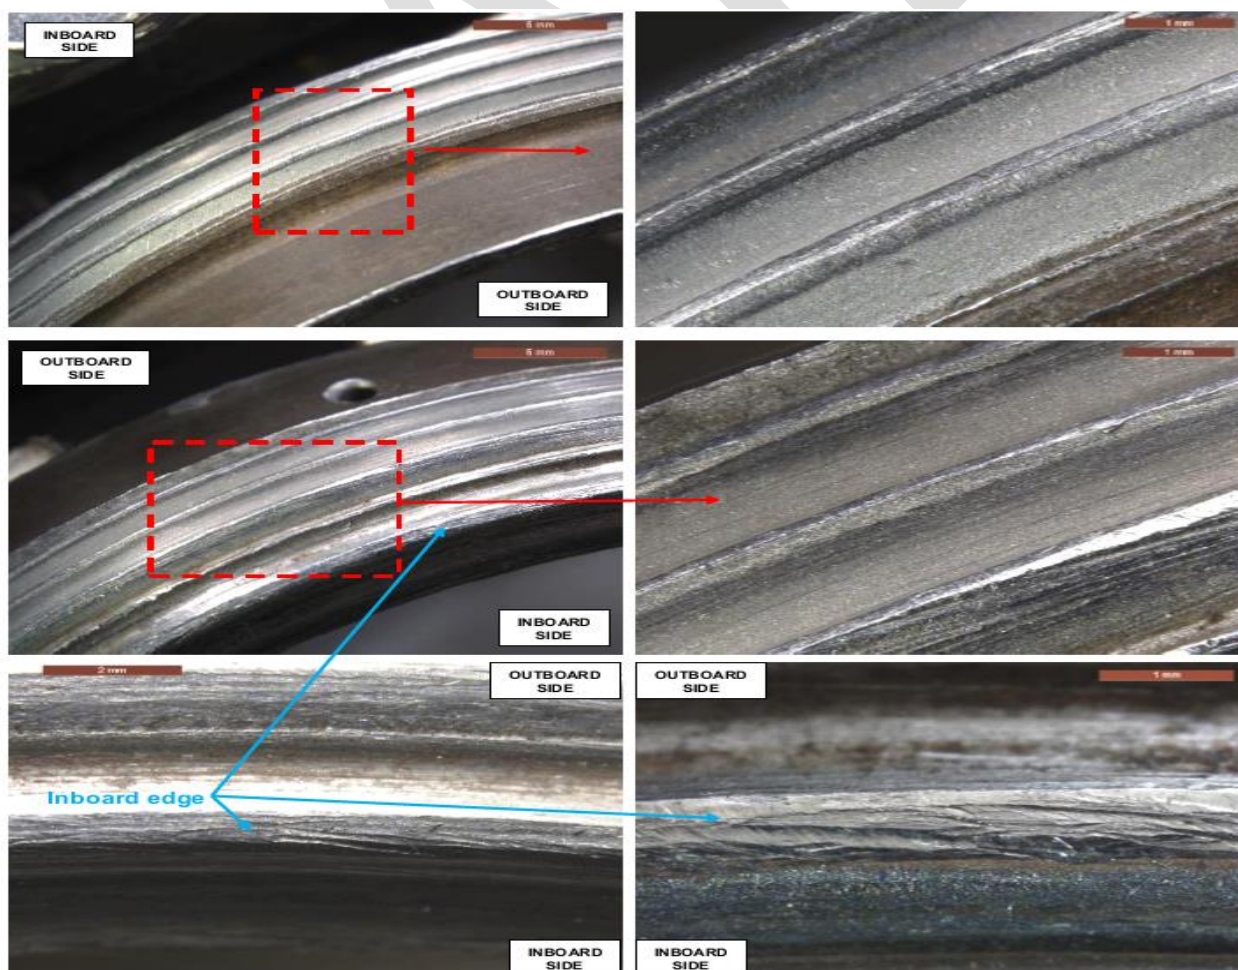
**Figure 24 – Details of the outboard locking nut threads, which do not show relevant damages. Crushed areas and oblique nicks are visible only on the two threads towards the inboard side and particularly on the inboard side edge of the nut.**

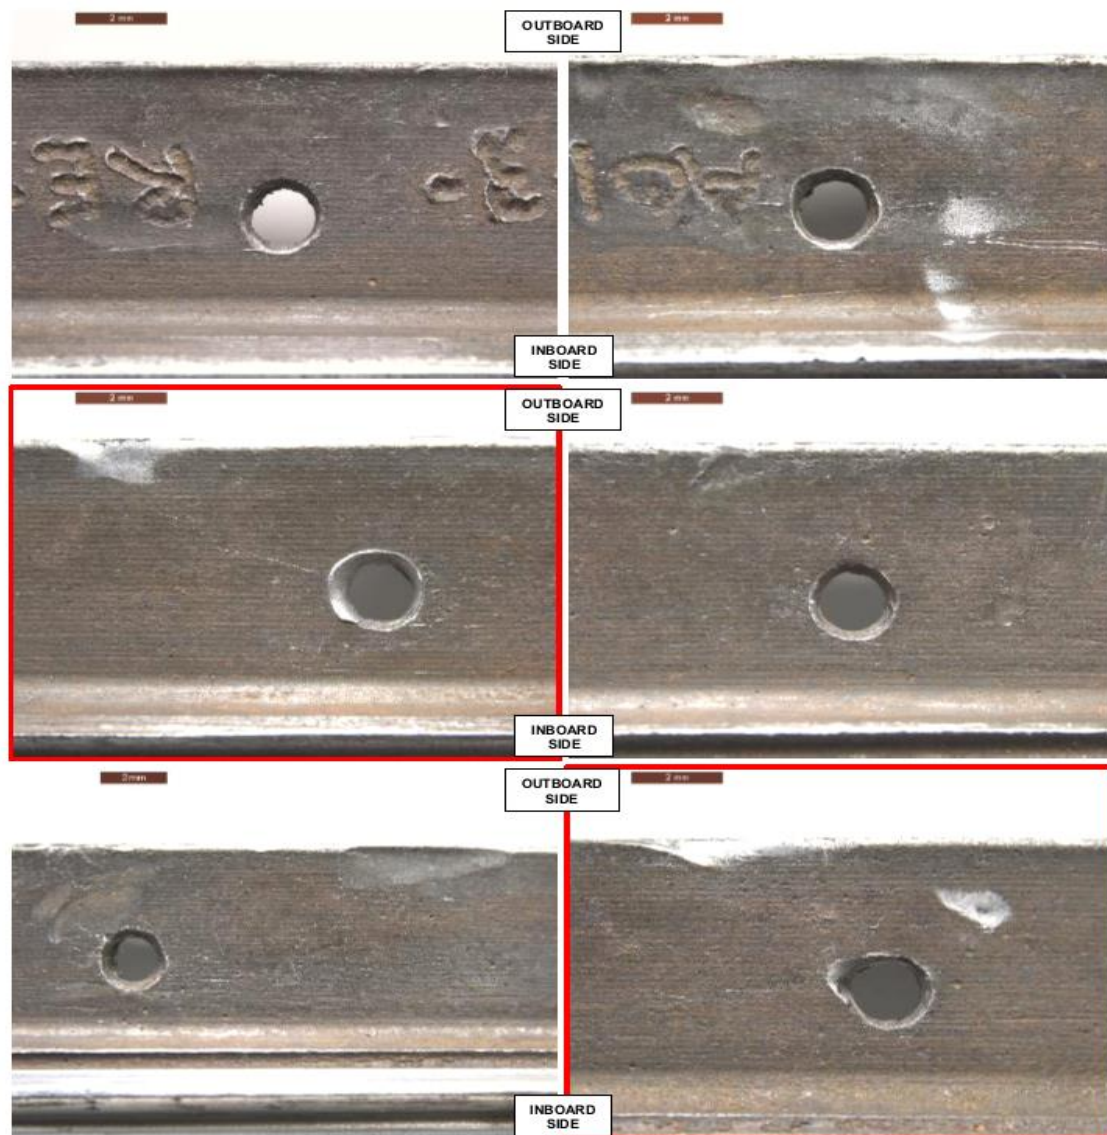
**Figure 25 – Details of the outboard locking nut holes for fixing the locking wires, observed from the outer side. All holes edges and the corresponding areas of the nut outboard edge are worn, indicating they have been used in the various tail rotor installations. All the worn areas are brown in color due to the generalized oxidation, with the exception of two holes (red rectangles), which were probably used in the last installation.**

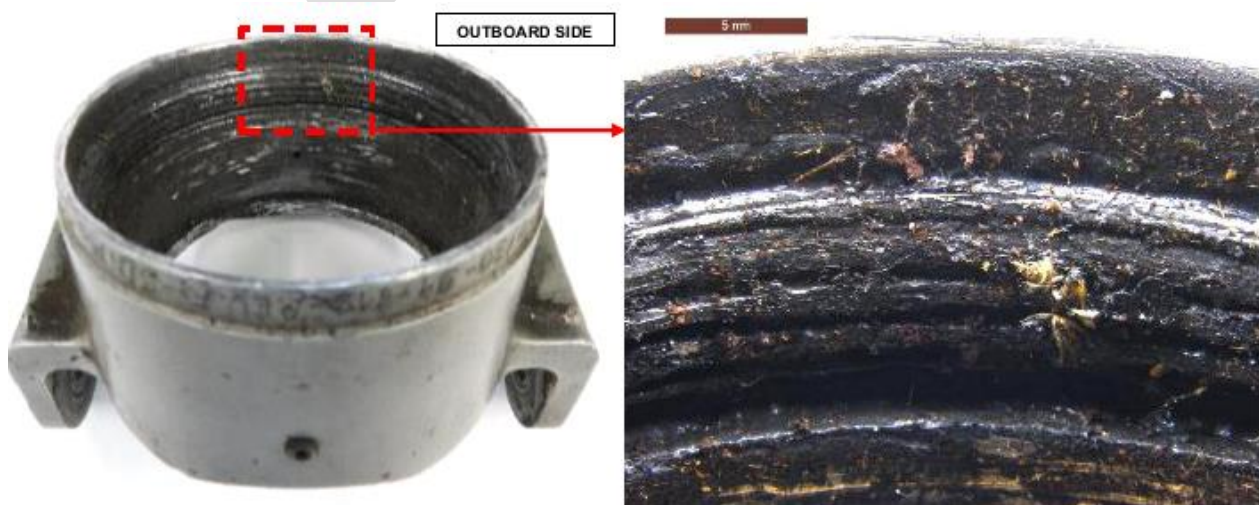
**Figure 26 – Details of the support bearing sleeve assembly with inner surface covered by soil-rich duplex bearing grease and missing of the locking wires, as arrived in the laboratory.**

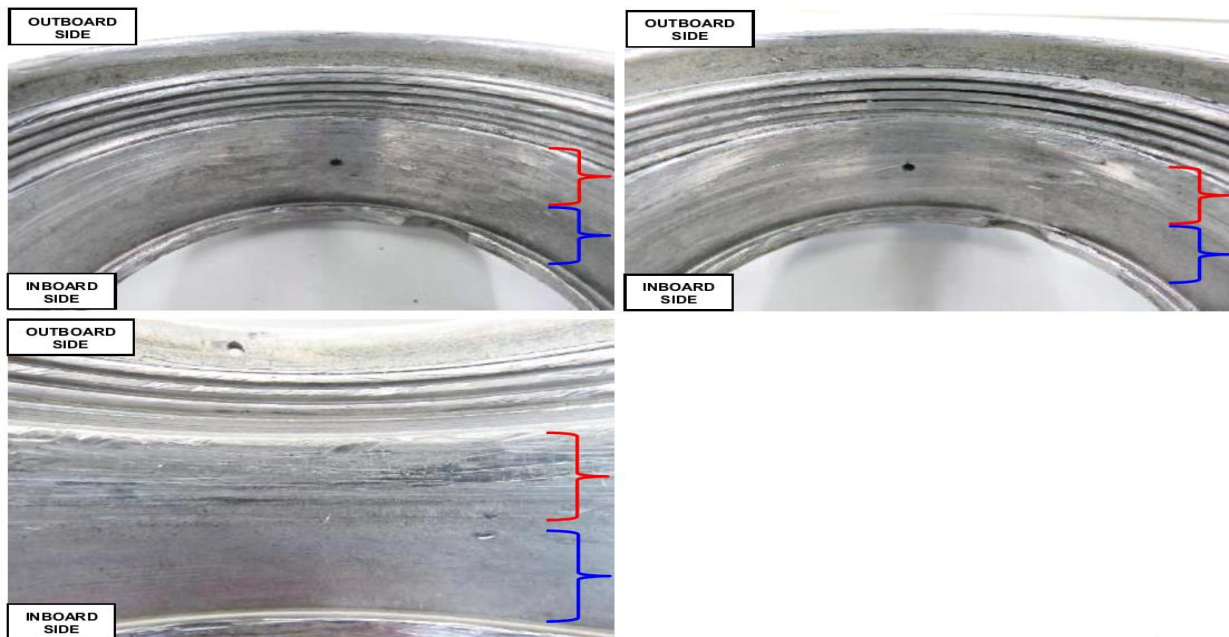
**Figure 27 – Details of the support bearing sleeve assembly inner surface after cleaning. The threads and the duplex bearing seat completely lost the yellowish color of the chromate conversion treatment required by the drawing. The inboard bearing seat (blue parentheses) shows no significant damages, while the outboard bearing seat (red parentheses) is characterized by a multitude of circumferential marks and deep inclined nicks. The nicks are also visible on the thread. These marks and nicks are showed in detail in Fig. 30.**

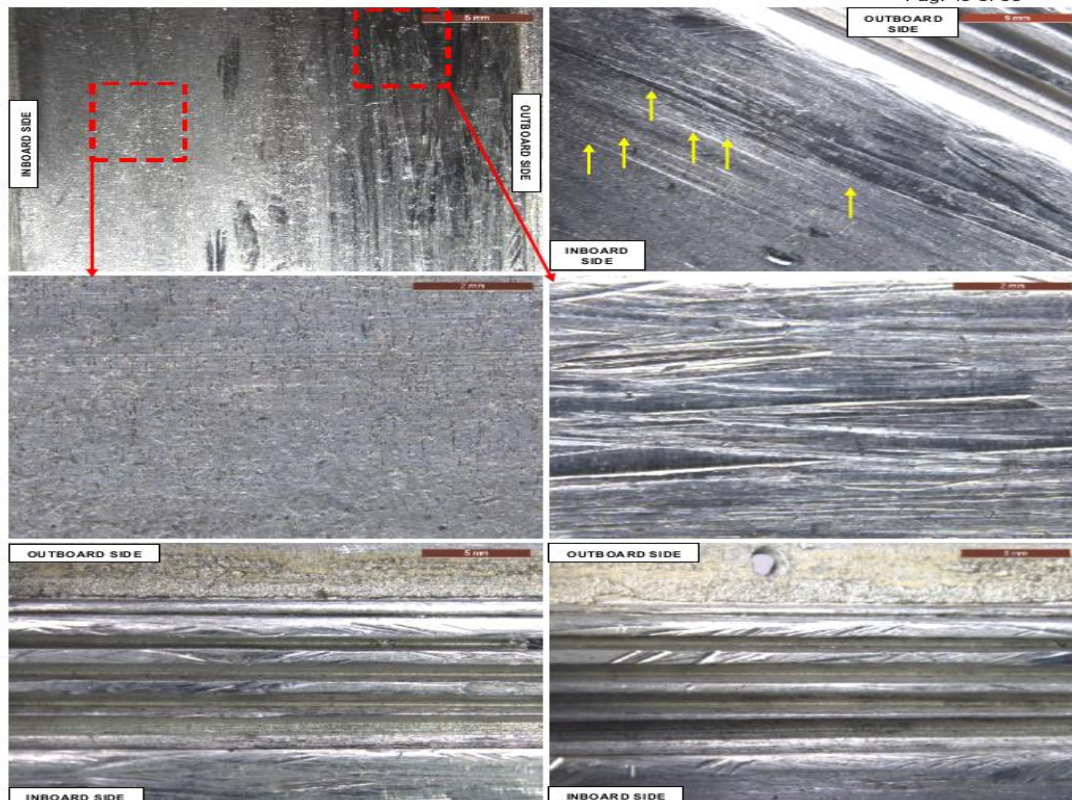
**Figure 30 – Details of the support bearing sleeve assembly inner surface. The threads and the duplex bearing seat completely lost the yellowish color of the chromate conversion treatment required by the drawing. The inboard bearing seat shows no significant damages, while the outboard bearing seat is characterized by a multitude of circumferential marks (yellow arrows) and deep inclined nicks. The nicks are also visible on the thread.**
