**FINAL INVESTIGATION REPORT ON ACCIDENT INVOLVING**  
**GOVERNMENT OF CHHATTISGARH AGUSTA A109E HELICOPTER**  
**VT-CHG AT RAIPUR AIRPORT**  
**ON 12 MAY 2022.**

**GOVERNMENT OF INDIA**  
**MINISTRY OF CIVIL AVIATION**  
**AIRCRAFT ACCIDENT INVESTIGATION BUREAU**

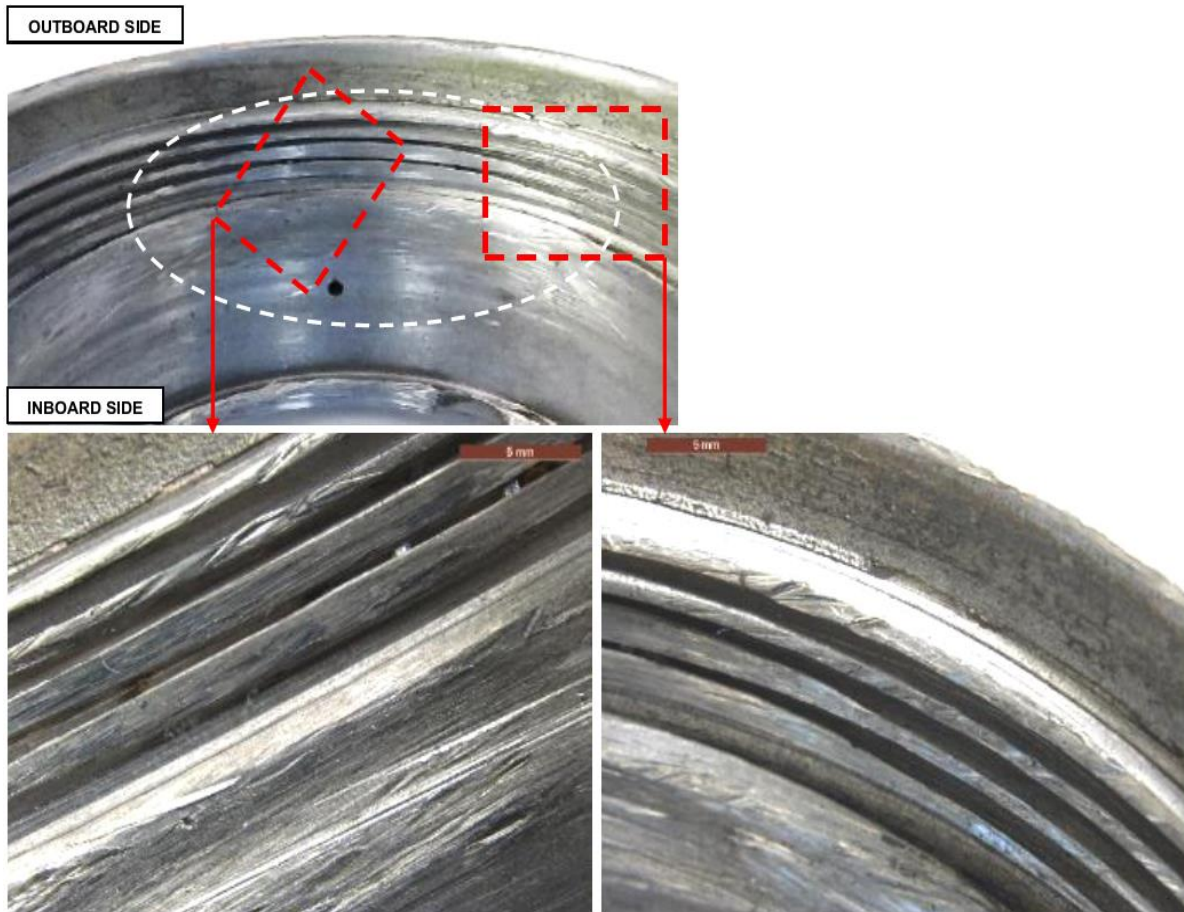
**Figure 31 – Detail of the significant crushed localized area involving the outboard bearing seat and the thread adjacent to it (white ellipse).**

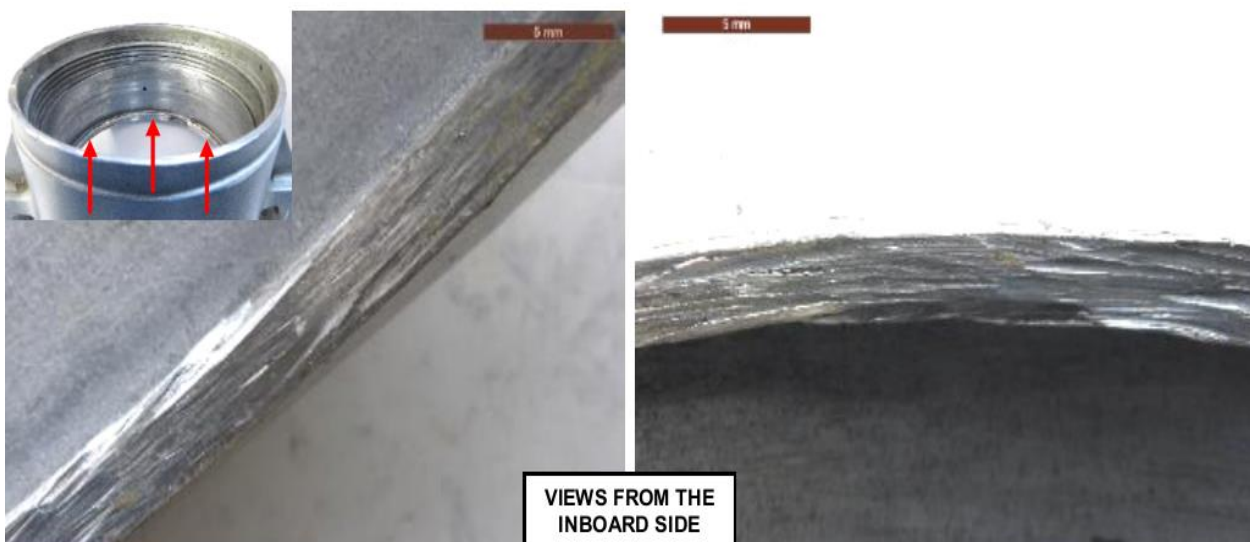
**Figure 35 – Details of some nicks visible on the side surface of the shoulder of the support bearing sleeve assembly mating with the inboard bearing (red arrows), due to the contact with the relief elements of the inboard locking nut.**

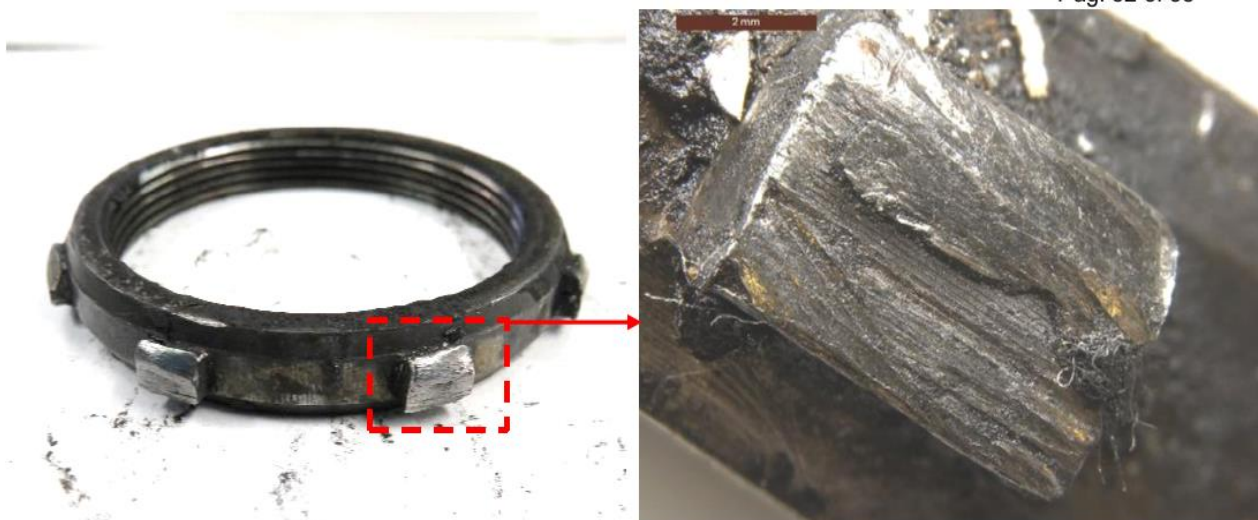
**Figure 36 – Details of the crushed areas and inclined nicks visible on the relief elements of the inboard locking nut, due to the contact with the shoulder of the support bearing sleeve assembly mating with the inboard bearing.**

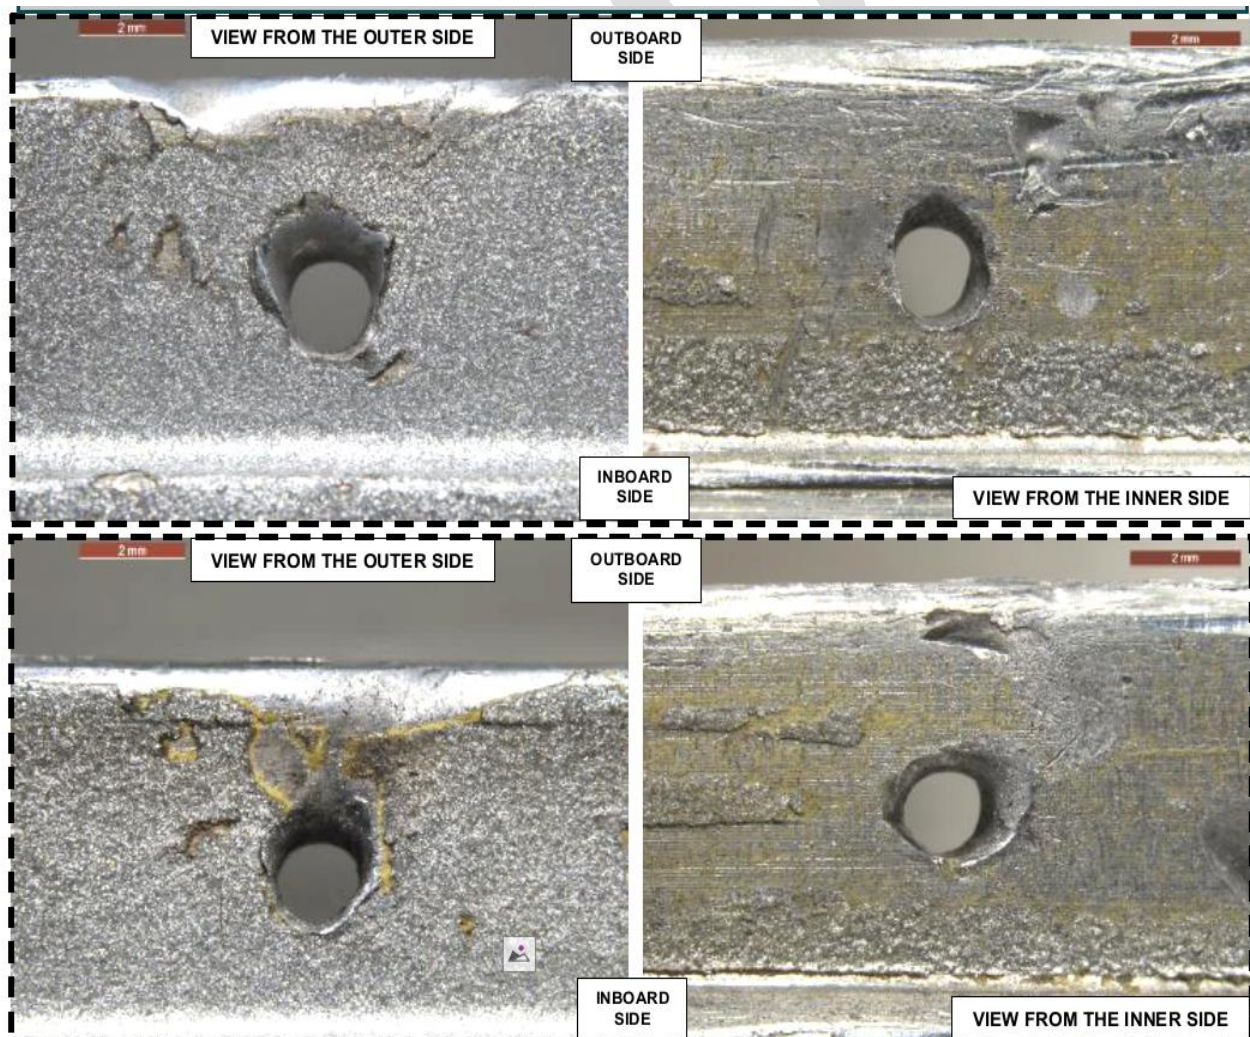
**Figure 37 – Details of the large worn areas visible at the edges of the support bearing sleeve assembly holes for fixing the locking wires, at their sides and at the support bearing outboard edge.**

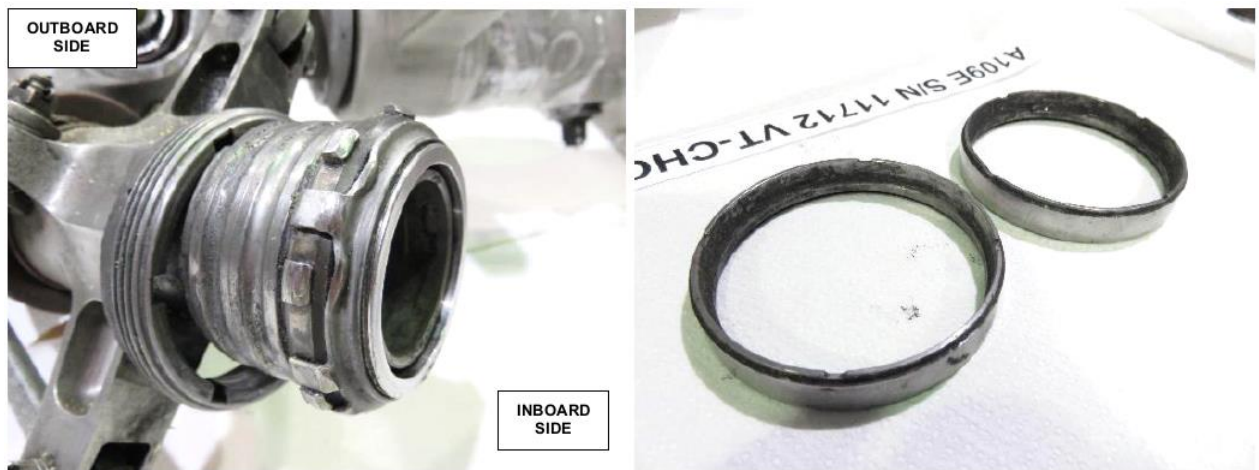
**Figure 38 – Details of the duplex bearing as arrived in the laboratory. The outer rings were separated from the inner ones.**

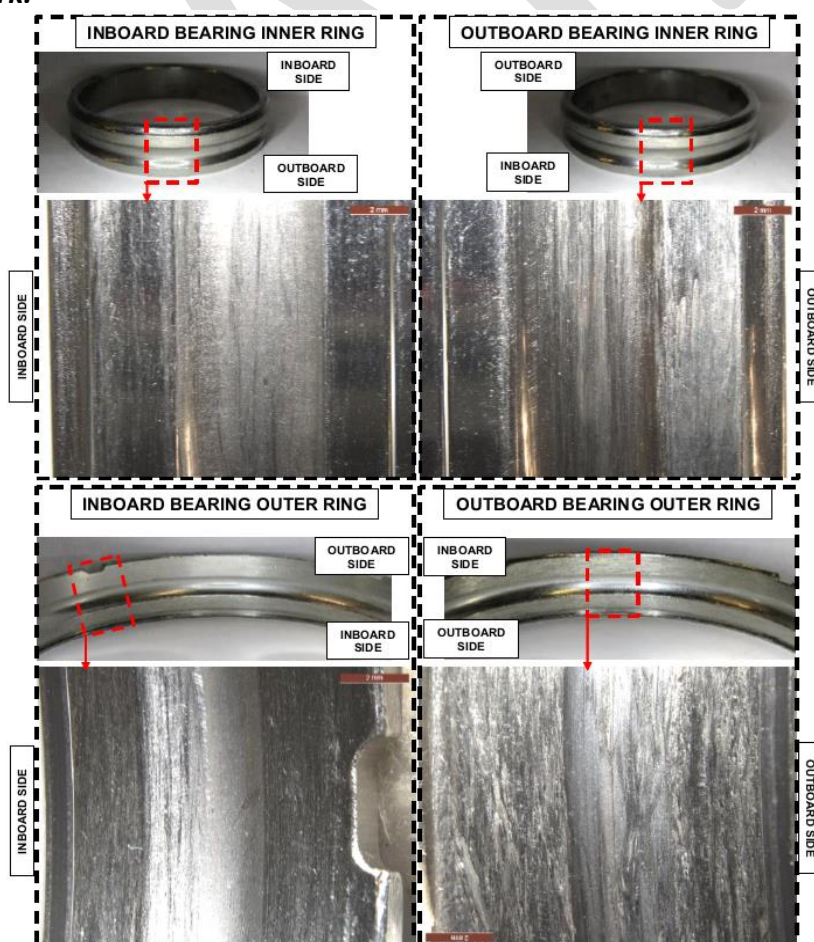
**Figure 42 – Details of the multitude of impact / slipping marks visible on the races and the surface of the shoulders at their two sides of all rings. The outboard bearing outer ring is particularly damaged.**

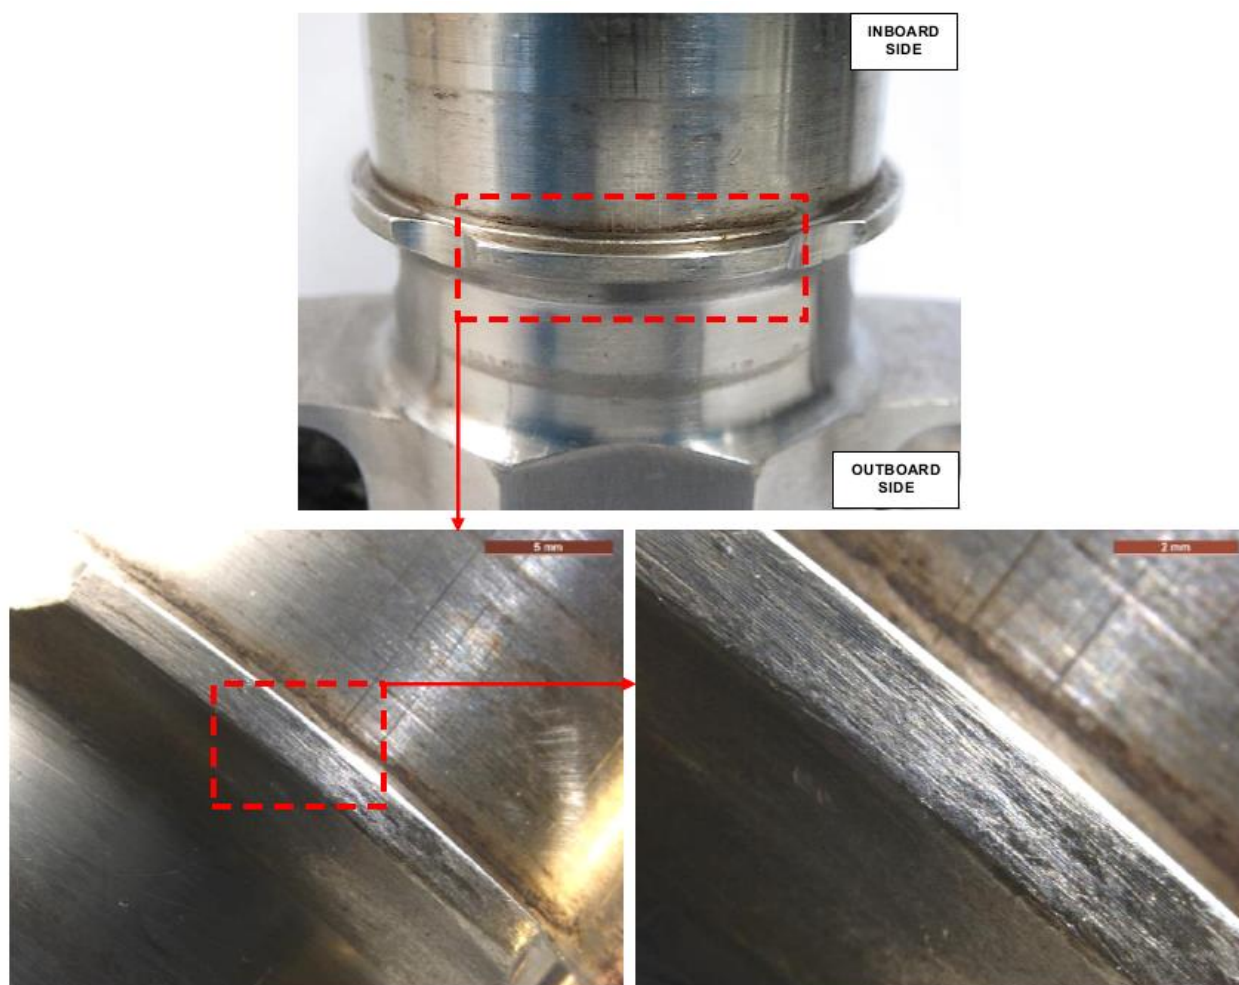
**Figure 43 – Details of the multitude of impact / slipping marks visible on the raised elements of the slider assembly.**
