**Government of India**  
**Ministry of Civil Aviation**  
**Aircraft Accident Investigation Bureau**

**Interim Report: Accident involving Helicopter Augusta AW109 of M/s Heritage Aviation Pvt Ltd bearing registration VT-EVV at Bavdhan, Pune on 02 Oct 2024**

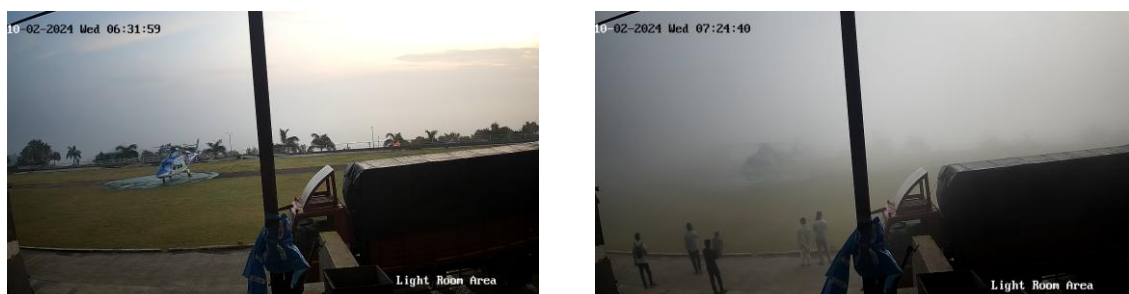
**Fig 2: Weather conditions at Oxford Helipad on Morning of 02 Oct 24**

**5.2 CCTV Footage.** CCTV footage obtained from the helipad was viewed. It was observed that the visibility at the Helipad was poor due to fog at the time of helicopter take-off. The conditions remained same till about 0400 UTC as per information given by witness.

The helipad is located approximately at an aerial distance of 10 Nautical miles from Pune Airfield in South West direction. Due to the topography and underlying terrain of the Helipad location, the weather conditions differ from those predicted for the Pune Airfield, as is evident from the CCTV footage and weather prediction.

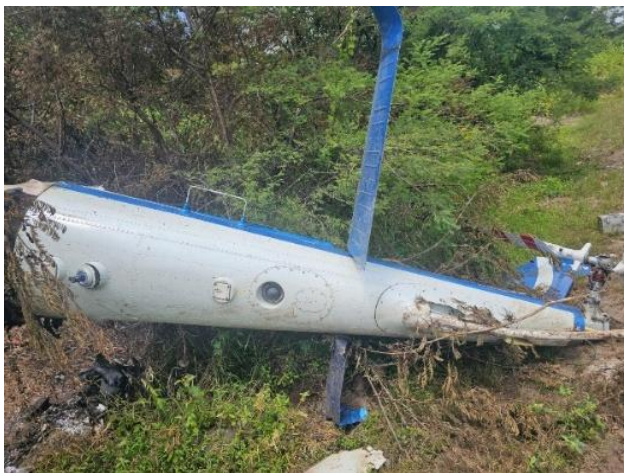
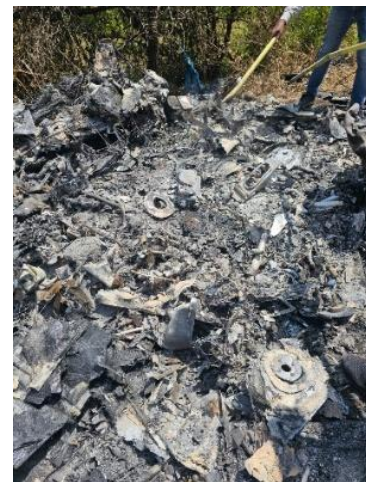
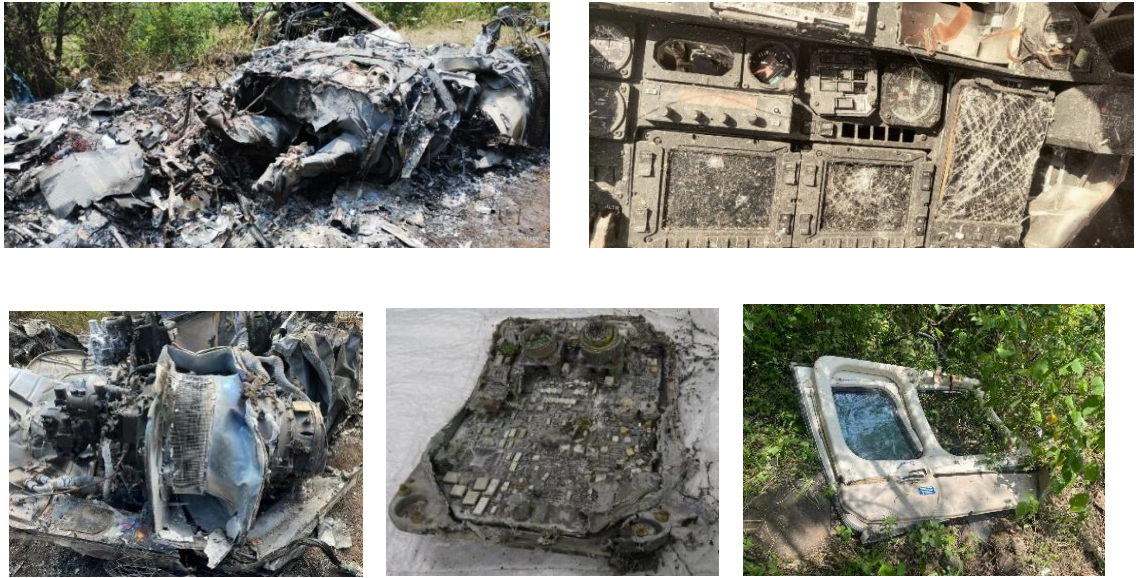
**Fig 3: Pictures of VT-EVV Wreckage**

The helicopter crashed at an aerial distance of approximately 400-420 m from Oxford Golf Course helipad. The main rotor blade touched the ground first due to the roll and pitch down attitude of the helicopter. The helicopter tumbled and due to the impact forces, the helicopter structure got disintegrated and tail portion got separated from the main body. All the three occupants sitting in the helicopter were thrown out of the helicopter along with seats. The wreckage was confined to a small area, and no damage was reported to any nearby property.

The helicopter caught fire and was destroyed in the accident. Many of the parts made of light alloy, composite material got burnt and destroyed. The Electronic Display Unit (EDU), Data Acquisition Unit (DAU), Data Collection Units (One on each engine) and FDR (only CSMU) were retrieved from the wreckage in damaged condition. The major components were heavily damaged due to fire and impact forces. The main and tail rotor blades were damaged on impact with ground. Both the aeroengines were found in the wreckage. The free turbine blades are damaged and the casing is found dented. The turbine blades of Gas Generator are available on the rotor and could be rotated with hand. Many of the gauges and display on the instrument cluster were broken/damaged. Some of the electrical looms are burnt. Due to the impact forces, the spring mechanism inside the switches is also damaged. No fuel or oil sample from the helicopter could be collected as the helicopter had caught fire and all the fuel and oil were burnt.

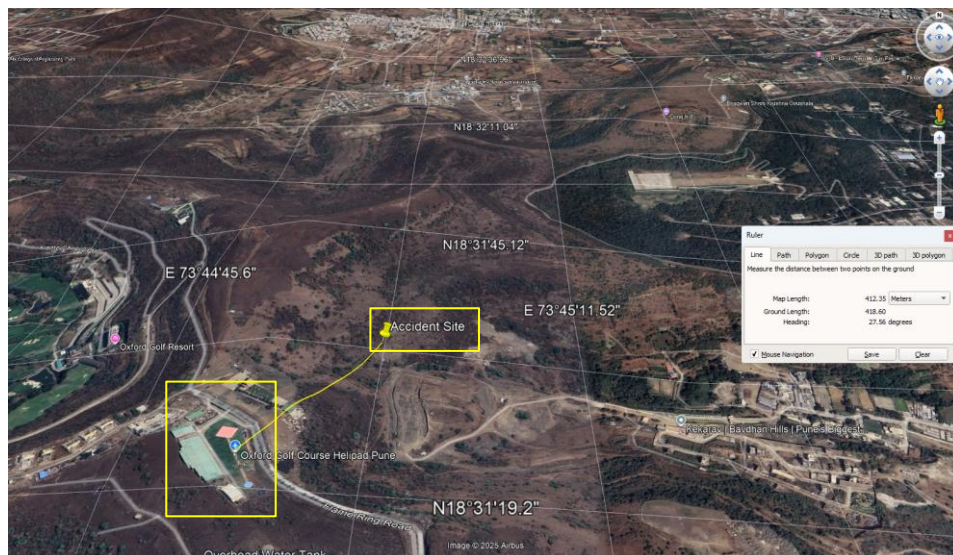
**Fig 4: Location of Accident Site and Helipad**

The coordinates of the accident site are 18° 31'33.94" N, 073° 44'58.09" E. As per FDR data, the helicopter was on a heading of 033° at the time of impact.

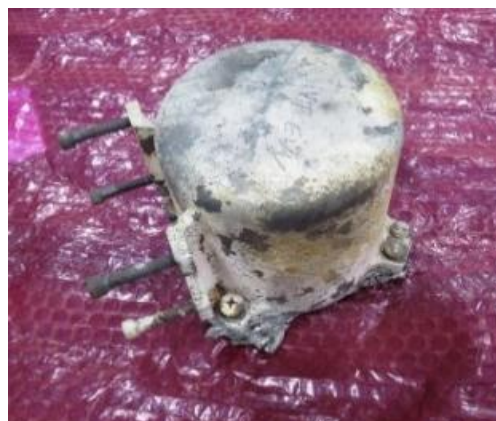
**Fig 5: CSMU of the FDR: VT-EVV**

**8.1 Preliminary FDR Analysis.** The Chassis of the FDR along with the circuit boards was heavily damaged due to fire. Only the CSMU of the FDR was found in burnt/damaged condition at the accident site. The cables, connectors and chassis of the FDR equipment had burnt in the fire. The data from the burnt CSMU of the FDR equipment was downloaded at ANSV facility at Italy.

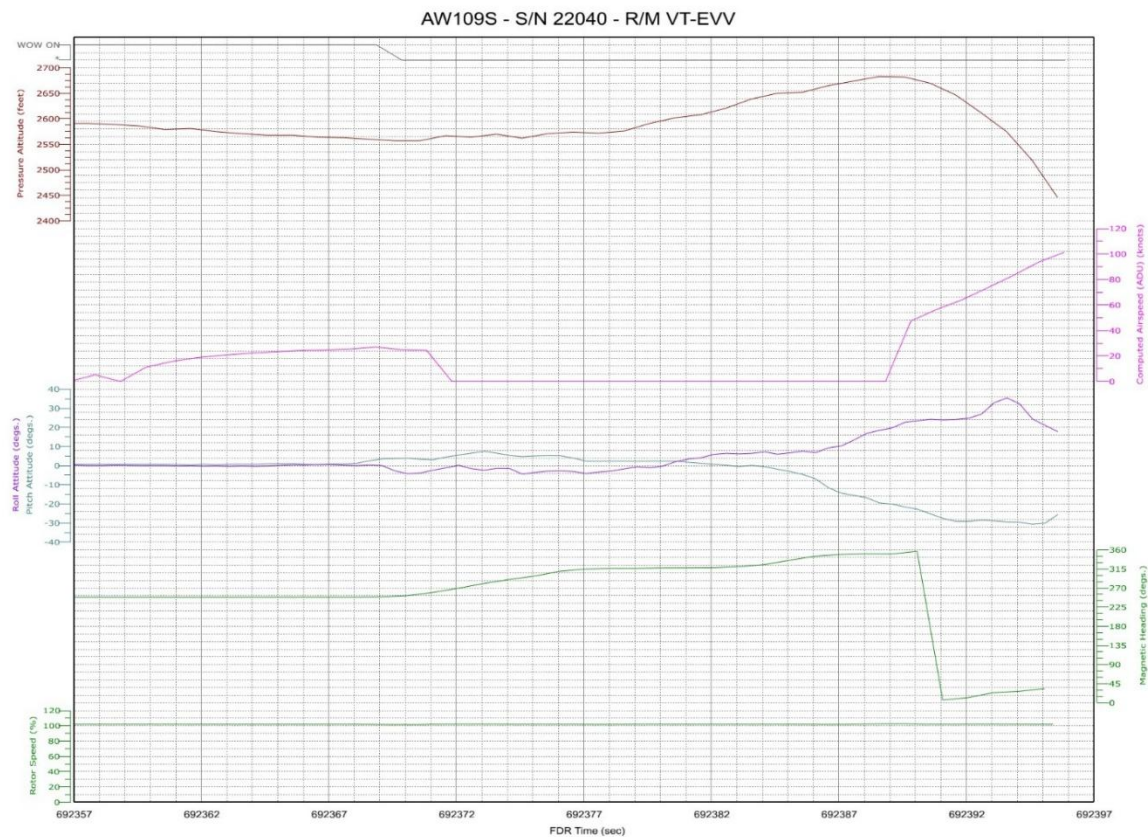
**Fig 6: FDR Parameters**

The FDR data reveal that the helicopter flew for about 26 sec after take-off from the helipad. Immediately after lift-off, the helicopter made a (on the spot) right hand turn changing the heading from 248° to 315° in about 8 sec. Thereafter, it started gaining height. The helicopter gained a maximum height of approximately 93 feet from the point of take-off in about 11 sec, before it started descending/losing altitude. At the time of impact the aircraft was approximately in 30° pitch down attitude with 35° roll to the right and on a heading of 033°. The place of impact is approximately at a height 2450 feet AMSL. The total time from engine start to the impact is 220 sec. Preliminary analysis of the FDR does not show any abnormality in Hydraulic pressures, Engine EGT, oil pressures and electrical voltages. The spectrum analysis of the engines is being attempted with the available CVR data. The Fuel quantity recorded in FDR previous day after landing at Oxford Golf Course Helipad and the one recorded in Tech Log is matching. The pressure altitude recorded on the FDR is similar to the AMSL altitude of Oxford Helipad and the crash site. Further analysis of the controls input and other parameters is under progress.

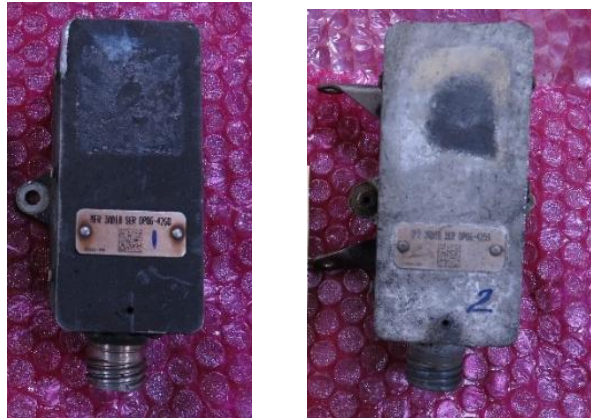
**Fig 7: DCU of Engine 1 and 2**

**8.2 DCU Analysis.** The DCUs retrieved from accident site were also burnt and damaged. The Data Collection Unit (DCU) of the two engines were sent to TSB Canada for downloading and analysis of the aeroengine related data. On opening the DCU it was found that the circuitry was significantly burnt and most of the components had separated from the boards. Also, some of the chips have been destroyed. The data could be obtained only from the DCU of Engine No BH0095. Data from DCU of Engine No BH0093 could not be retrieved as it was damaged. The

analysis of the decoded data indicate that the engines were running at power and coupled to the main rotor.
