**on 01 May 2022**

## Ministry of Civil Aviation

## 1.3 Damage to Aircraft

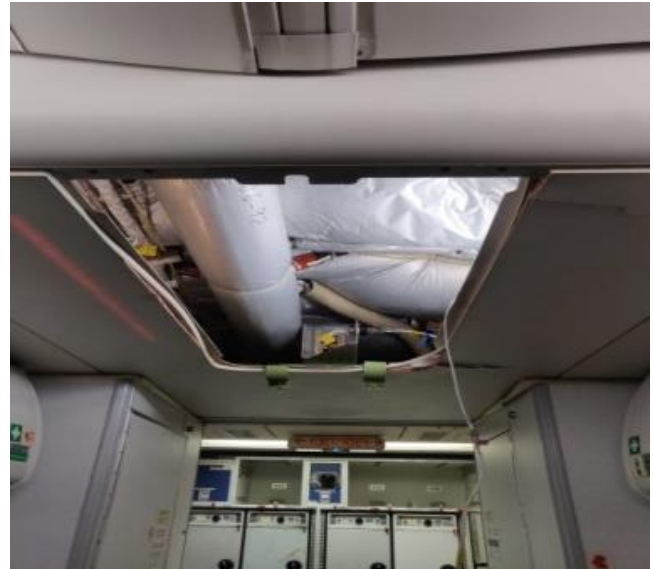
Figure 1

However due to severe Weather encountered, the cabin of the aircraft was damaged at various places. Impact Dents were observed in cabin ceiling at various places. These damages were noticed over seat numbers 16D, 21D, 22D, 23D, 25D, 30D, 31D. Overhead panel above seat number 32 row was damaged and required replacement.

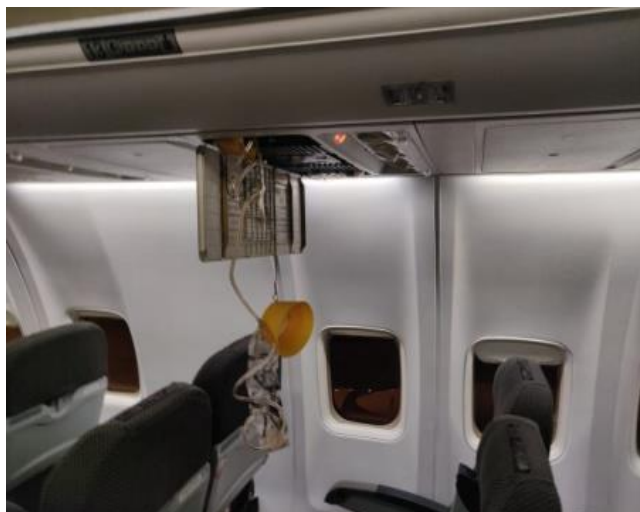
Figure 2

Oxygen mask from Passenger service units, above seat numbers 10ABC, 25ABC, 30ABC, 31DEF, 27DEF, 13DEF, and 10DEF had fallen off from their units. Oxygen generators in passenger service units above seat nos. 10ABC, 11ABC, 31DEF and 32ABC required a replacement. Nineteen

Passengers Service Units (PSU) were found either damaged/ loose. The corresponding seat no. of the PSUs are 7DEF, 8ABC, 8DEF, 9ABC, 9DEF, 10DEF, 11ABC, 11DEF, 15DEF, 16DEF, 17ABC, 19ABC, 19DEF, 21DEF, 25ABC, 26DEF, 27DEF, 29ABC, 31DEF. Four seat handles for seat no. 13BC, 16A, 27C, 17DEF were found broken. Cabin hat rack lock was found broken for seat no 30ABC. Packing foams were found dislocated and coming out for seats 4 ABC and DEF. Call lights lens were missing for seats 17ABC, 19ABC, 26 DEF.

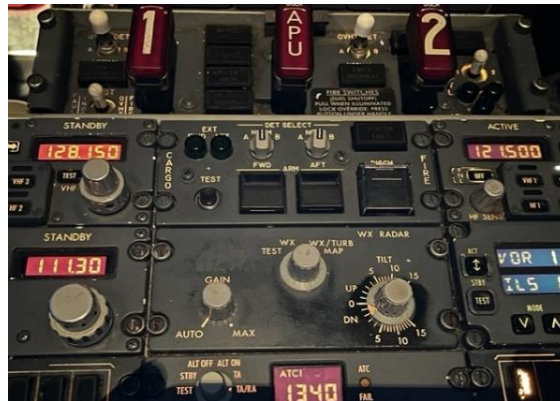
Figure 6

1. Wx Radar knob paint is worn out. During night flights, it is difficult to ascertain the required setting for better weather avoidance strategy and planning.

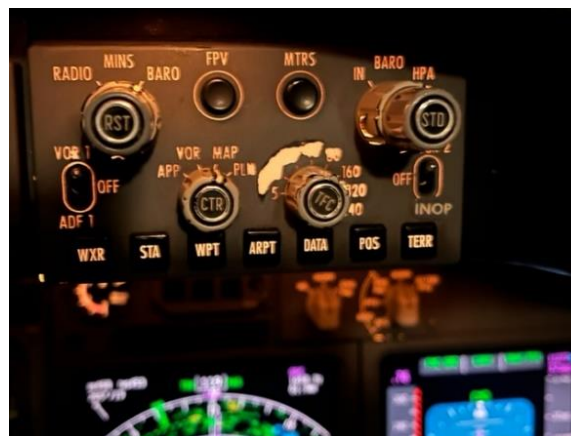
Figure 7

2. EFIS Control Panel (P2 side), the range figures are not readable at all to the pilot.

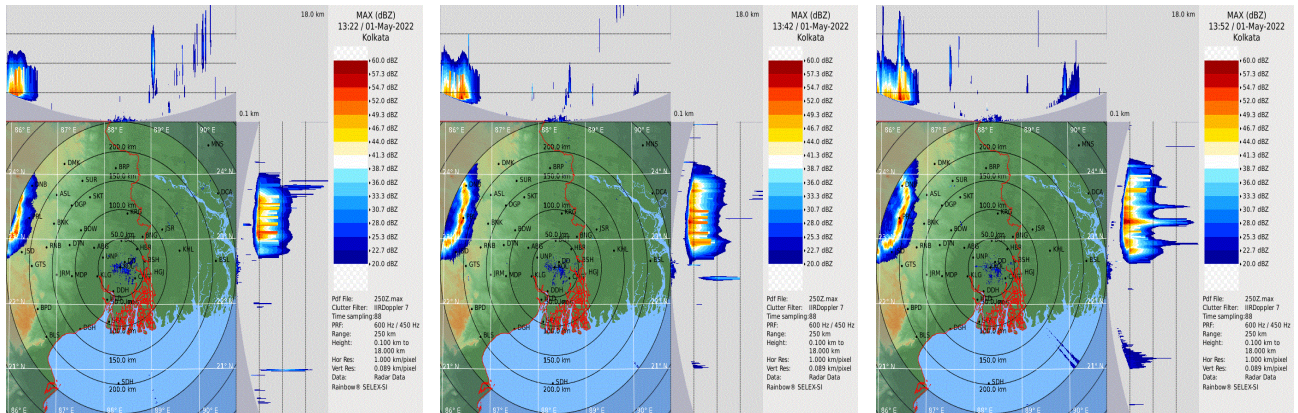
Figure 8 : Kolkata Doppler Radar images

The weather images obtained from Kolkata Doppler Radar show significant weather buildup in the flight path enroute Durgapur. The Doppler images of 1322 UTC, 1342 UTC and 1342 UTC (Figure 8) and later till 1502 UTC show weather buildup moving eastwards.

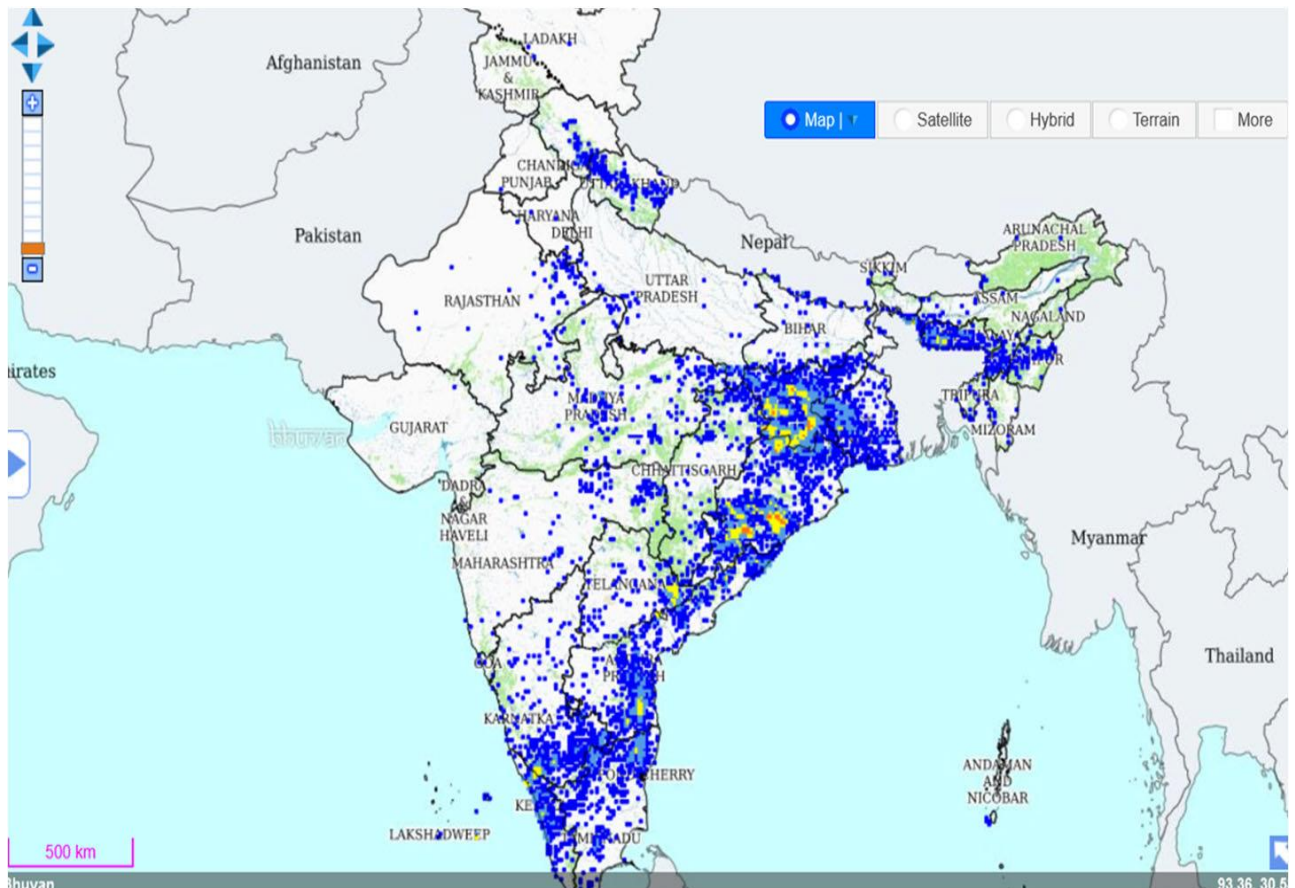
Figure 9: Lightning presence

The figure 9 shows the lightning image provided by Boeing for May 1. It indicates a significant amount of lightning present in the flight path taken by VT-SLH. The temporal resolution of this tool is poor, but the shape of the lightning matches the shape of the thunderstorms from radar and satellite imagery. There is high concentration near the incident location which is also matching the strongest satellite indicated storm position.

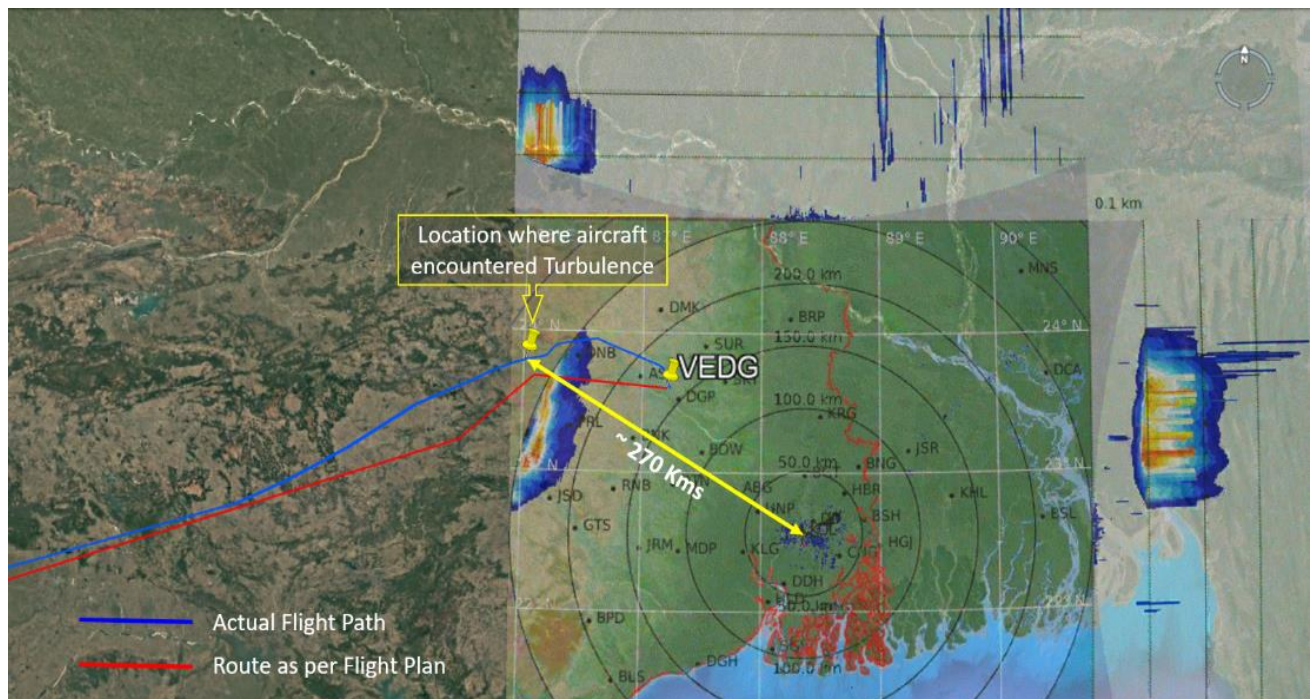
Figure 12

The bad weather patch was west of Durgapur, extending from North to South. The weather was across the flight path to destination Durgapur and the overall length of the weather patch was more than 160 nm. It can also be seen from the flight path plotted on satellite map that the aircraft had deviated from the route to be followed as per flight plan. The weather images from Kolkata Doppler Radar showing weather up to 250 Km from Kolkata weather station were obtained. The images for the time ranging from 1322-1502 UTC (Figure 15-24) shows that the weather patch was advancing eastwards with time.

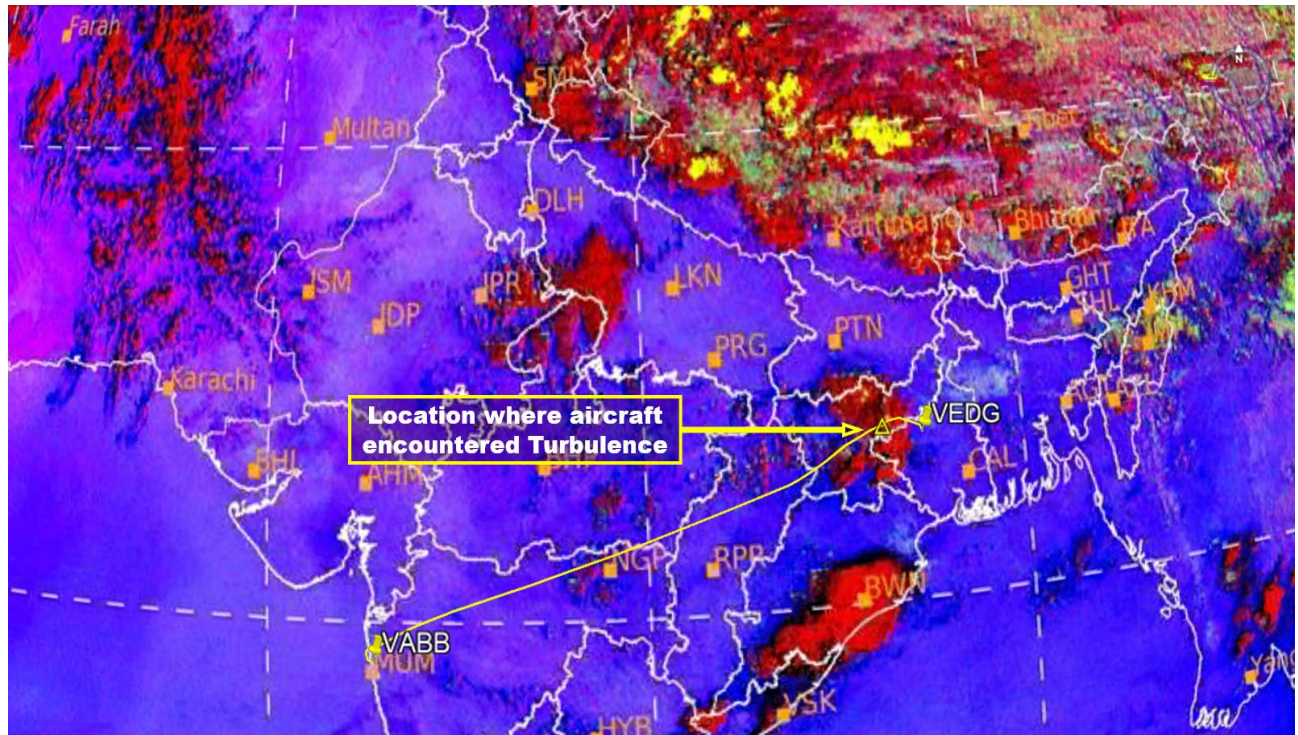
Figure 13

Further, by plotting the location over INSAT-3D weather image of time 1300-1326 UTC it can be seen that the flight path crossed through an area surrounded by CB clouds (Figure 13)
