Final Investigation Report on Serious Incident: Airprox

AeroLogic, Boeing, B77F, German, DAALJ (BOX622)

**Air Arabia, Airbus, A320-214, United Arab Emirates, A6AOS
(ABY405)**

04 May 2025 in Mumbai FIR (INDIA)

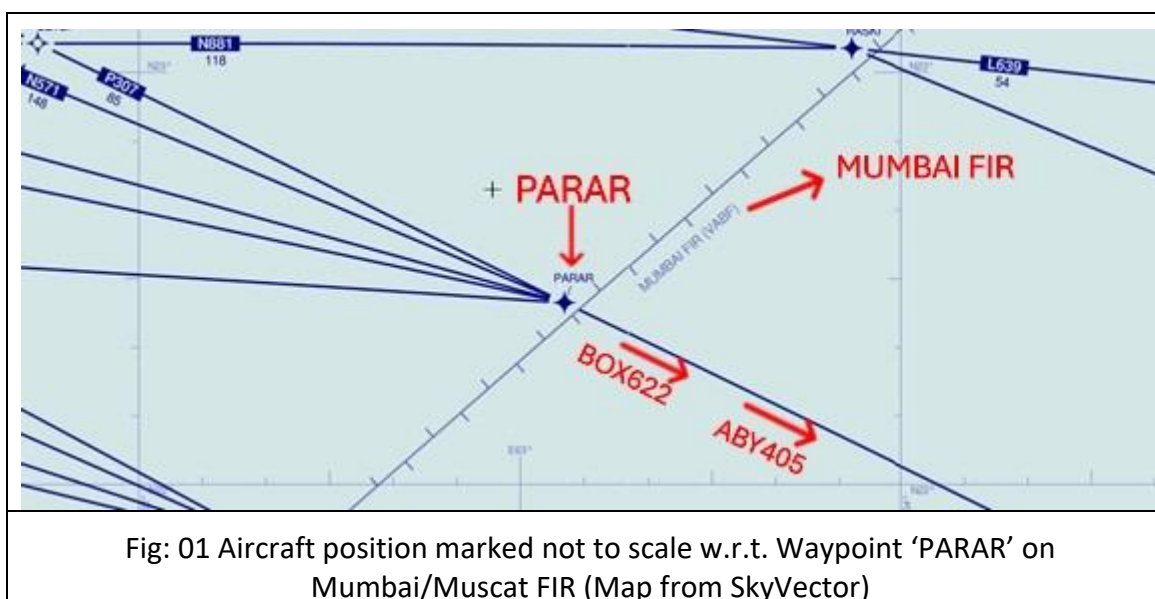
ABY405 was ahead of BOX622, with both scheduled to operate on the same route but at different flight levels at waypoint PARAR, which lies on the Muscat/Mumbai FIR boundary (refer Fig: 01).

The flight paths of both aircraft converged at Waypoint VAXIM, from where they continued on the same route segment (P307 to PARAR and then N571 to SUGID). Between VAXIM and PARAR, both aircraft were under the control of Muscat Control – Sector Alpha. Subsequently, they were handed over to Mumbai OCC (North) via High Frequency (HF) communication.

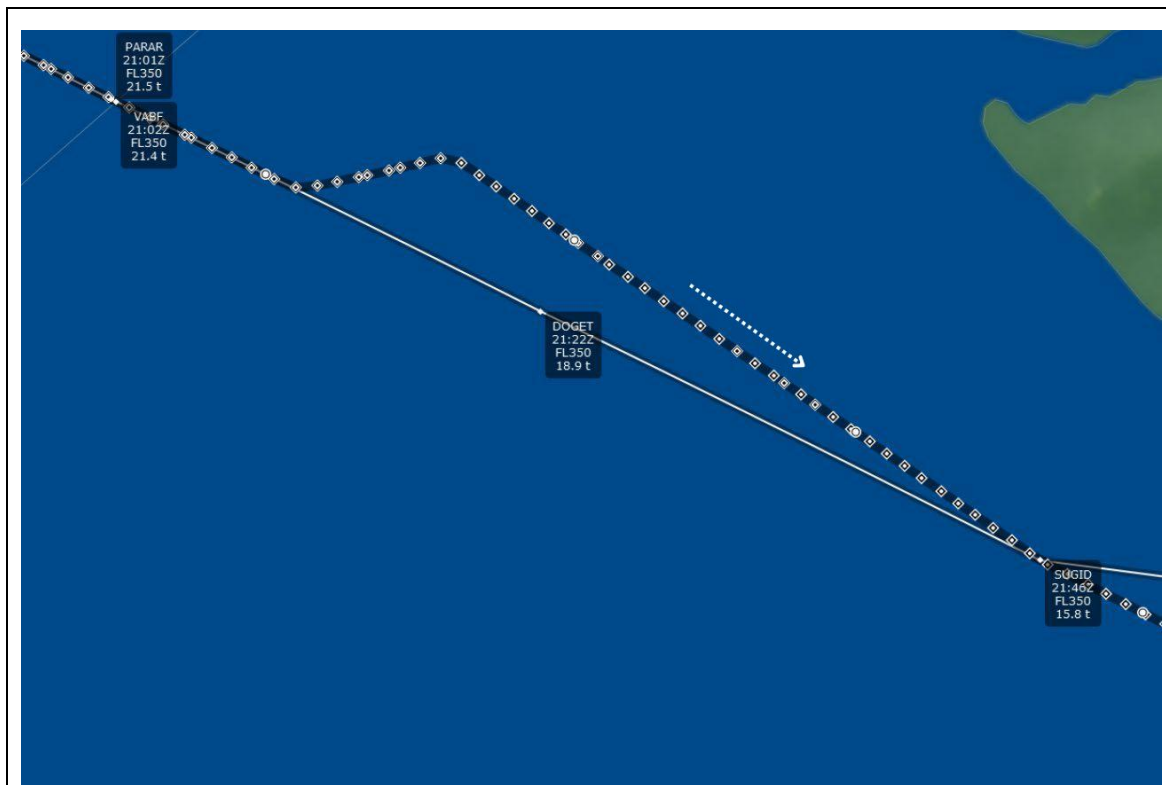
As per FDR data for BOX622 the track followed by the aircraft was as shown in Fig: 04. The deviation was due to instruction given by ATC Mumbai OCC (North) to resolve conflict. The Controller took BOX622 left of track to provide standard separation from ABY405 and other preceding and succeeding aircraft. He descended BOX622 to F310 and directed it to proceed direct way point 'SUGID'.

Fig: 04 Dotted track given by Mumbai OCC (North) descending to FL310. Solid track is the filed route which was supposed to maintain FL350 by BOX622 . (Data from Aerologic safety management)
